# **Geo-environmental Ground Investigation Report**

**PROPOSED RESIDENTIAL DEVELOPMENT**

**LAND OFF MOOR LANE, GOMERSAL**

**E22/7944/R002**

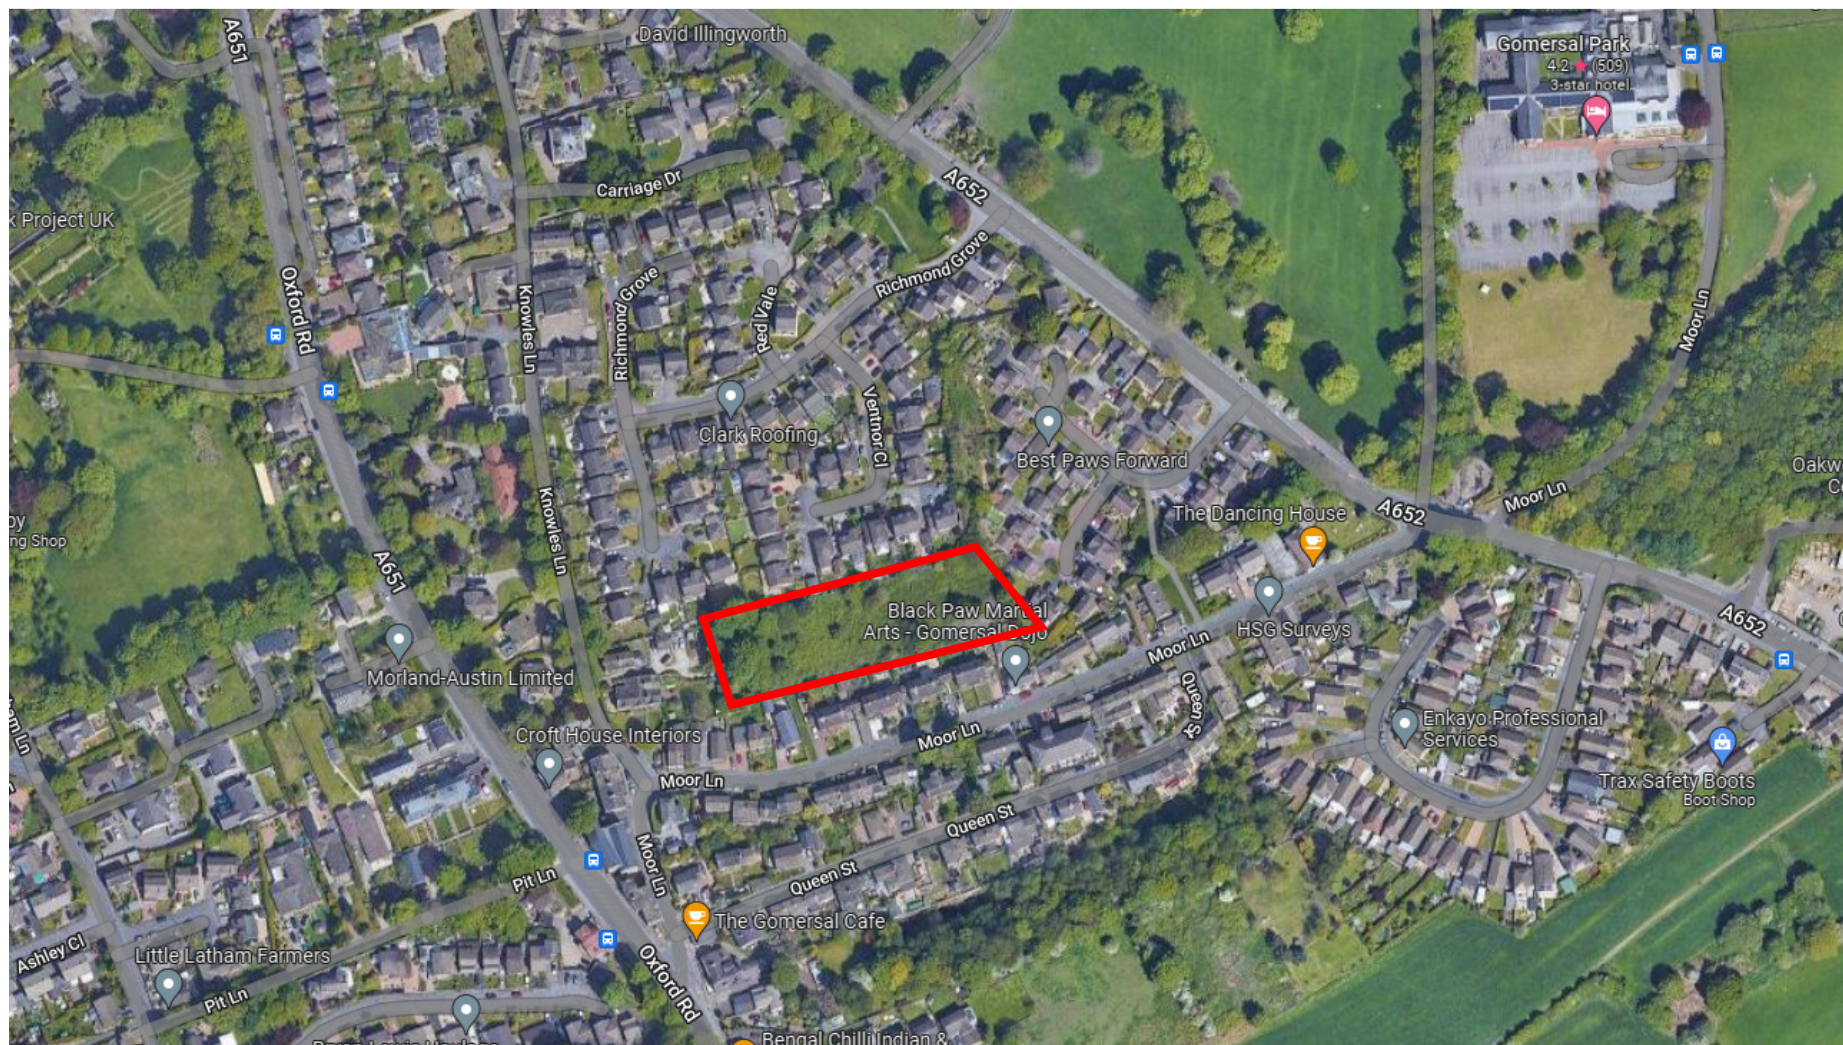
**Section through site**

- Upper coal seam – 0.3m thick coal seam encountered at depth 7.6-7.9m in BH04 in the west of the site. Likely outcrops between BH04 and BH03.
- Middle coal seam – 0.2-0.3m thick coal seam encountered at depths of 1.5-14.1m in TP101, BH01, BH02 and BH04. Likely outcrops near the eastern boundary and passed below BH03 which only extended to 10m in depth.
- Lower coal seam – 2.0m thick coal seam encountered at depth of 21.0-23.0m in BH01. A 3.1m depth of broken ground was encountered in BH02 at 25.8-28.9m below existing ground levels indicating that this seam had been worked. Due to the dip of the coal and the gradient of the site, this was below the depth of BH03 and BH04.

If the coal strata is encountered within the foundation, the coal seam should be immediately sealed to prevent spontaneous combustion. Any foundations should be taken beneath the coal seam to the underlying natural strata.

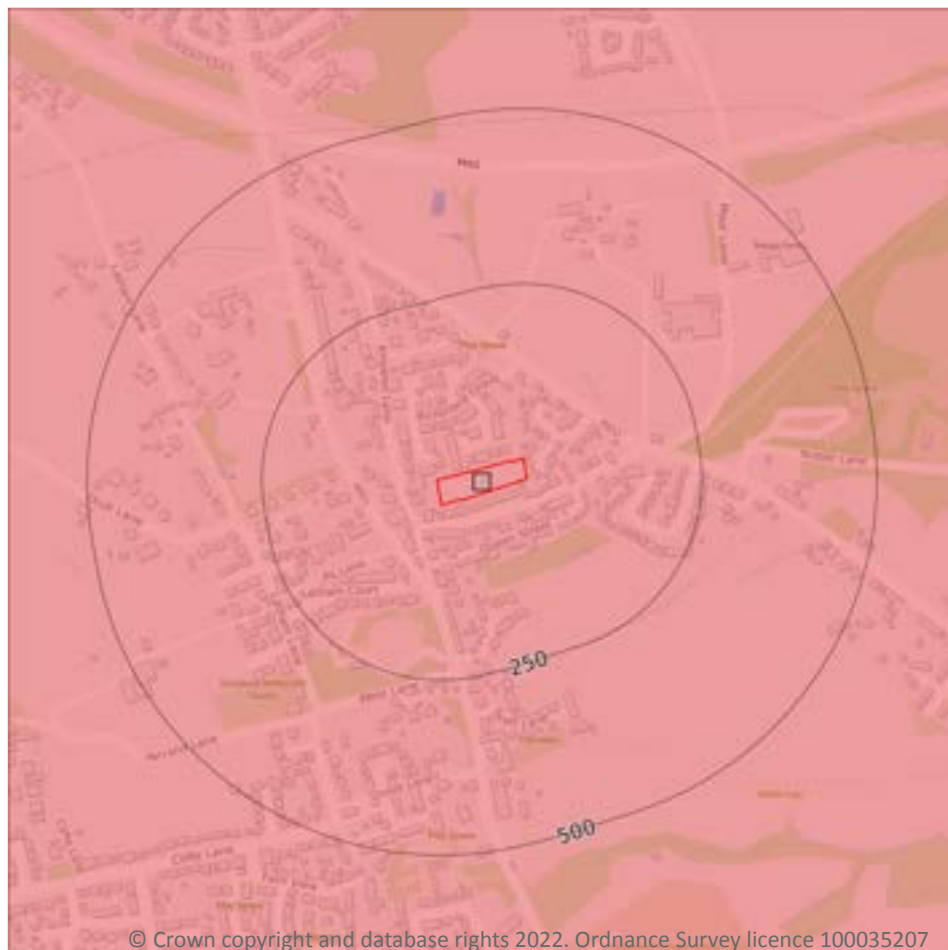
## Bedrock aquifer

| ID | Location | Summary | Soil / surface | Superficial geology | Bedrock geology |
|---|---|---|---|---|---|
| 1 | On site | <b>Summary Classification:</b><br>Secondary bedrock aquifer -<br>Medium Vulnerability<br><b>Combined classification:</b><br>Productive Bedrock Aquifer,<br>No Superficial Aquifer | <b>Leaching class:</b> Low<br><b>Infiltration value:</b><br><40%<br><b>Dilution value:</b> 300-<br>550mm/year | <b>Vulnerability:</b> -<br><b>Aquifer type:</b> -<br><b>Thickness:</b> <3m<br><b>Patchiness value:</b> <90%<br><b>Recharge potential:</b> No<br>Data | <b>Vulnerability:</b> Medium<br><b>Aquifer type:</b> Secondary<br><b>Flow mechanism:</b> Well<br>connected fractures |

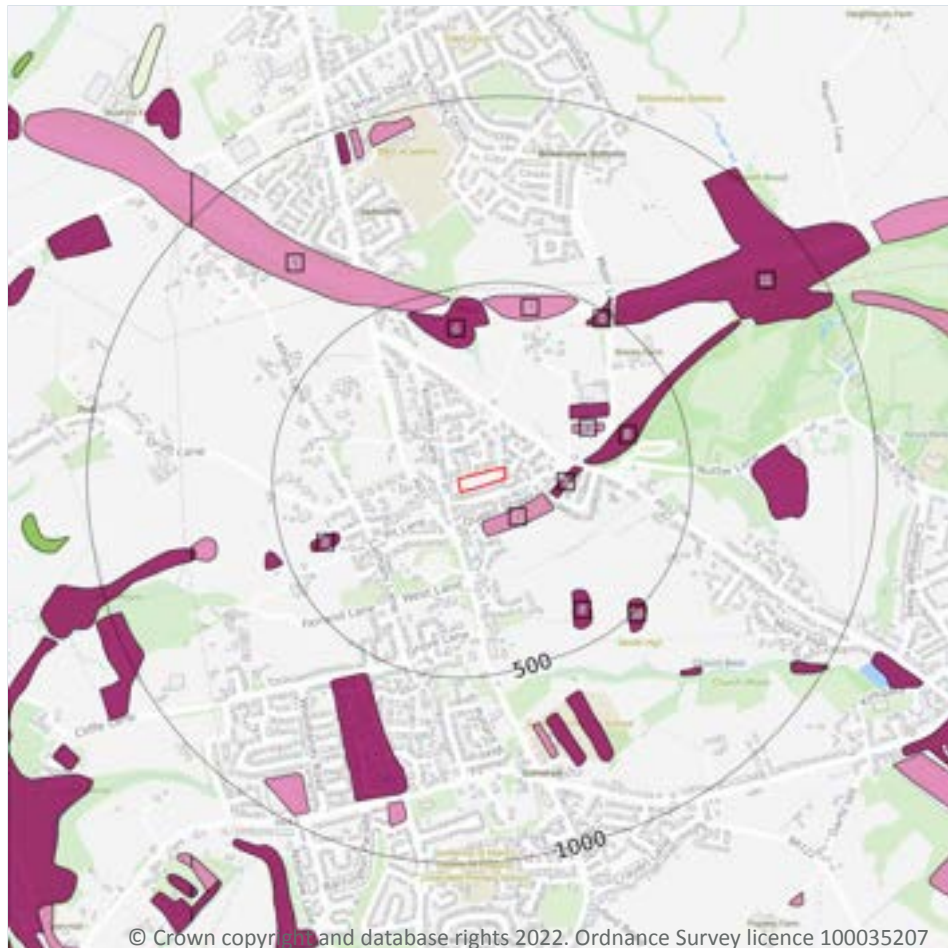
## Geology 1:10,000 scale - Artificial and made ground

Details of made, worked, infilled, disturbed and landscaped ground at 1:10,000 scale. Artificial ground can be associated with potentially contaminated material, unpredictable engineering conditions and instability.

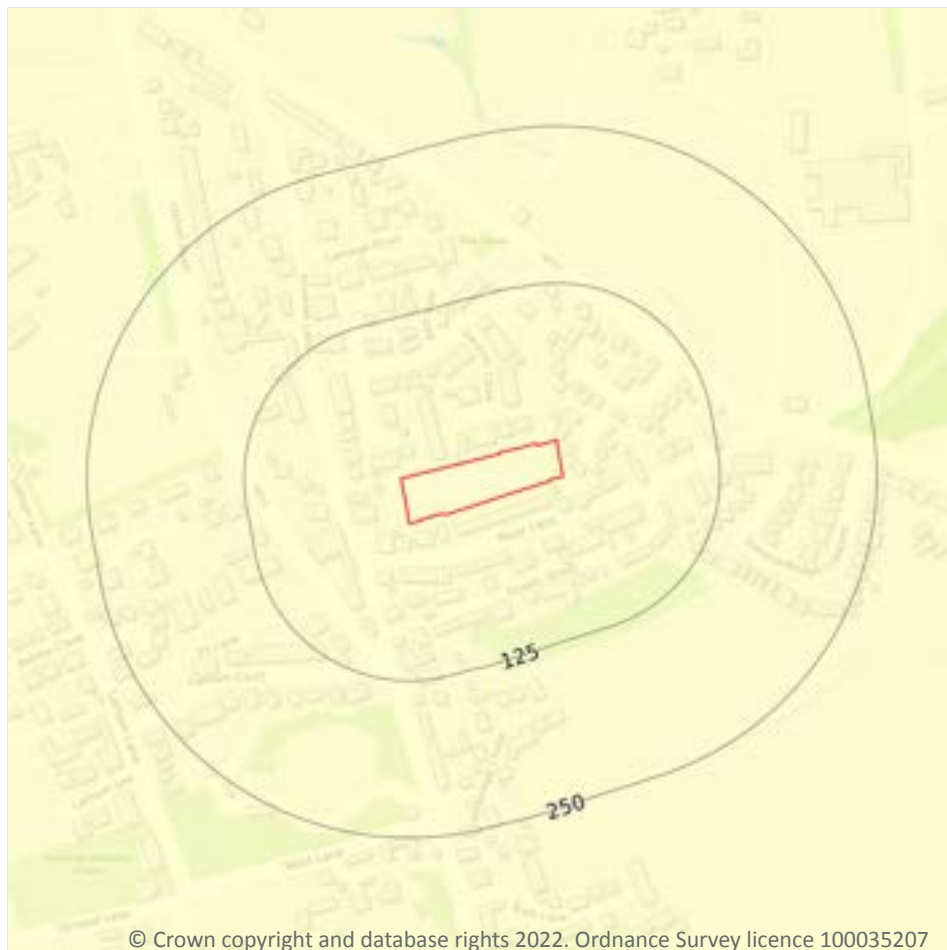
## Natural ground subsidence - Ground dissolution of soluble rocks

### 17.6 Ground dissolution of soluble rocks

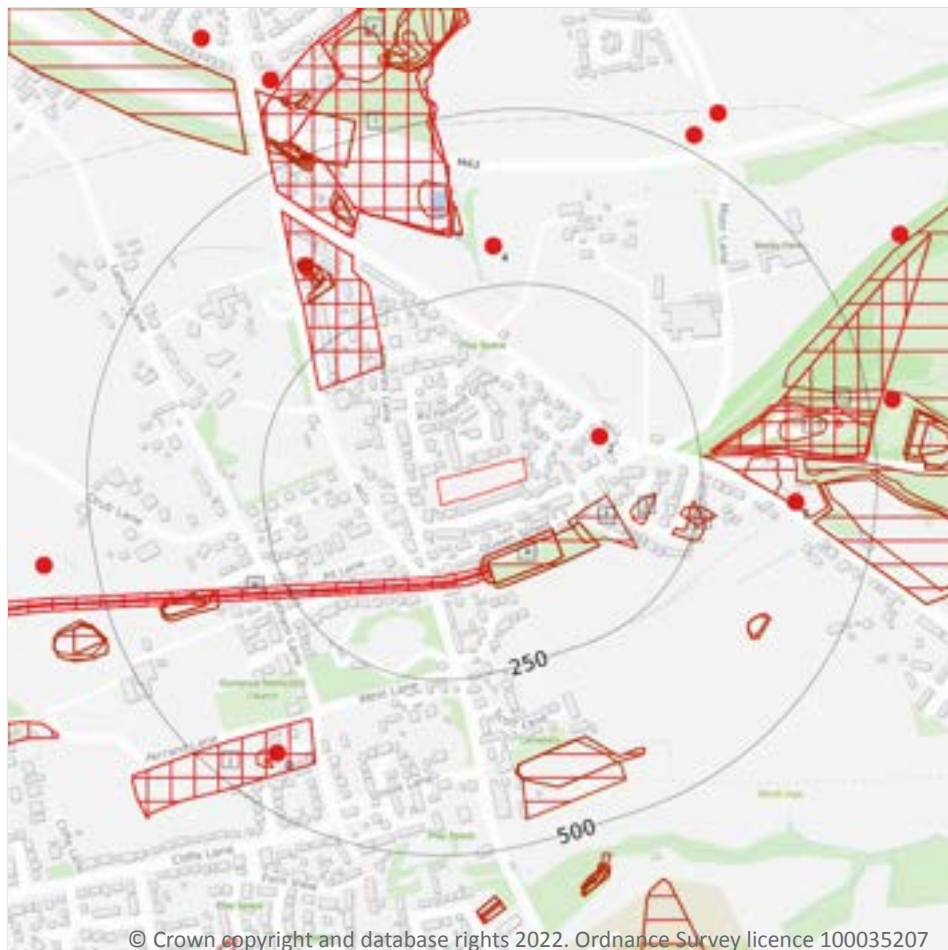
## 18 Mining, ground workings and natural cavities

- Site Outline
- Search buffers in metres (m)
- Natural cavities (Area)
- Natural cavities (Point)
- BritPits
- Surface ground workings
- Underground workings
- Historical Mineral Planning Areas
- Mining Cavities
- Non Coal Mining
- Sporadic underground mining of restricted extent possible
- Localised small scale underground mining possible
- Small scale mining possible
- Underground mining known or likely within or in close proximity
- Underground mining known within or in very close proximity
