Land at Granny Lane, Mirfield For Miller Homes Yorkshire

Report no: 2935/3

Date: November 2023

VERIFICATION REPORT
for the
REMEDIATION & PREPARATORY WORKS
of land at
GRANNY LANE, MIRFIELD

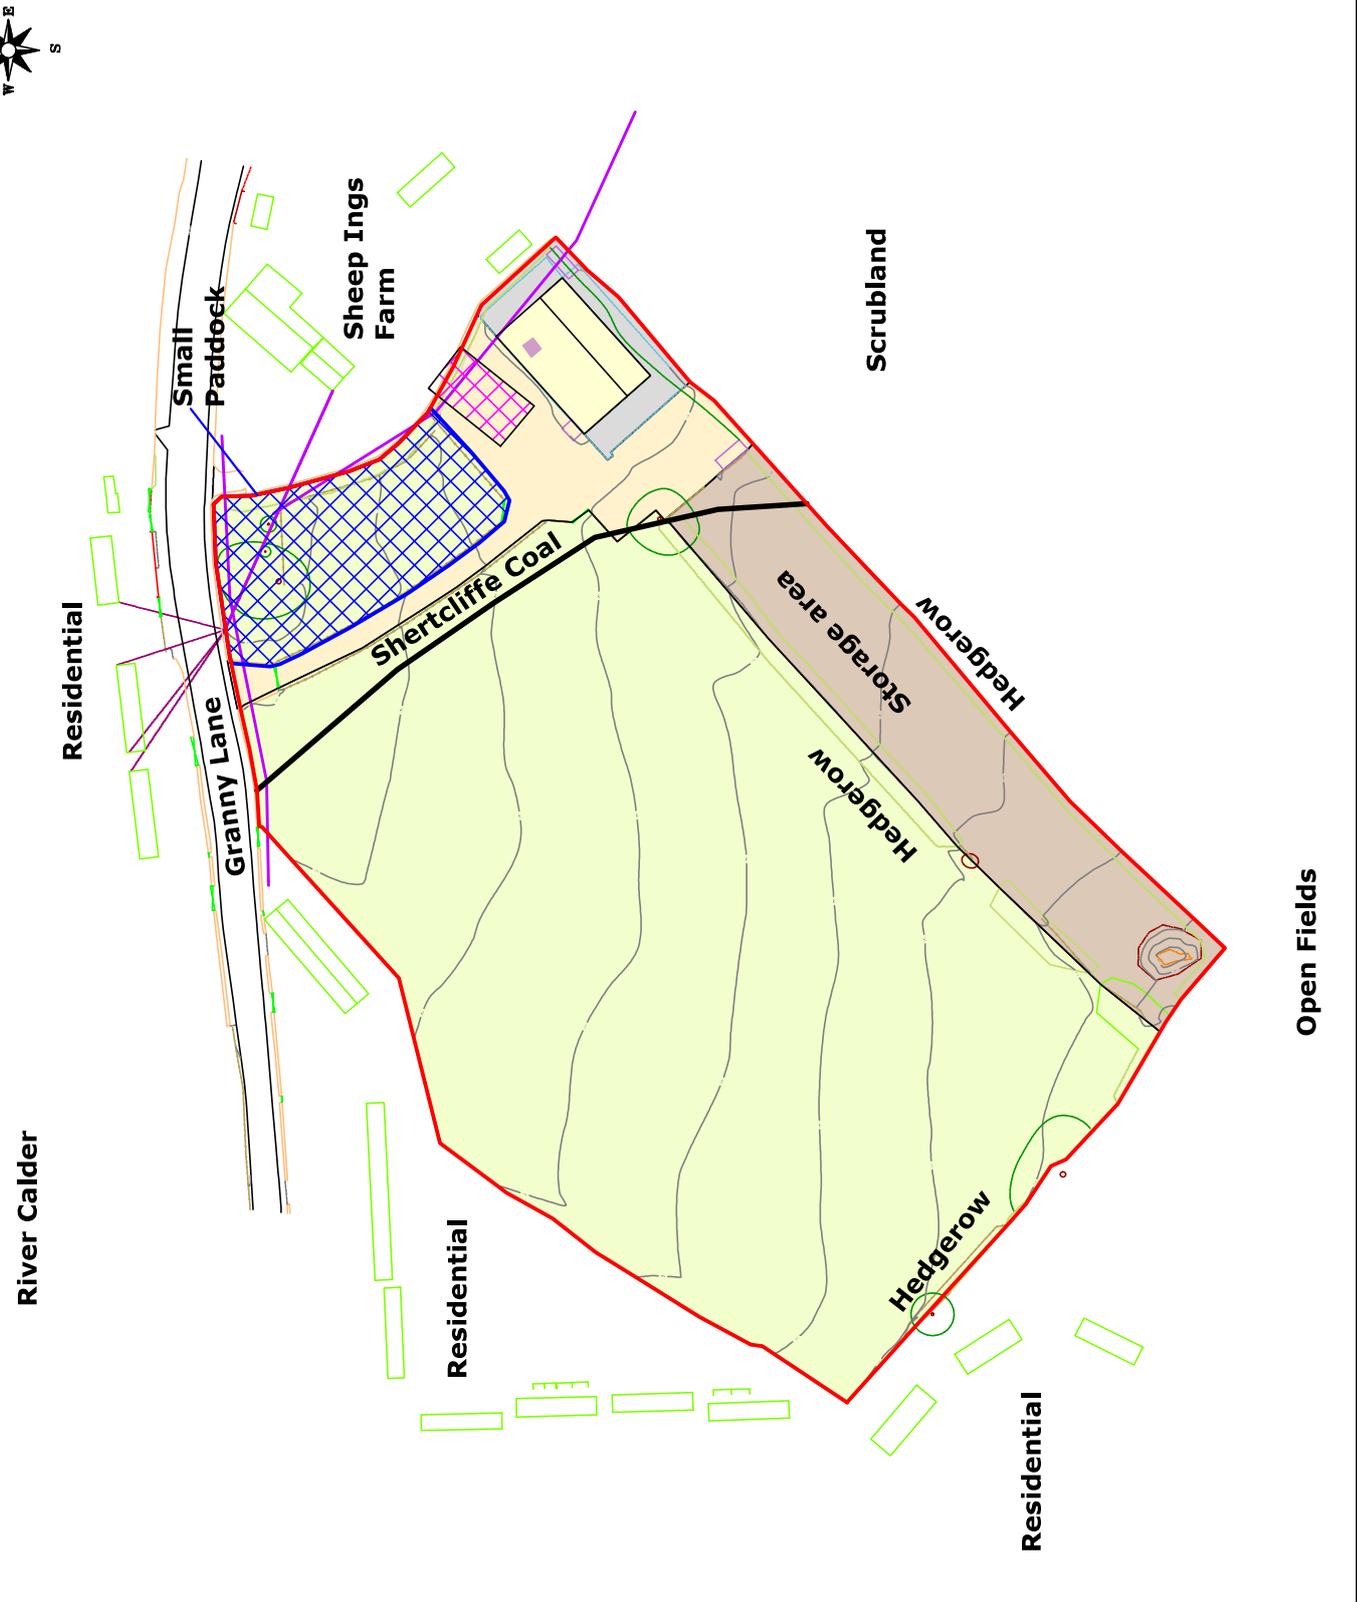
SCALE	Not to scale	SHEET	A3	DRAWING NO.	2935/7	REVISION	B
-------	--------------	-------	----	-------------	--------	----------	---

2.2.12 The Revised Conceptual Site Model is presented as Drawing 2935/7 in Appendix A.

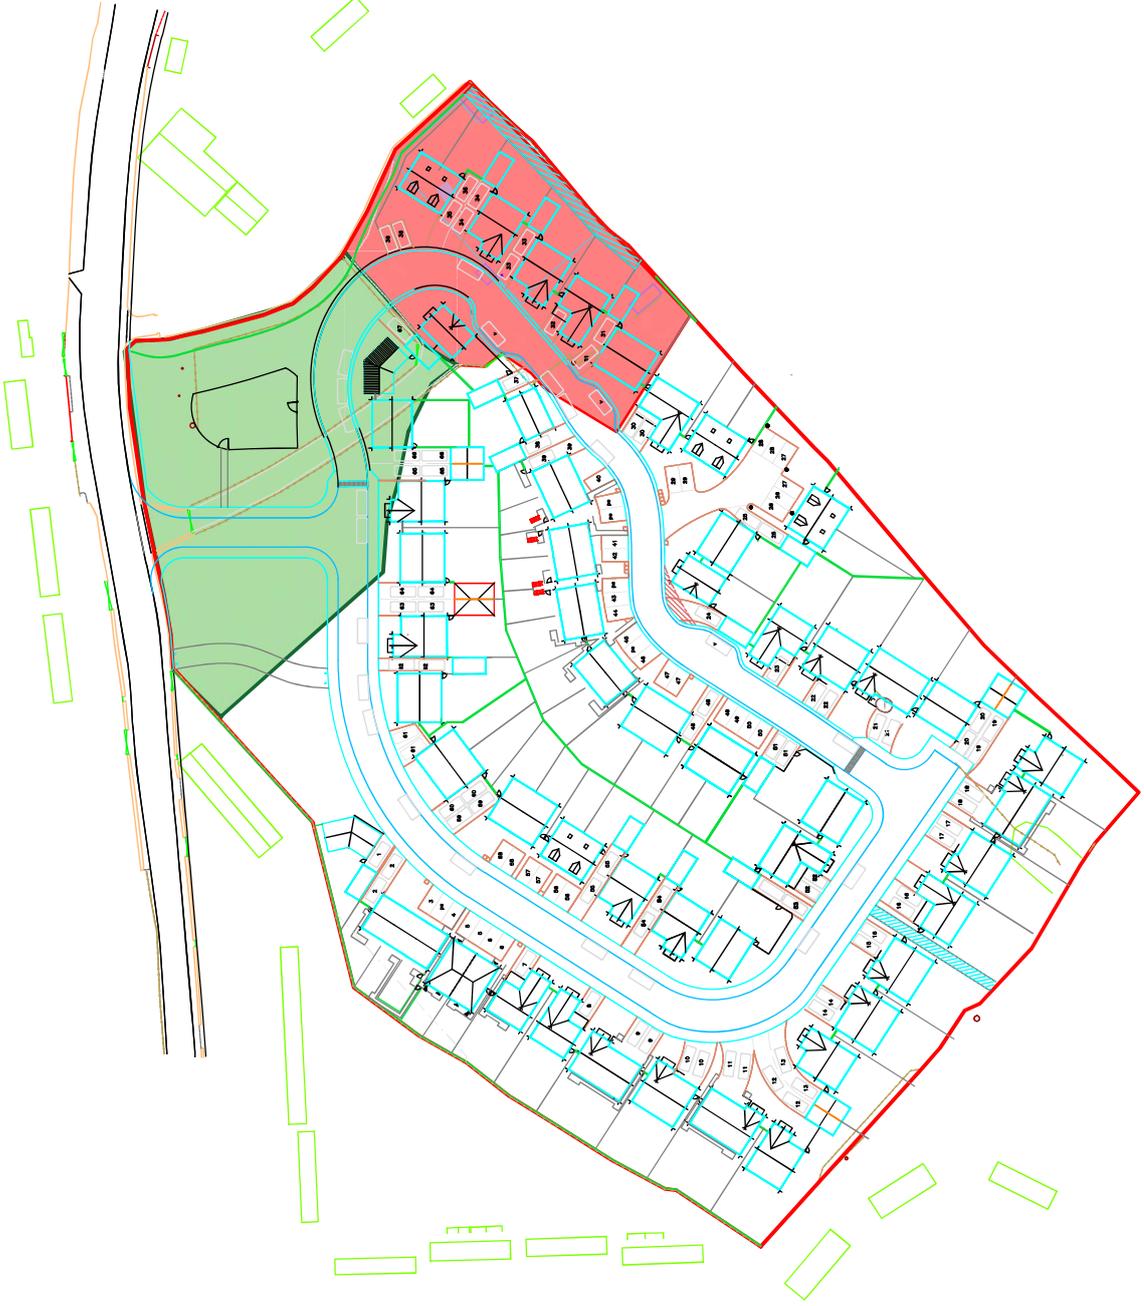
SCALE	1:1000	SHEET	A3	DRAWING NO.	2935/11	STORED	-
-------	--------	-------	----	-------------	---------	--------	---

2.2.3 Made ground was typically restricted to the paddock and area of hardstanding in the east and northeast of site. The approximate extent of made ground is shown on Drawing 2395/11 in Appendix A.

- AREA OF DEEP MADE GROUND (>600mm)
- AREA OF SHALLOW MADE GROUND (<600mm)

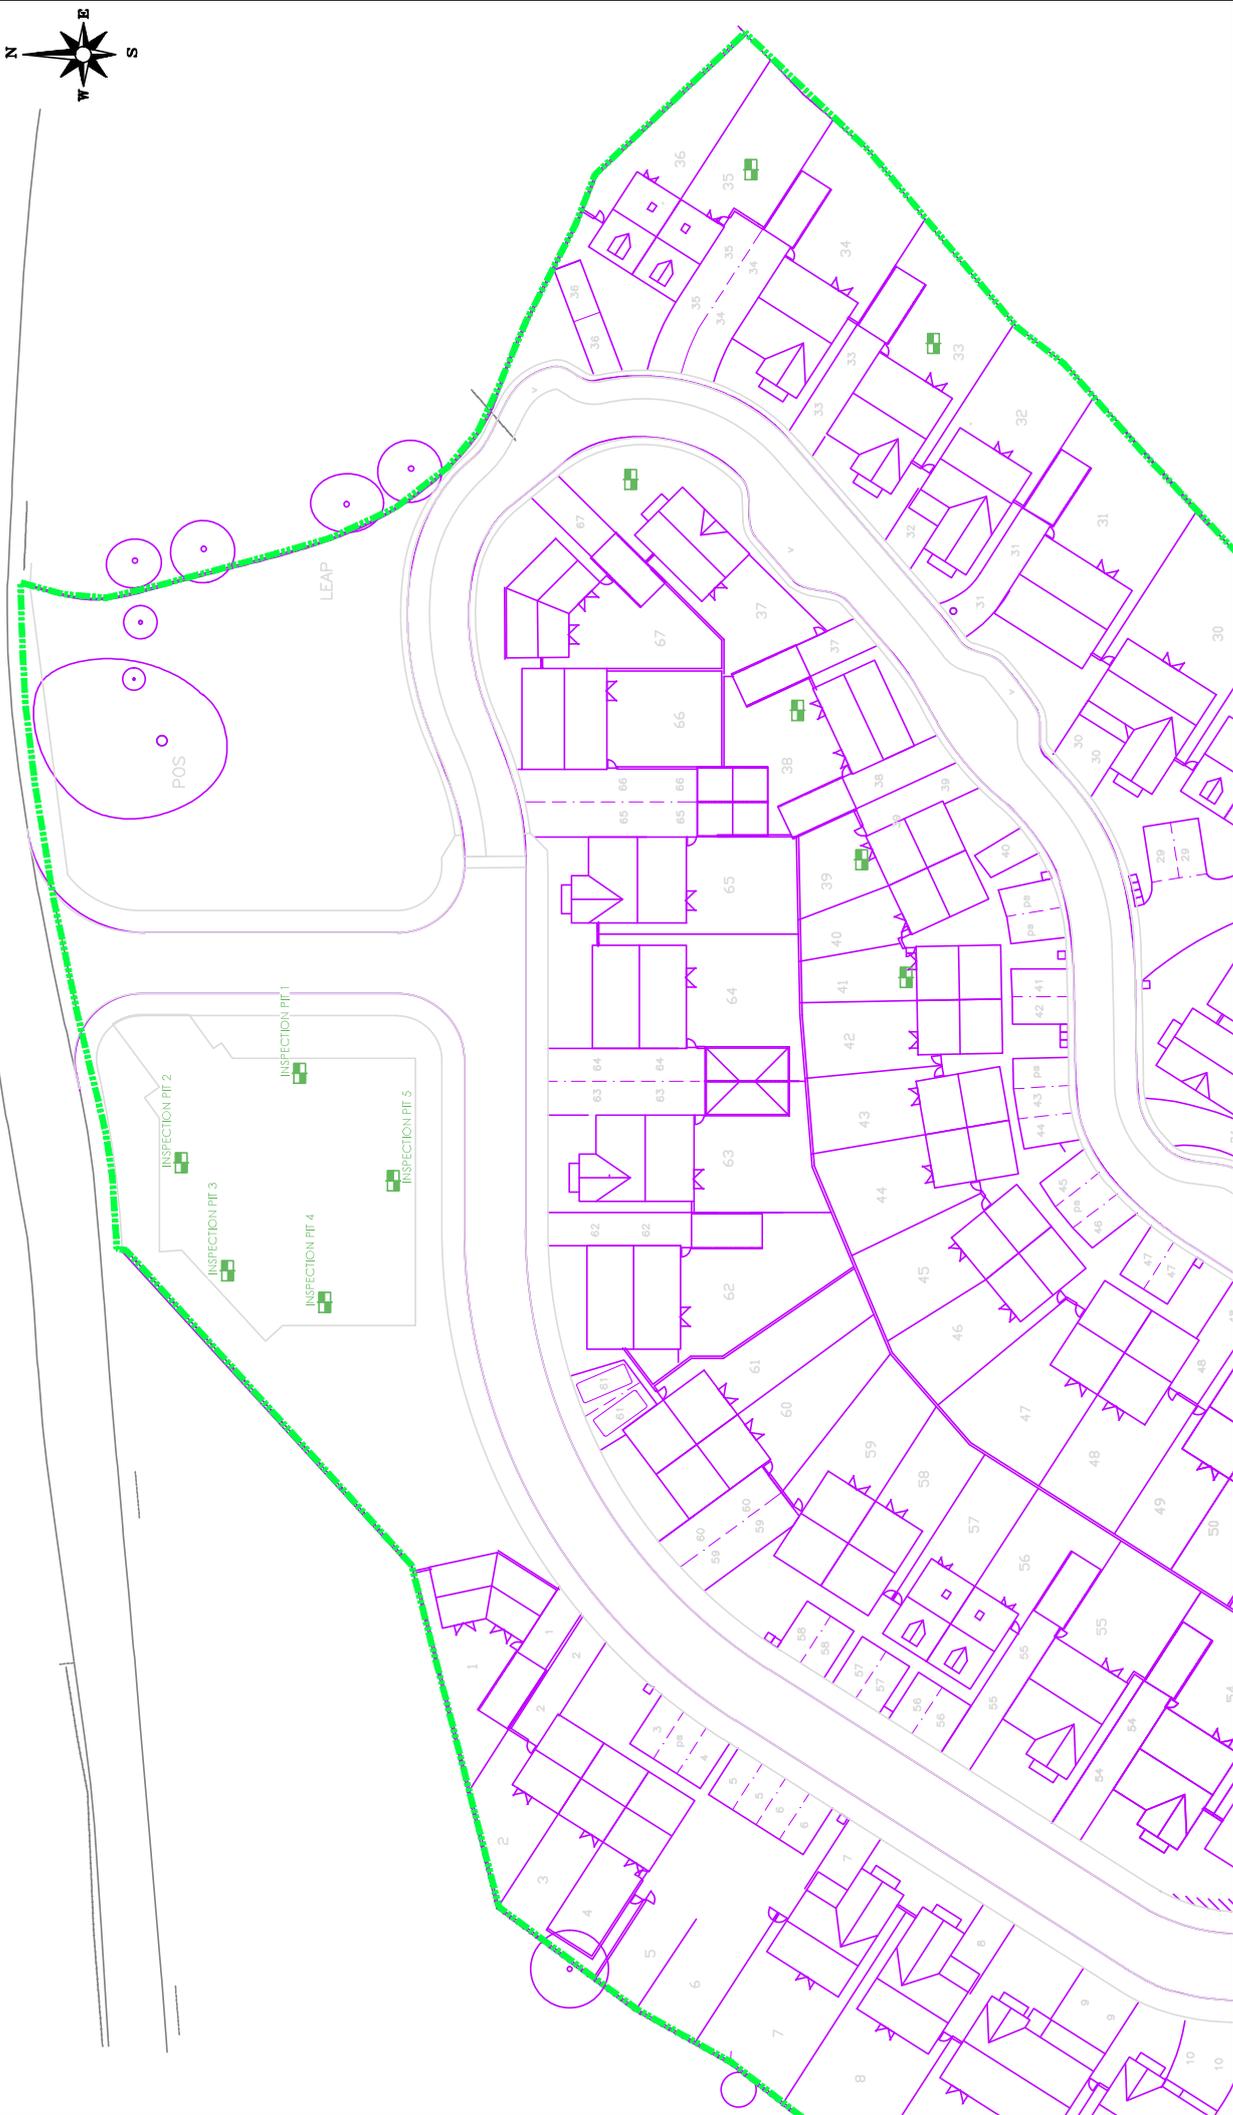
STATUS		<input type="checkbox"/> FOR COMMENT	<input type="checkbox"/> FOR APPROVAL	<input type="checkbox"/> DRAFT	<input checked="" type="checkbox"/> FINAL
DRAWN	KSE	DATE	17/10/2023		
APPROVED	SRJ	DATE	30/11/2023		
SCALE	1:500	SHEET	A3		
DRAWING NO.	2935/12

- 4.3.4 The locations of these inspection pits are shown on the Remediation Plan presented as Drawing 2935/12 in Appendix A to this report. The ground conditions encountered are detailed in Table 2 in Annex I and inspection pit photos are presented in Appendix C.
- 4.3.5 These inspection pits confirmed that no residual made ground was present within 600mm of the finished garden / POS surface.

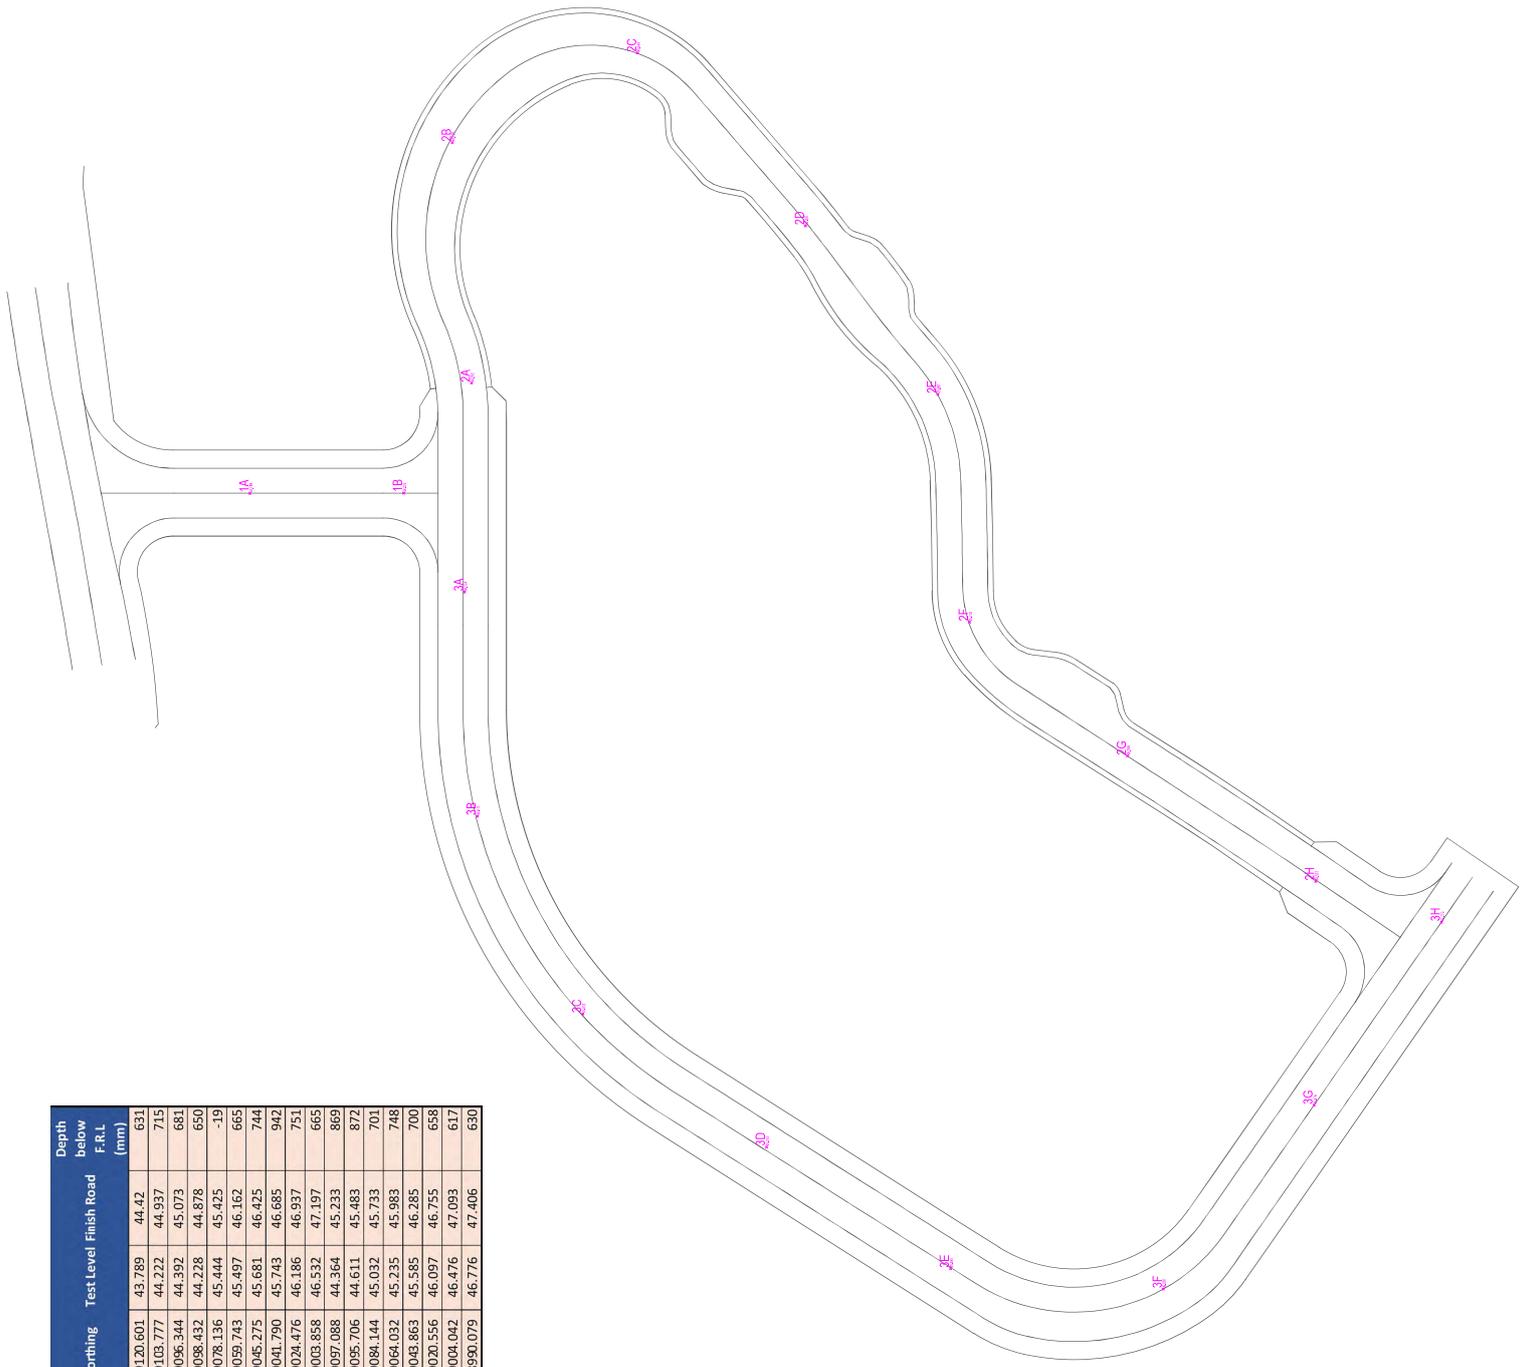
SHEET:	GRANNYLANE MIRFIELD
TITLE:	CBR-TESTS
SCALE:	AS SHOWN
DATE:	10/06/2022
PROJECT NO.:	BC
REVISION:	BC

4.2.7 The results are summarised in Table 1 in Annex I and the laboratory test certificates are presented in Appendix D (i). The test locations are shown on BGC's CBR-Tests drawing copied to Appendix A.

Location	Easting	Northing	Test Level	Finish Road	Depth below F.R.L. (mm)
1A	420766.954	419120.601	43.789	44.42	631
1B	420766.995	419103.777	44.222	44.937	715
2A	420779.132	419096.344	44.392	45.073	681
2B	420805.685	419098.432	44.228	44.878	650
2C	420815.583	419078.136	45.444	45.425	-19
2D	420796.473	419099.743	45.497	46.162	665
2E	420777.895	419045.275	45.681	46.425	744
2F	420752.761	419041.790	45.743	46.685	942
2G	420737.969	419024.476	46.186	46.937	751
2H	420724.117	419003.858	46.532	47.197	665
3A	420756.056	419097.088	44.364	45.233	869
3B	420731.326	419095.706	44.611	45.483	872
3C	420709.523	419084.144	45.032	45.733	701
3D	420694.828	419064.032	45.235	45.983	748
3E	420681.381	419043.863	45.585	46.285	700
3F	420679.133	419020.556	46.097	46.755	658
3G	420699.416	419004.042	46.476	47.093	617
3H	420719.638	418990.079	46.776	47.406	630

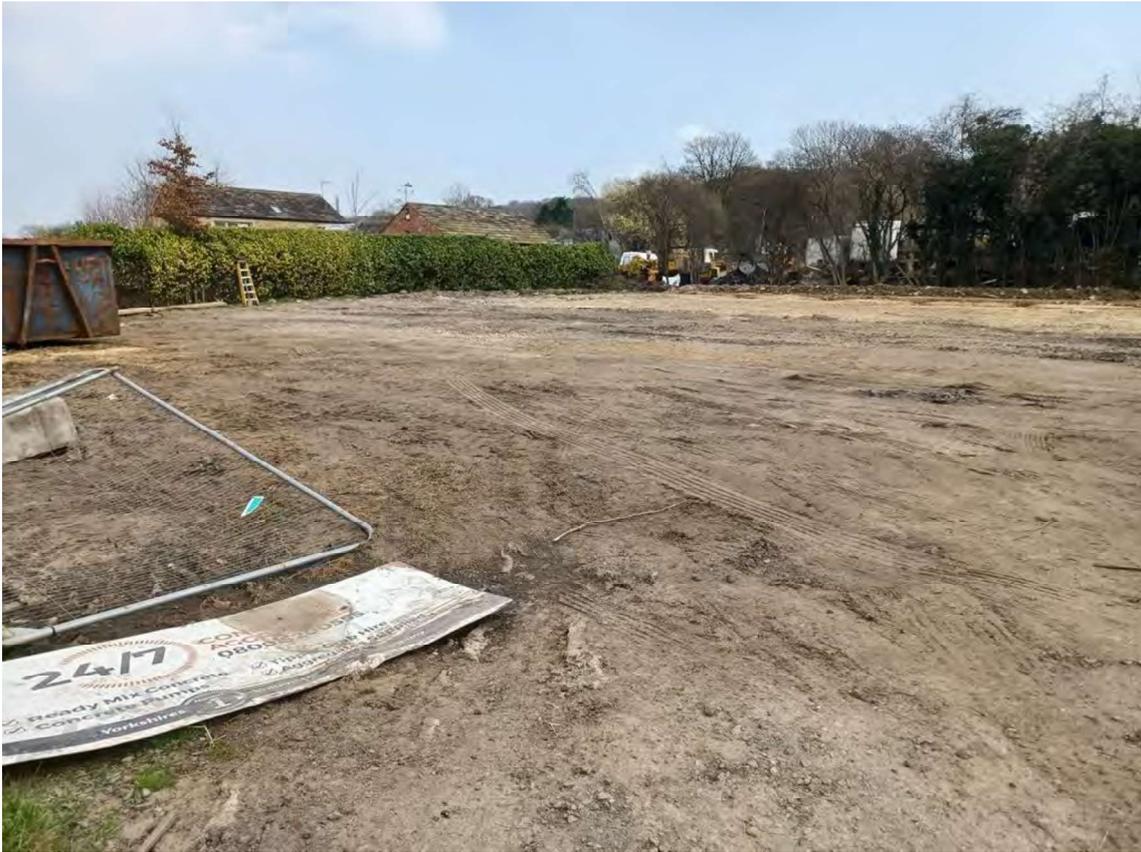
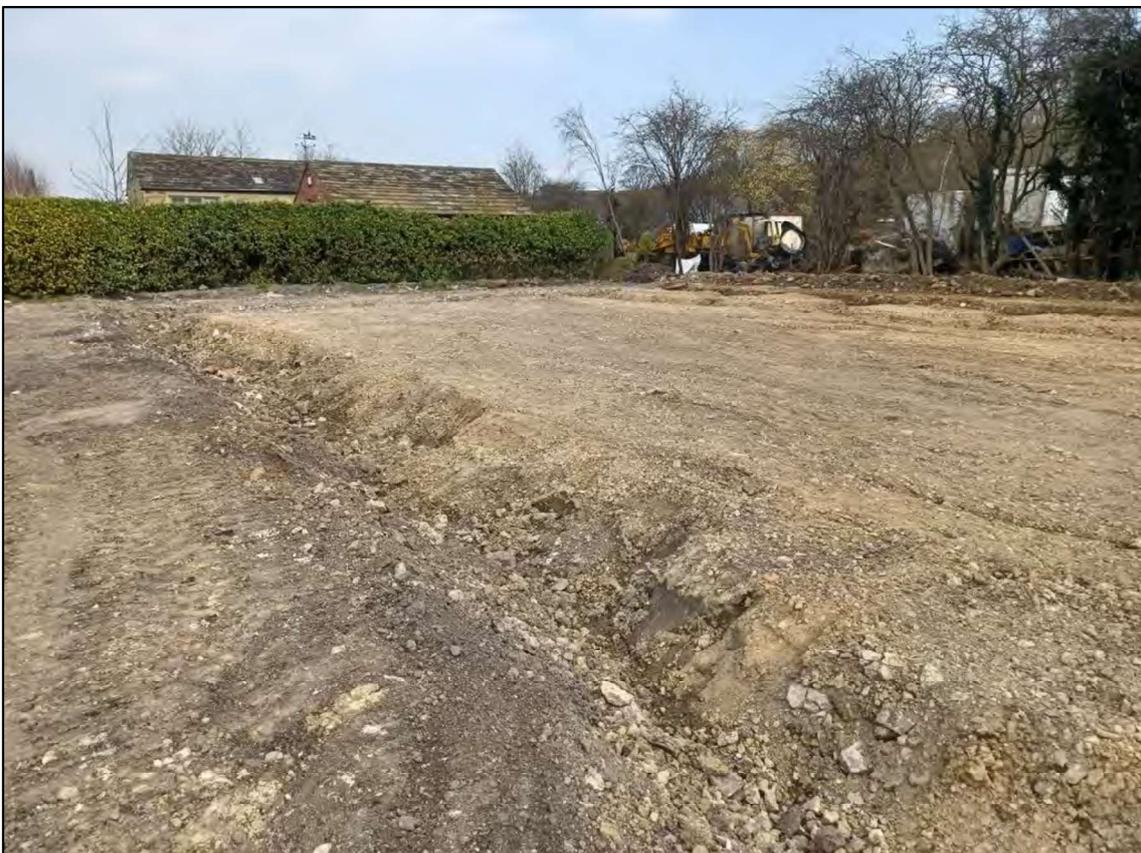
Photo 1 Eastern corner of site following demolition of stables & workshop building

Photo 2 Eastern corner of site following demolition of stables & workshop building

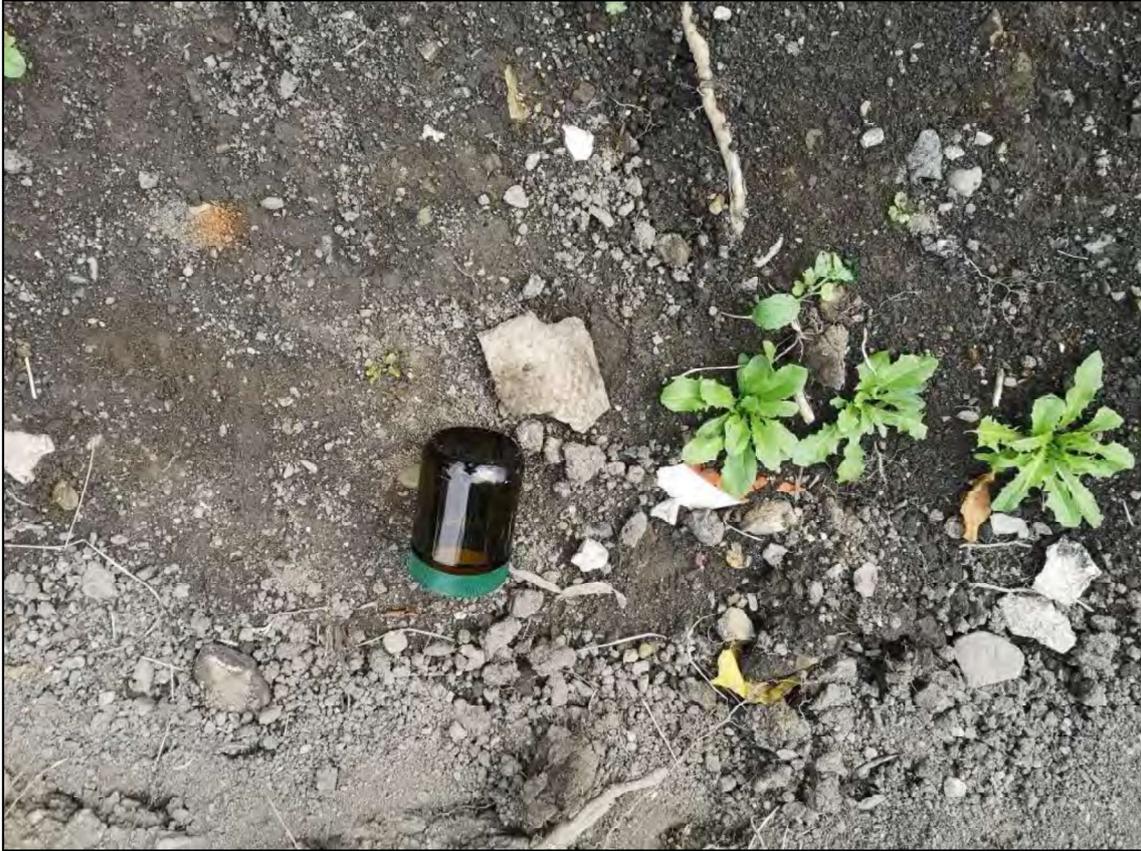
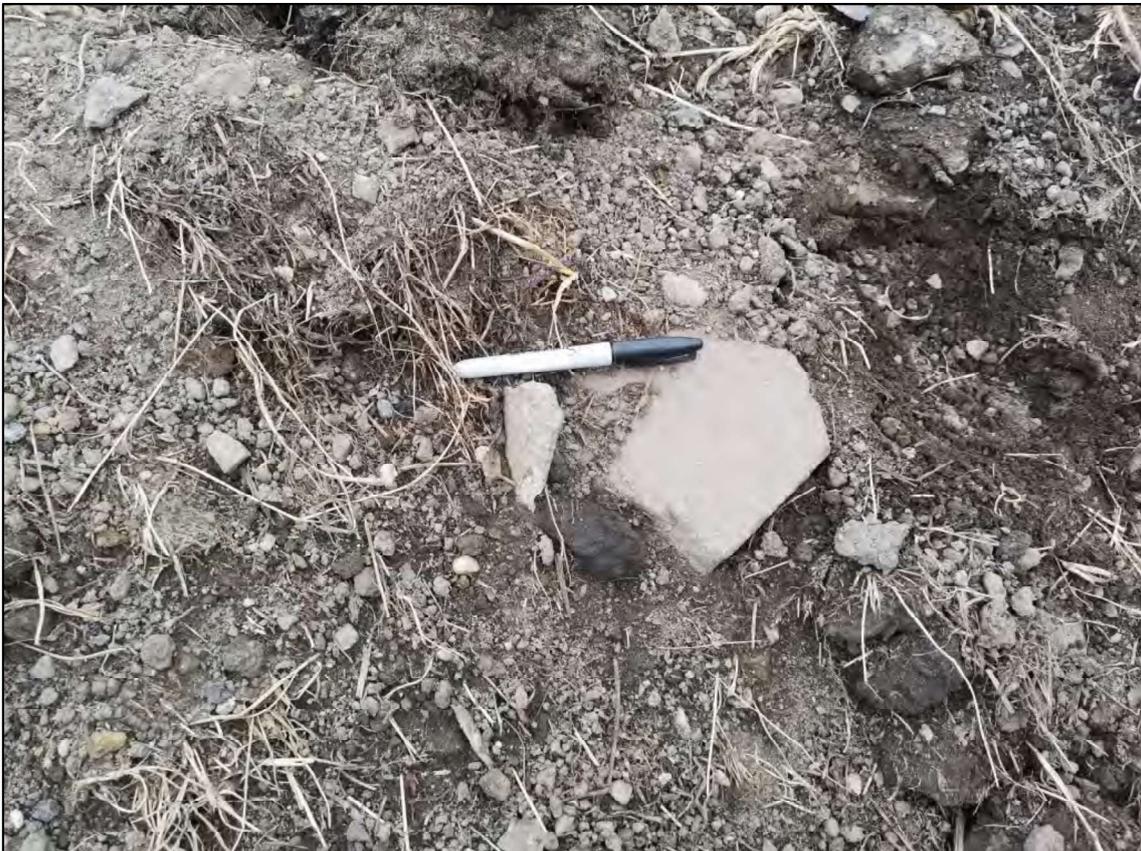
4.1.5 However, during this sampling exercise a number of fragments of suspected asbestos containing materials (ACMs; cement sheet) were recovered.

Photo 3 ACM fragments encountered during topsoil strip from paddock

Photo 4 ACM fragments encountered during topsoil strip from paddock

4.1.7 The contaminated topsoil arising from the former paddock area was removed from site.

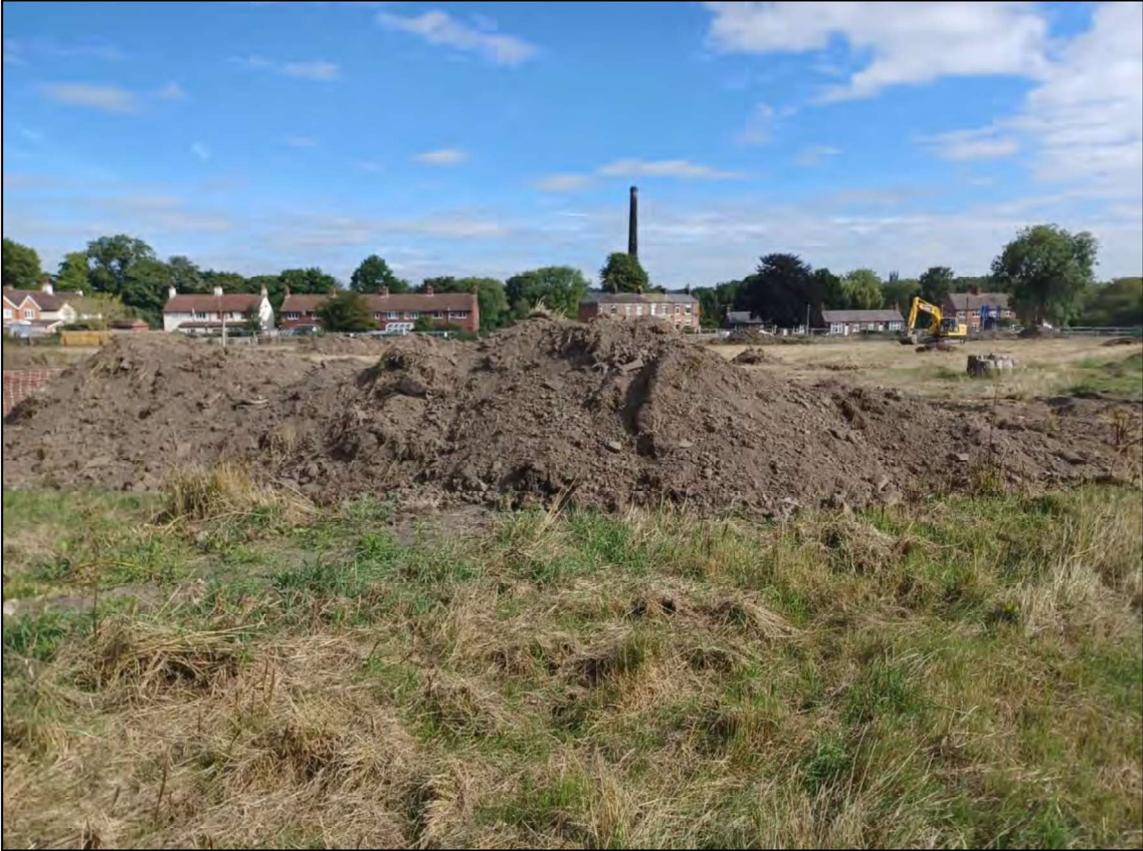
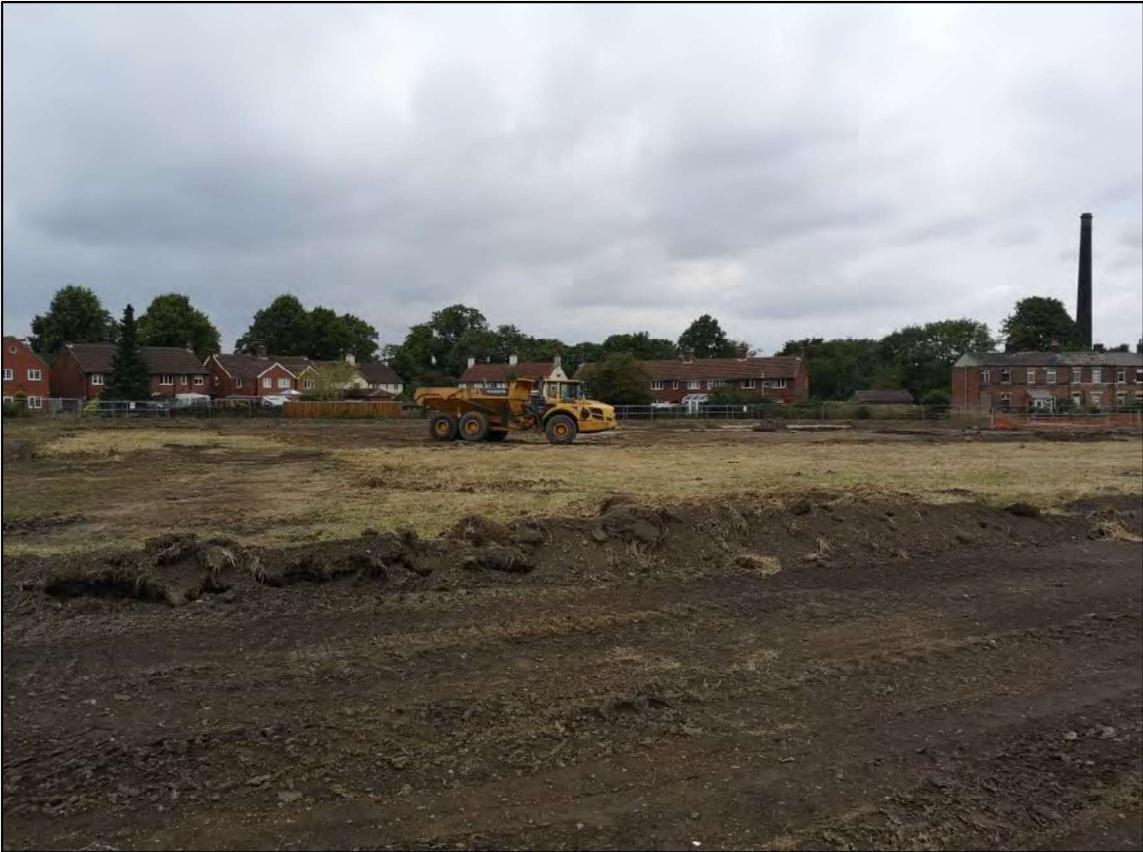
Photo 5 General site strip

Photo 6 General site strip

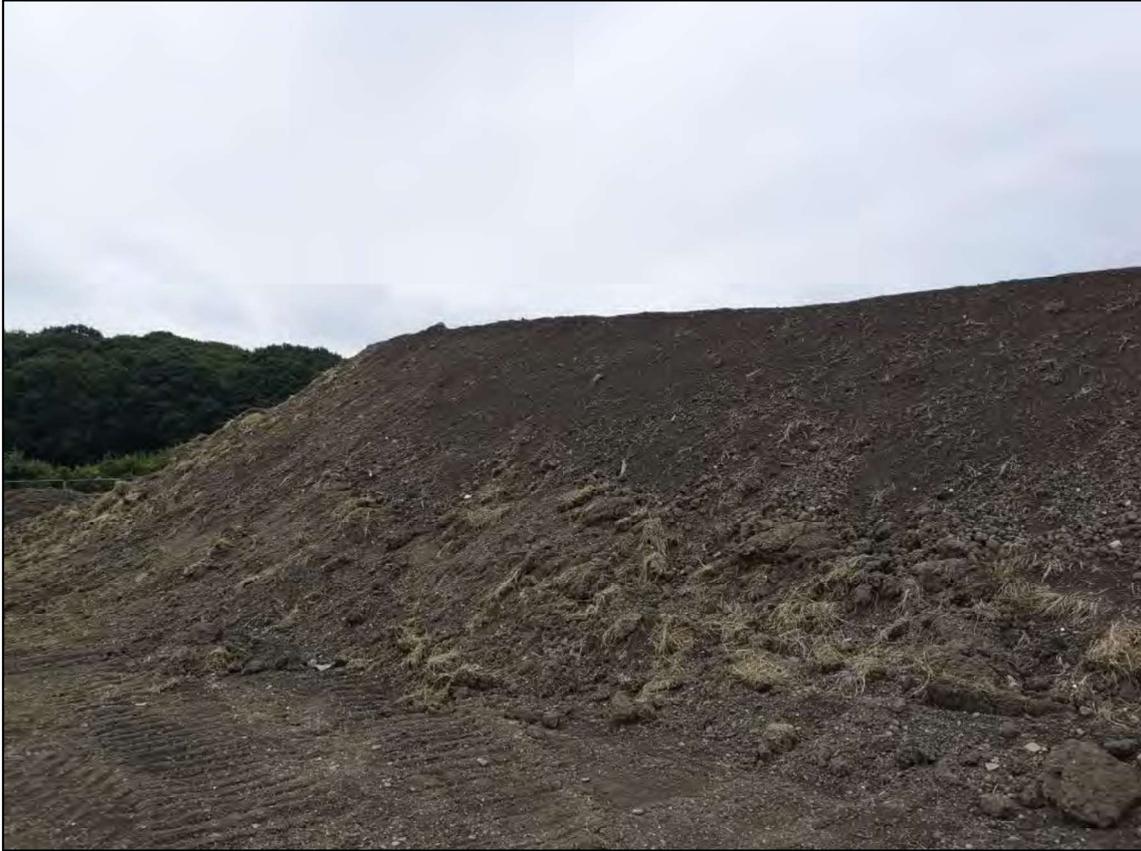
4.1.3 Topsoil from the remainder of the site was then stripped and placed in a separate stockpile, for subsequent re-use within the development.

Photo 7 Uncontaminated topsoil stockpile

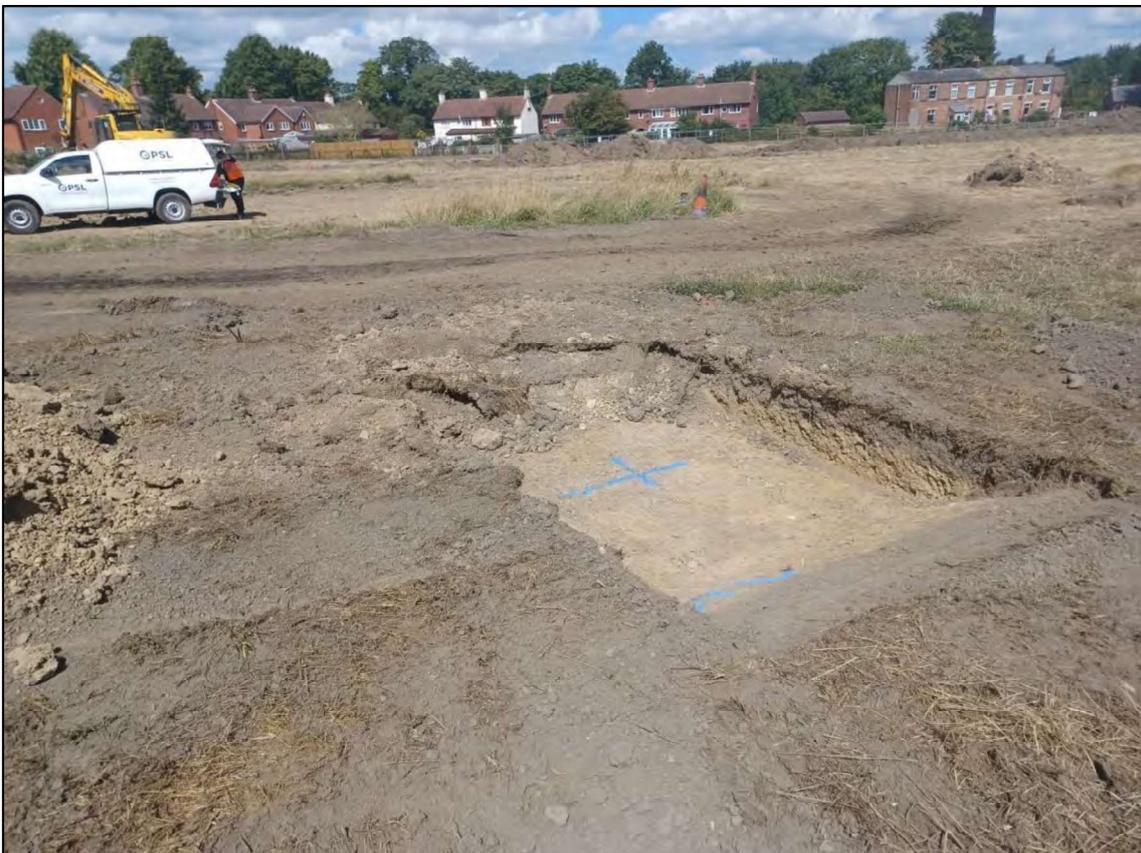
4.2.5 The tests were undertaken mainly on undisturbed natural Residual Soils exposed following removal of the topsoil. Six tests in the northeast of the site were undertaken on existing made ground materials.

Photo 8 Reduced level dig for CBR test

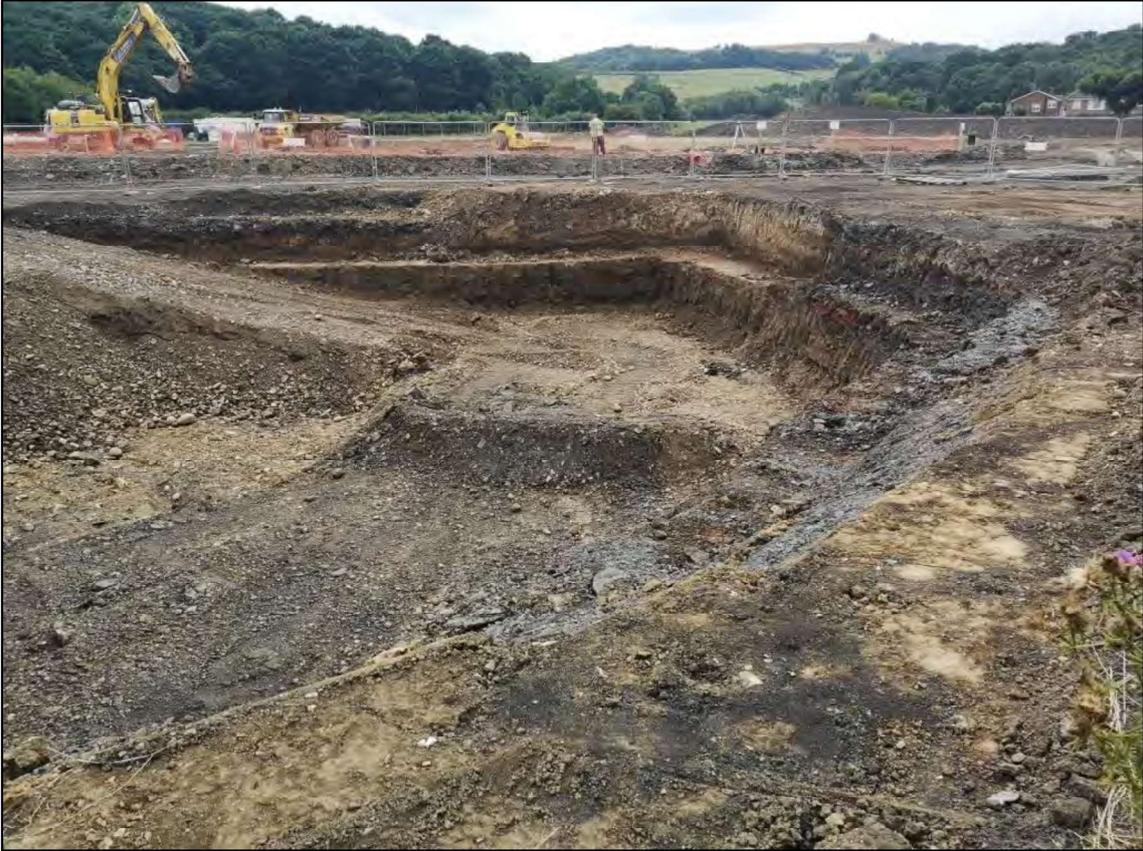
Photo 9 Excavation for surface water attenuation tank

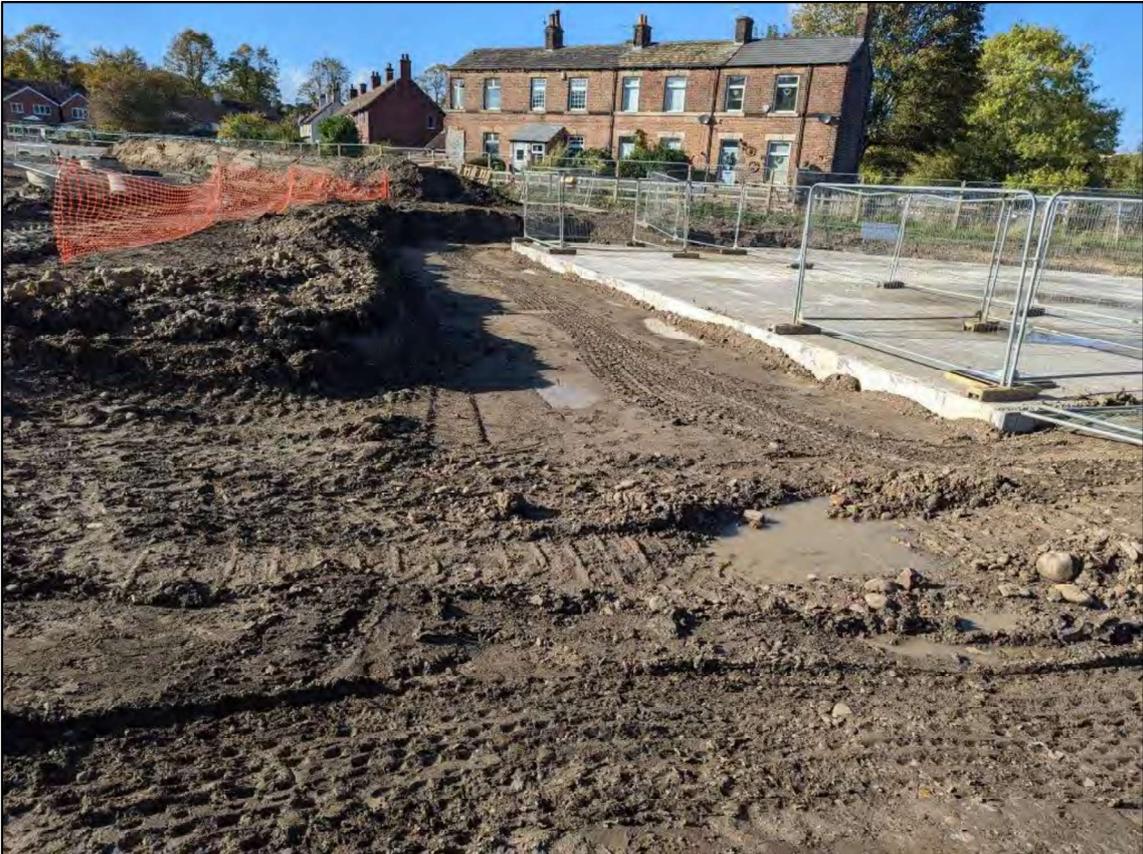
Photo 10 Installation of surface water attenuation tank

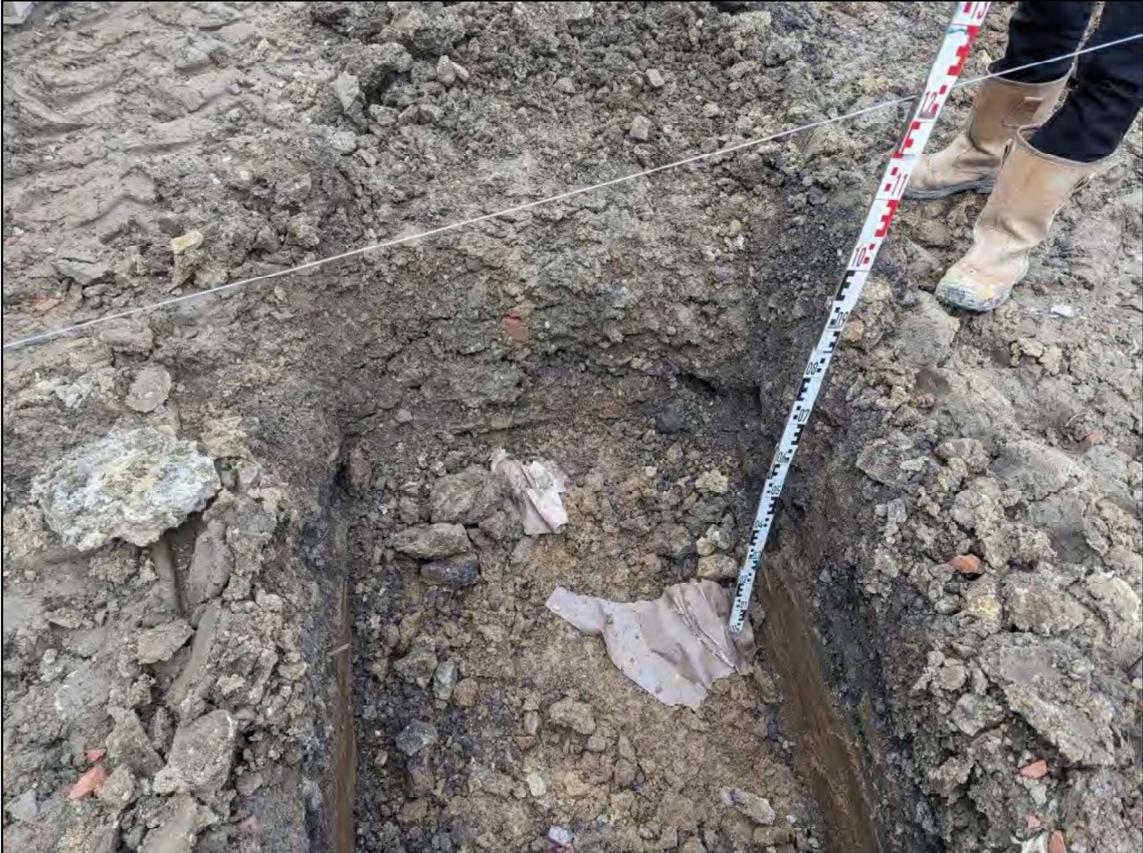
Hole ID	Ground conditions	Remarks
Plot 31		No access as area in use as construction compound
Plot 33	Reworked natural clay (subsoil) to 1.05m over in-situ natural clay to 1.20m	Existing ground level 0.55m below finished level; topsoil & subsoil to be placed
Plot 35	Reworked natural clay (subsoil) to 0.90m over in-situ natural clay to 1.10m	Existing ground level 0.50m below finished level; topsoil & subsoil to be placed
Plot 37	Reworked natural clay (subsoil) to 0.70m over in-situ natural clay to 0.80m	Existing ground level 0.10m below finished level; topsoil to be placed
Plot 38	Reworked natural clay (subsoil) to 0.55m over Cohesive Made Ground	Existing ground level 0.25m below finished level; topsoil to be placed
Plot 39	Cohesive Made Ground present at 0.70m depth below finished level	Existing ground level 0.70m below finished level; topsoil & subsoil to be placed
Plot 41	In-situ natural clay at 0.70m depth below finished level	Existing ground level 0.70m below finished level

Photo 11 Plot 33 inspection pit

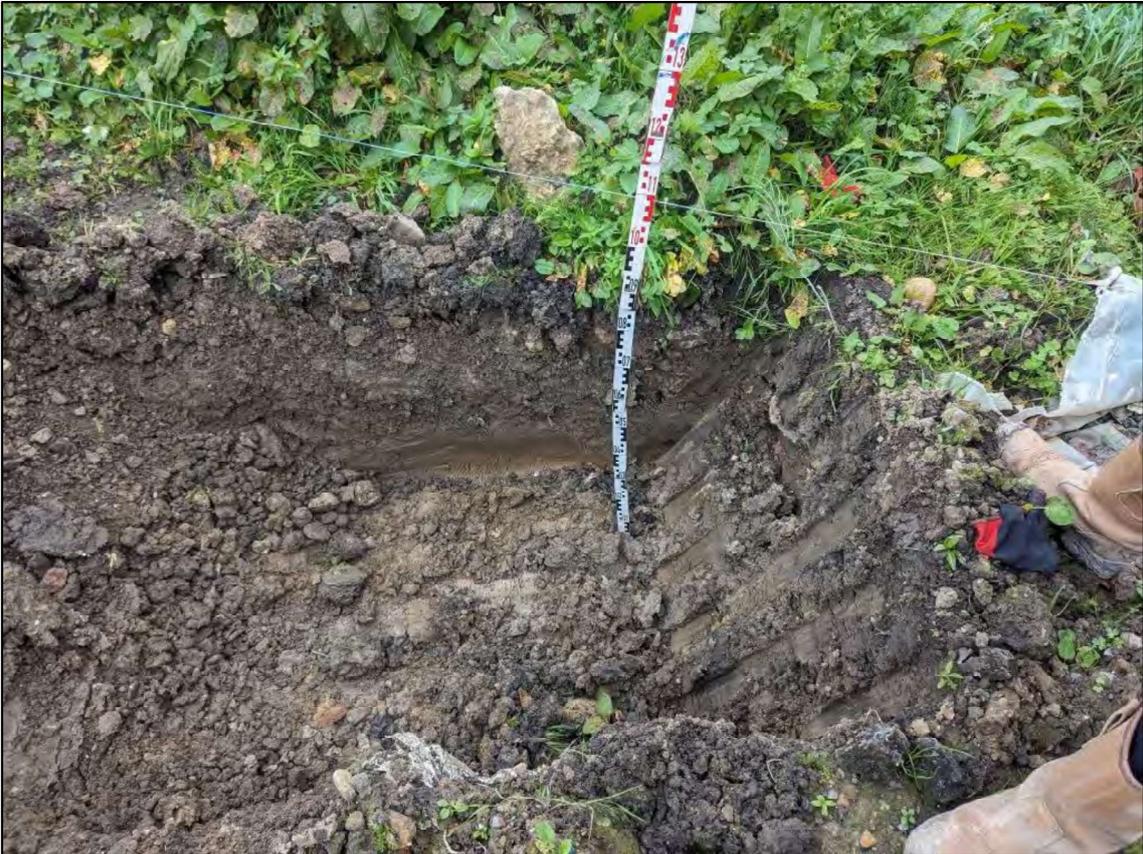
Photo 12 Plot 35 inspection pit

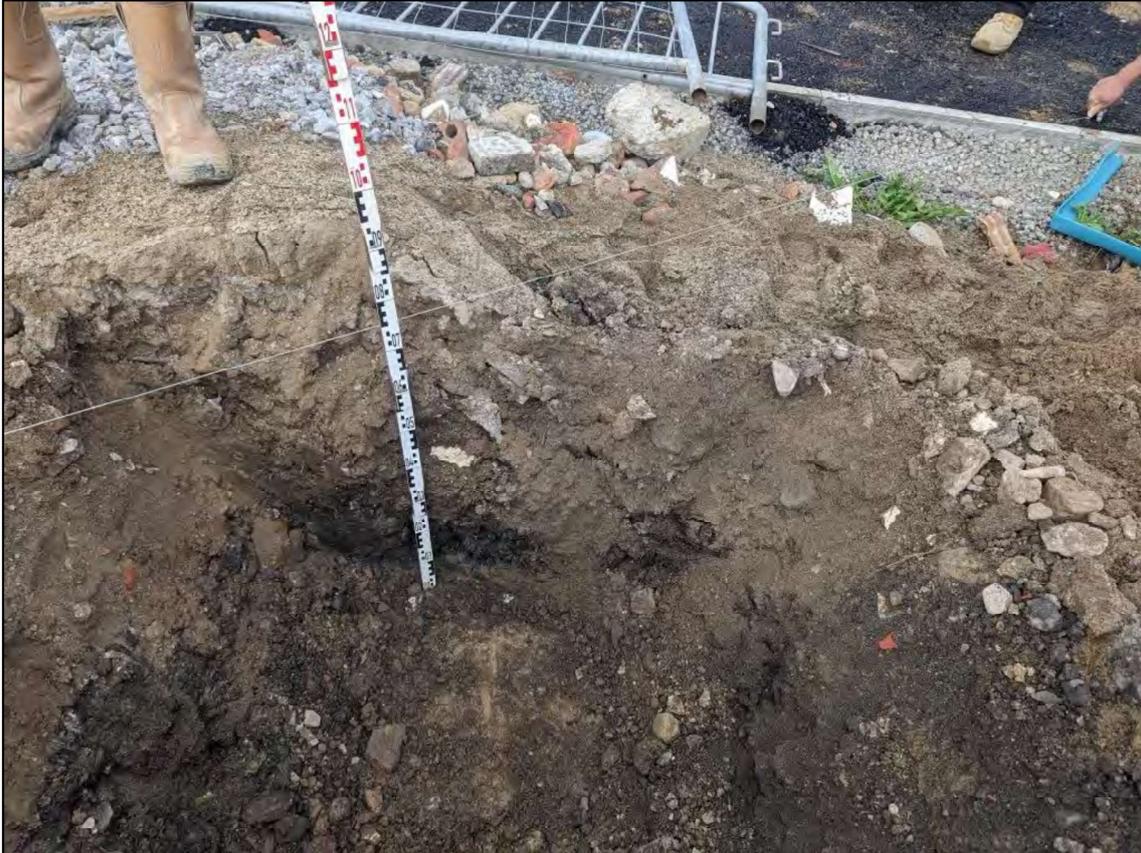
Photo 13 Plot 37 inspection pit
