Land at Granny Lane, Mirfield For Miller Homes Yorkshire

Report no: 2935/3

Date: November 2023

VERIFICATION REPORT
for the
REMEDIATION & PREPARATORY WORKS
of land at
GRANNY LANE, MIRFIELD

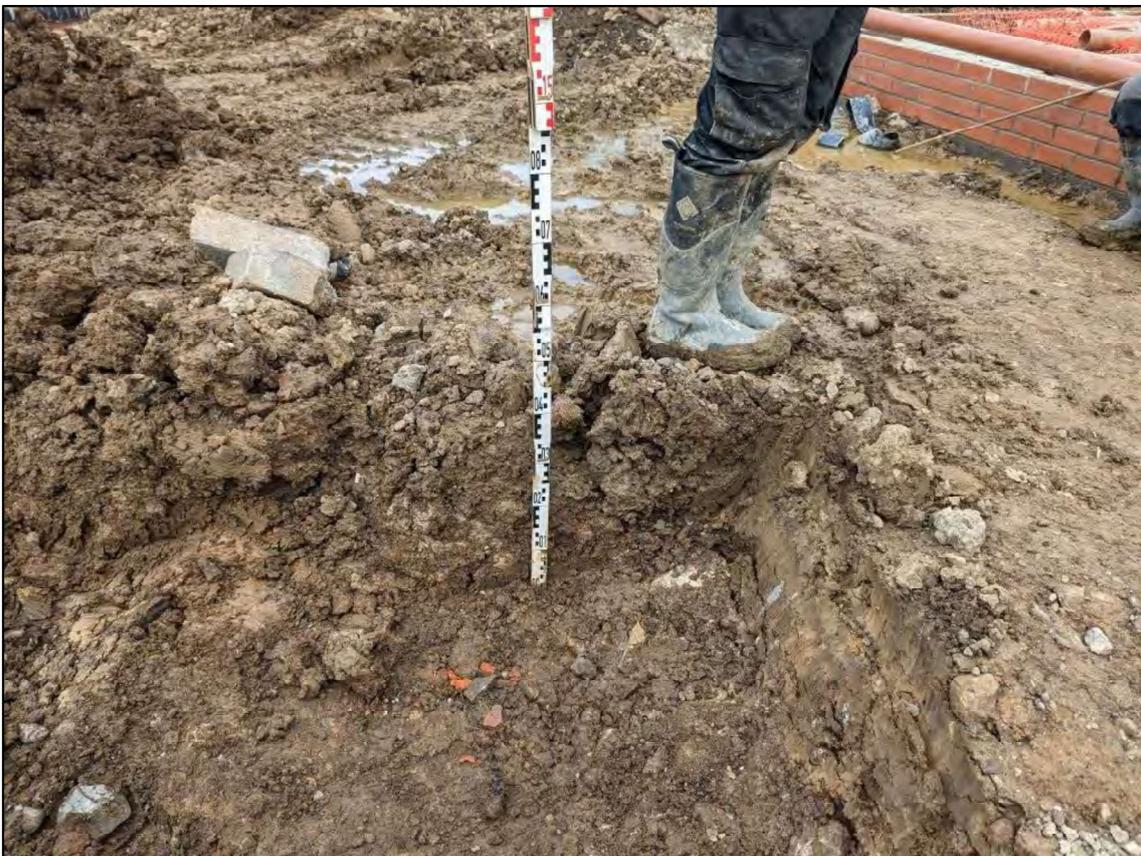
Photo 14 Plot 38 inspection pit

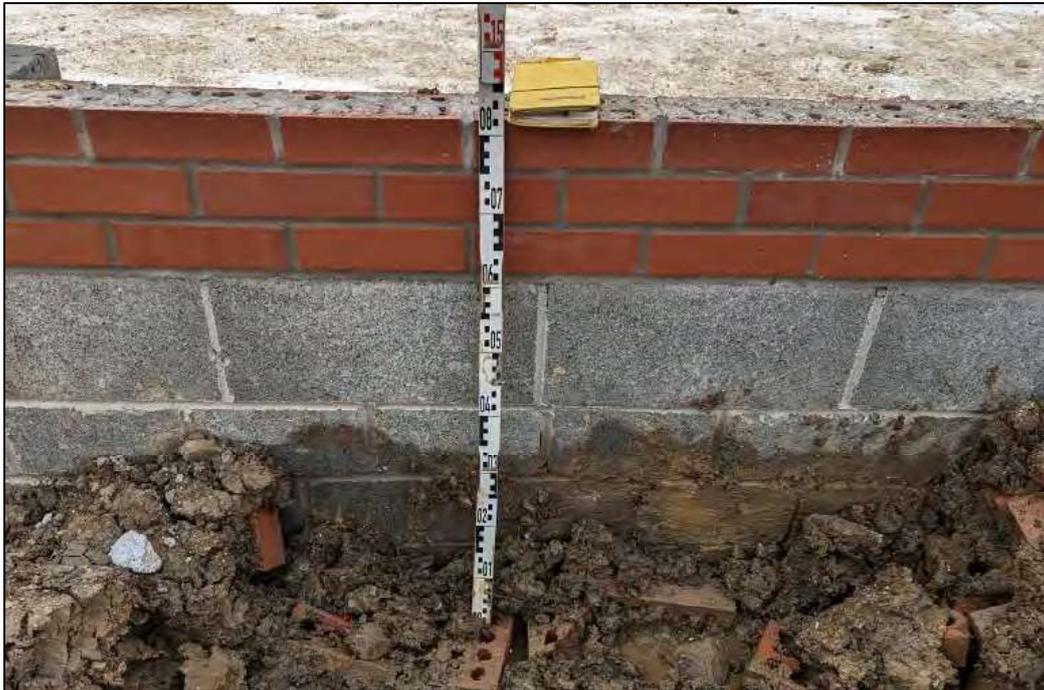
Photo 15 Plot 39 inspection pit

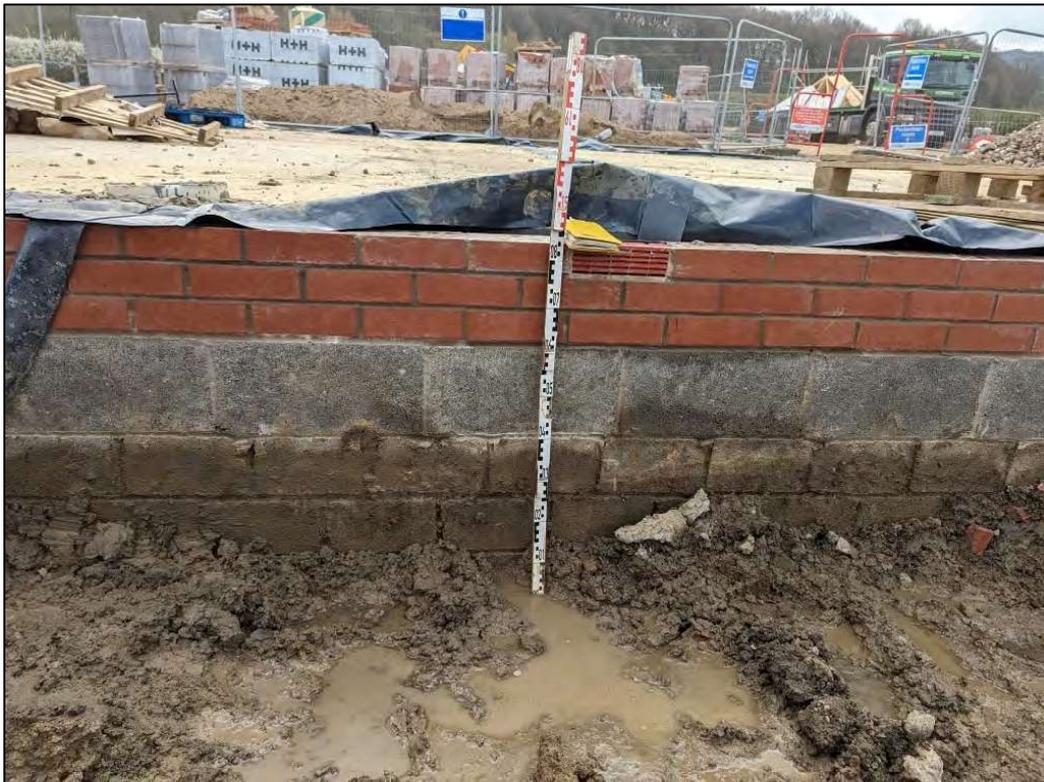
Photo 16 Plot 41 inspection pit

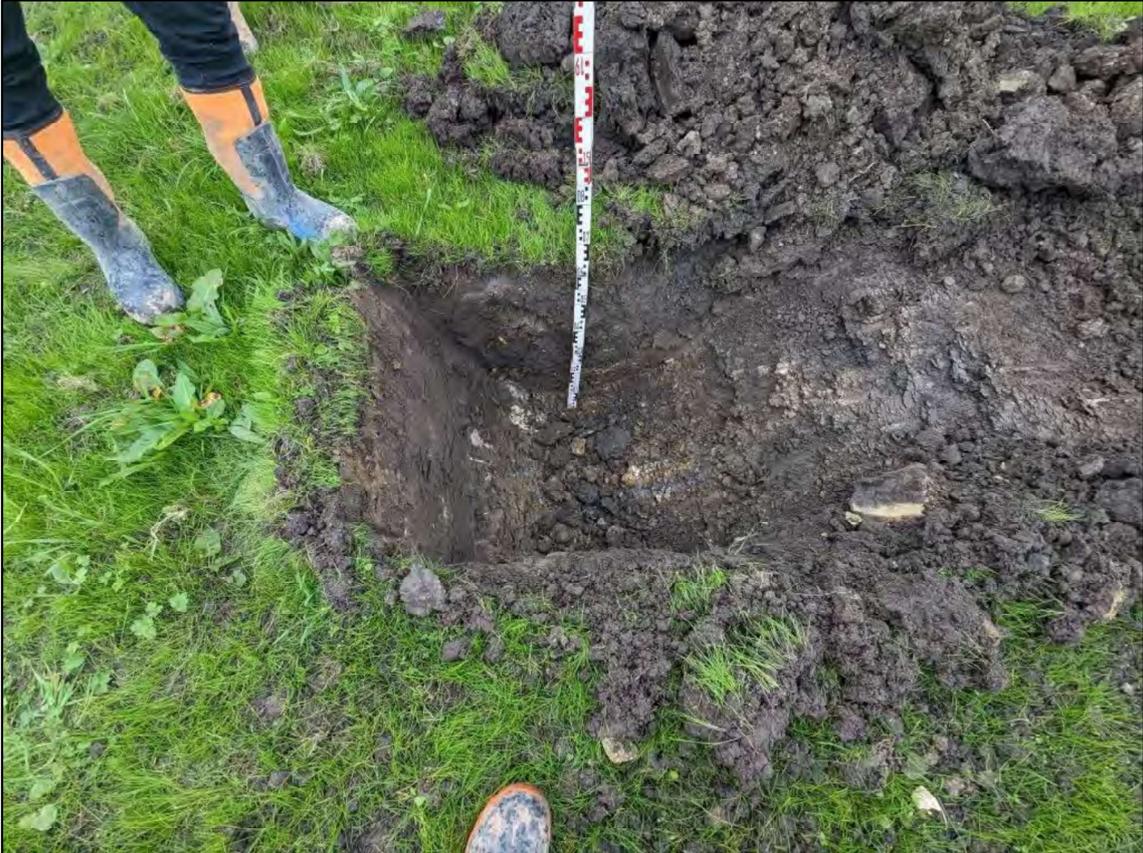
Photo 17 POS Inspection Pit 1

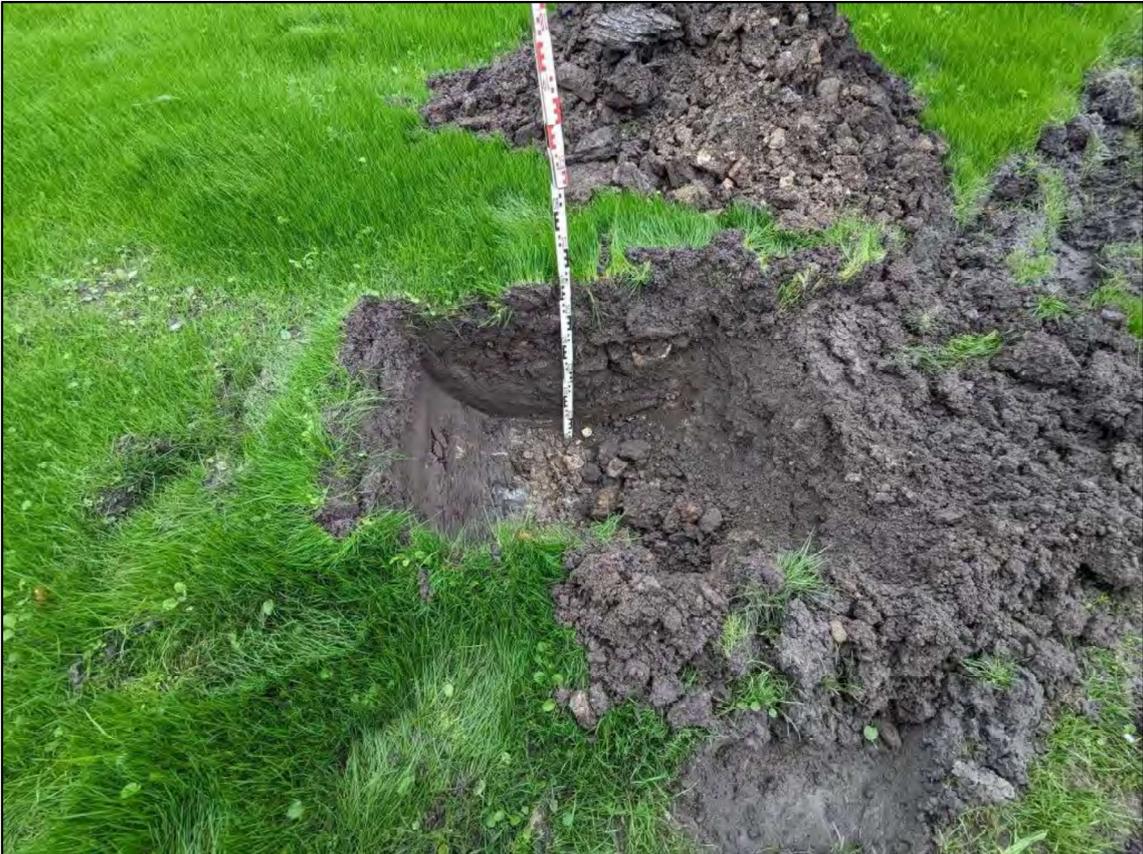
Photo 18 POS Inspection Pit 2

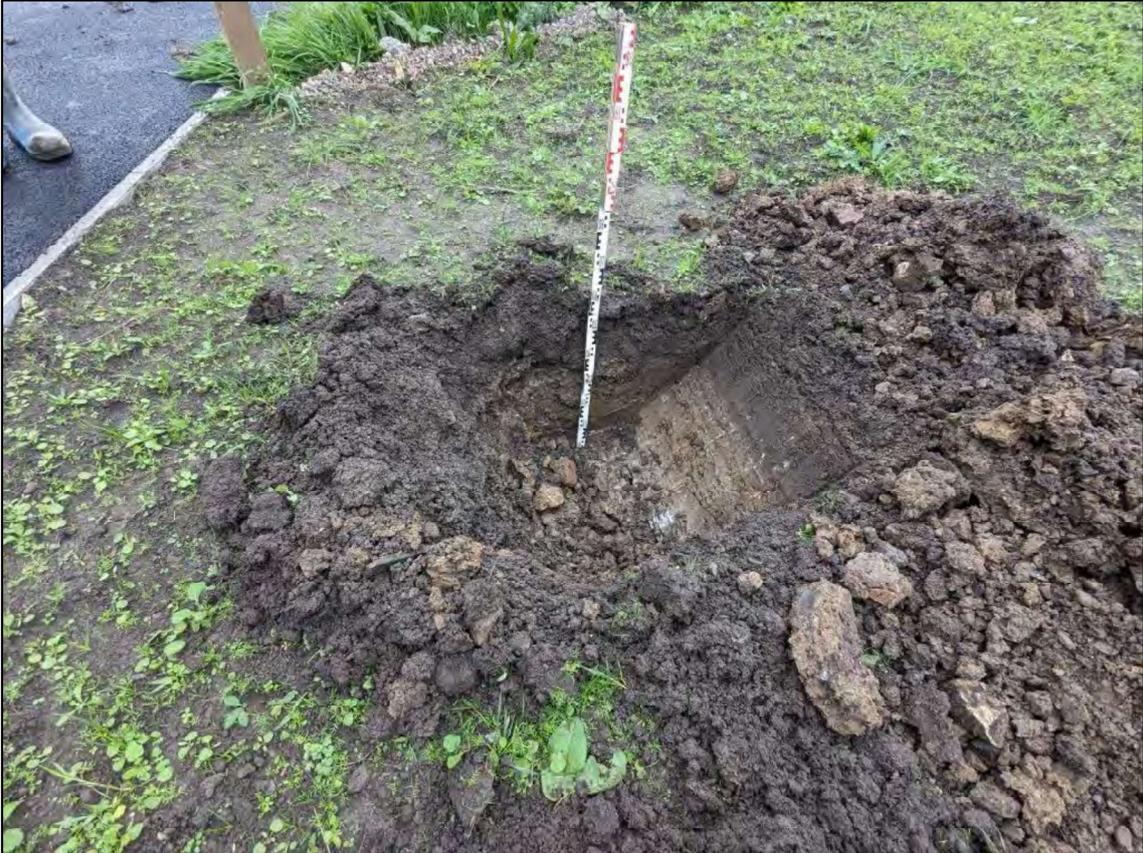
Photo 19 POS Inspection Pit 3

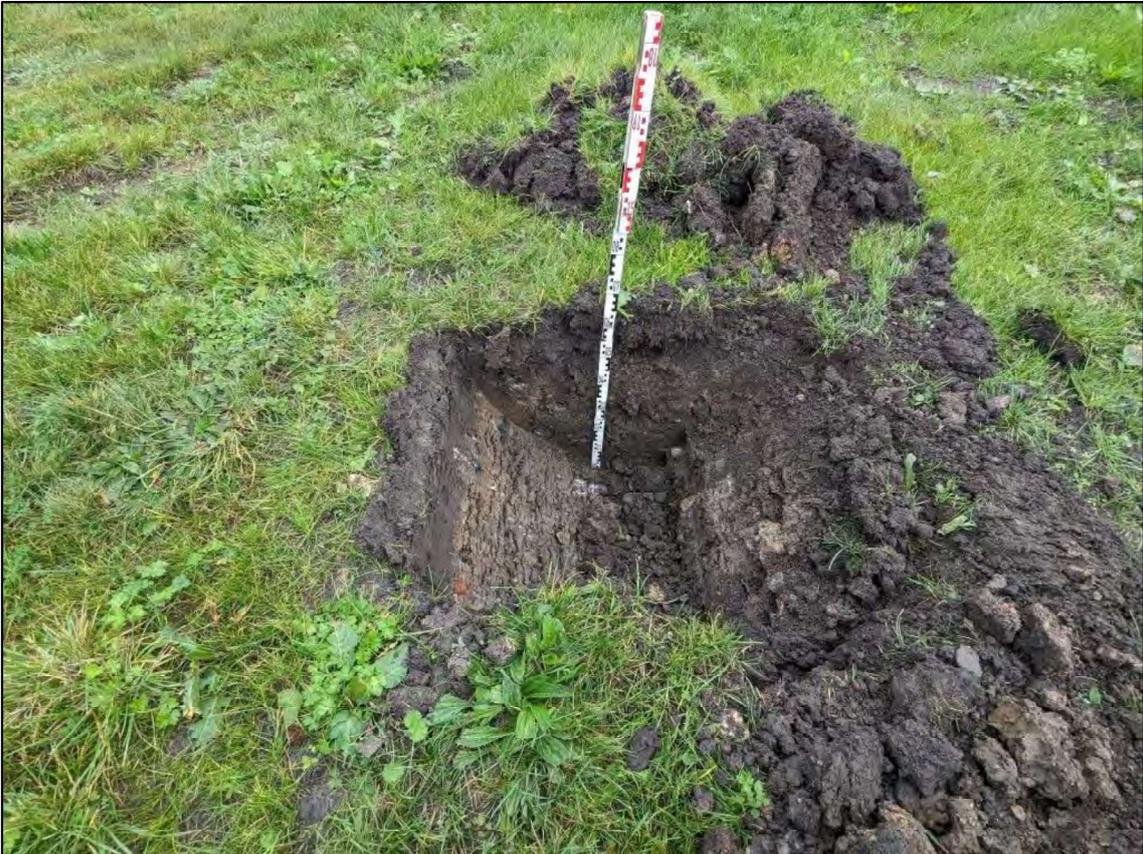
Photo 20 POS Inspection Pit 4

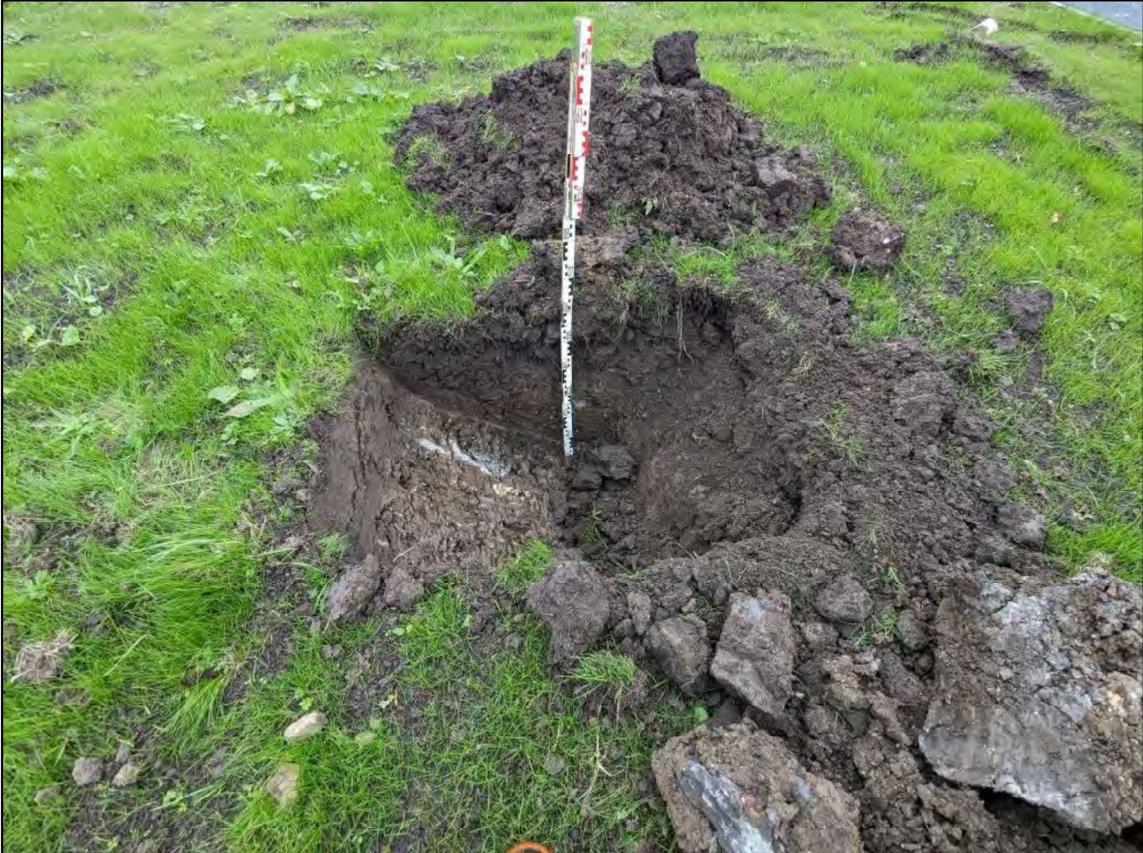
Photo 21 POS Inspection Pit 5

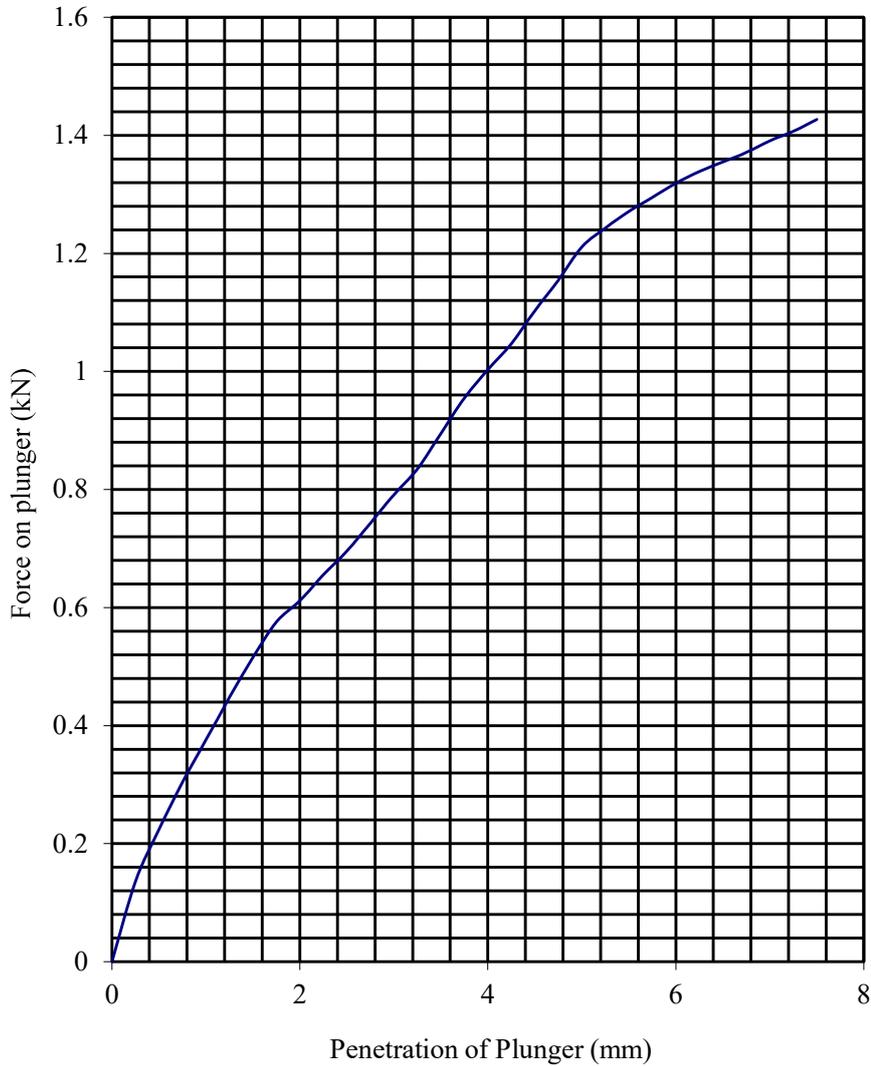
Position Number: 3B

Initial Sample Conditions	Method of Test	Insitu	C.B.R. Value %	6.1
Test Date	08-Aug-22	Estimated Percentage above 20mm:	0	Moisture Content:
Remarks:	Brown slightly gravelly slightly sandy CLAY.			
Required CBR Value:	N/A	Passed /Failed	N/A

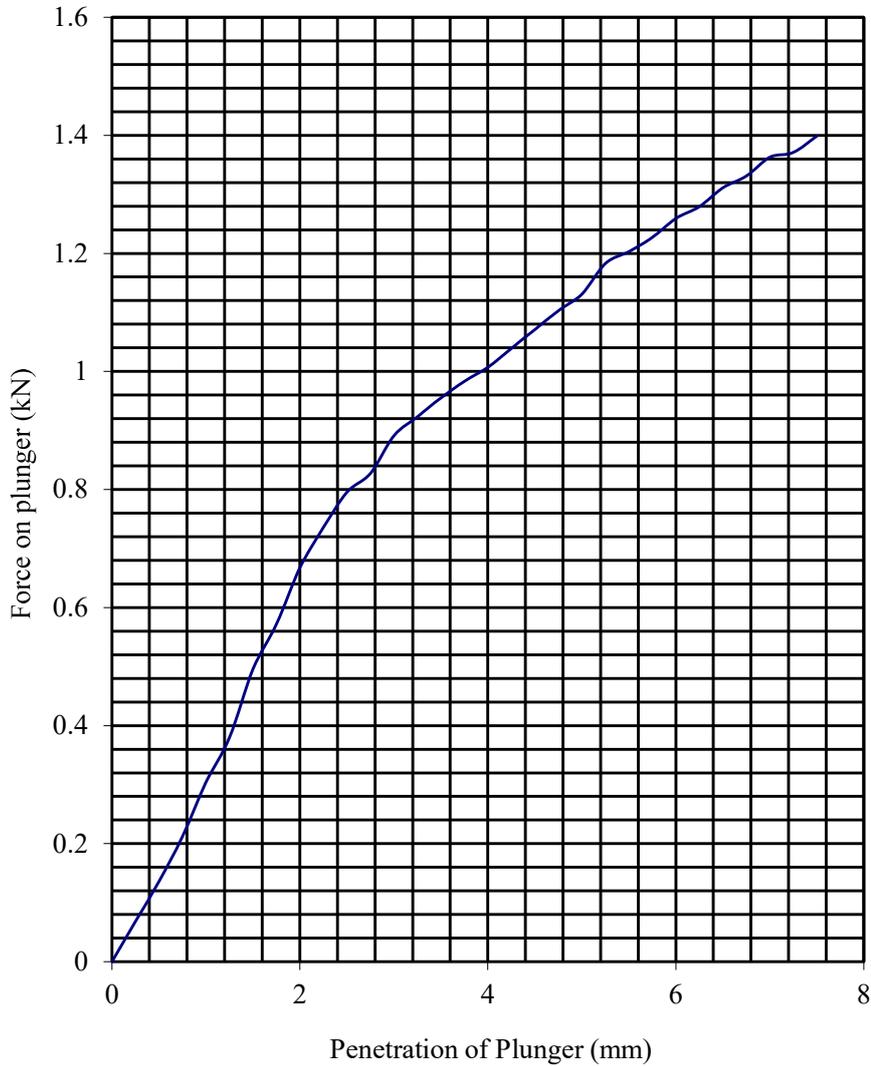
Position Number: 3C

Initial Sample Conditions	Method of Test	Insitu	C.B.R. Value %	6.0
Test Date	08-Aug-22	Estimated Percentage above 20mm:	0	Moisture Content:
Remarks:	Brown slightly gravelly slightly sandy CLAY.			
Required CBR Value:	N/A	Passed /Failed	N/A
