# **Ground Investigation Report** [intrusive]

Ashbrow Road, Fartown, Huddersfield

| Project Number | 20459 |
| Report Number | 001 |

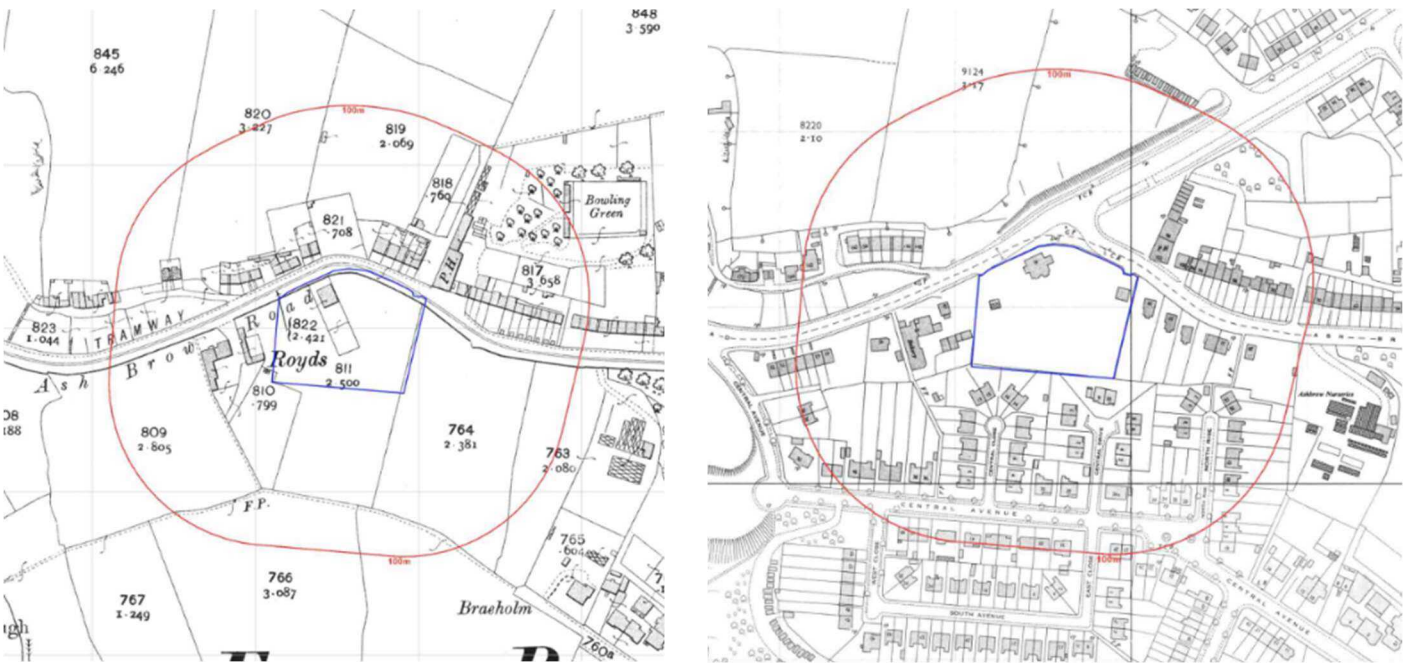
**Figure 2:** Historical mapping extracts

Potentially harmful material represents a possible hazard on all Brownfield sites, including this former residential plot. Strictly, it is considered likely that sources of potentially harmful material exist on Site, e.g. discarded coal ash deposits associated with former coal fires in the dwelling and the former glasshouse (Figure 2).

- > Extract from 'Phase 1 Environmental Desk Study & Coal Mining Risk Assessment' prepared by Rogers Geotechnical Services Ltd
- > LEFT HAND IMAGE: 1906-1907 mapping; RIGHT HAND IMAGE: 1958 mapping

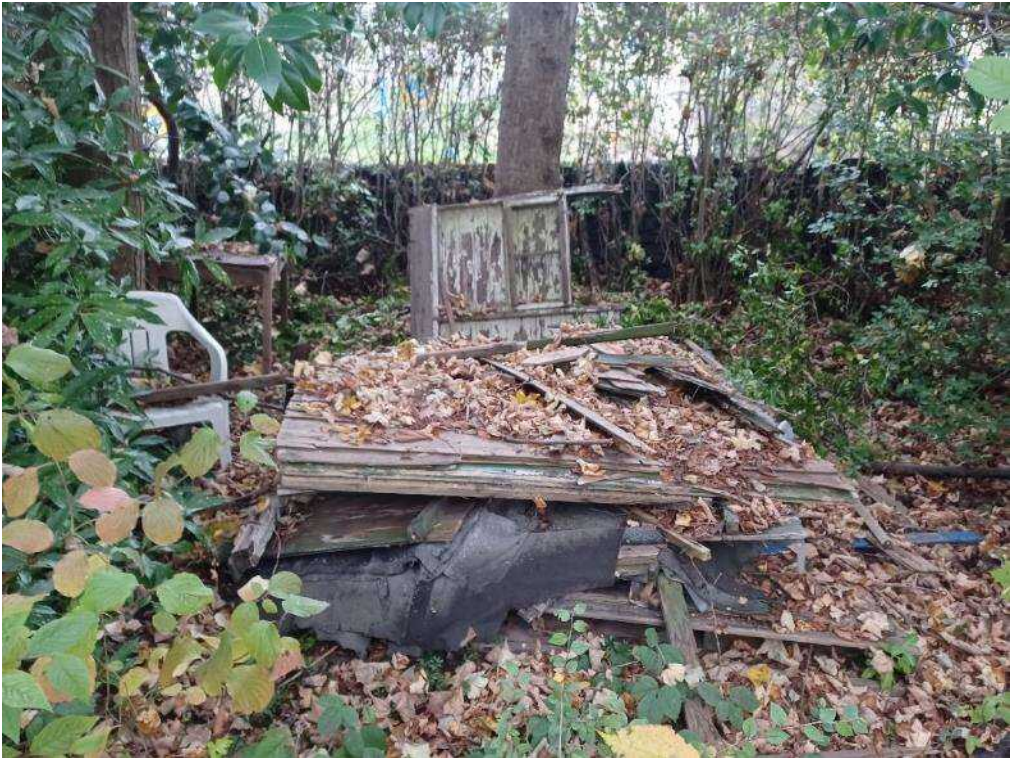
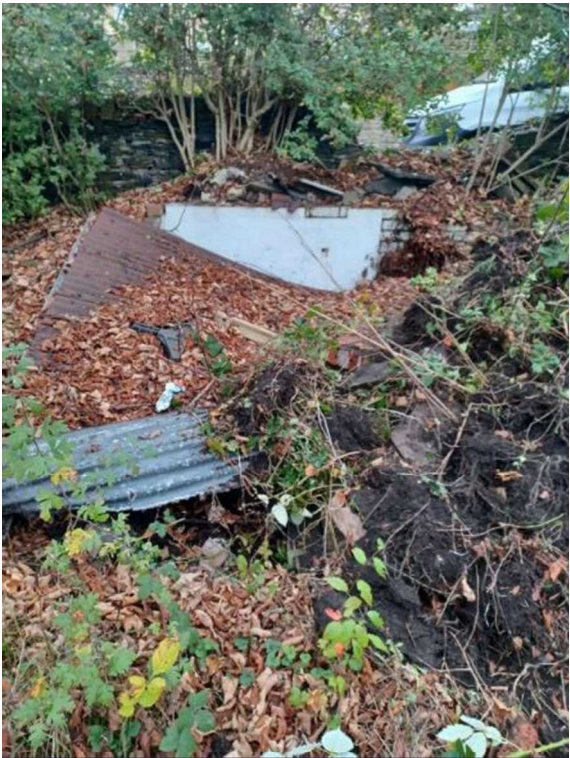
- > **Variation 1:** Relic structures (dilapidated sheds) are present on Site (not previously noted in the RGS report).
- > **Observation 1:** No evidence of potentially harmful or polluting material was encountered in the relic structures, exploratory holes or the surface of the Site;

**Photograph 2 (left) and 3 (right):** Former outbuildings – no evidence of potentially harmful or polluting material, e.g. asbestos containing material

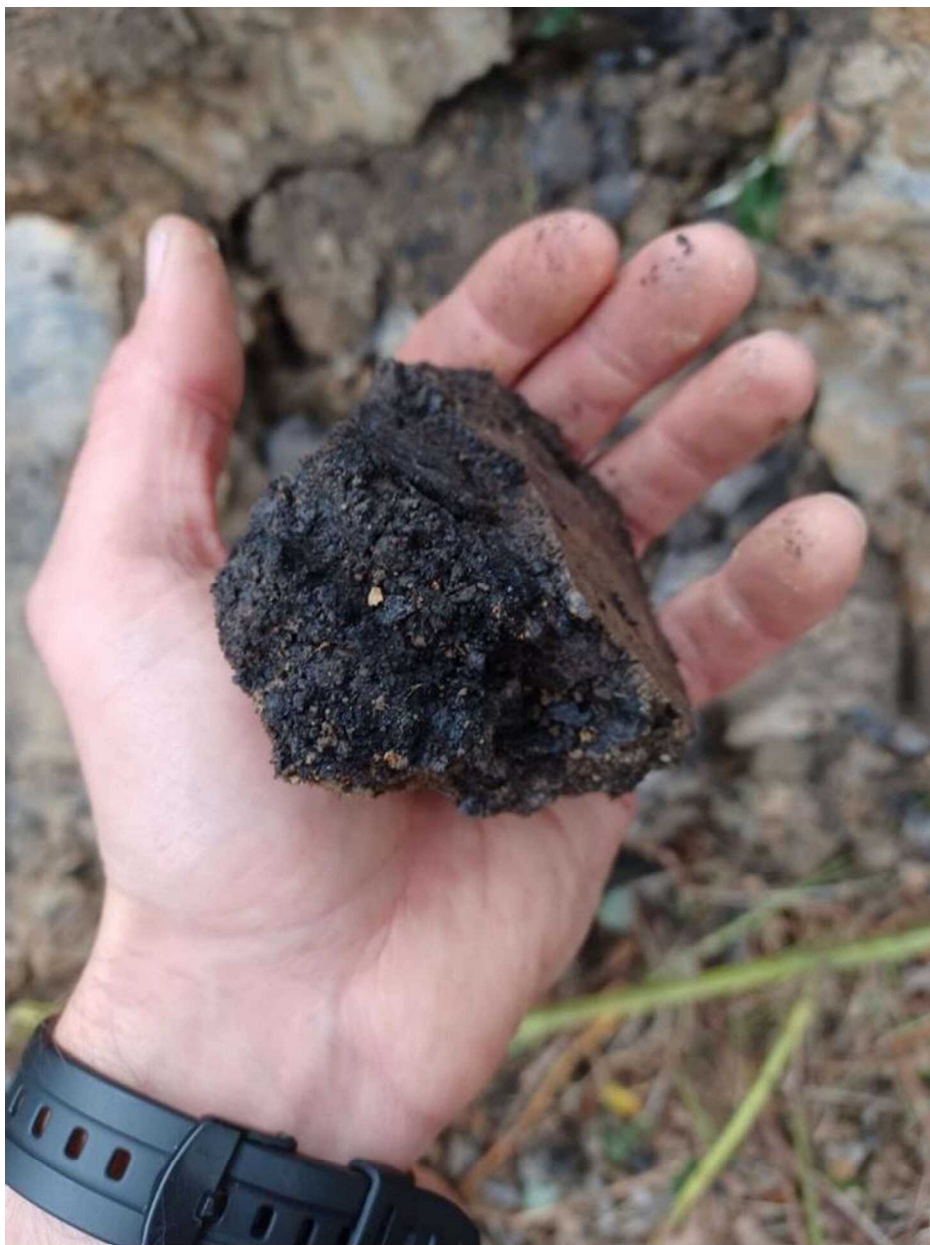
**Photograph 4:** Texture of the carbonaceous mudstone (possible completely weathered / washed out coal) recovered from a depth of 0.40 m below ground level in TP104

- > The presence of carbonaceous mudstone / washed out coal deposits (relatively low strength and degradable) beneath the Site directs the need for foundations to be taken through this material (encountered in TP104 only);

The material is too thin and too weathered/degraded to have been of economic value for extraction / mining historically with the next coal seam viable for extraction in the bedrock sequence too deep to present residual stability issues for the proposed structure.

- > In any case, the material includes a degradable and potentially combustible content with the following risk mitigation advice relating to potential fire risk. Whilst coal fires are considered a low likelihood overall, coal fires have occurred, are occurring at present and can occur in the UK. If and where an underground fire develops, they are very difficult and costly to extinguish.

- A strict no-smoking policy should be adhered to on Site.
  - If and where evidence of smouldering or fires within the carbonaceous mudstone deposits is observed the fire should be smothered with spoil and compacted, if safe to do so and the emergency services contacted alongside the Mining Remediation Authority’s emergency mine hazard line **01623 646 333**. **Dowsing with water SHOULD NOT be considered as this can lead to explosions.**

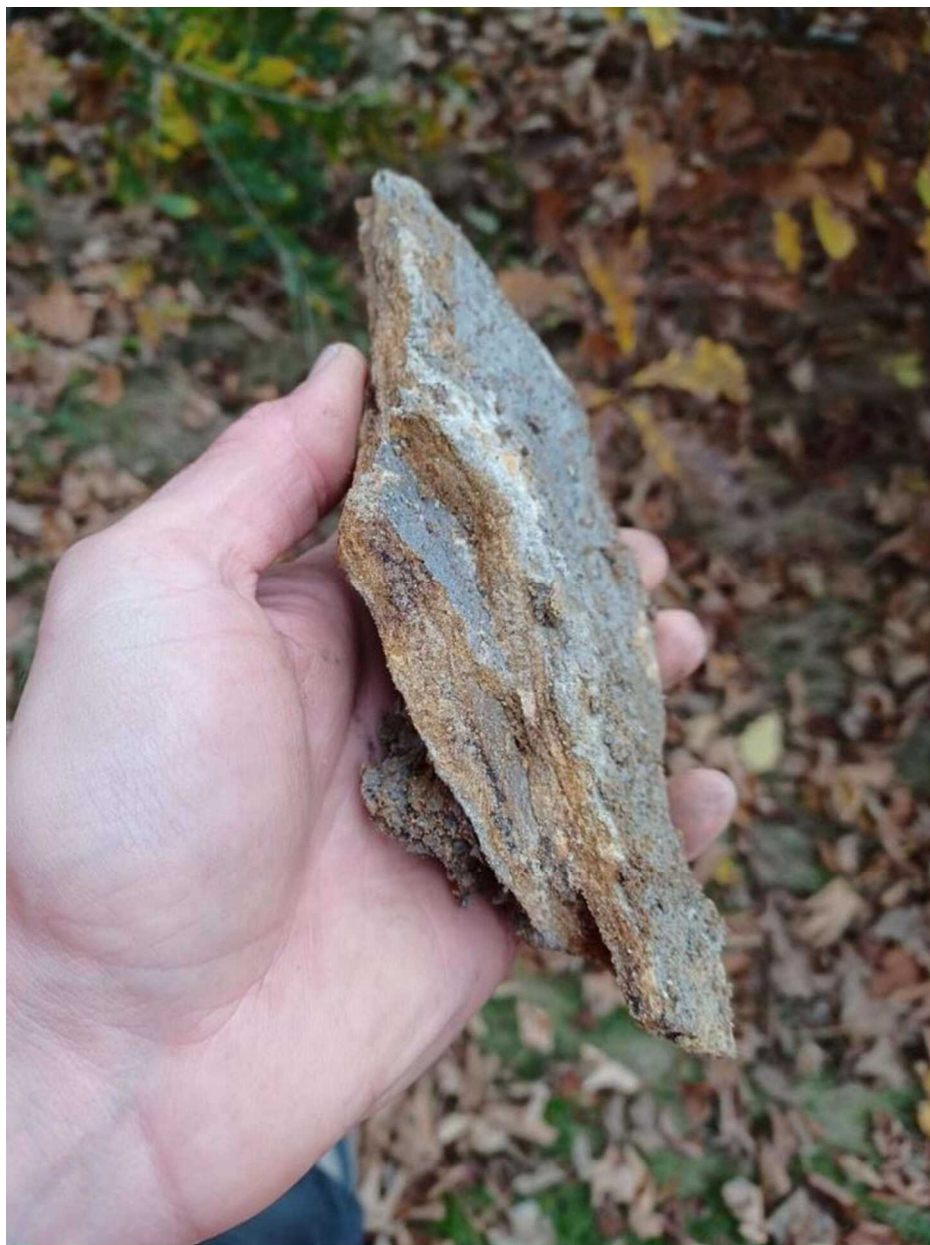
**Photograph 5:** Texture of the sandstone recovered from a depth of 0.50 m below ground level in TP106

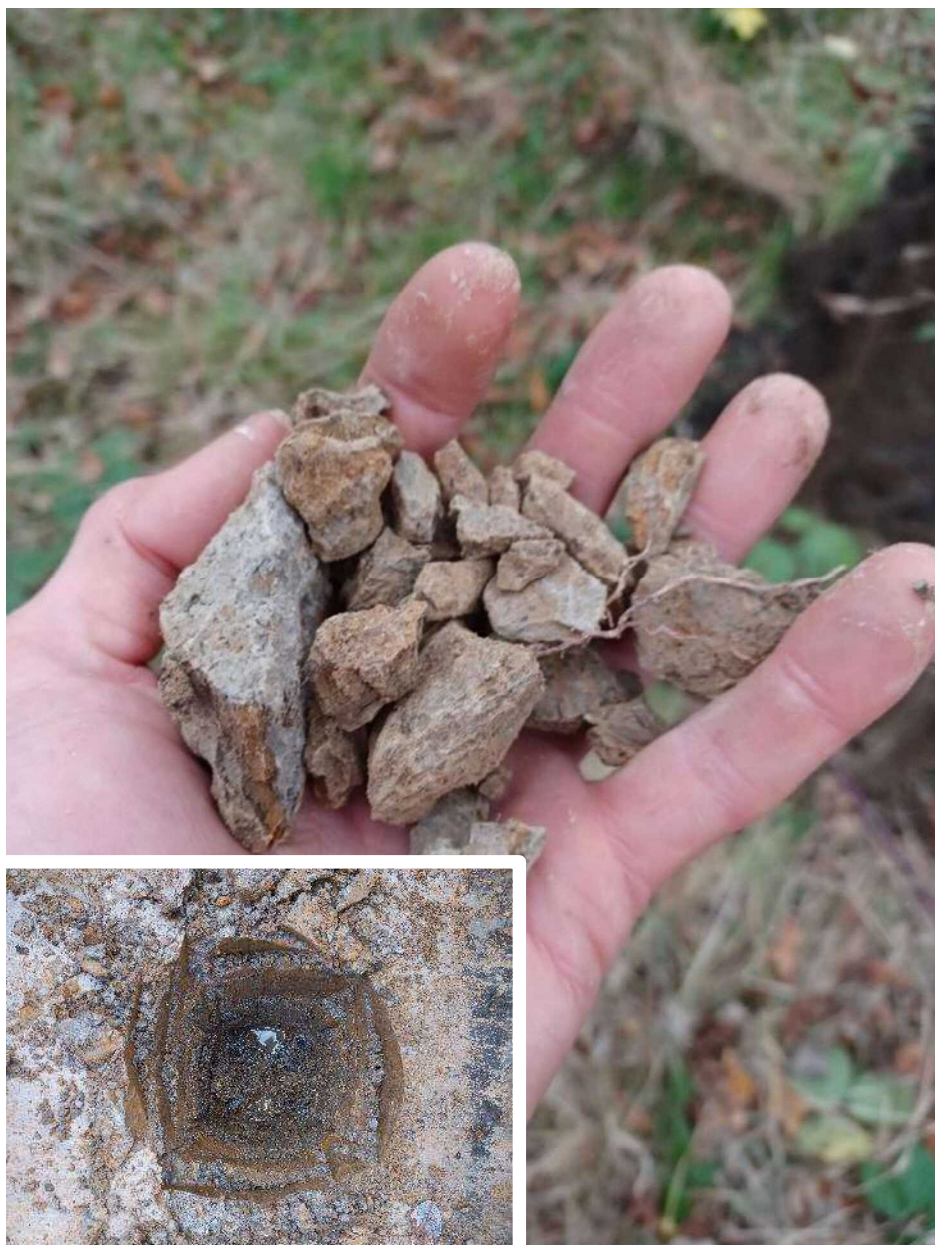
**Photograph 6:** Texture of the siltstone (and inferior sandstone) recovered from a depth of 1.00 m below ground level in TP101

*INSERT:* TP101 infiltration test pit (water in hole has been introduced and is not 'groundwater')

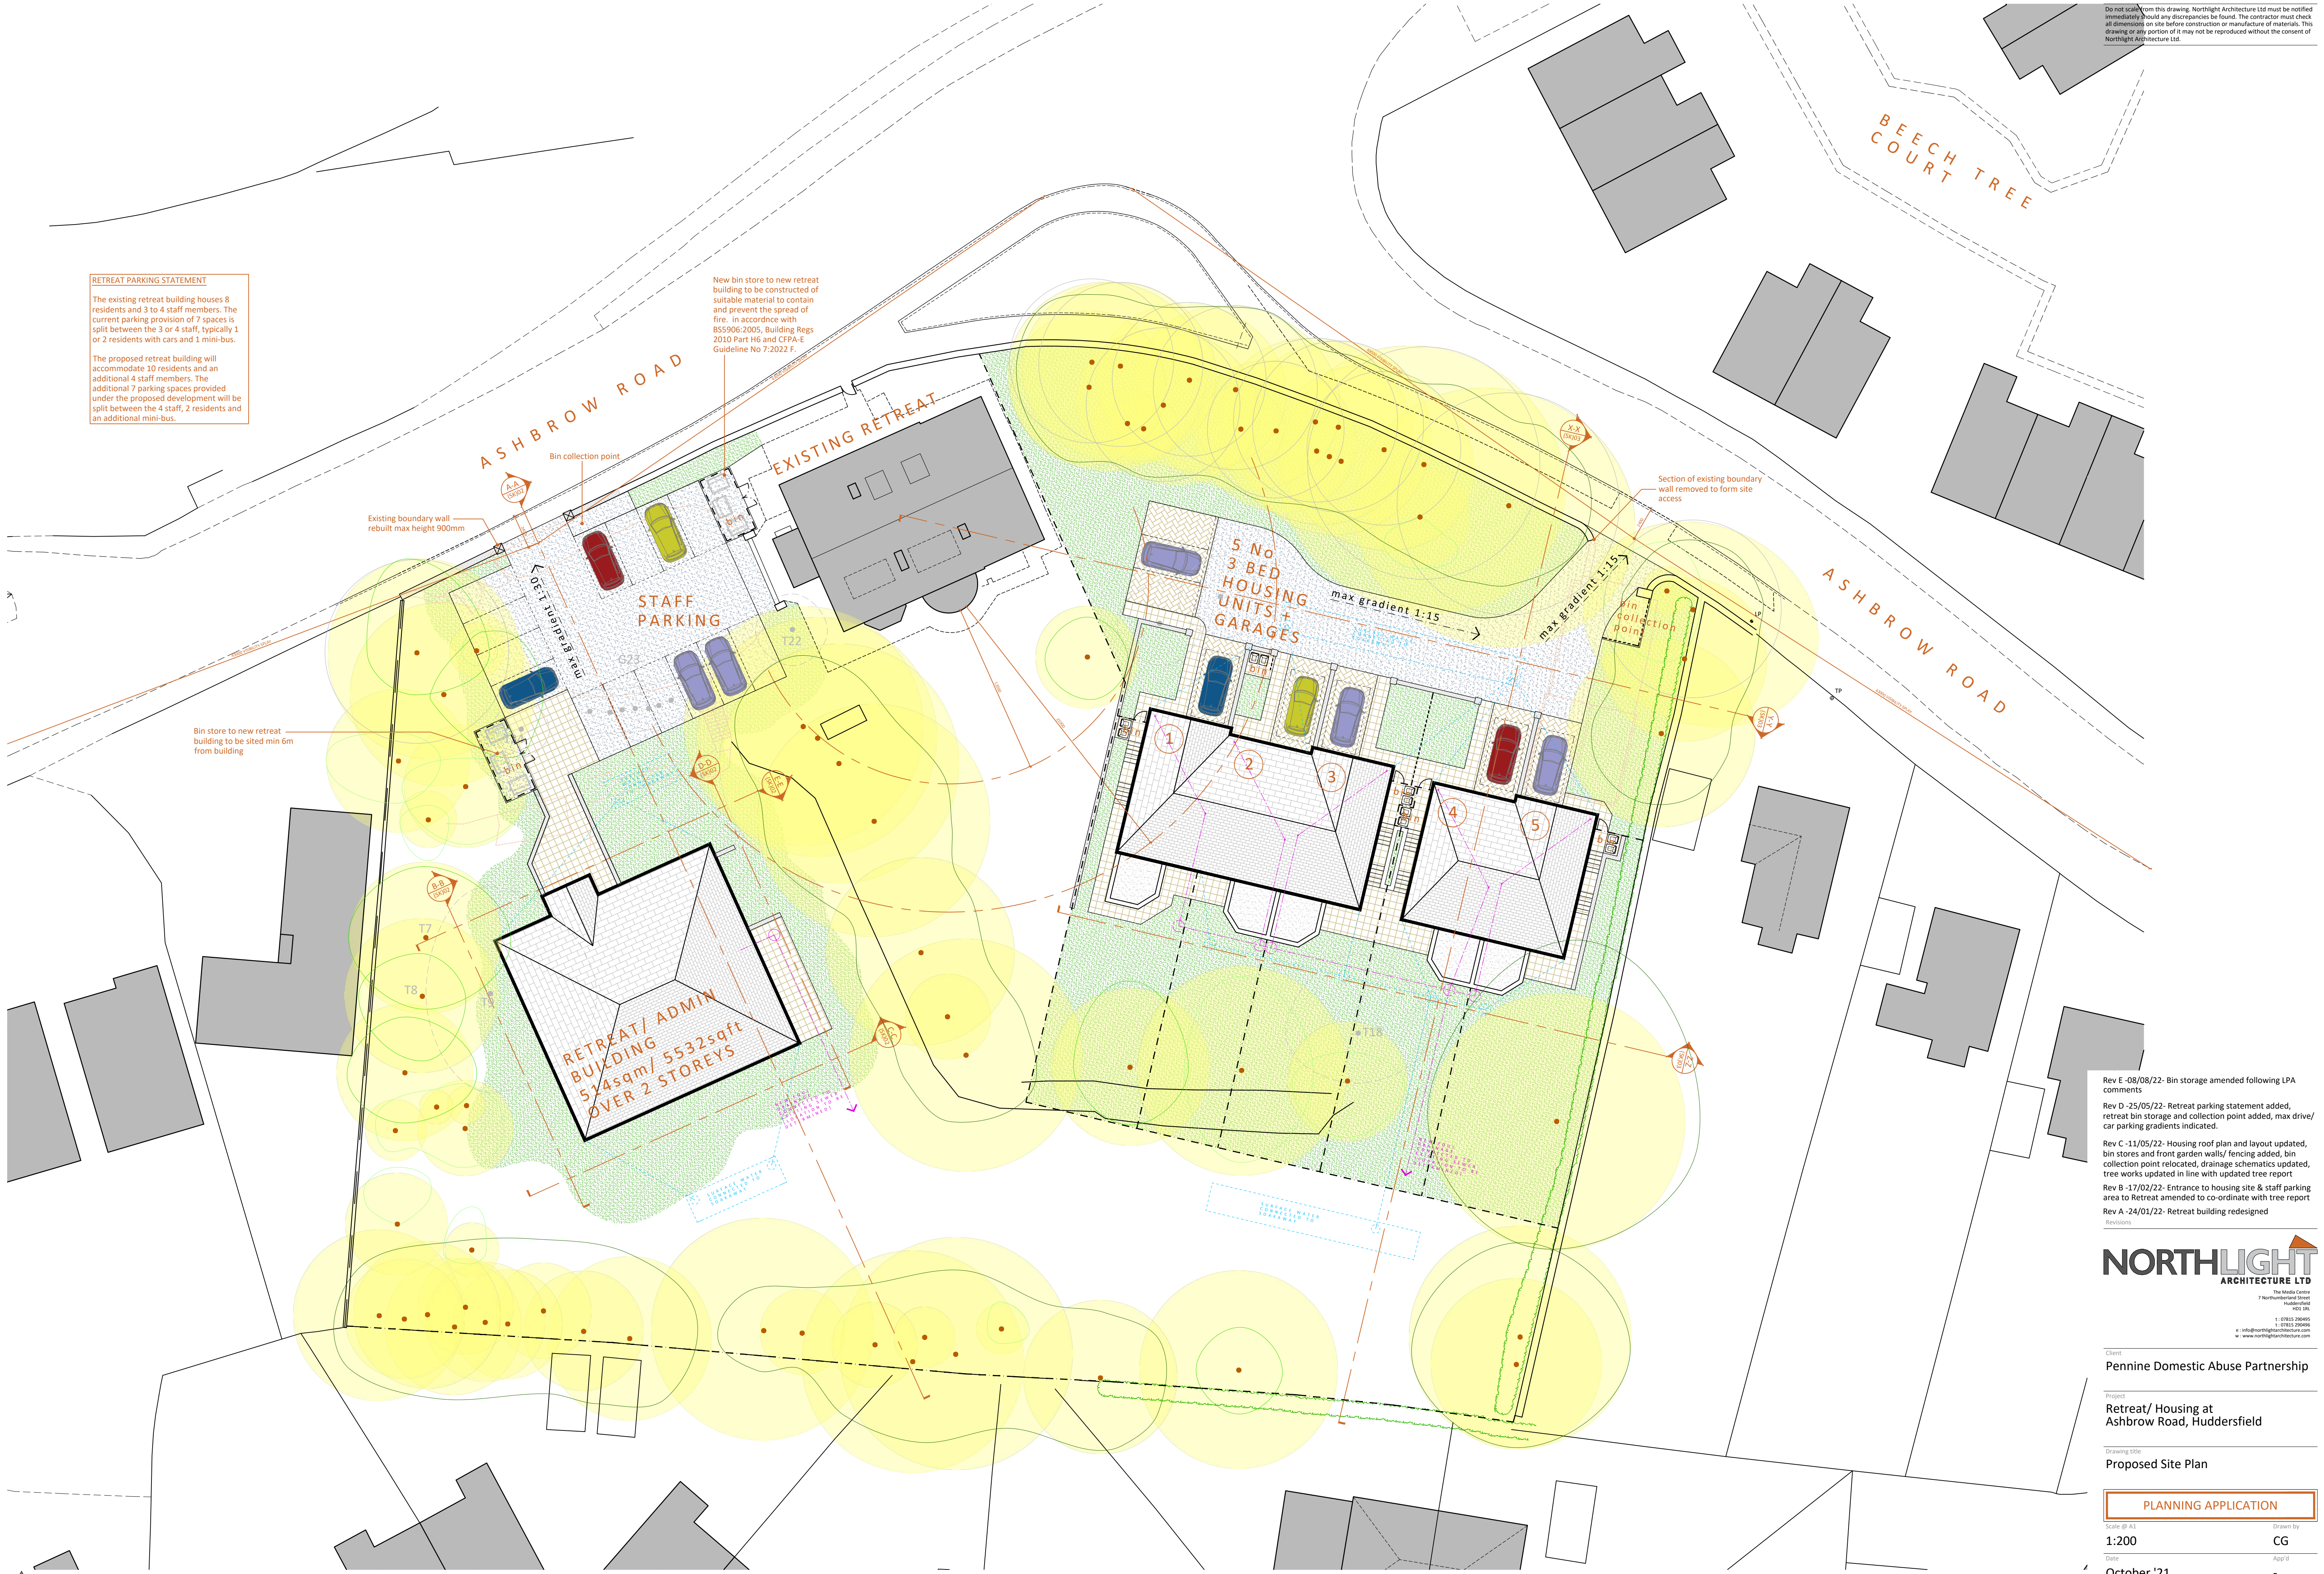
Existing boundary wall rebuilt max height 900mm

Bin store to new retreat building to be sited min 6m from building

Rev E -08/08/22- Bin storage amended following LPA comments  
Rev D -25/05/22- Retreat parking statement added, retreat bin storage and collection point added, max drive/ car parking gradients indicated.  
Rev C -11/05/22- Housing roof plan and layout updated, bin stores and front garden walls/ fencing added, bin collection point relocated, drainage schematics updated, tree works updated in line with updated tree report  
Rev B -17/02/22- Entrance to housing site & staff parking area to Retreat amended to co-ordinate with tree report  
Rev A -24/01/22- Retreat building redesigned

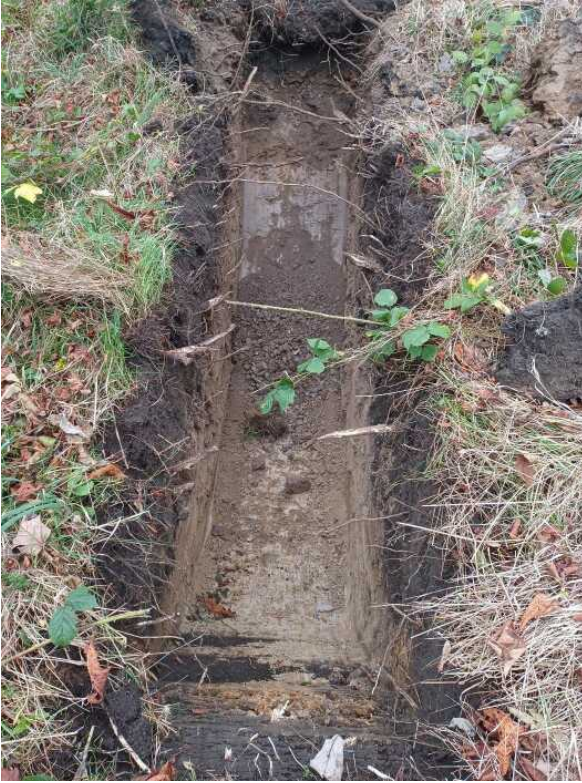
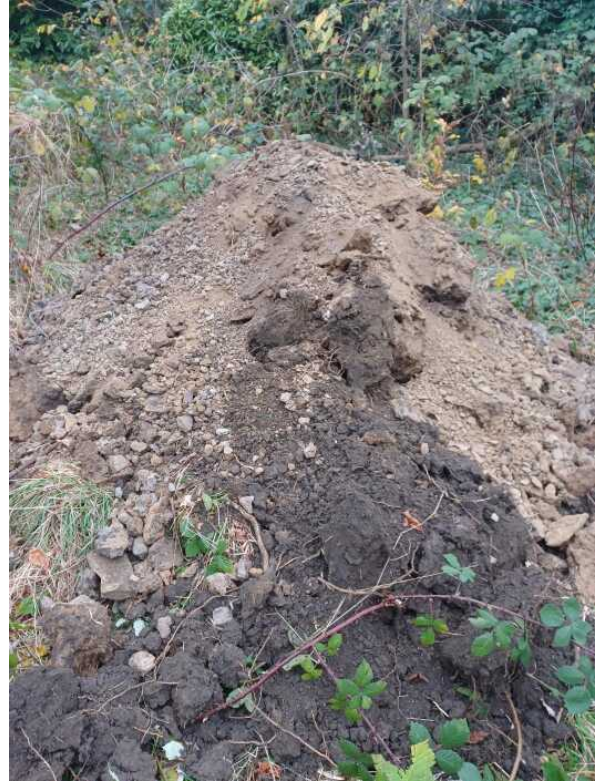
**REMARKS:** PURPOSE: General coverage of the Site. TERMINATION: Very slow progress with toothless bucket on 3CX excavator. GROUNDWATER: None encountered. STABILITY: Stable throughout depth. IN-SITU TESTING: Infiltration testing 300mm head of water. Test 1: 180 mins to fall 20mm. OTHER: No evidence of potentially polluting or harmful material.

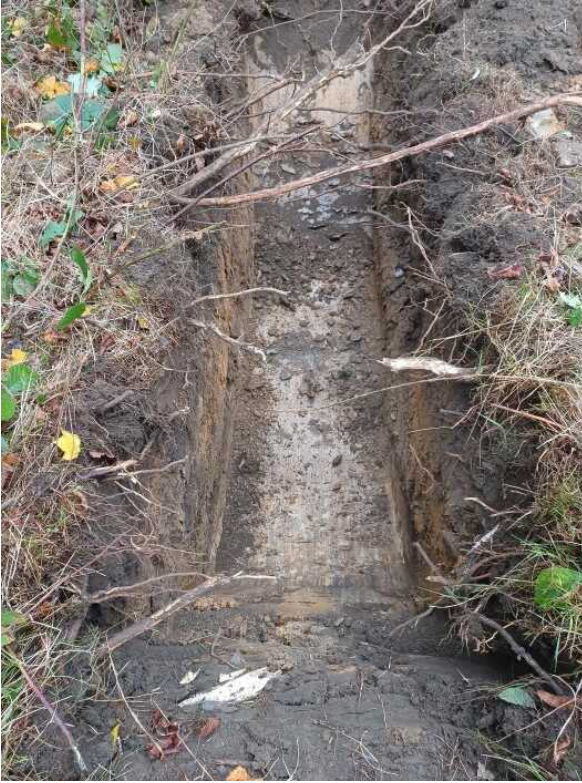
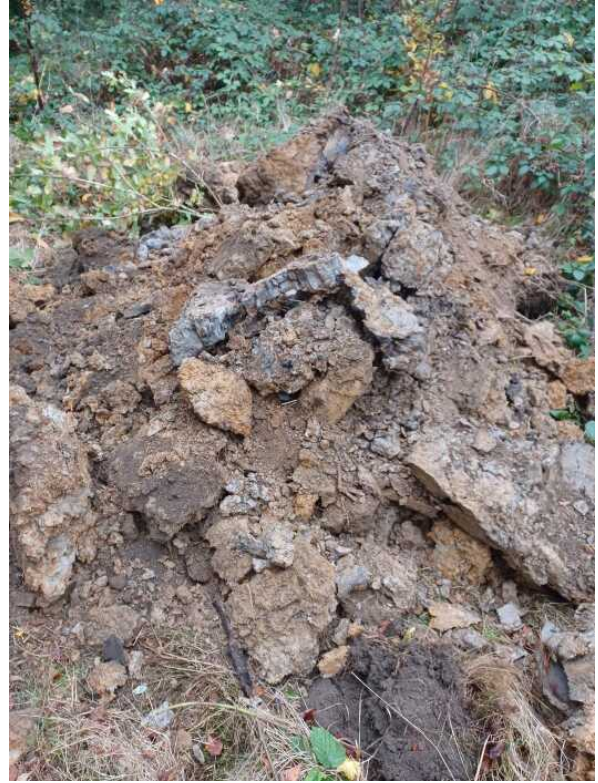
**REMARKS:** **PURPOSE:** General coverage of the Site. **TERMINATION:** Scraping with toothless bucket on 3CX excavator. **GROUNDWATER:** None encountered. **STABILITY:** Stable throughout depth. **OTHER:** No evidence of potentially polluting or harmful material.

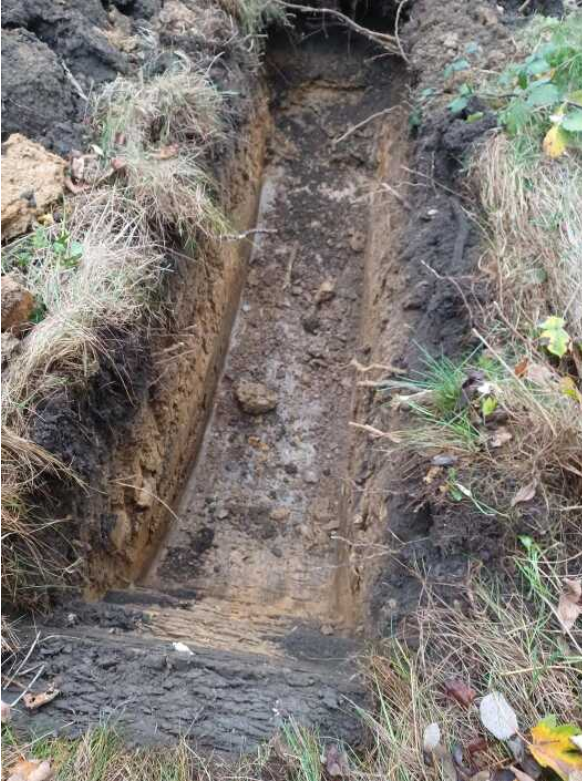
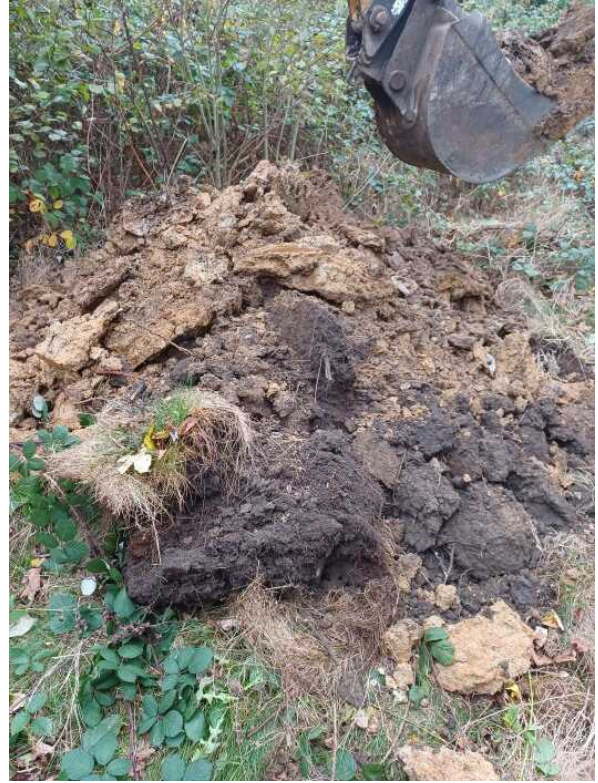
**REMARKS:** **PURPOSE:** General coverage of the Site. **TERMINATION:** Scraping with toothless bucket on 3CX excavator. **GROUNDWATER:** None encountered. **STABILITY:** Stable throughout depth. **OTHER:** No evidence of potentially polluting or harmful material.

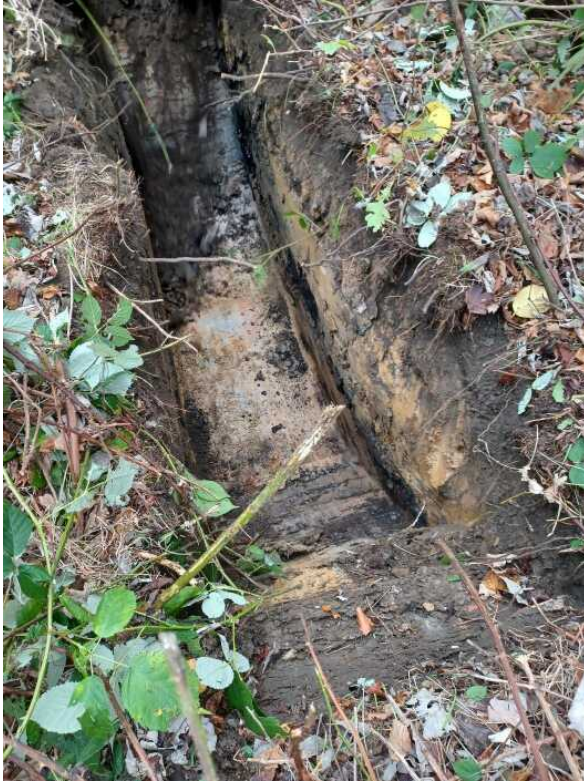
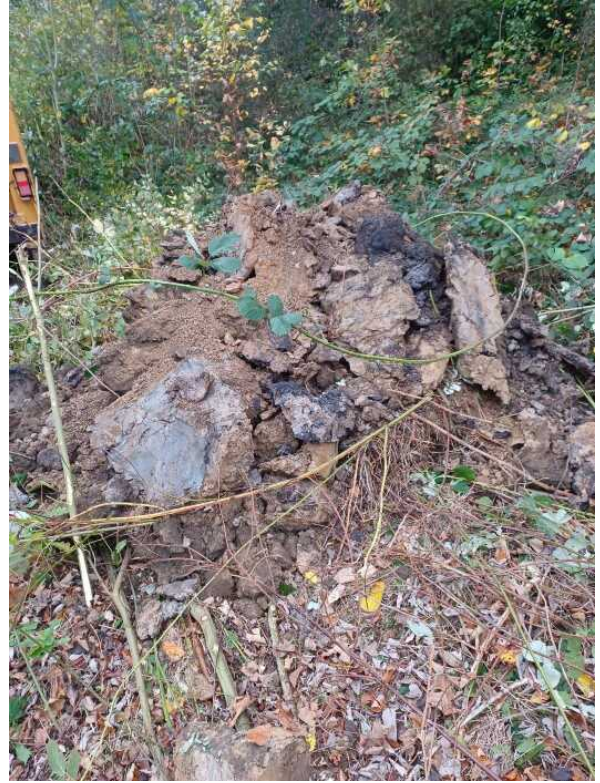
**REMARKS:** PURPOSE: General coverage of the Site and attempt to target the former glasshouse location (access restricted by slope and dense vegetation). TERMINATION: Scraping with toothless bucket on 3CX excavator. GROUNDWATER: None encountered. STABILITY: Stable throughout depth. OTHER: No evidence of potentially polluting or harmful material.

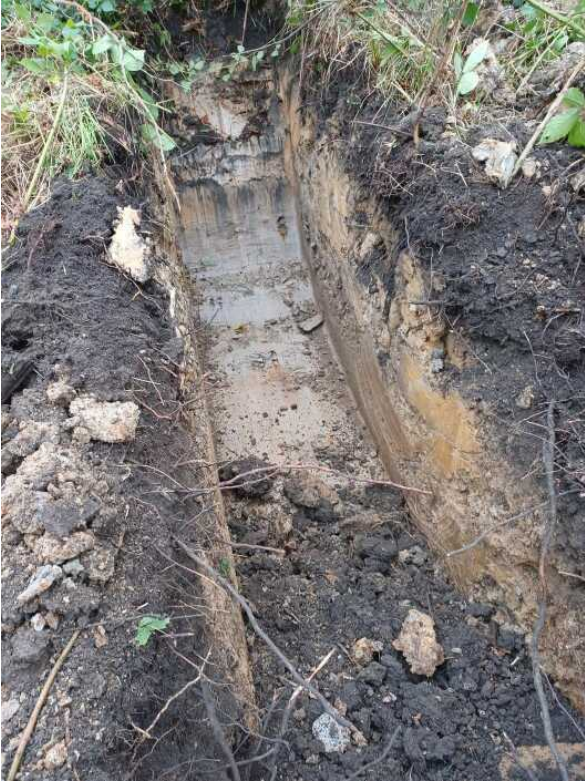
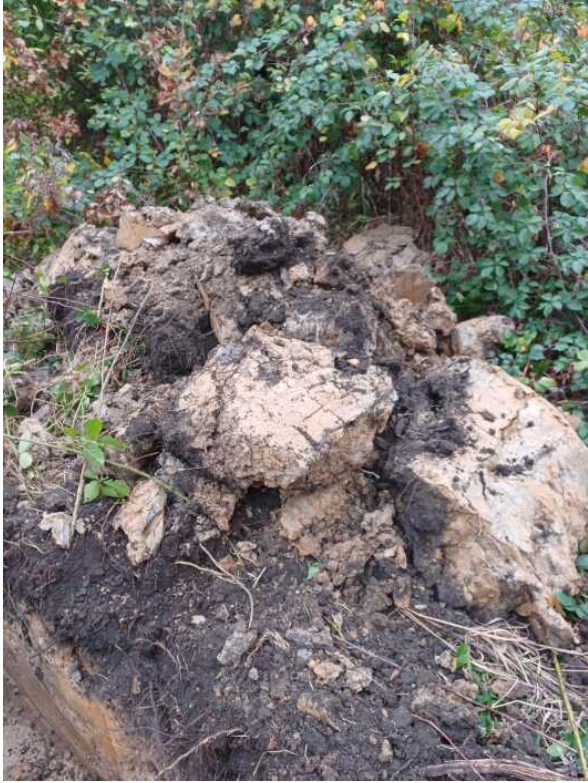
| Remarks<br>PURPOSE: General coverage of the Site. TERMINATION: Scraping with toothless bucket on 3CX excavator. GROUNDWATER: None encountered. STABILITY: Stable throughout depth. OTHER: No evidence of potentially polluting or harmful material. | | Method, Plant, Stability, Dimensions<br>Logger | | | |

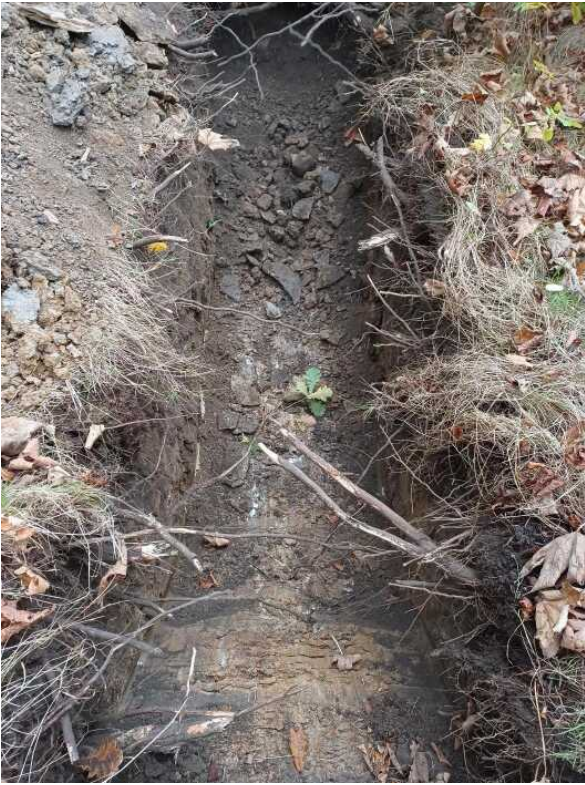
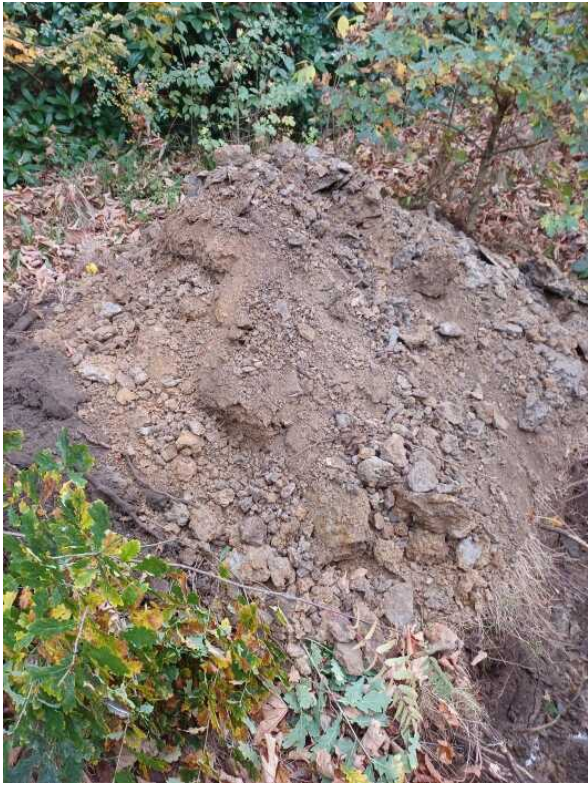
| Remarks<br>PURPOSE: General coverage of the Site. TERMINATION: Scraping with toothless bucket on 3CX excavator. GROUNDWATER: None encountered. STABILITY: Stable throughout depth. OTHER: No evidence of potentially polluting or harmful material. | | Method, Plant, Stability, Dimensions<br>Logger | | | |
