Route Approval Document

JOB NOTES

openreach	FTTP MDU - INTERNAL ROUTE DESIGN
MDU ID	SM-00066273
NGWFMT Project ID	KYCPS
Grid Reference	413871.0000,417208.0000
Site Address	highfield court, huddersfield, HD15NG
Property Agent/Manager/Owner	HIGHFIELD COURT RESIDENTS (HUDDERSFIELD) LIMITED;- ,Flat 6,No Value,Highfield Court,Kirklees,West Yorkshire,,HD1 5NQ;akhan@watspm.co.uk
Telephone No	01132738788
Access Contact Details	Aleena Khan;01132738788;akhan@watspm.co.uk; Asbestos Report and Access Info saved to Teams file
Openreach Contact Details	612958652;+447483442411,+447483442411,lois.whitaker@openreach.co.uk
Exchange Name	HUDDERSFIELD TE
THP	19
Company	Chief Eng - North DL
Orion Workorder ID	MDU_MDU6100000002836213A
Surveyor Details	Millar McCoy, millar.mccoy@openreach.co.uk

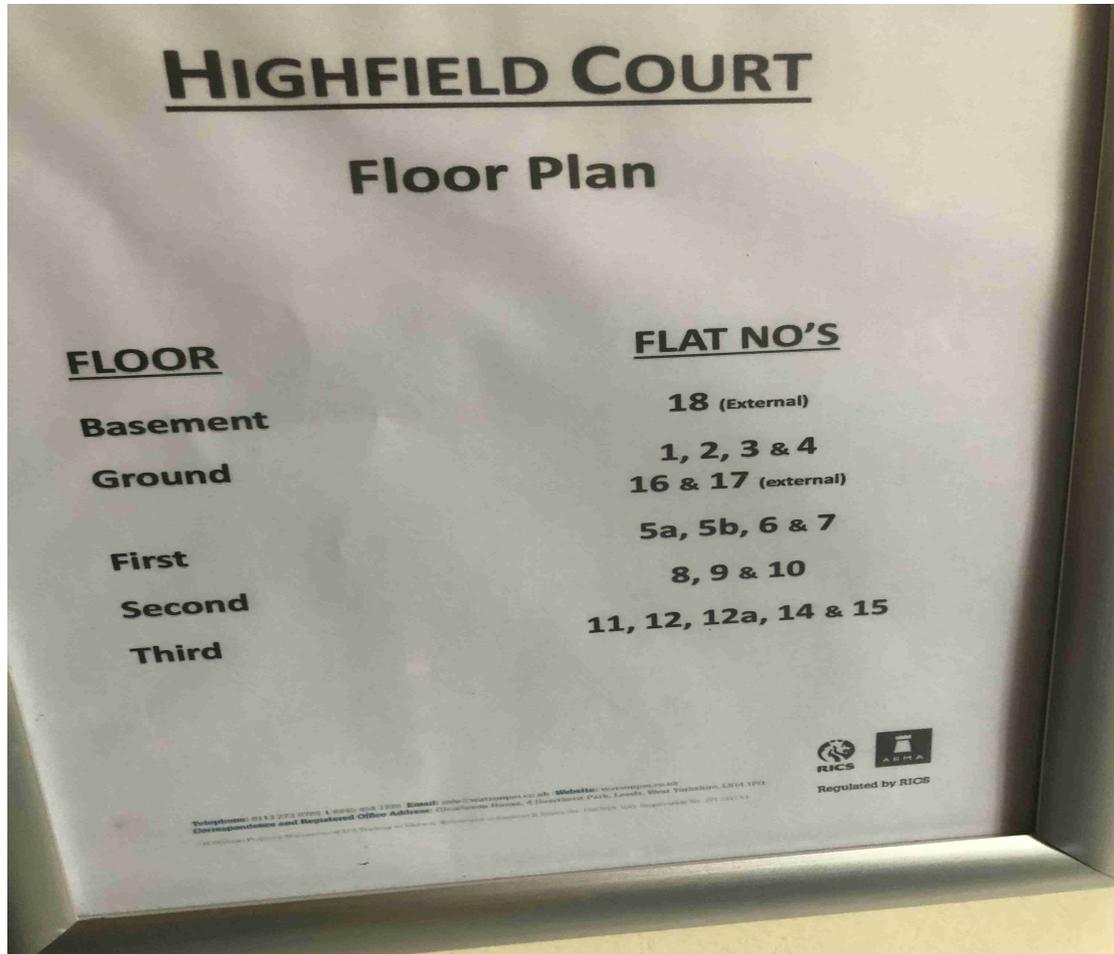
floor plan

Floor name: basement, ground, 1, 2, 3

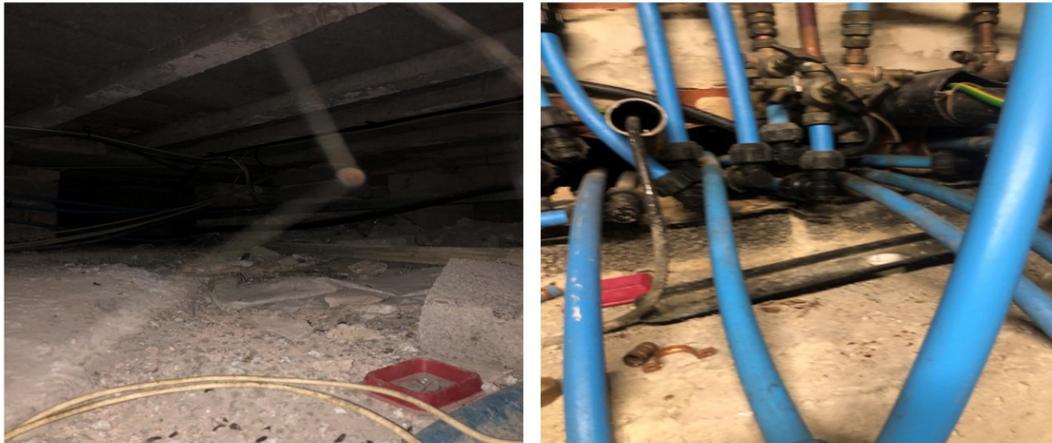
route 1

Existing UG route is blocked by water pipes, and would require utilising small crawl space/confined space.

Overhead route most appropriate way of feeding the building and existing cables to elevations already exist

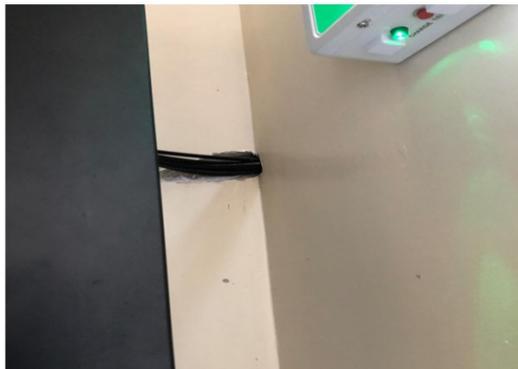
Use existing hole to bring cable into the building. And locate USF above existing black box.

From there use invisilight cable to feed each floor and 1 external cable for external flats.
