GEO-ENVIRONMENTAL REPORT

job number	4800/24/E/7331	date	31.01.2025
------------	----------------	------	------------

site address	The Priory, Cleckheaton, West Yorkshire, BD19 6HR
--------------	--

Report on a Phase 2 Geo-environmental Investigation

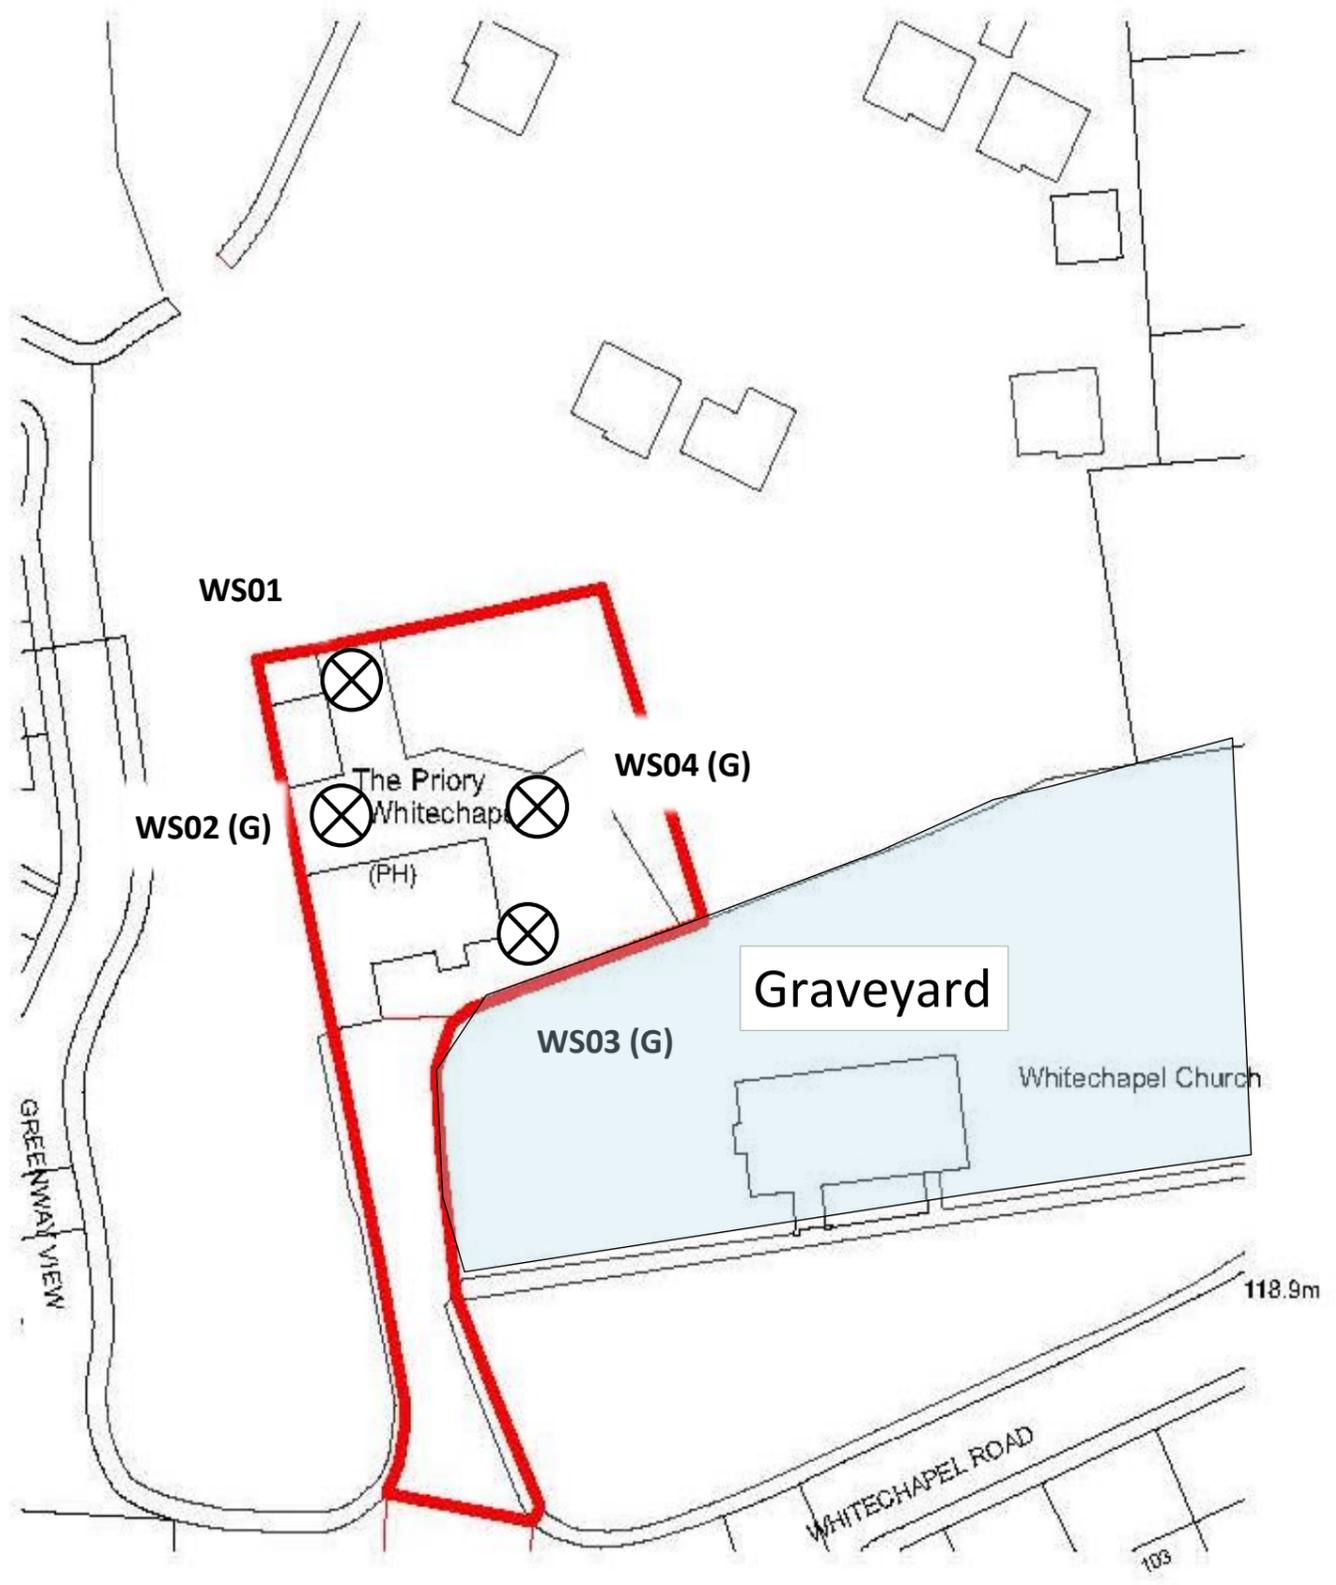
Site Plan

Notes:
Investigation positions approximated from site operative's notes.

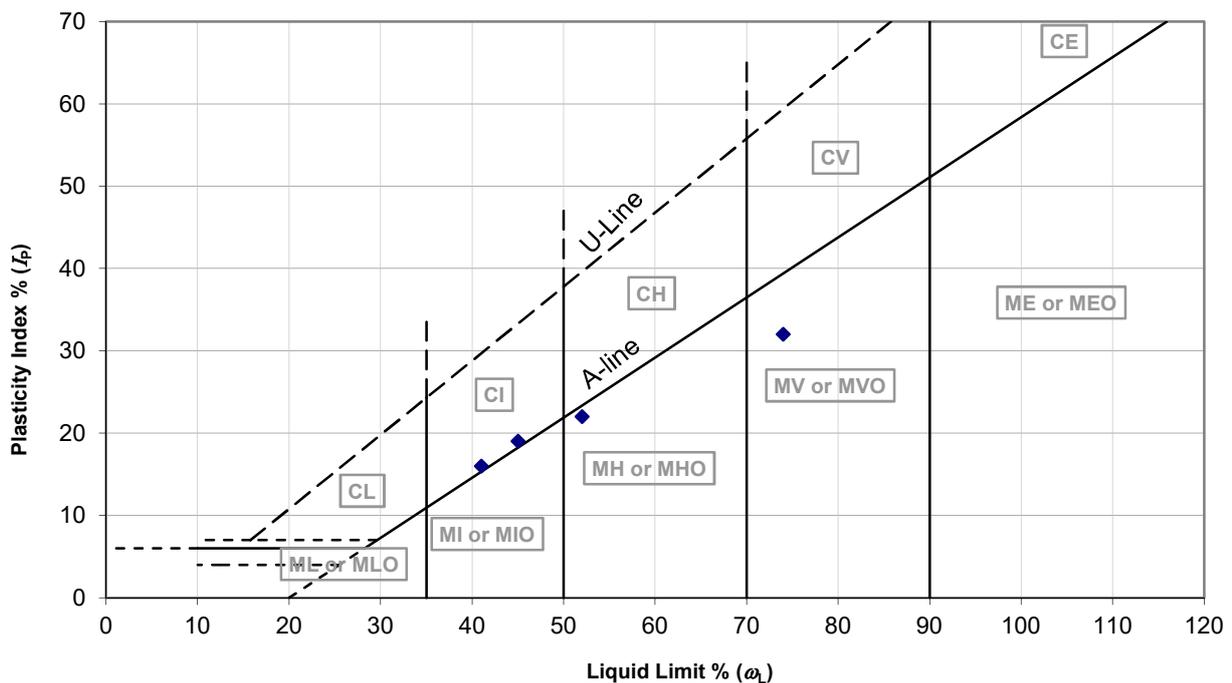
Location	Depth (m)	Water Content (ω) (%)	Liquid Limit (ω_L) (%)	Plastic Limit (ω_P) (%)	Plasticity Index (I_P) (%)	Retained by 0.425mm (%)	Modified (ω) (%)	Modified (I_P) (%)	Liquidity/ Consistency		Casagrande Class	N.H.B.C Class (%)
									(I_L) (%)	(I_C) (%)		
WS03	1.60	26	45	26	19	27	36	14	0.0	1.0	C I	LOW
WS03	2.30	18	41	25	16	1	18	16	-0.4	1.4	C I	LOW
WS04	1.70	56	74	42	32	0	56	32	0.4	0.6	M V	MEDIUM
WS04	2.30	30	52	30	22	2	31	22	0.0	1.0	M H	MEDIUM
