Arboricultural Method Statement

WC-416.2a

Moorgate Farm, Moor Lane,
Netherthong, Holmfirth HD9 3UP

Report type:	Arboricultural Method Statement
Report reference:	WC-416.2
Revision:	a
Client:	Mr. and Mrs. Rushworth
Site address	Moorgate Farm, Moor Lane, Netherthong, Holmfirth HD9 3UP
OS Grid Ref:	SE 12950 09478
Report prepared by:	Jack Delaney MICFor MArborA
Date:	20 th February 2026

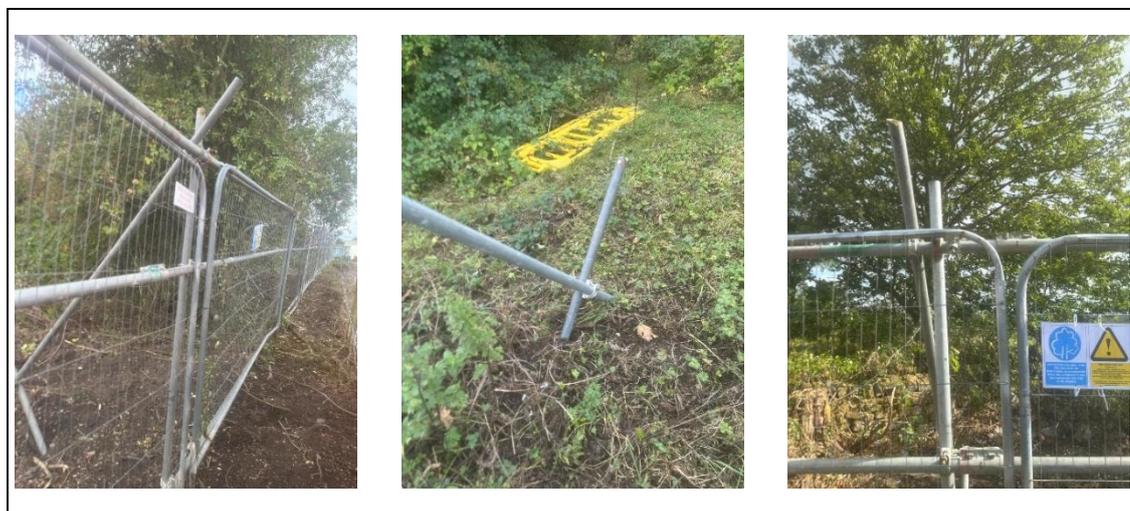
Figure 3.1: Examples of scaffold framework temporary tree protection fencing.

- 3.4.1.** Temporary tree protection barriers shall be installed prior to the commencement of development works, and should be fit for the purpose of excluding site personnel and machinery. The default specification should be in accordance with *BS 5837: 2012*.
- 3.4.2. Specification:** Barriers shall be a minimum 2 m high, and should consist of a vertical and horizontal scaffold framework, well braced to resist impacts, as is illustrated in **Fig. 3.1**, below and **Fig. 3.2**, on the next page.
- 3.4.3.** The vertical tubes should be spaced at a minimum interval of 3 m and driven securely into the ground. Onto this framework, welded mesh panels should be securely fixed.

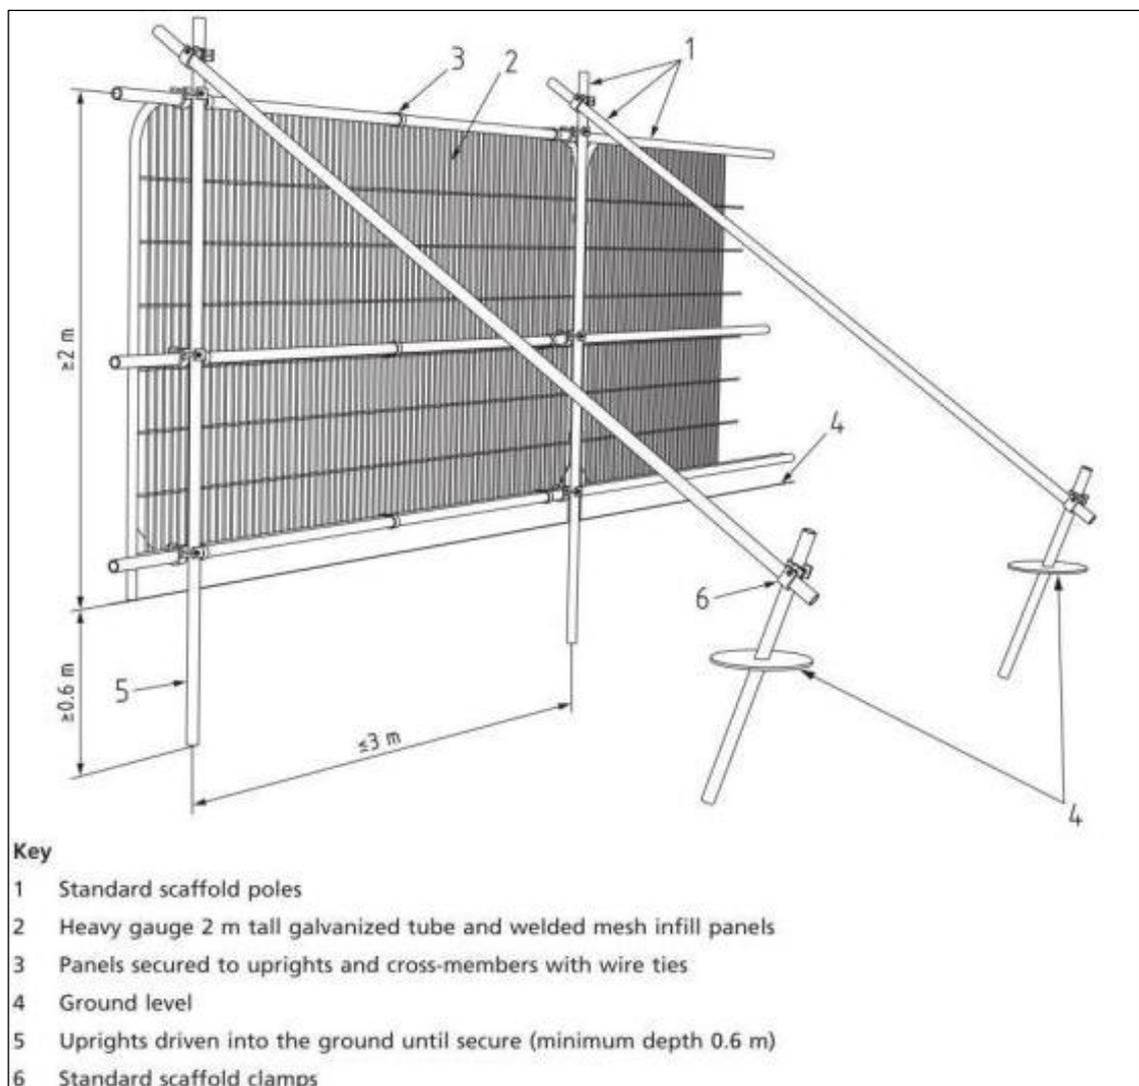
Figure 3.2: Specification for temporary 2 m steel protective fencing¹.

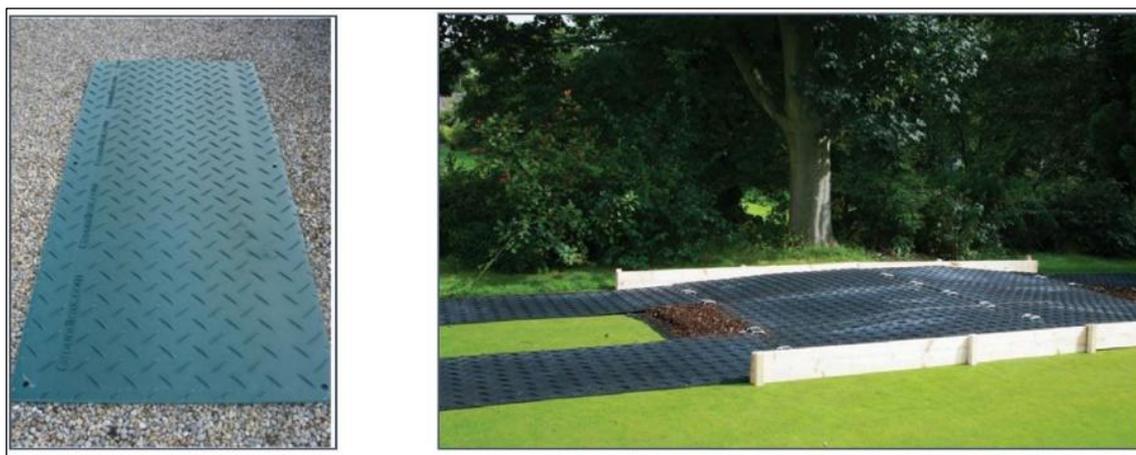
Figure 4.3: Examples of temporary ground protection panels.

- 3.6.1. Due to site constraints, and to allow for suitable working space, the temporary tree protection fencing adjacent to T001, T002, T003, T004, T005, T006, T007, and T008 will be setback from the default BS 5837:2012 positioning. As a result, uncovered ground within the RPAs of these trees will be exposed to development activities.
- 3.6.2. Temporary ground protection should therefore be installed - in the locations shown in the **Tree Protection Plan** - and shall remain in place until construction works have been completed.
- 3.6.3. The temporary ground protection will consist of proprietary, inter-linked ground protection boards placed on top of a compression-resistant layer (e.g. 150 mm depth of woodchip), which are laid onto a geotextile membrane, similar to those which are shown in **Fig. 3.3**, below.

- 3.6.4. Any vehicles, plant, or machinery operating within the RPAs of T001, T002, T003, T004, T005, T006, T007, and T008 must ensure it does so upon adequate ground protection at all times.

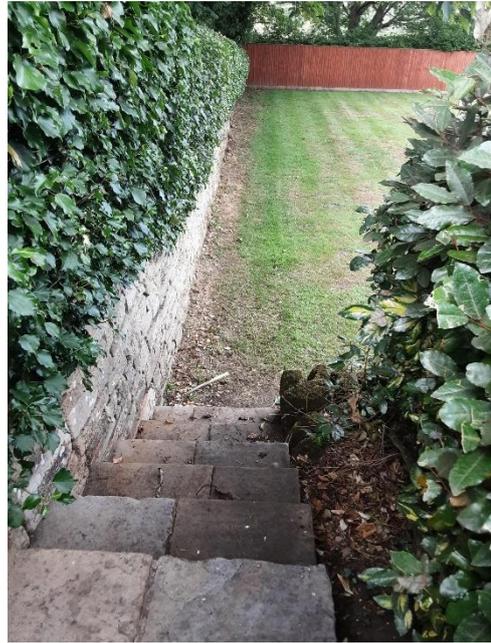
Plate 2: Current site access and retaining wall along western boundary

1.3.2. The topography of the site and surrounding area falls away from the south-west to the north-east. There is a retaining wall along the western boundary of the site.

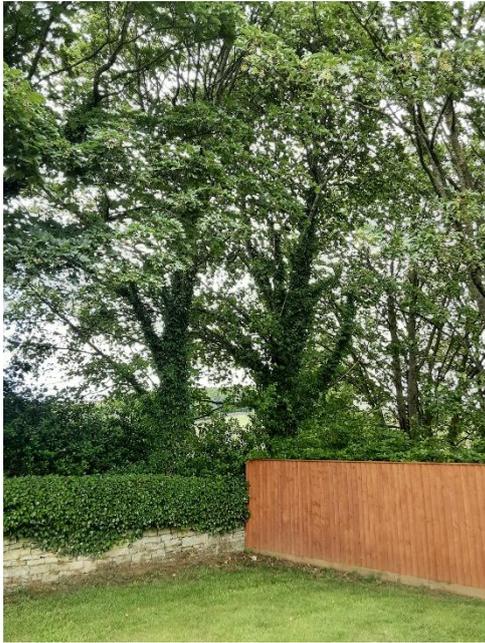
Plate 5: T005, T006, & T007 (left to right)

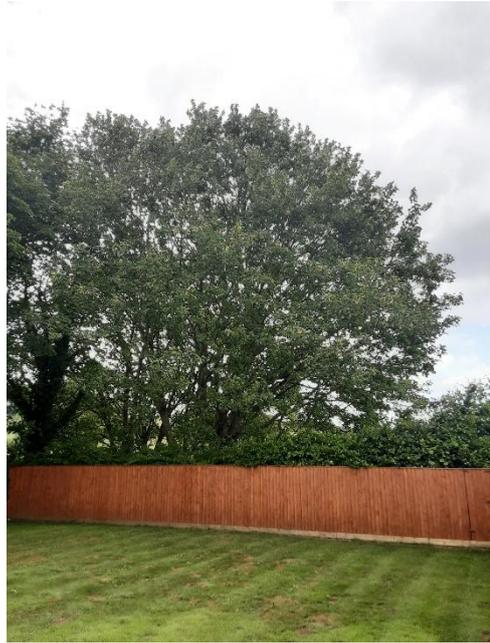
Plate 6: T008

- 3.9.1. The proposed padel court will encroach onto the RPA of T008. To minimise disturbance to tree roots, the following mitigation measures should therefore be implemented during construction:

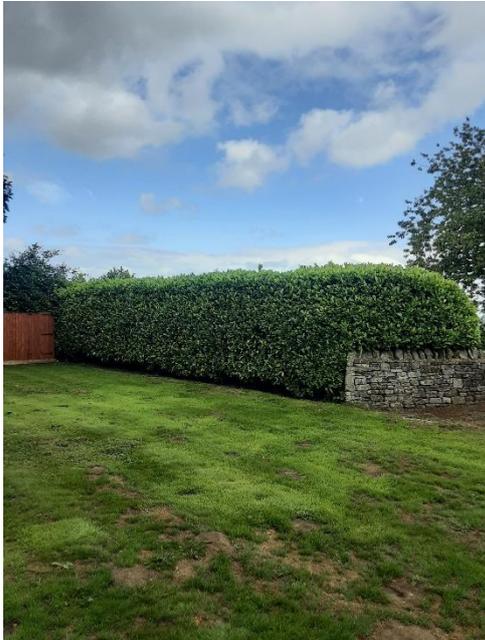
Plate 7: G001

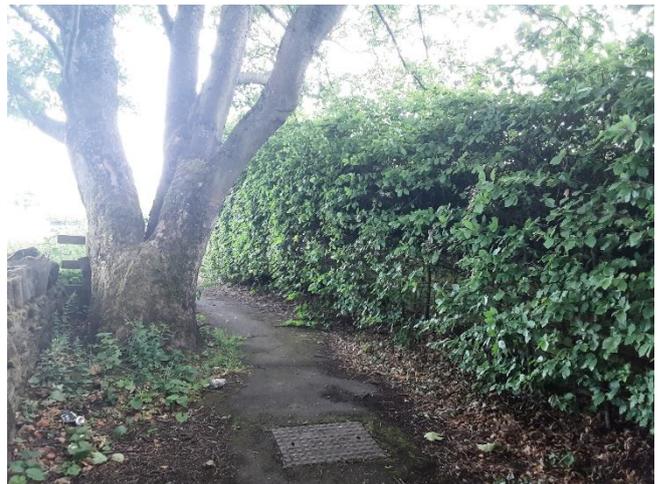
Plate 8: G002

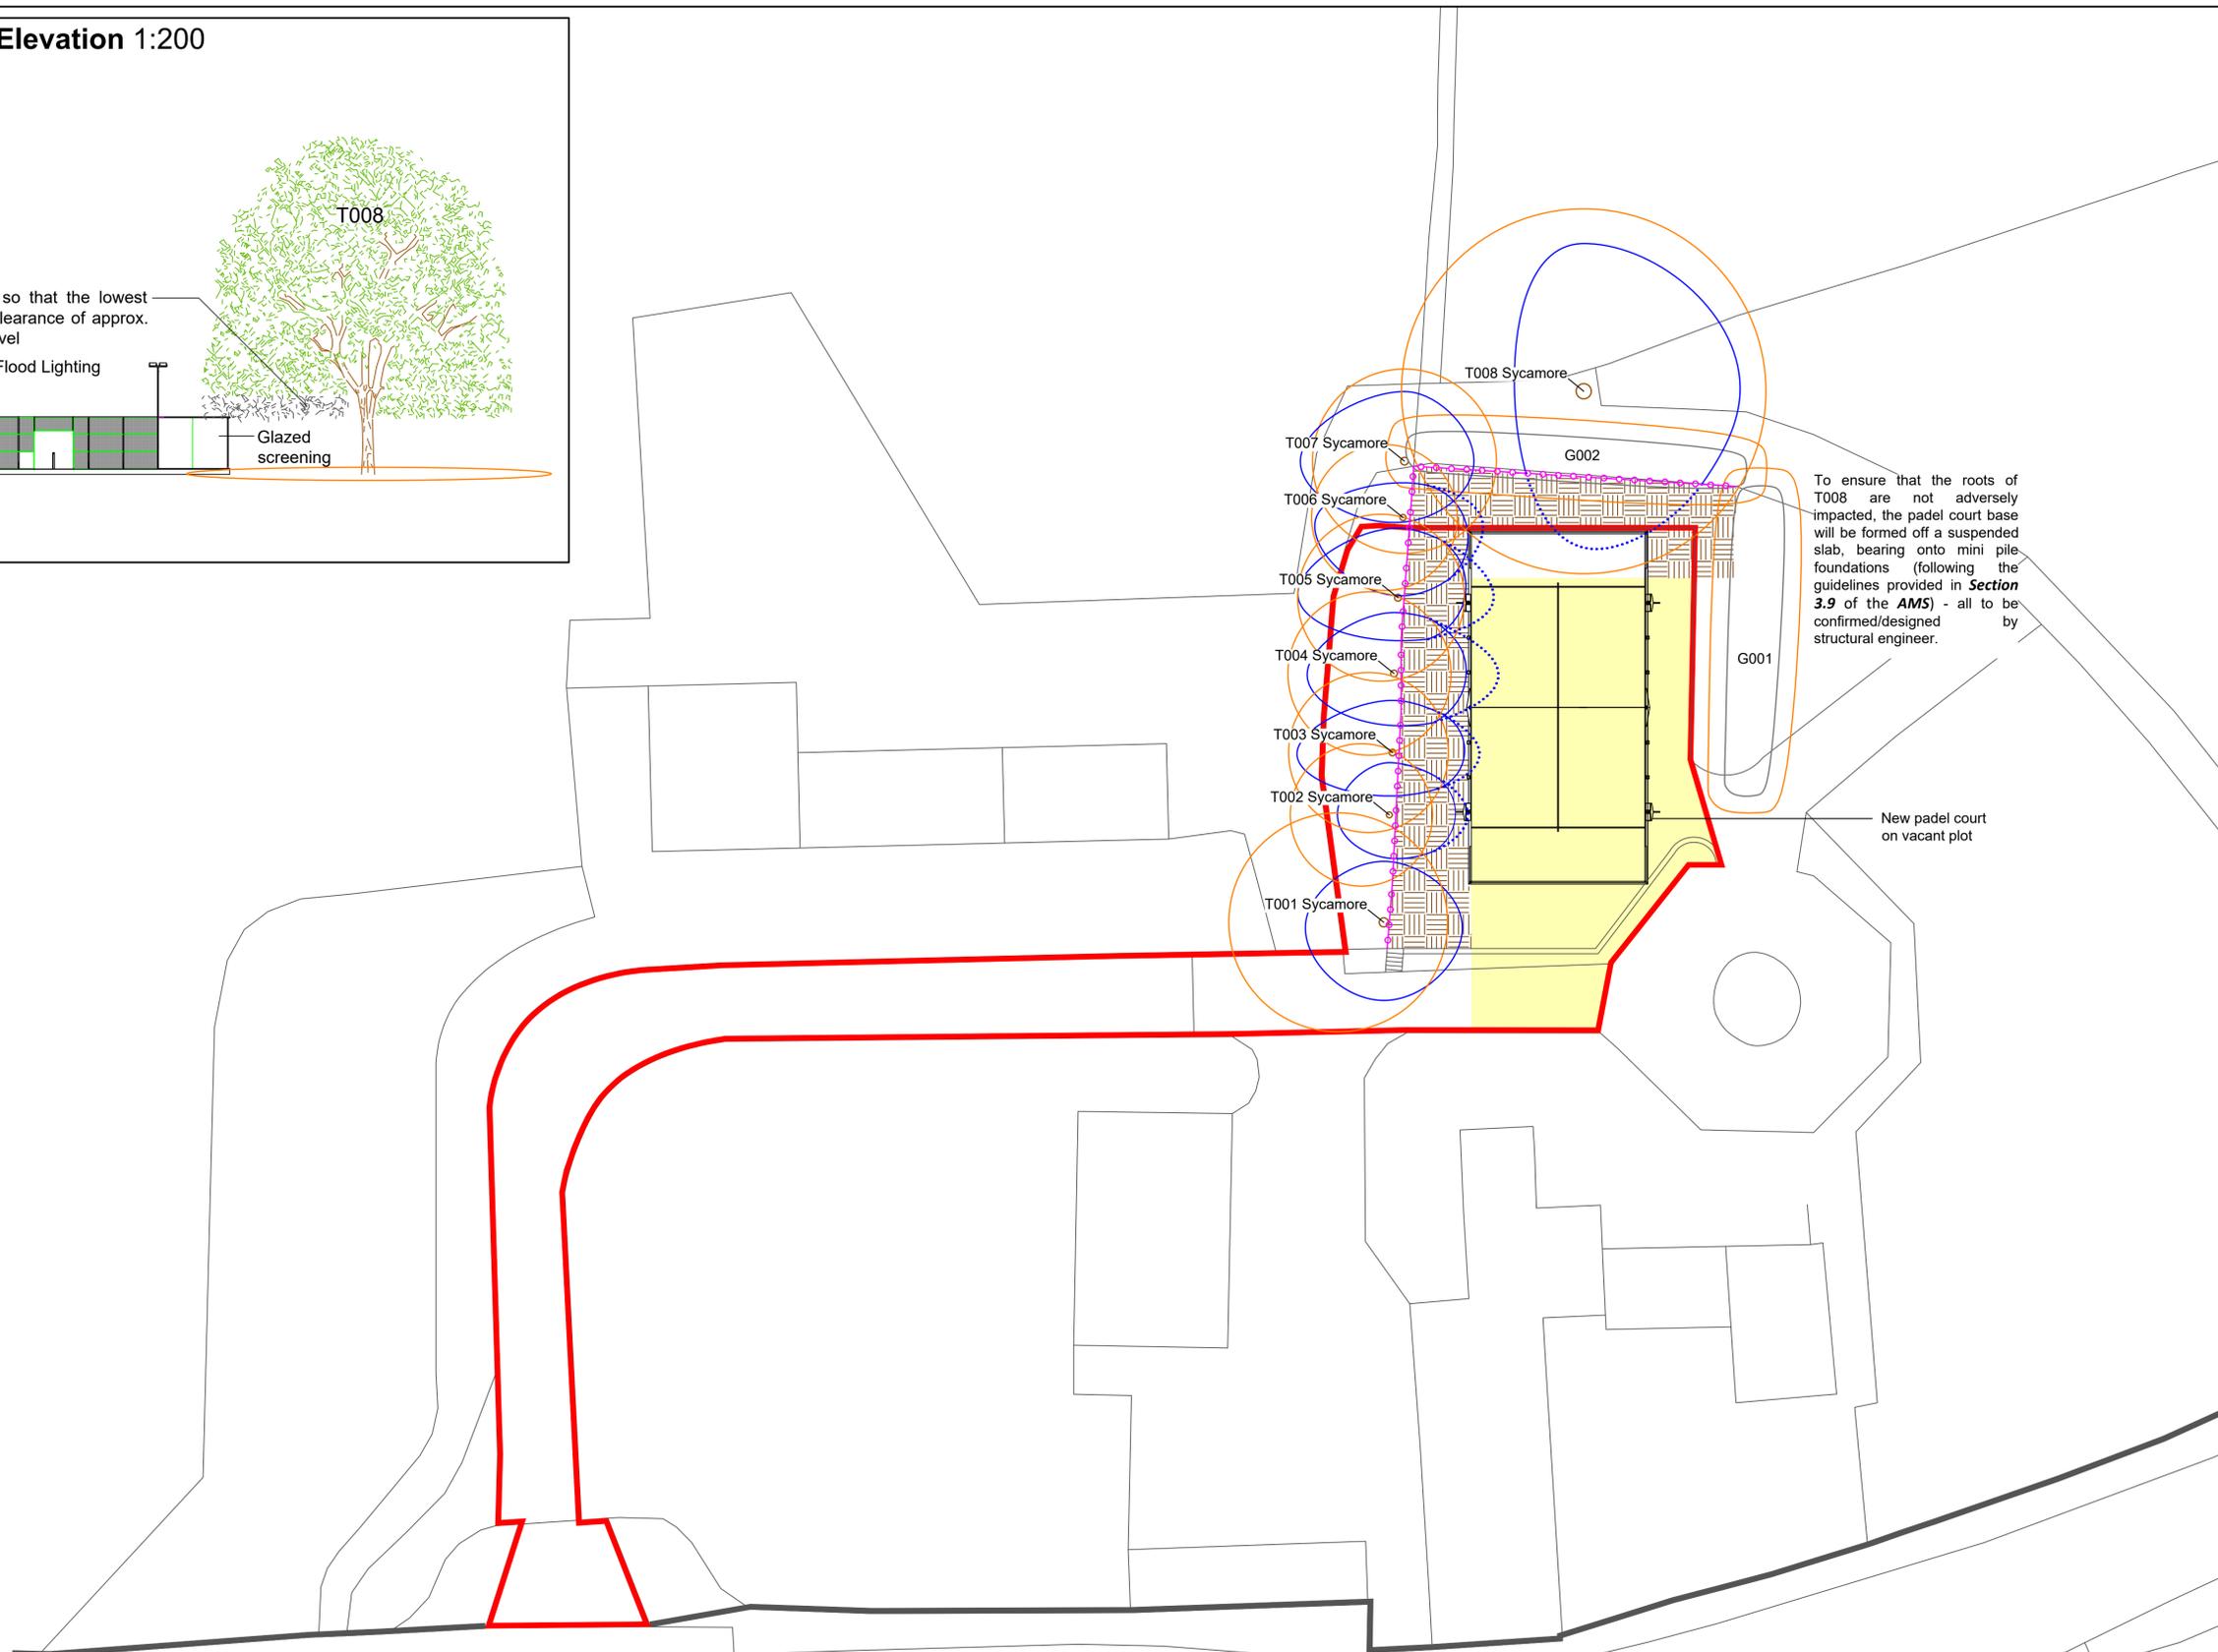
Appendix 3: Tree Protection Plan

Category B trees of moderate quality	
Root protection area (RPA)	Tree canopy
Tree stem	Trees requiring facilitation pruning shown with dotted line (works to be carried out in accordance with BS 3998: 2010)
Category C groups of low quality	
RPA	Tree canopy
Temporary tree protection fencing, to BS 5837: 2012 specification, as detailed in Section 3.4 of the <i>Arboricultural Method Statement (AMS)</i> .	
Temporary ground protection, to BS 5837: 2012 specification, as detailed in Section 3.6 of the <i>AMS</i>	
Designated area for routing of underground utilities and drainage systems

To ensure that the roots of T008 are not adversely impacted, the padel court base will be formed off a suspended slab, bearing onto mini pile foundations (following the guidelines provided in Section 3.9 of the *AMS*) - all to be confirmed/signed by structural engineer.

- The use of conventional concrete slab foundations within tree RPAs can result in extensive root loss and should be avoided. The design shall therefore not require excavation into the soil (including through lowering of levels and/or scraping), other than the removal, using hand tools, of any turf layer or other surface vegetation.

- The padel court will be constructed upon a suspended slab, with a ventilated air space between the underside of the slab and the existing soil surface (to enable gas exchange and venting through the soil surface). The slab will be supported by pile foundations - of the smallest feasible diameter - which will reduce the possibility of striking major tree roots.
