Phase 2 Ground Investigation

Client: Lidl Great
Britain Ltd

Blackmoorfoot
Road, Huddersfield

Report No: 1219.01.01

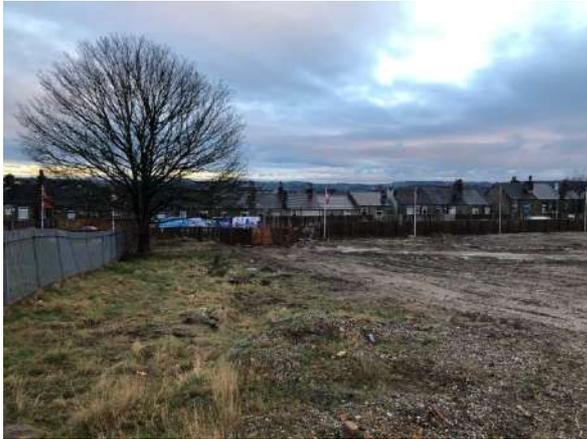
Photo 1: A steel fence runs parallel to the site's northern boundary within the northern portion of the site and forms the site's secure entrance. This is a view facing northeast from the site entrance.

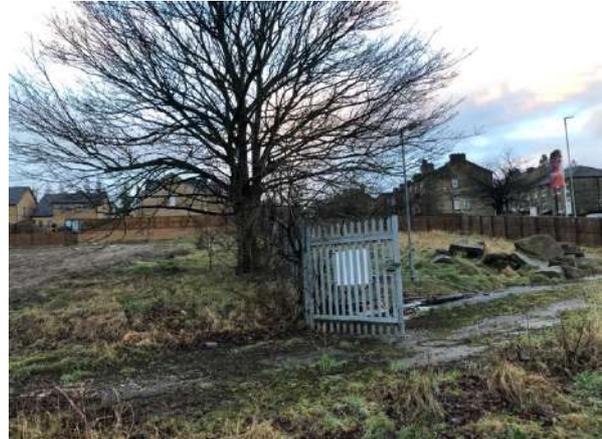
Photo 2: A view facing southwest towards the site entrance and the western site boundary beyond. To the north of the steel fence the site comprises a grassed area sloping gently downwards from the west to the east of the site. South of the steel gate, the site has been stripped and relict concrete and asphalt ground cover was noted.

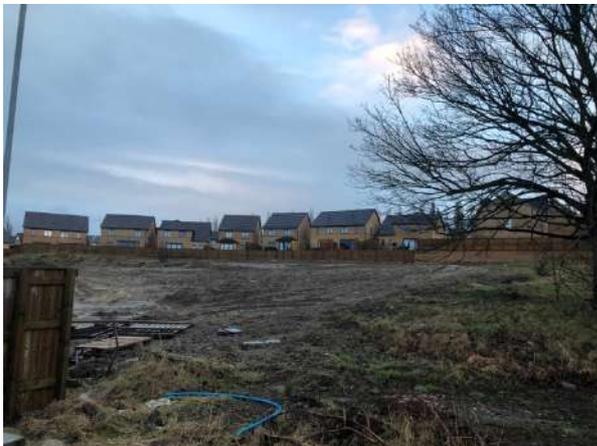
Photo 3: View facing southwest from the site's eastern boundary, showcasing the transition from the grassed area in the north to the stripped portion of the site in the south and also highlighting the fly tipping and dumping of demolition/construction material on-site.

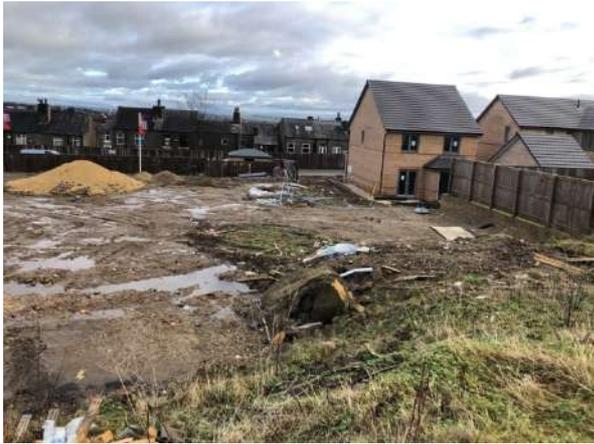
Photo 5: View facing northeast from the southwest corner of the site. Dumping of construction material (gravel) presumably by the adjoining Avant Homes development is noted.

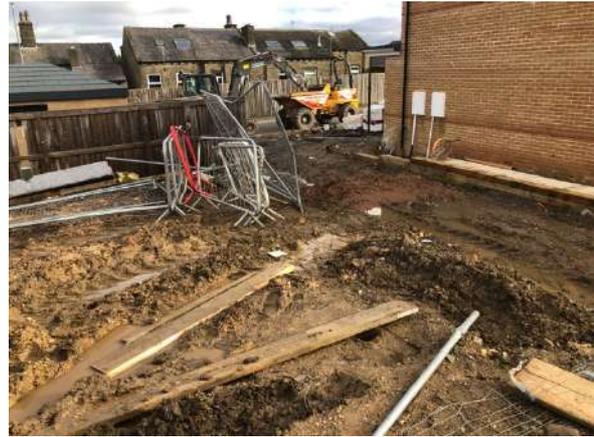
Photo 6: View of construction of landscaped areas during the site works apparently encroaching onto the site by its southern boundary. The electrical substation adjoining the site's eastern boundary is visible in the top left of the photograph.

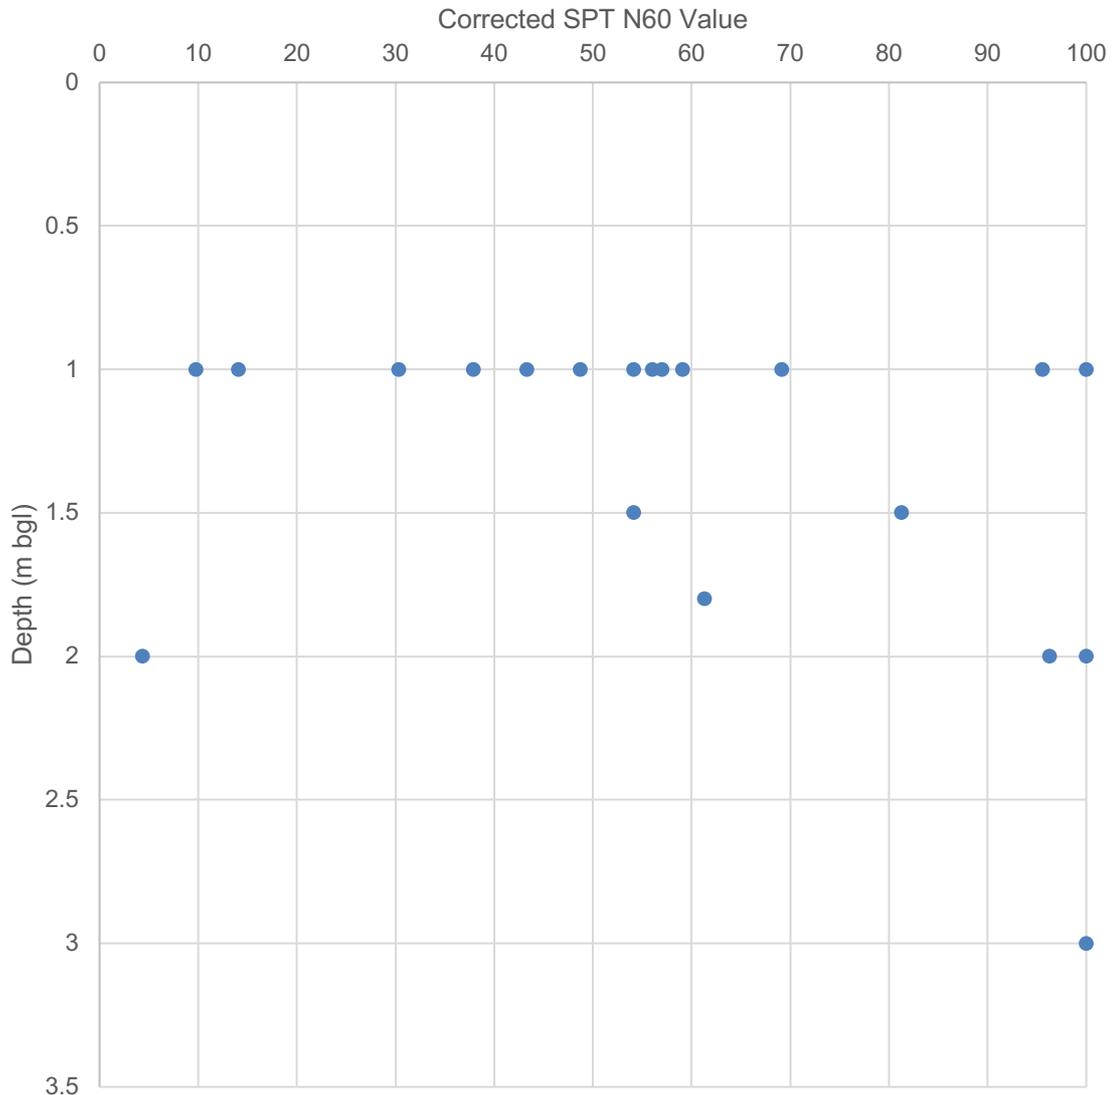
Graph 1: Plot of Corrected SPT N-Values Versus Depth

In-situ SPTs were undertaken to assist with the interpretation of strata encountered. The results of the corrected N-values versus depth are plotted in the graph below. The corrected N₆₀ values have been capped at 100, where the calculated N₆₀ >100.

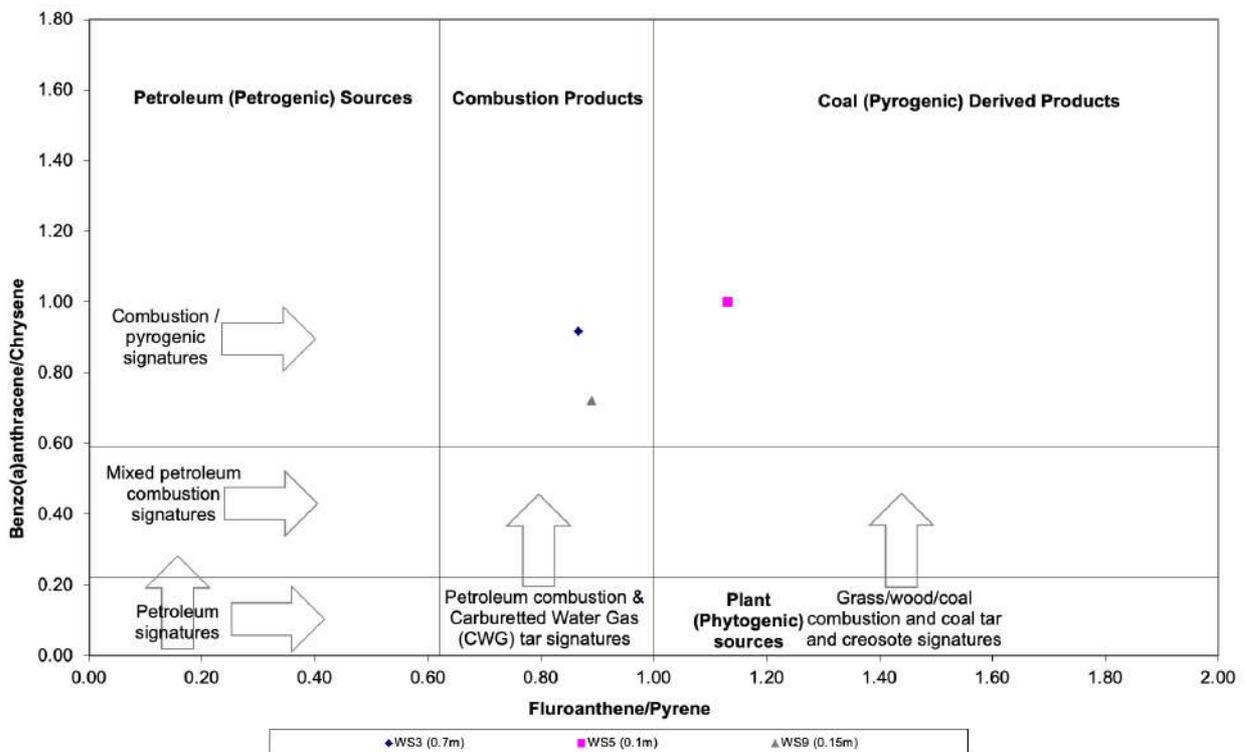
Graph 2: PAH Double Ratio Plot

In addition, the PAH concentrations have been plotted on a double ratio plot to provide an indication of the likely source of the PAHs. All of the samples that had detections of the four PAHs used have been plotted and all are indicated to be combustion related PAHs which could be associated with urban background sources.

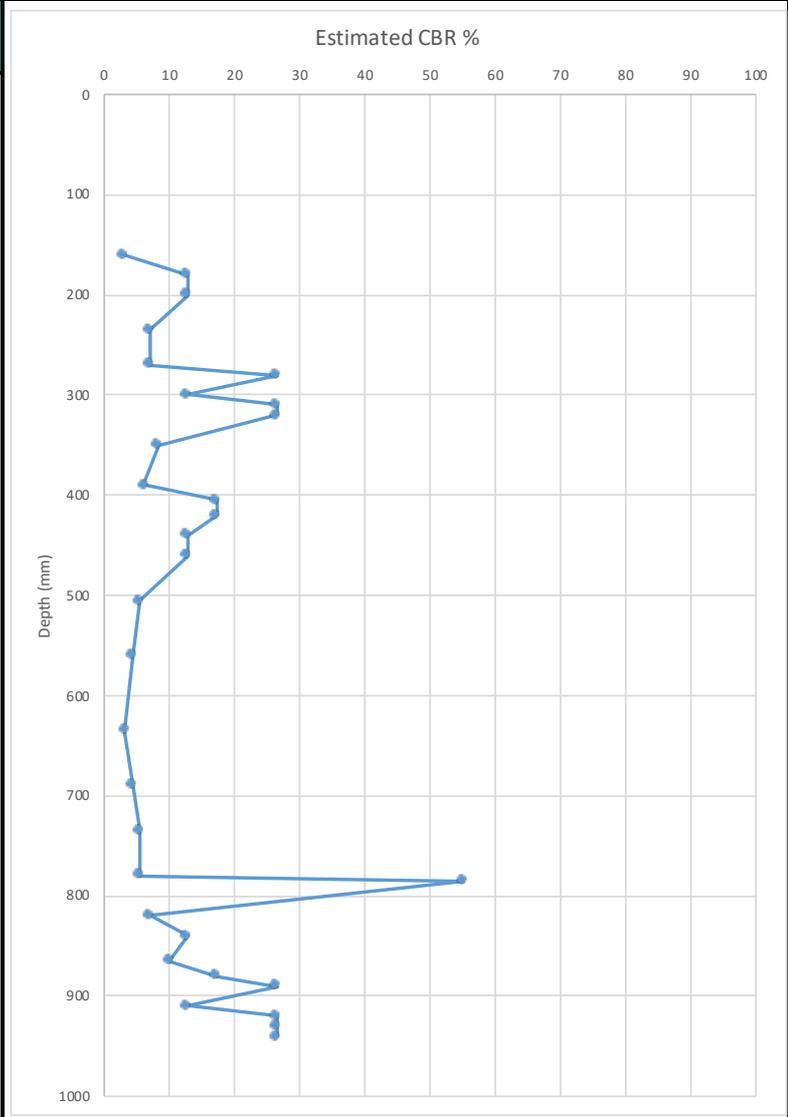
Client:	Lidl Great Britain Ltd	Site Location:	Blackmoorfoot	Test No:	CBR1	Location:	412519, 415555
Project No:	1219.01	Date:	31.01.24	Start Depth:	Surface	Test Strata:	Topsoil
$\text{Log10}(\text{CBR}) = 2.480 - 1.057 \times \text{Log10}(\text{mm/blow})$						Weather:	Dry Sunny

No of Blows	Depth Reading mm	Penetration/ Blow mm	CBR %
0	80	0	
1	160	80.0	2.9
2	180	20.0	12.7
3	200	20.0	12.7
4	235	35.0	7.0
5	270	35.0	7.0
6	280	10.0	26.5
7	300	20.0	12.7
8	310	10.0	26.5
9	320	10.0	26.5
10	350	30.0	8.3
11	390	40.0	6.1
12	405	15.0	17.3
13	420	15.0	17.3
14	440	20.0	12.7
15	460	20.0	12.7
16	505	45.0	5.4
17	560	55.0	4.4
18	635	75.0	3.1
19	690	55.0	4.4
20	735	45.0	5.4
21	780	45.0	5.4
22	785	5.0	55.1
23	820	35.0	7.0
24	840	20.0	12.7
25	865	25.0	10.1
26	880	15.0	17.3
27	890	10.0	26.5
28	910	20.0	12.7
29	920	10.0	26.5
30	930	10.0	26.5
31	940	10.0	26.5

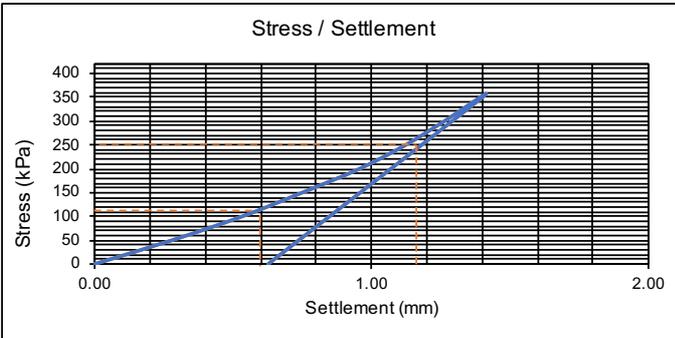
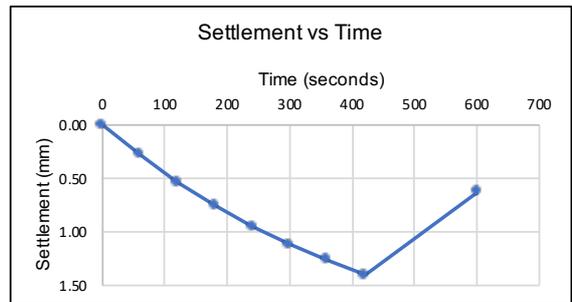
Time (s)	Stress (kPa)	Settlement (mm)
0	0	0.00
60	50	0.28
120	100	0.53
180	150	0.75
240	200	0.96
300	250	1.12
360	300	1.26
420	350	1.40
600	0	0.63

Plate Diameter (mm)	Maximum σ [kN/m ²]	0.3 σ [kN/m ²]	0.7 σ [kN/m ²]	s1 (mm)	s2 (mm)	Ev [MN/m ²]
600	350.0	105.00	245.00	0.56	1.11	114.20

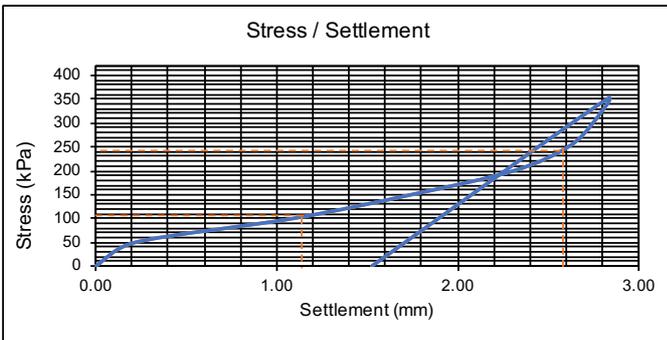
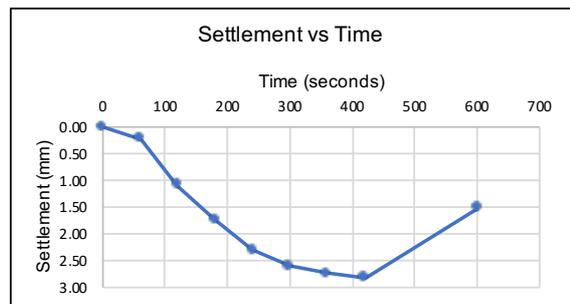
Time (s)	Stress (kPa)	Settlement (mm)
0	0	0.00
60	50	0.22
120	100	1.09
180	150	1.75
240	200	2.31
300	250	2.61
360	300	2.75
420	350	2.82
600	0	1.53

Plate Diameter (mm)	Maximum σ [kN/m^2]	0.3 σ [kN/m^2]	0.7 σ [kN/m^2]	s1 (mm)	s2 (mm)	Ev [MN/m^2]
600	350.0	105.00	245.00	1.16	2.58	44.32

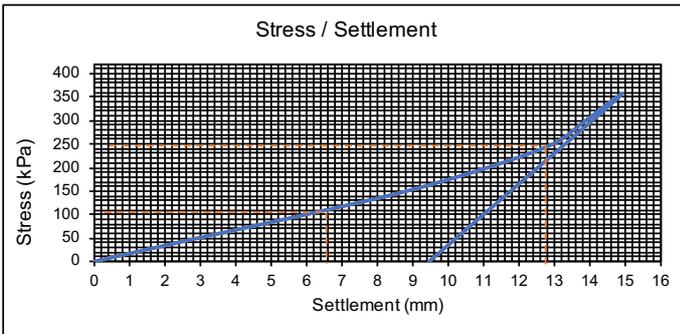
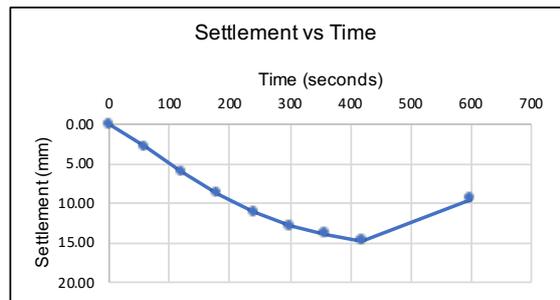
Time (s)	Stress (kPa)	Settlement (mm)
0	0	0.00
60	50	2.95
120	100	5.98
180	150	8.82
240	200	11.10
300	250	12.94
360	300	13.87
420	350	14.81
600	0	9.46

Plate Diameter (mm)	Maximum σ [kN/m ²]	0.3 σ [kN/m ²]	0.7 σ [kN/m ²]	s1 (mm)	s2 (mm)	Ev [MN/m ²]
600	350.0	105.00	245.00	6.27	12.76	9.70

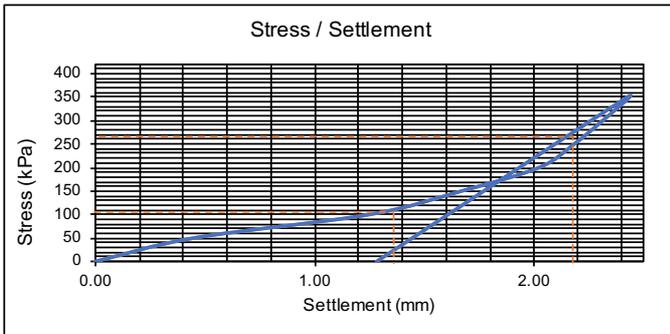
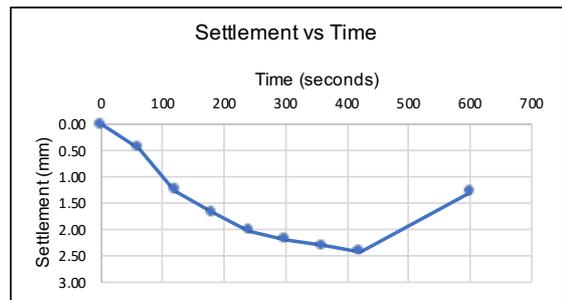
Time (s)	Stress (kPa)	Settlement (mm)
0	0	0.00
60	50	0.45
120	100	1.25
180	150	1.67
240	200	2.02
300	250	2.18
360	300	2.31
420	350	2.43
600	0	1.28

Plate Diameter (mm)	Maximum σ [kN/m ²]	0.3 σ [kN/m ²]	0.7 σ [kN/m ²]	s1 (mm)	s2 (mm)	Ev [MN/m ²]
600	350.0	105.00	245.00	1.29	2.17	71.97

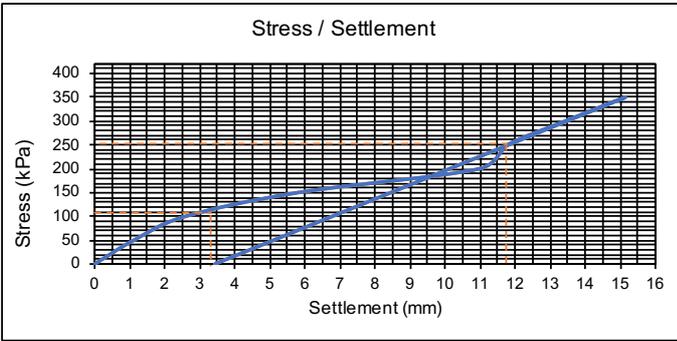
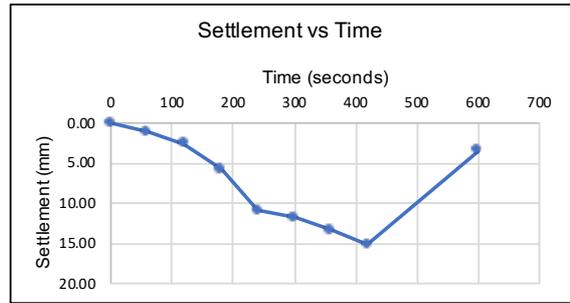
Time (s)	Stress (kPa)	Settlement (mm)
0	0	0.00
60	50	1.12
120	100	2.59
180	150	5.80
240	200	10.98
300	250	11.78
360	300	13.42
420	350	15.14
600	0	3.43

Plate Diameter (mm)	Maximum σ [kN/m ²]	0.3 σ [kN/m ²]	0.7 σ [kN/m ²]	s1 (mm)	s2 (mm)	Ev [MN/m ²]
600	350.0	105.00	245.00	2.91	11.70	7.17

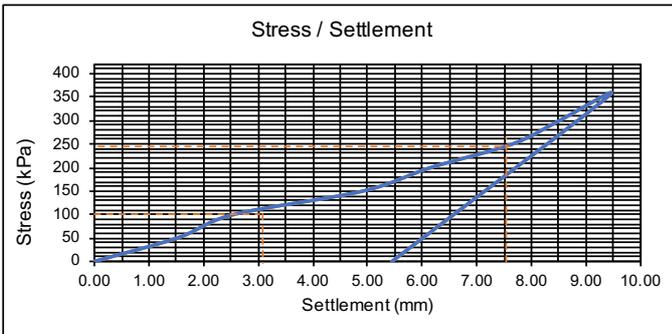
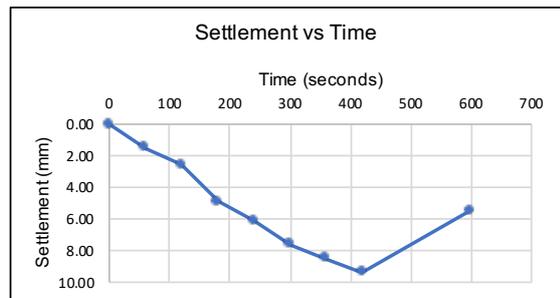
Time (s)	Stress (kPa)	Settlement (mm)
0	0	0.00
60	50	1.52
120	100	2.55
180	150	4.92
240	200	6.16
300	250	7.65
360	300	8.51
420	350	9.39
600	0	5.45

Plate Diameter (mm)	Maximum σ [kN/m ²]	0.3 σ [kN/m ²]	0.7 σ [kN/m ²]	s1 (mm)	s2 (mm)	Ev [MN/m ²]
600	350.0	105.00	245.00	2.79	7.50	13.37
