**PROPOSED CADET HUT  
2 HUDDERSFIELD ROAD  
MIRFIELD  
WF14 9DQ**

**REMEDICATION AND ENABLING WORKS  
STRATEGY  
REPORT REFERECE: MRN-25312-RMS-REV.02**

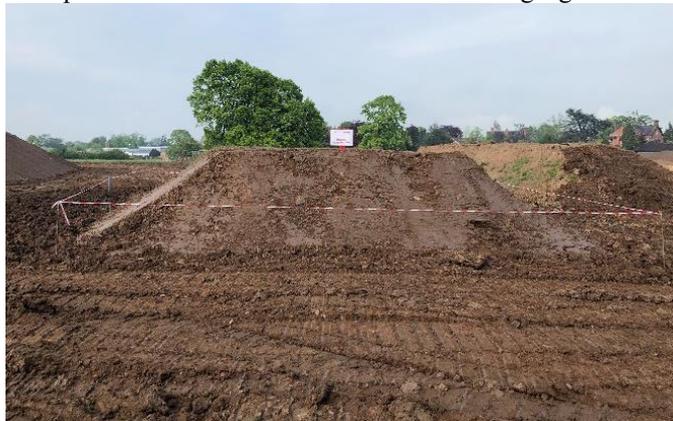
Stockpile sealed and cordoned off with a warning sign

Examples of good site practice for stockpile management are presented below:

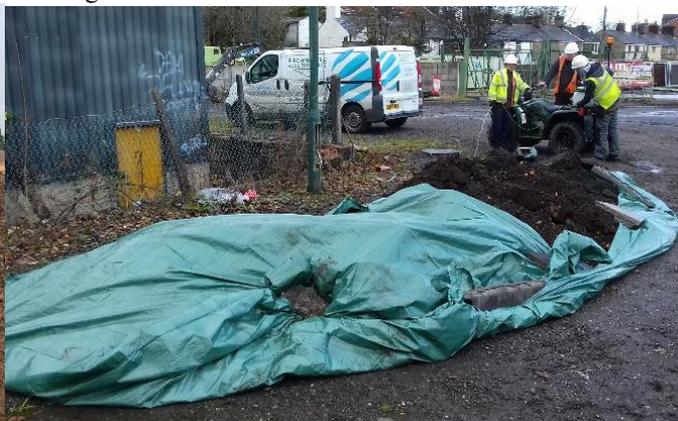
Sheeting of contaminated materials

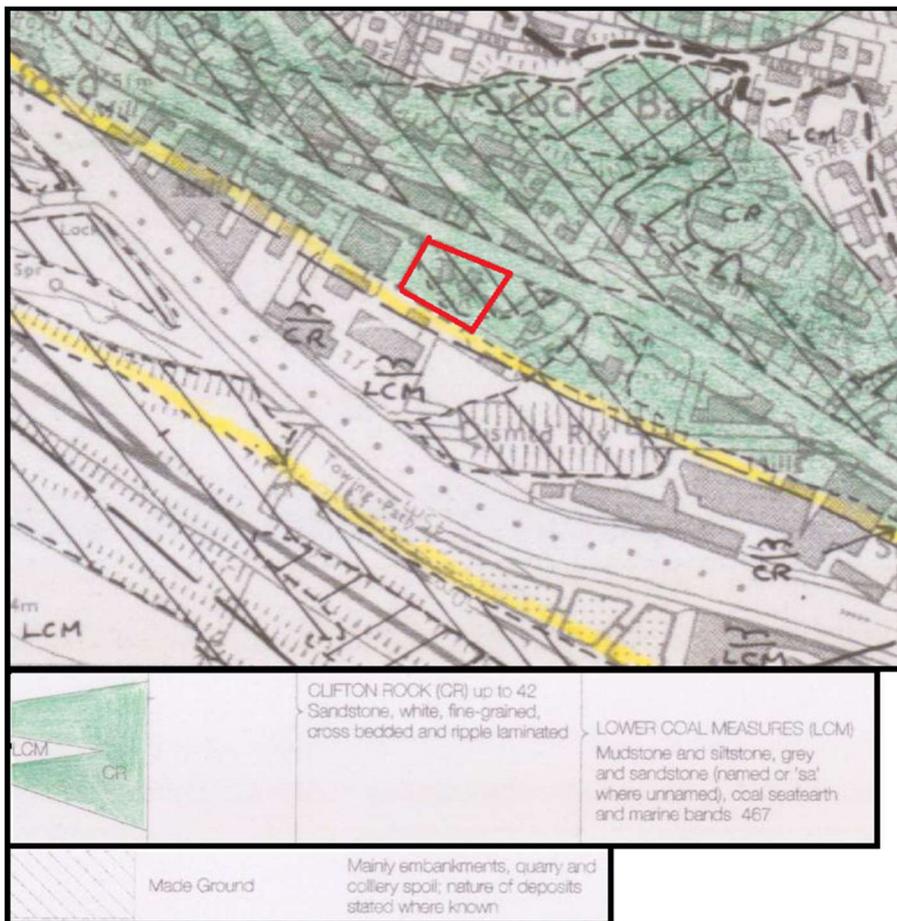
Figure 2: Geological Setting (reproduced from 1:10,000 SE12SE 1999)

The geology of the site has been obtained from publicly available information, the British Geological Survey (BGS) published geological map covering the site and the BGS GeoIndex Onshore viewer. These indicate that the geology comprises made ground overlying bedrock of Clifton Rock.

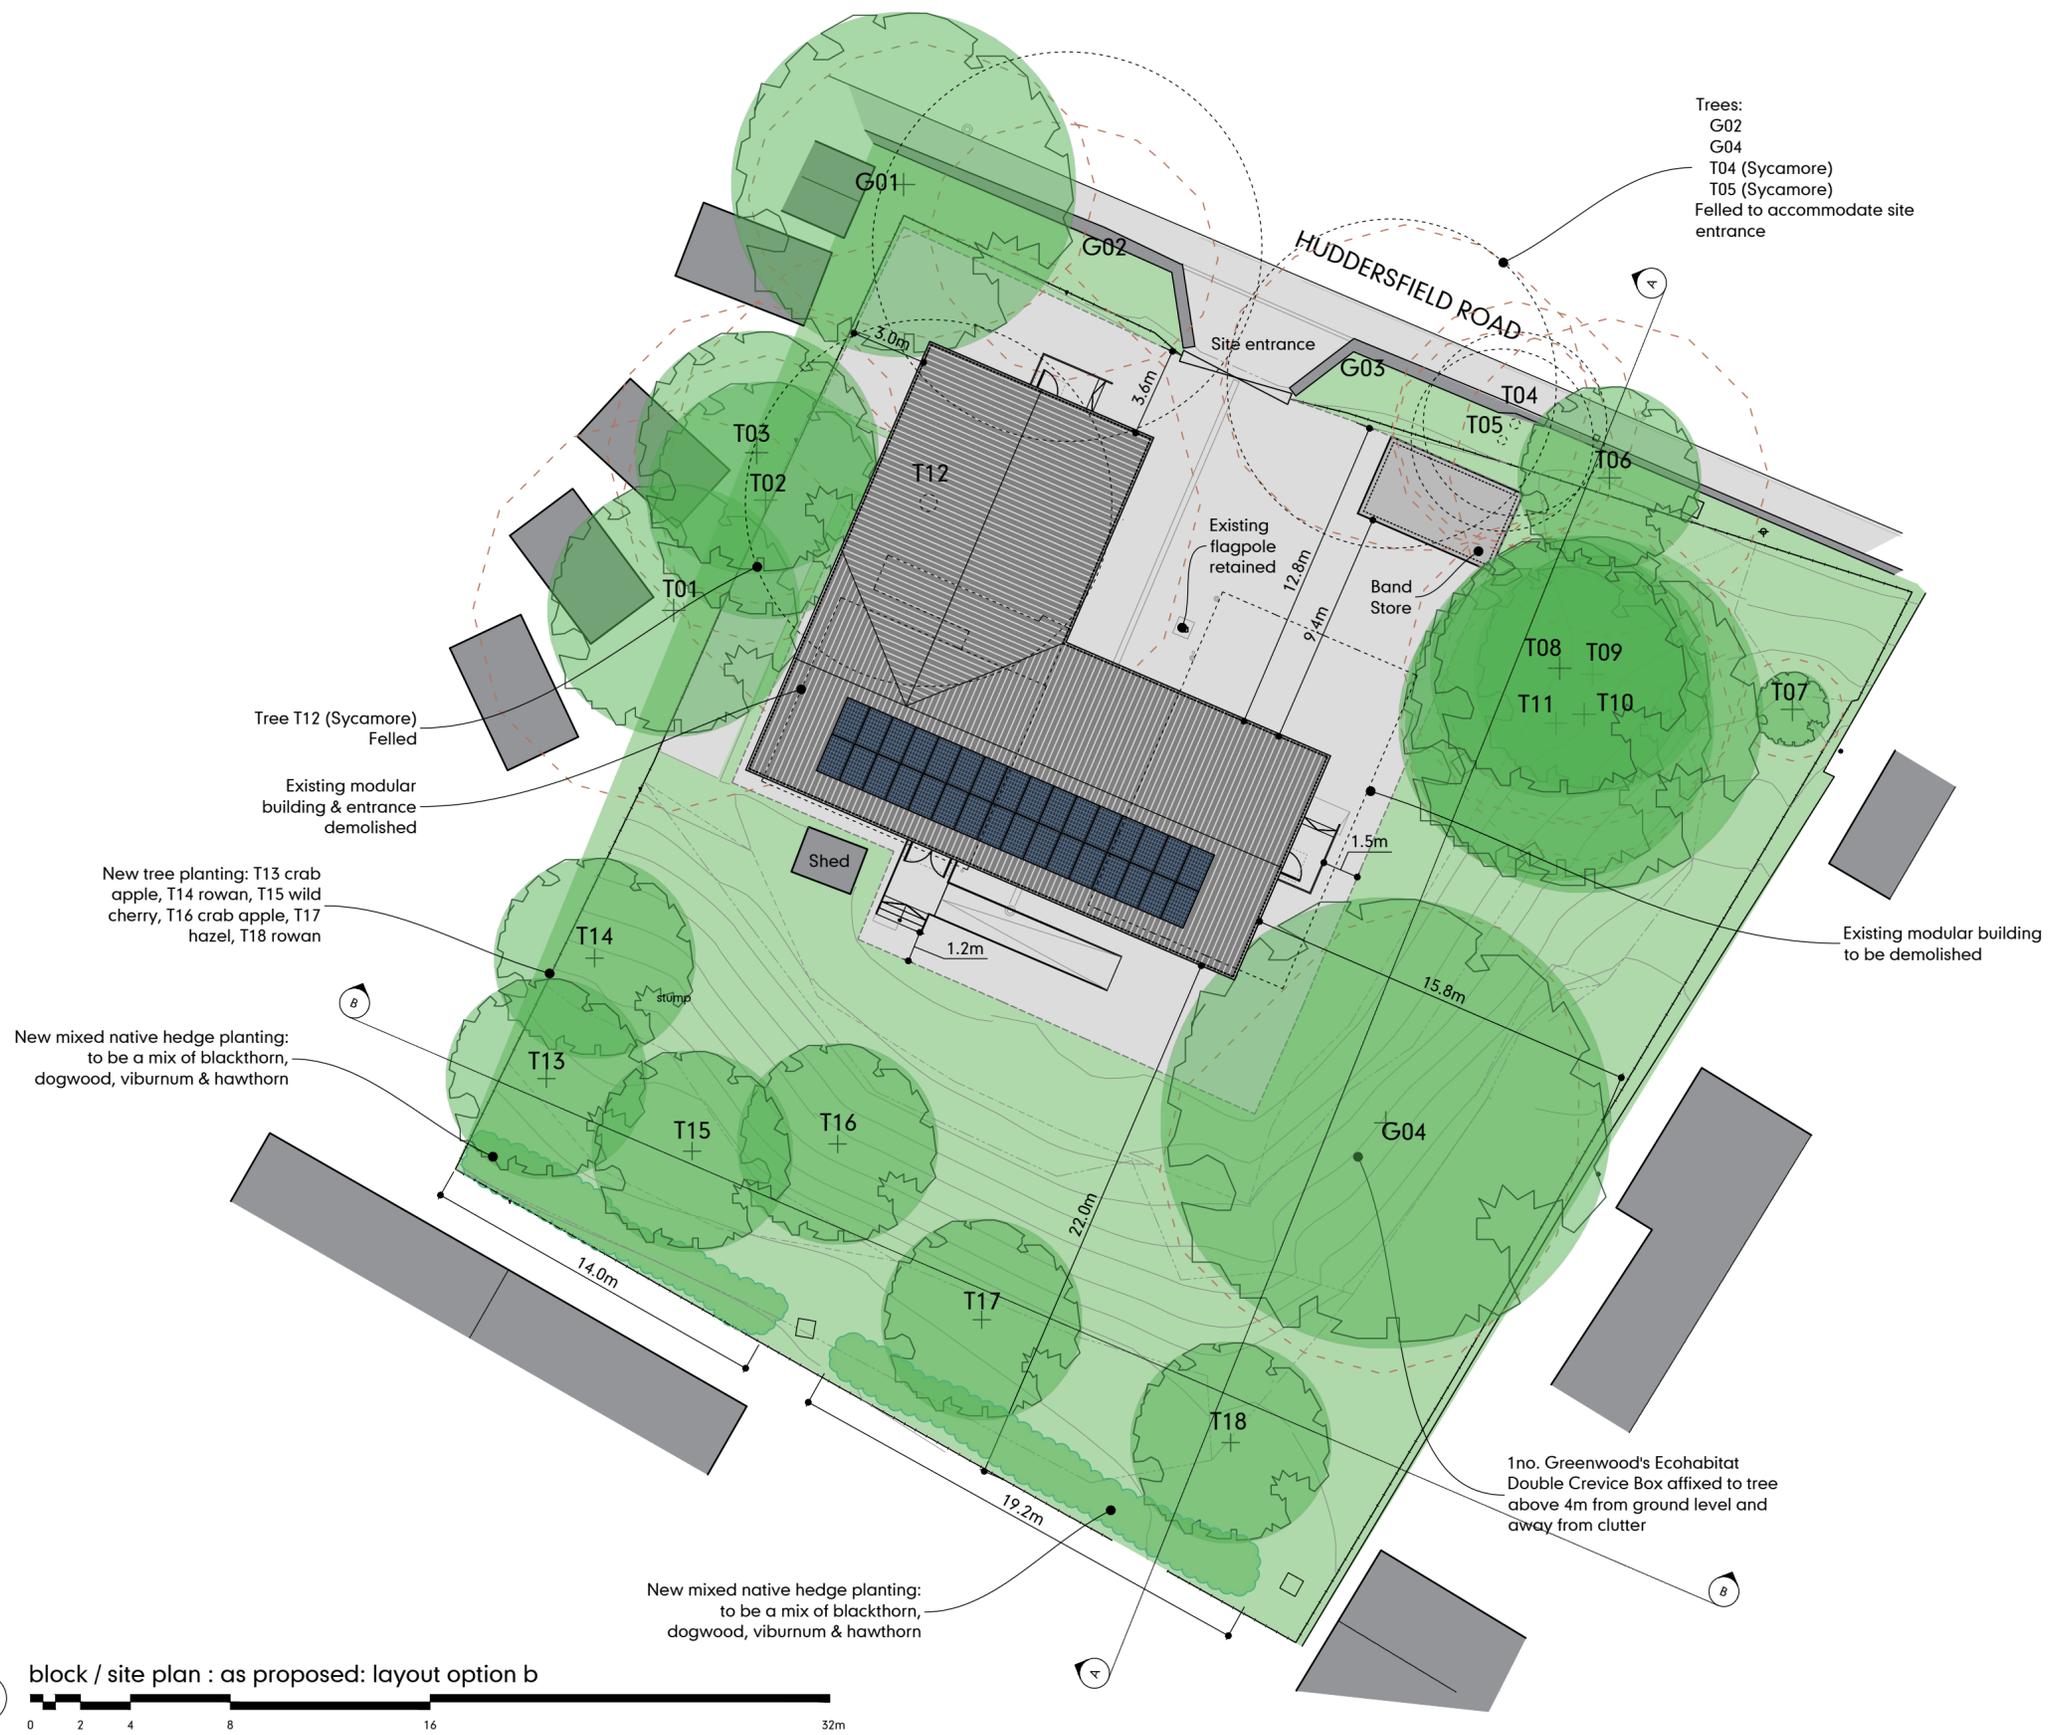
client	Integra Buildings Ltd	created	01nov23
project	CRFCA Mirfield	job N°	230711
title	site : layout : proposed	scale	1:200 @ A2

.03	Northern steps reversed, additional planting information, site section lines added.	11dec23
.02	Stairs and ramps amended to new dimensions.	29nov23
ver	notes	date

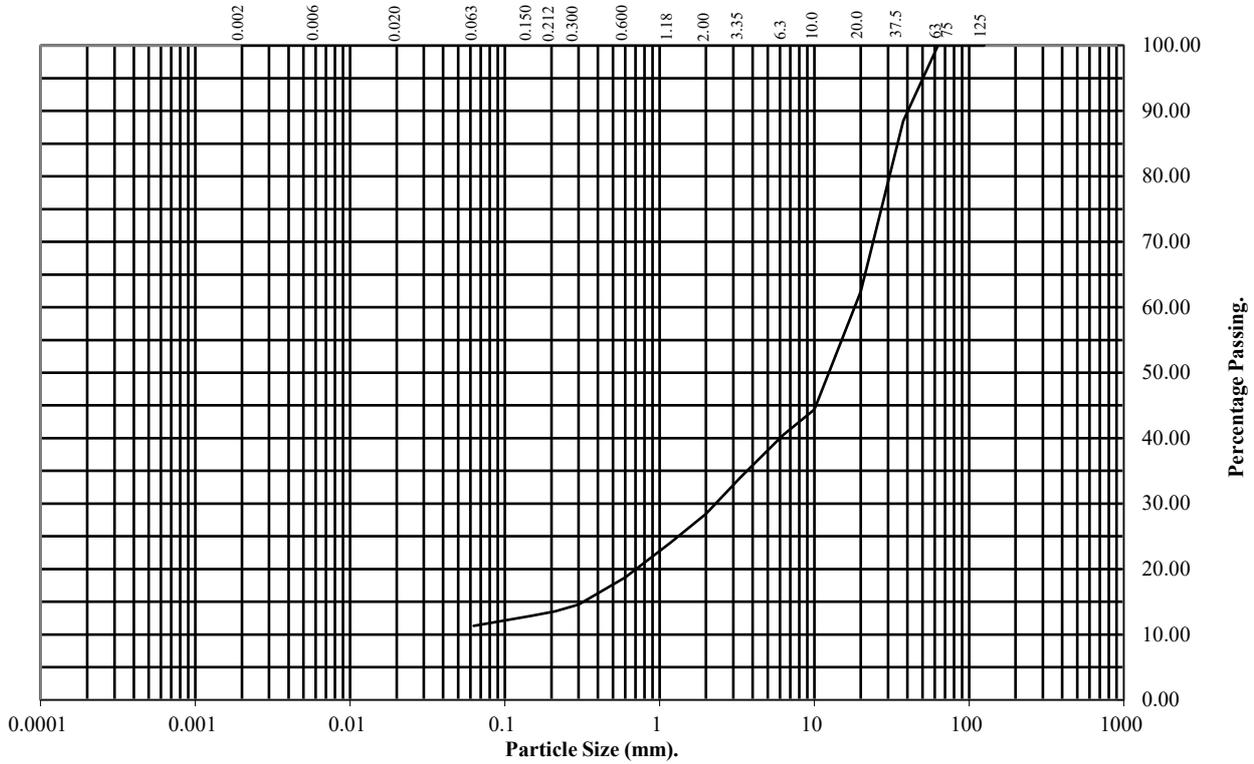
Sample Number: **7** Base Depth(m):

BS Test Sieve (mm)	Percentage Passing
125	100
75	100
63	100
37.5	88
20	62
10	44
6.3	40
3.35	34
2	28
1.18	24
0.6	19
0.3	15
0.212	14
0.15	13
0.063	11

Soil Fraction	Total Percentage
Cobbles	0
Gravel	72
Sand	17
Silt/Clay	11

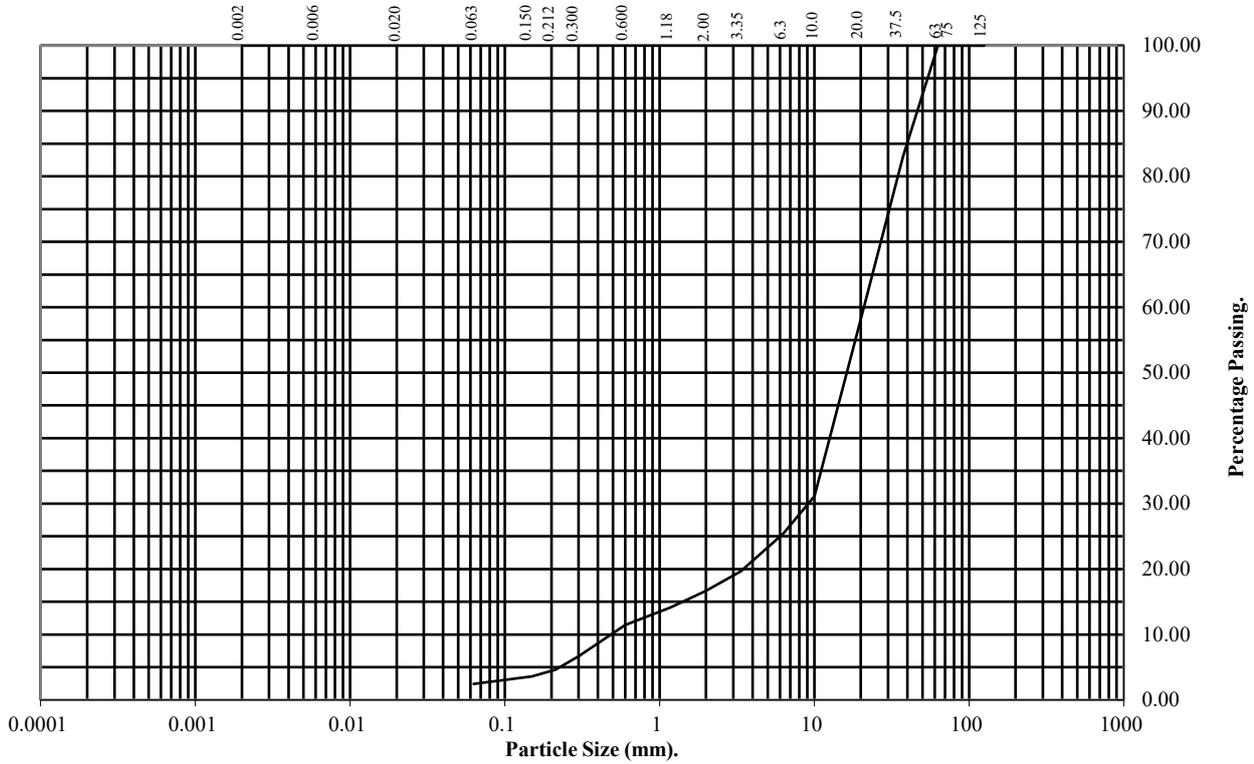
Sample Number: **11** Base Depth(m):

BS Test Sieve (mm)	Percentage Passing
125	100
75	100
63	100
37.5	83
20	58
10	31
6.3	25
3.35	20
2	17
1.18	14
0.6	11
0.3	7
0.212	5
0.15	4
0.063	2

Soil Fraction	Total Percentage
Cobbles	0
Gravel	83
Sand	15
Silt/Clay	2

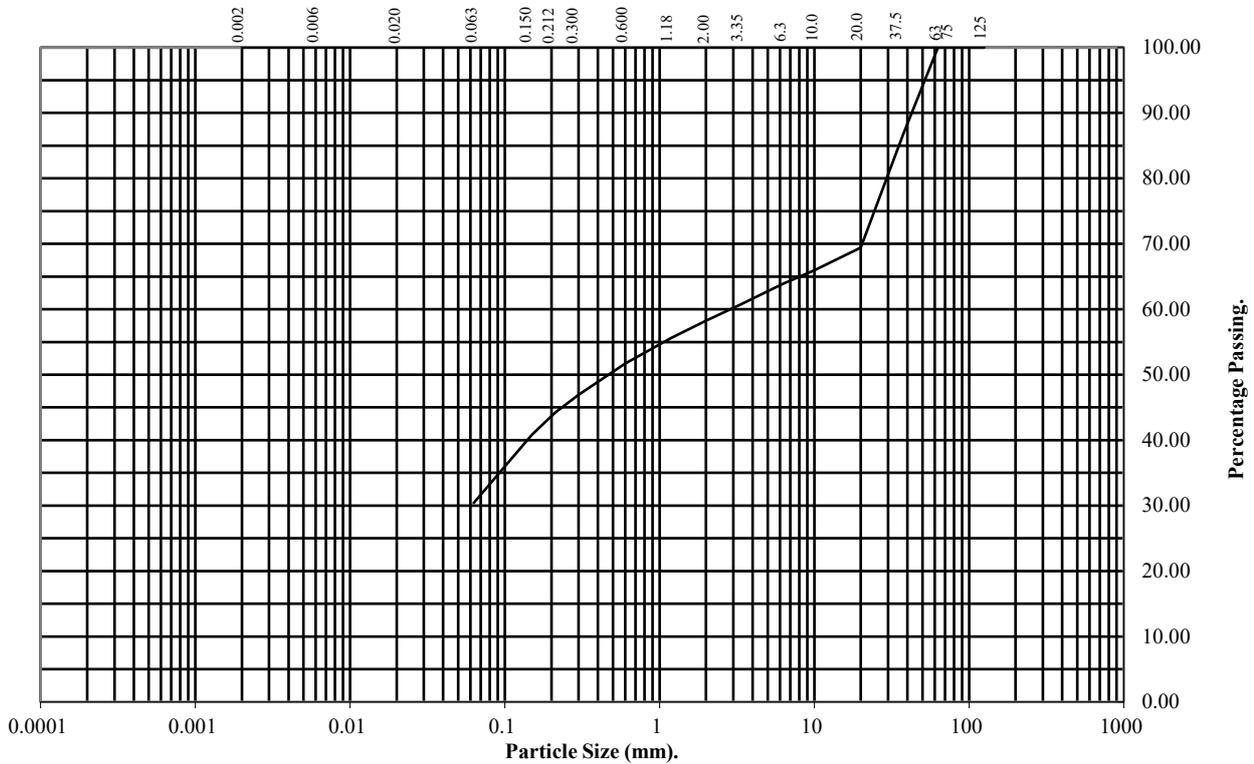
Sample Number: **2** Base Depth(m):

BS Test Sieve (mm)	Percentage Passing
125	100
75	100
63	100
37.5	87
20	69
10	66
6.3	64
3.35	61
2	58
1.18	56
0.6	52
0.3	47
0.212	44
0.15	41
0.063	30

Soil Fraction	Total Percentage
Cobbles	0
Gravel	42
Sand	28
Silt/Clay	30
