STAGE 2 GEO-ENVIRONMENTAL REPORT

JILL LANE

MIRFIELD

CLIENT: PAMELA DEWS
 JOB NUMBER: PWS/01
 PROJECT: JILL LANE, MIRFIELD
 REPORT TYPE: STAGE 2 GEO-ENVIRONMENTAL
 REPORT REFERENCE: REPORT PWS/01r2

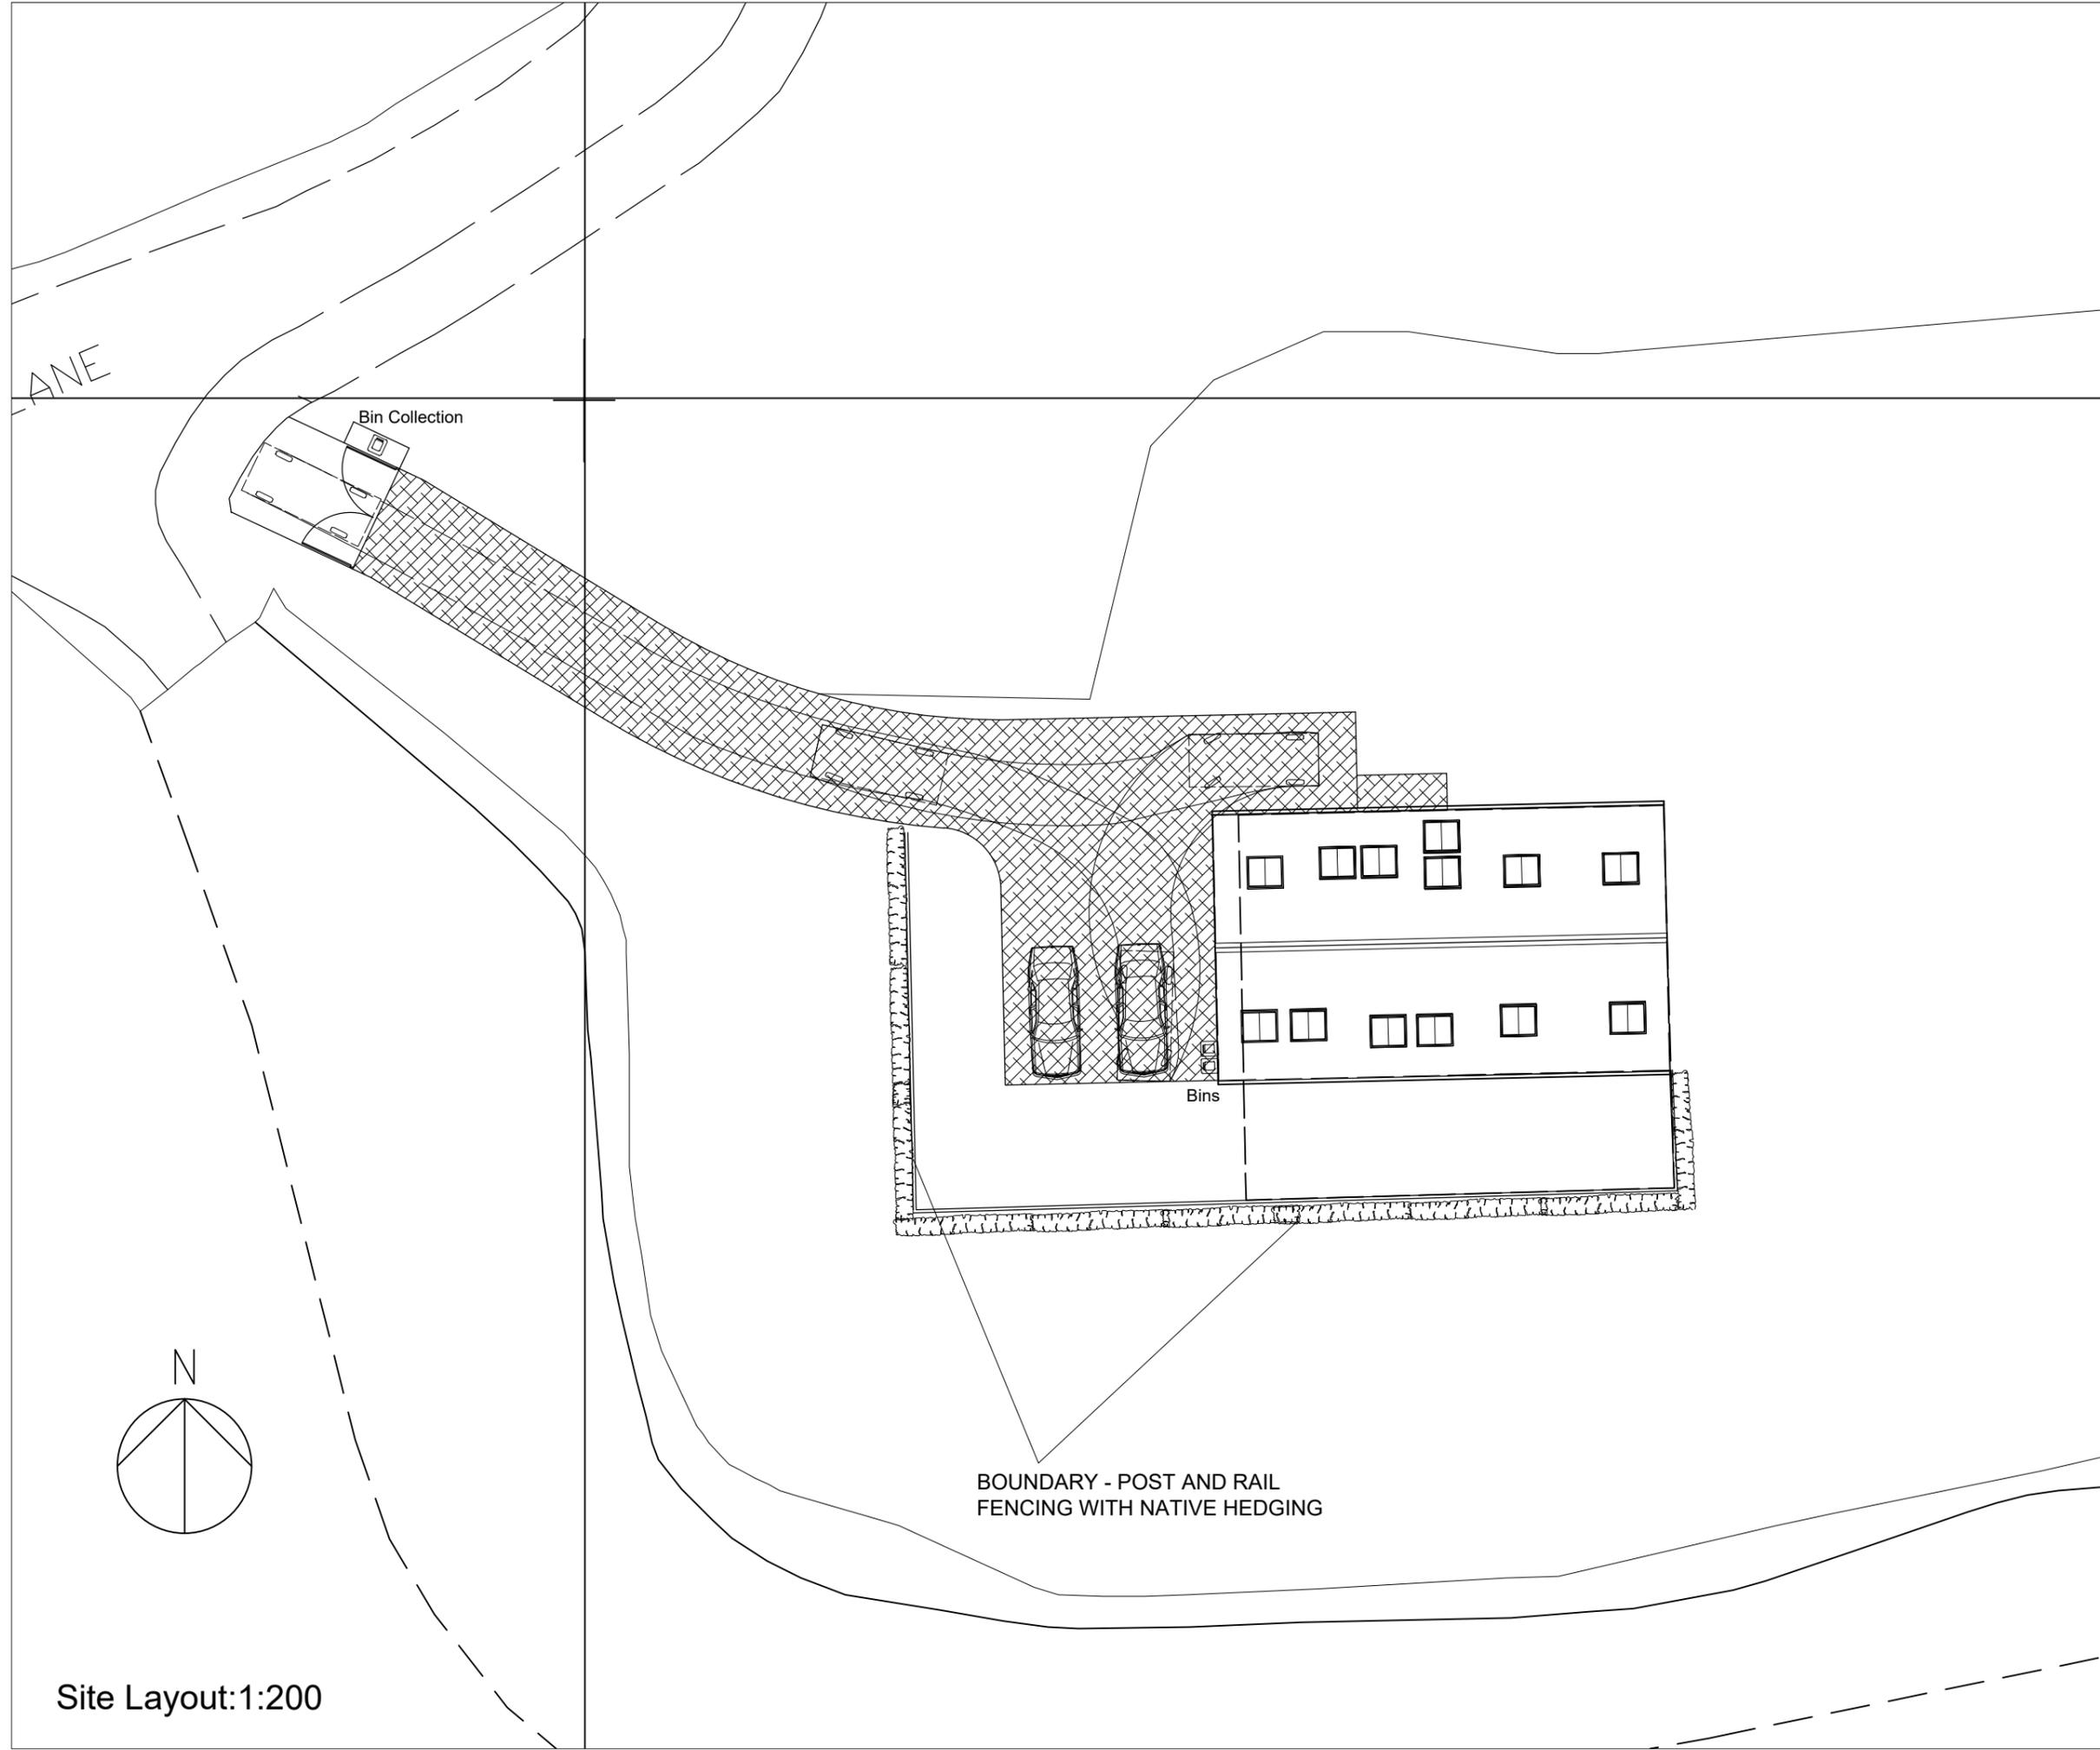
Site Layout: 1:200

BOUNDARY - POST AND RAIL
 FENCING WITH NATIVE HEDGING

- 2.9 The report refers to, and includes, a copy of an indicative proposed layout. This is only for the purposes of generating a conceptual site model for the contamination risk assessment. Unless the proposed layout changes significantly, such that the conceptual model and risk assessment is affected, there is no requirement to re-issue this report when the layout is revised.

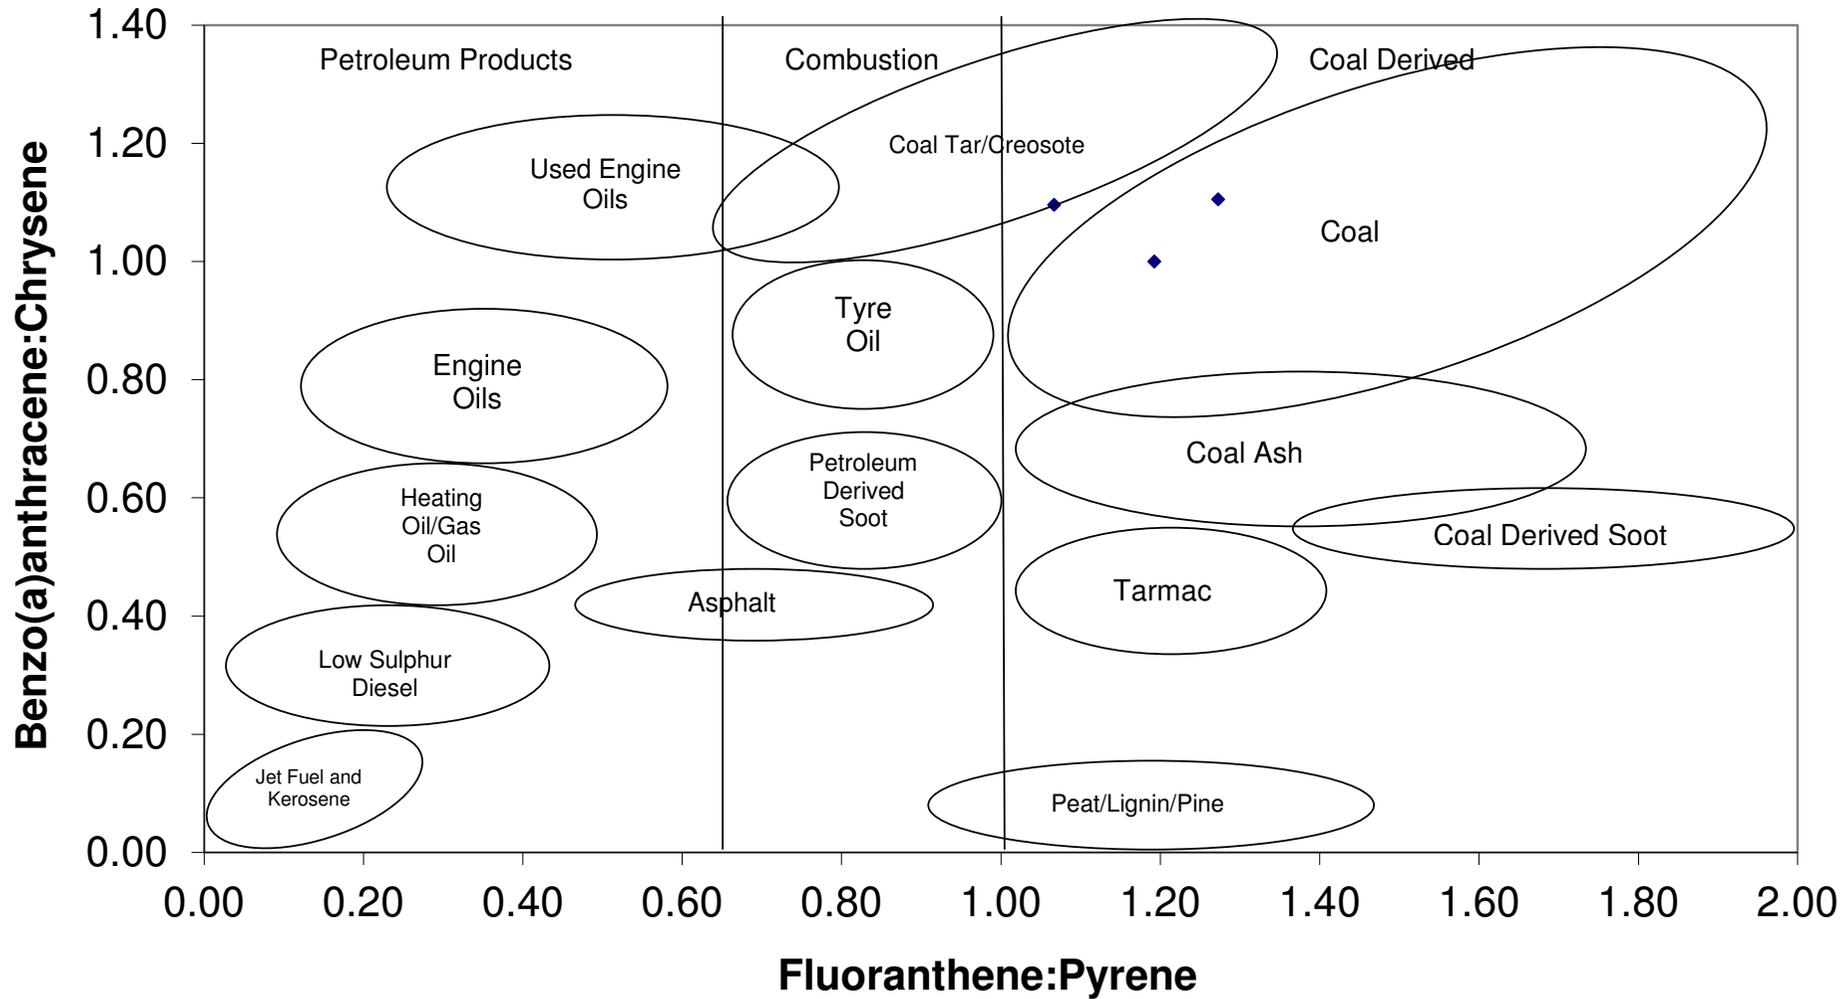
PAH Double Ratio Plot

Sample	Fluoranthene	Pyrene	Ratio Fl:Py	BAP Conc.	Benzo(a) anthracene	Chysene	Ratio B:Ch
TP2	3.4	2.7	1.27	1.4	1.4	1.5	1.11
TP2	30	24	1.07	10	12	11	1.10
TP3	4.3	3.8	1.19	3.0	2.3	2.3	1.00

7.9 It can be seen from the table that concentrations of the PAH compounds benzo[a]anthracene (BaA), benzo[b]fluoranthene (BbF), benzo[a]pyrene (BaP), and dibenz(a,h)anthracene (DahA) have exceedances within the made ground. In addition, chrysotile cement (white asbestos) was detected within one of the samples (1.1% quantification). Double plot ratios for the PAH compounds indicate the PAH to be as a result of the presence of coal fragments, with the exception of the sample from TP2 at 0.3m, where the PAH is likely to be present as a result of coal tar/creosote (most likely a fragment of tarmac within the fill).
