STAGE 1 & 2 ROAD SAFETY AUDIT

SECTION 278 ACCESS WORKS, FIELD HEAD LANE, BIRSTALL

Job No: 26019

March 2026

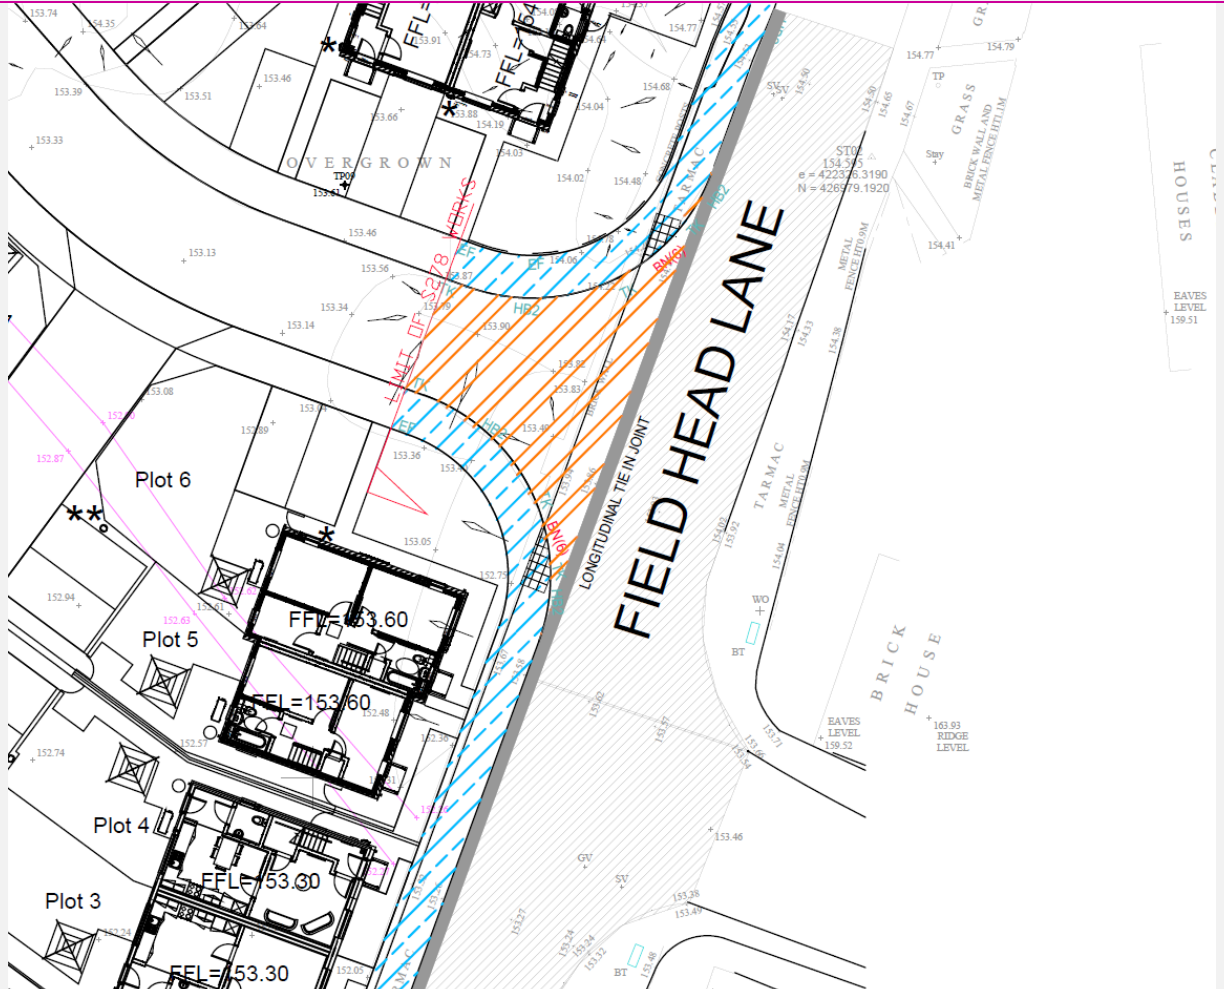
Problem 2	
Location	Site access off Field Head Lane.
Summary	No visibility details provided at site access. Insufficient intervisibility at this location above will result in road user conflicts.
It is not clear if there is sufficient inter-visibility at the above, which will result in insufficient stopping distances and lead to road user conflicts.

Recommendation	
It is recommended that the designers demonstrate that there is sufficient inter-visibility at the above proposed access junction.

JUNCTION VISIBILITY AS ASSESSED AT PLANNING STAGE AND THE JUNCTION HAS THE REQUIRED 2.4X43M VISIBILITY SPLAYS IN PLACE
