STAGE 1 & 2 ROAD SAFETY AUDIT

SECTION 278 ACCESS WORKS, FIELD HEAD LANE, BIRSTALL

Job No: 26019

March 2026

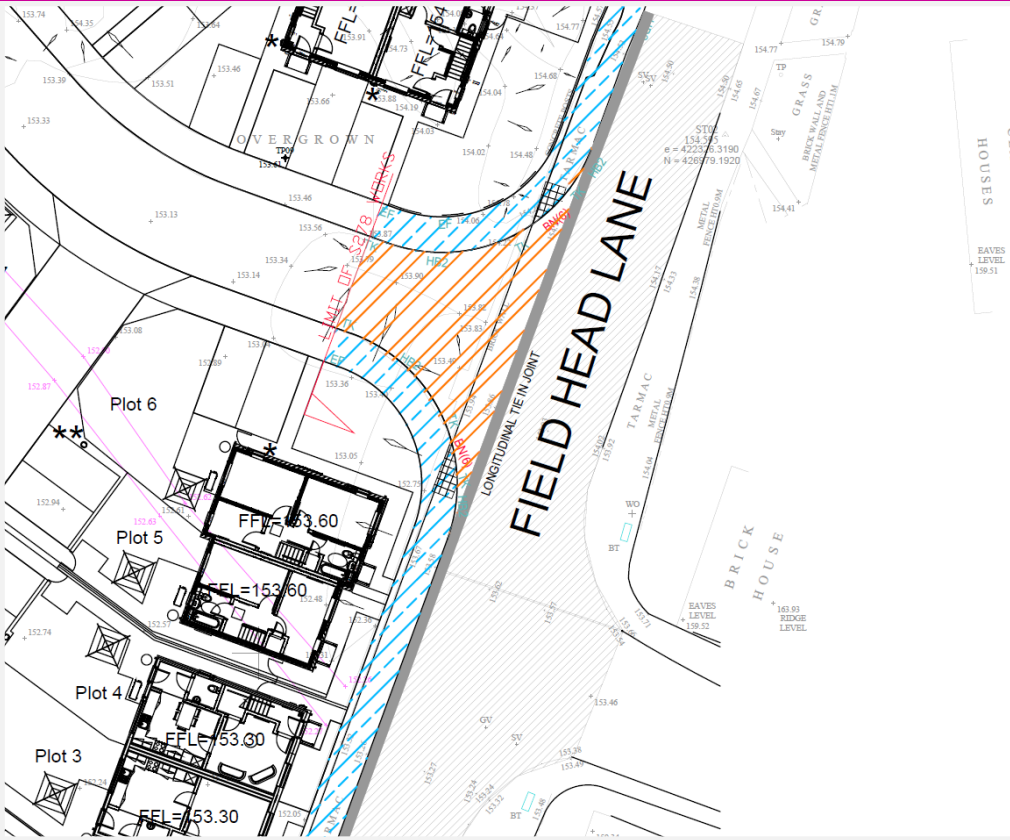
Problem 3	
Location	Site access off Field Head Lane
Summary	Inappropriate layout of the tactile paving at the pedestrian crossing points will reduce their effectiveness and increase the risk of pedestrian vehicle conflicts here.
<p>The inline location of the tactile paving is not arranged in accordance with best practice and therefore will reduce their effectiveness and not alert pedestrians to the crossing location. This will result in vehicle pedestrian conflicts.</p>

<p>The diagram is a detailed site plan of a residential area. A road labeled 'FIELD HEAD LANE' runs diagonally from the bottom right towards the top right. To the left of the road are several plots labeled 'Plot 3', 'Plot 4', 'Plot 5', and 'Plot 6'. Each plot contains a house with a footprint and various annotations like 'FFL = 53.60' and 'FEL = 53.30'. A 'LONGITUDINAL TIE IN JOINT' is marked on the road. A 'BRICK HOUSE' is shown to the right of the road. The tactile paving layout is shown with blue and orange hatched areas. The blue hatching is oriented parallel to the road, while the orange hatching is oriented perpendicular to it. A 'SMALL DRIP GUTTER' is also indicated. The plan includes numerous elevation points and technical details.</p>

Recommendation	
<p>It is recommended that the designers arrange the inline tactile paving in accordance with best practice.</p> <p>In general, all tactile paving layout arrangements, whether located, in line, indented or mid link, are to be provided in accordance with the latest best practice guidance. In this case the number of tiles should not be less than 3 no. deep in the direction of travel.</p> <p>Further, the designers should satisfy themselves that the dropped crossing is wide enough to meet pedestrian demand, and in the optimal location to best accommodate the crossing desire lines, the necessary visibility and minimum crossing distance.</p>

AMENDED TO SHOW IN LINE PAVING AS SUGGETED REFER TO 25469-DR-C-0131 P5 S278
Construction Layout
