FWS Geotechnical & Environmental Consultants

PHASE 2 GROUND INVESTIGATION FOR RESIDENTIAL DEVELOPMENT ON LAND AT ROWLEY LANE, LEPTON

3959OR01Rev03/JANUARY 2024

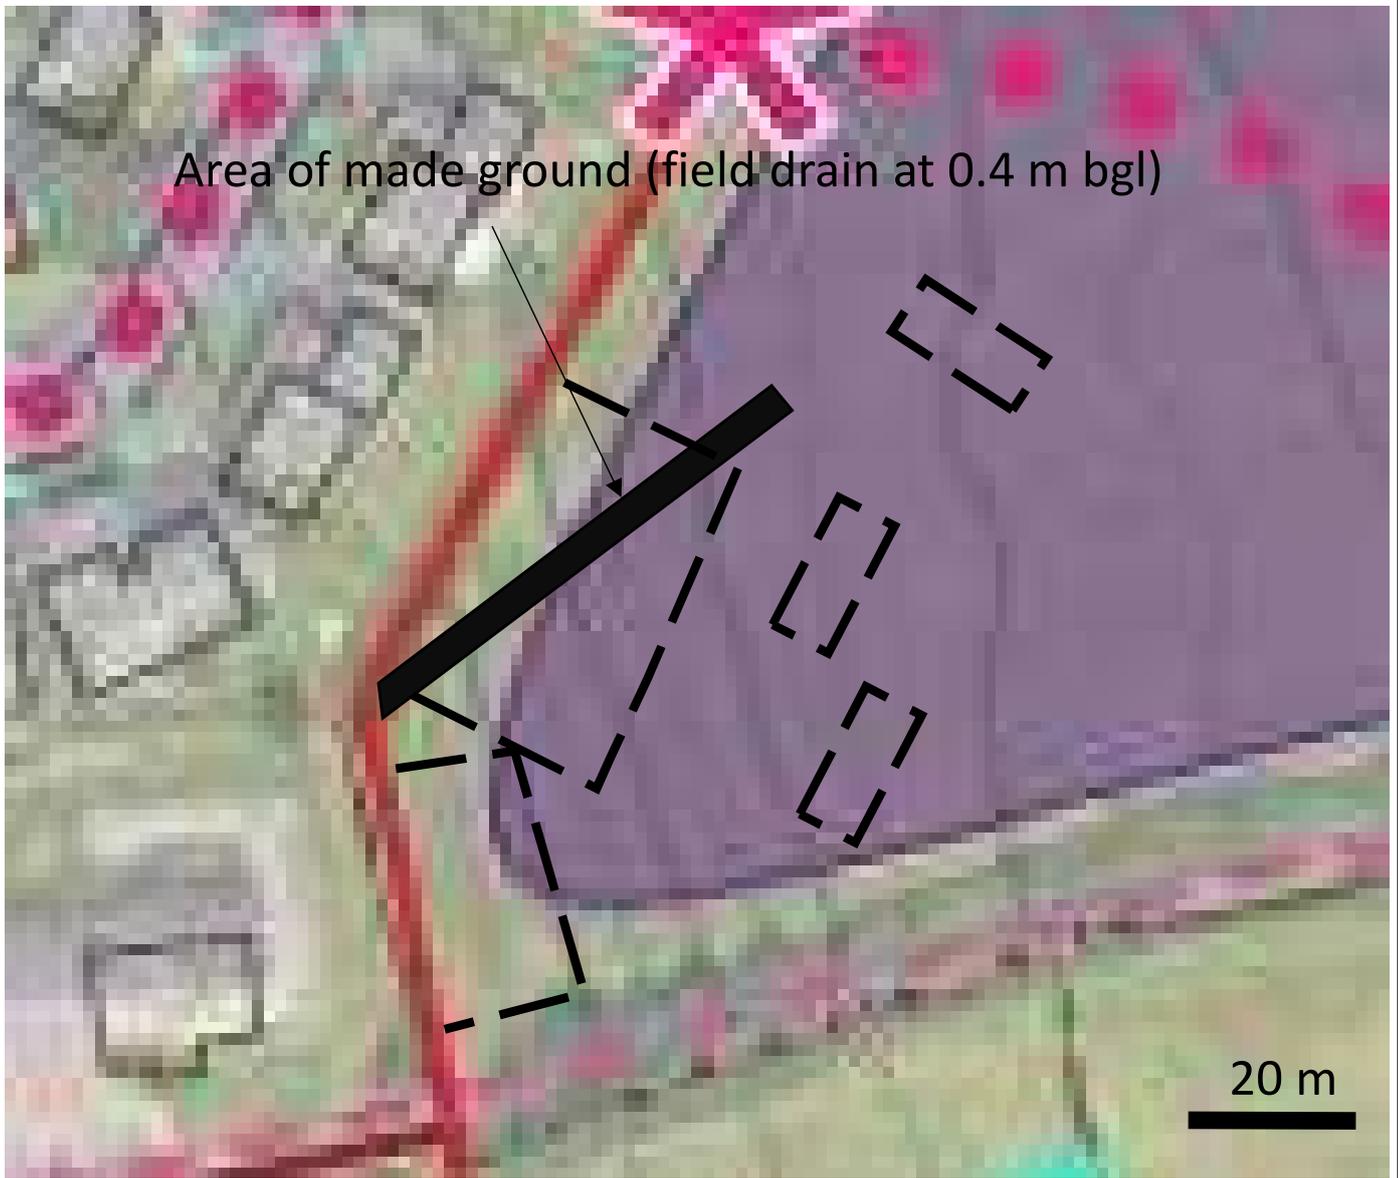
Denotes area of excavation, topsoil was removed until natural subsoil was excavated.

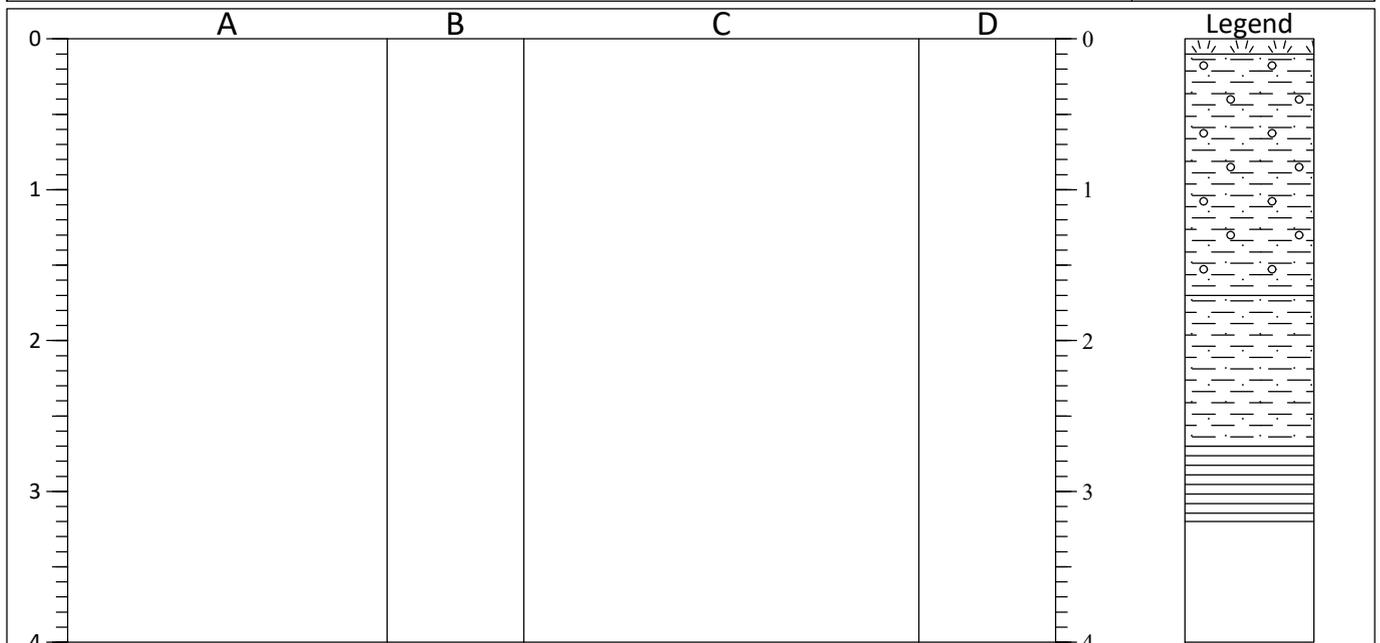
Project Rowley Lane, Lepton				TRIAL PIT No TP01
Job No 3959	Date 21-02-22	Ground Level (m) 137.62	Co-Ordinates () E 419,254.8 N 414,764.8	
Contractor Hawley Plant Hire Ltd				Sheet 1 of 1

STRATA			SAMPLES & TESTS		
Depth	No	DESCRIPTION	Depth	No	Remarks/Tests
0.00-0.10		Dark brown sandy clayey TOPSOIL with rootlets.	0.10	E	
0.10-1.70		Firm light brown and grey sandy gravelly CLAY. Gravel is fine to coarse subangular sandstone. Low cobble content subangular of sandstone.	0.70	E	
			1.00	D	
1.70-2.70		Firm light brown with grey mottling very sandy CLAY.	1.80	E	
			2.00	D	
2.70-3.20		Weathered MUDSTONE bedrock recovered as grey gravelly fine to coarse sand. Gravel fine to coarse subangular of mudstone.	2.80	D	
3.20		End of trial pit.

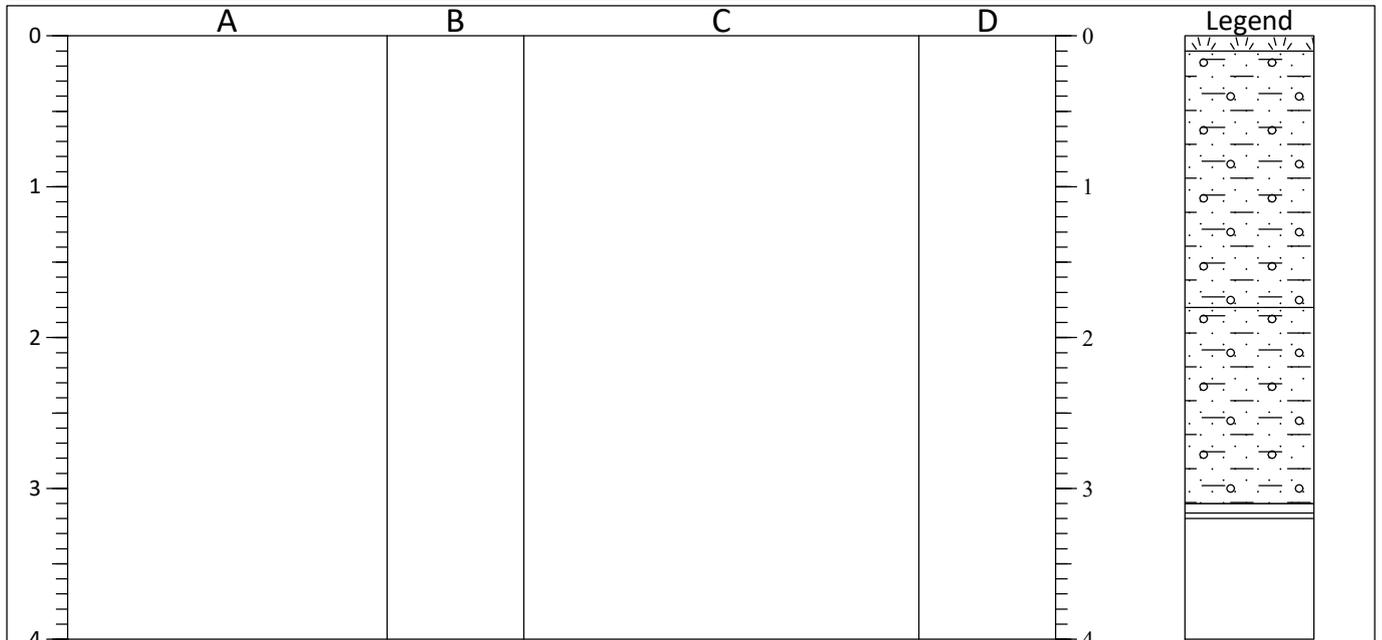
Project Rowley Lane, Lepton				TRIAL PIT No TP02
Job No 3959	Date 21-02-22	Ground Level (m) 140.85	Co-Ordinates () E 419,315.9 N 414,777.3	
Contractor Hawley Plant Hire Ltd				Sheet 1 of 1

STRATA			SAMPLES & TESTS		
Depth	No	DESCRIPTION	Depth	No	Remarks/Tests
0.00-0.10		Dark brown sandy clayey TOPSOIL with rootlets.	0.10	E	
0.10-1.80		Very light brown and grey very clayey slightly gravelly fine to coarse SAND. Gravel is fine to coarse subangular sandstone. Low cobble content subangular of sandstone.	0.30	E	
			0.90	D	
1.80-3.10		Weathered mudstone bedrock recovered as slightly clayey fine to coarse gravelly SAND. Gravel is fine to coarse subangular mudstone.	1.90	E	
3.10-3.20		Weak weathered thinly bedded grey MUDSTONE.			
3.20		End of trial pit

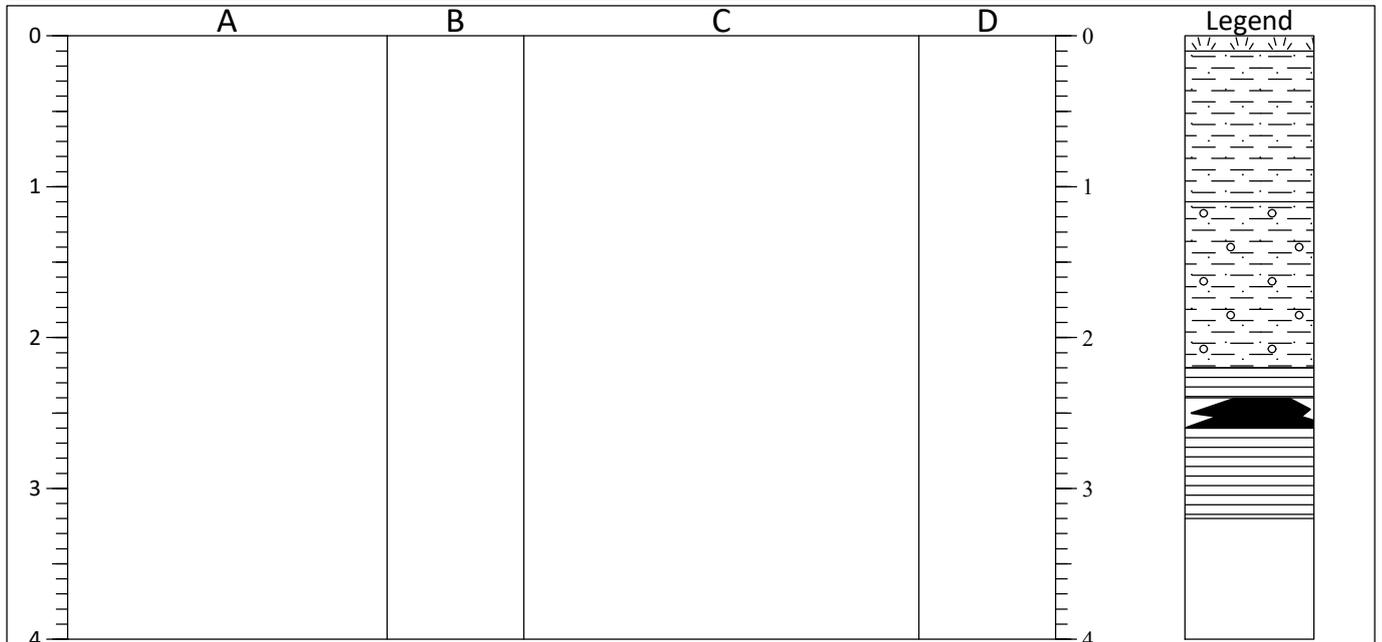
Project Rowley Lane, Lepton				TRIAL PIT No TP03
Job No 3959	Date 21-02-22	Ground Level (m) 146.07	Co-Ordinates () E 419,370.1 N 414,790.7	
Contractor Hawley Plant Hire Ltd				Sheet 1 of 1

STRATA			SAMPLES & TESTS		
Depth	No	DESCRIPTION	Depth	No	Remarks/Tests
0.00-0.10		Dark brown sandy clayey TOPSOIL with rootlets.	0.05	E	
0.10-1.10		Firm light brown with grey mottling very sandy CLAY.	0.70	E	
			0.90	D	
1.10-2.20		Firm to stiff grey with brown mottling sandy slightly gravelly CLAY. Gravel is fine to coarse subangular of mudstone.	1.70	E	
			2.00	D	
2.20-2.40		Weak weathered dark grey thinly bedded MUDSTONE.			
2.40-2.60		Weathered COAL recovered as clayey sandy fine to coarse subangular gravel.			
2.60-3.20		Weak weathered dark grey thinly bedded MUDSTONE.			
3.20		End of trial pit.

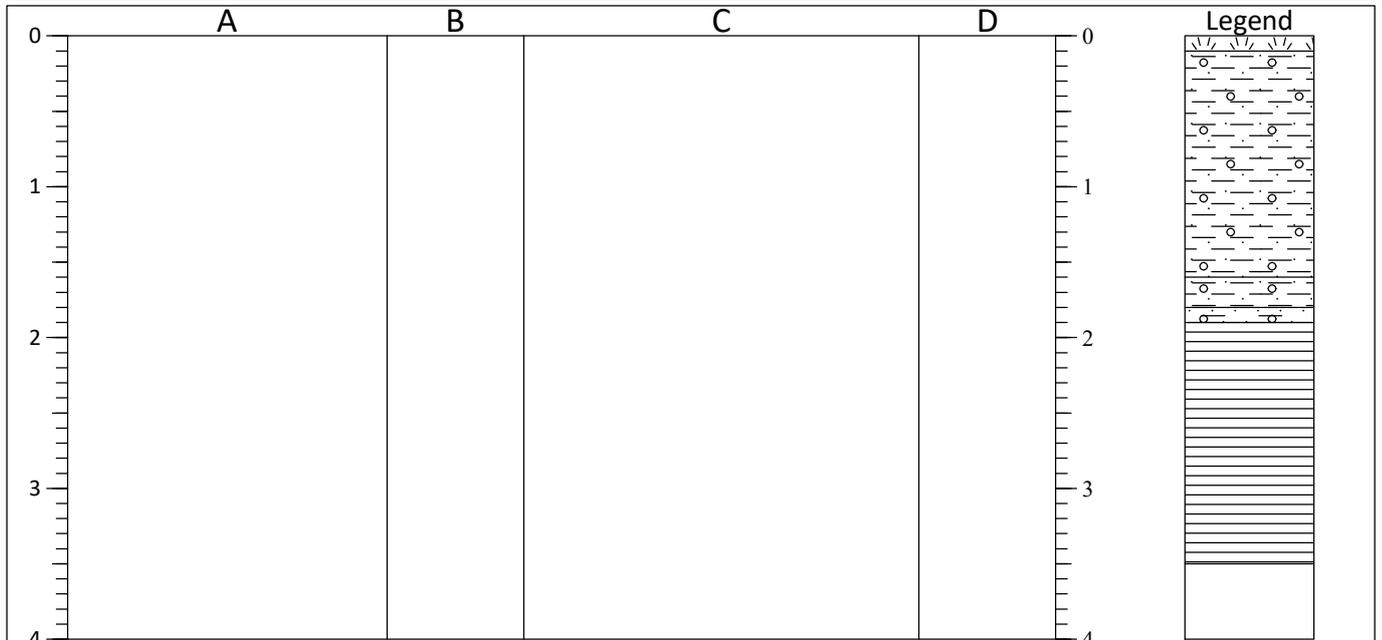
Project Rowley Lane, Lepton				TRIAL PIT No TP04
Job No 3959	Date 21-02-22	Ground Level (m) 138.66	Co-Ordinates () E 419,284.5 N 414,749.9	
Contractor Hawley Plant Hire Ltd				Sheet 1 of 1

STRATA			SAMPLES & TESTS		
Depth	No	DESCRIPTION	Depth	No	Remarks/Tests
0.00-0.10		Dark brown sandy clayey TOPSOIL with rootlets.	0.10	E	
0.10-1.60		Firm light brown and grey sandy slightly gravelly CLAY. Gravel is fine to coarse subangular of sandstone. Low cobble content subangular of sandstone.	0.50	E	
			0.90	D	
1.60-1.80		Firm to stiff grey sandy gravelly CLAY. Gravel is fine to coarse subangular of mudstone and coal.	1.70	D	
1.80-1.90		Grey and black clayey gravelly fine to coarse SAND. Gravel is fine to coarse subangular of mudstone and coal. MUDSTONE recovered as grey with red weathered surface sandy fine to coarse subangular gravel.			
1.90-3.50			2.50	D	
3.50		End of trial pit.

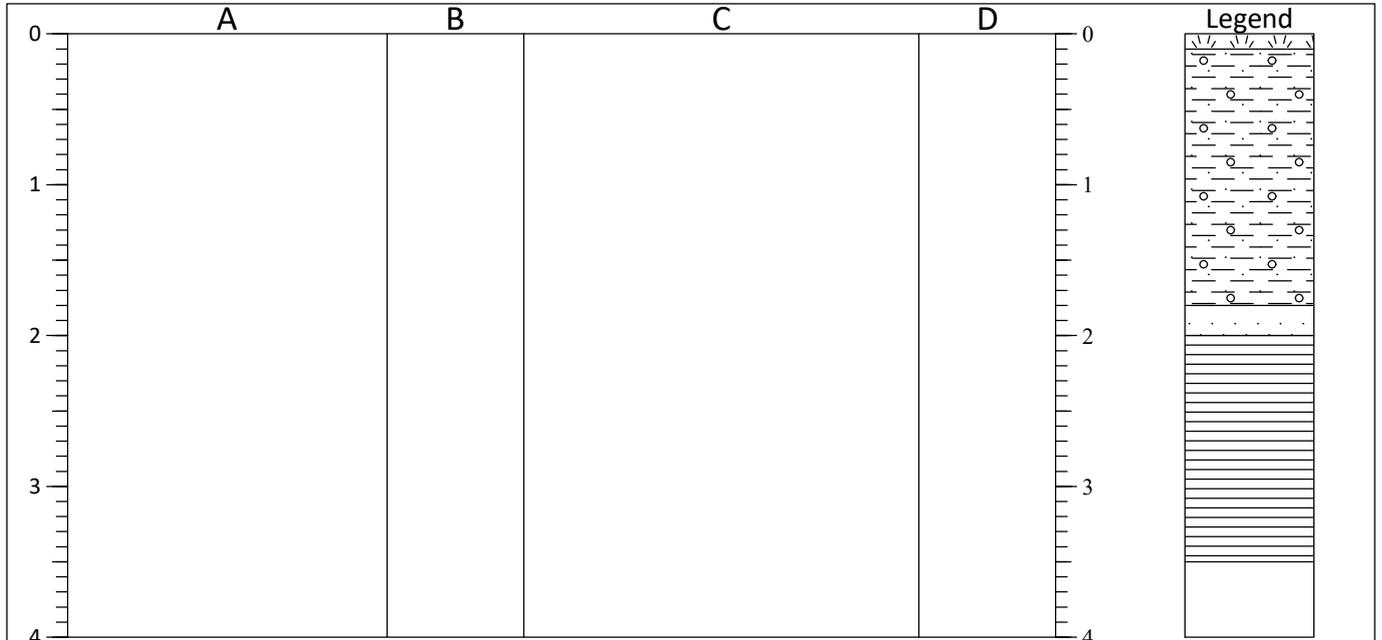
Project Rowley Lane, Lepton				TRIAL PIT No TP05
Job No 3959	Date 21-02-22	Ground Level (m) 135.47	Co-Ordinates () E 419,229.2 N 414,730.5	
Contractor Hawley Plant Hire Ltd				Sheet 1 of 1

STRATA			SAMPLES & TESTS		
Depth	No	DESCRIPTION	Depth	No	Remarks/Tests
0.00-0.10		Dark brown sandy clayey TOPSOIL with rootlets.	0.10	E	
0.10-1.80		Firm to stiff grey sandy gravelly CLAY. Gravel is fine to coarse subangular of sandstone coal and mudstone.	0.50	E	
			1.00	D	
1.90-2.00		Grey and black clayey gravelly fine to coarse SAND. Gravel is fine to coarse subangular of mudstone and coal.	1.90	D	
2.00-3.50		MUDSTONE recovered as grey sandy fine to coarse subangular gravel.	2.40	D	
3.50		End of trial pit.

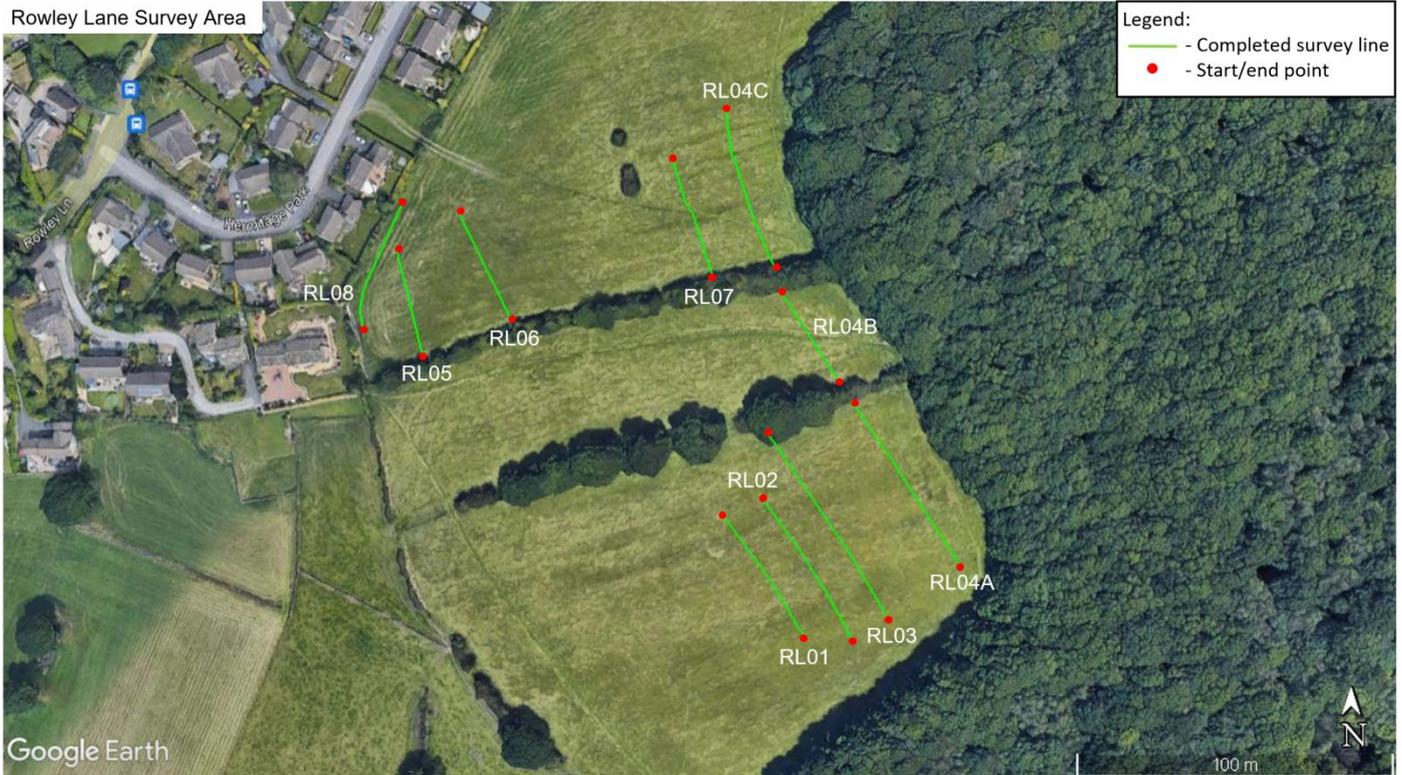
Figure 6.3: Image showing the survey line locations.

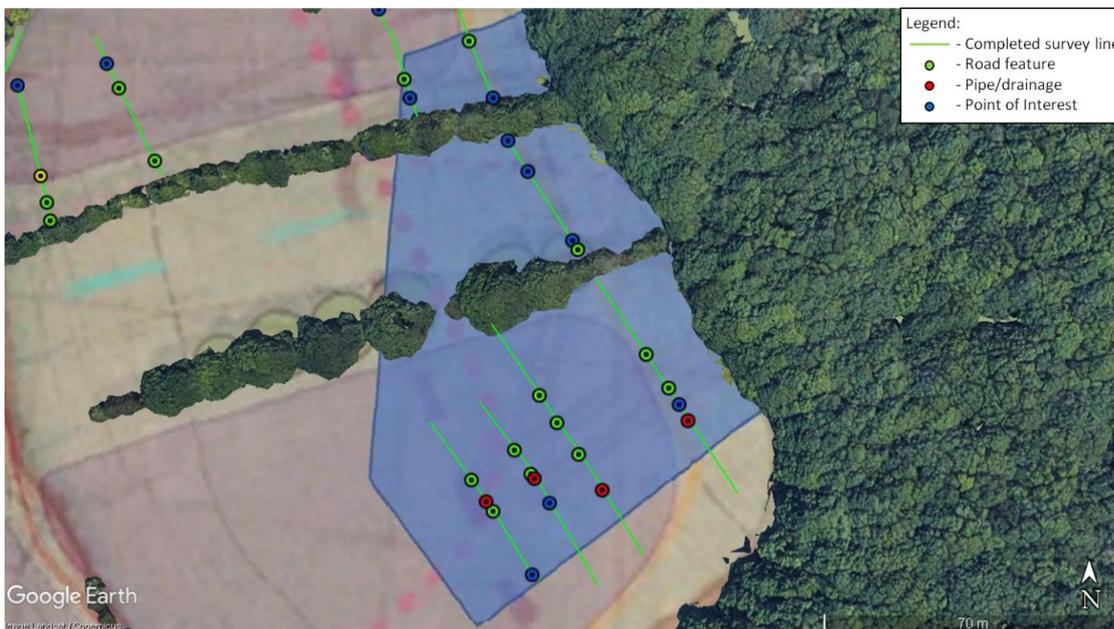
Fig 7.1: Surface locations of anticipated underground features and other POI within Zone 1

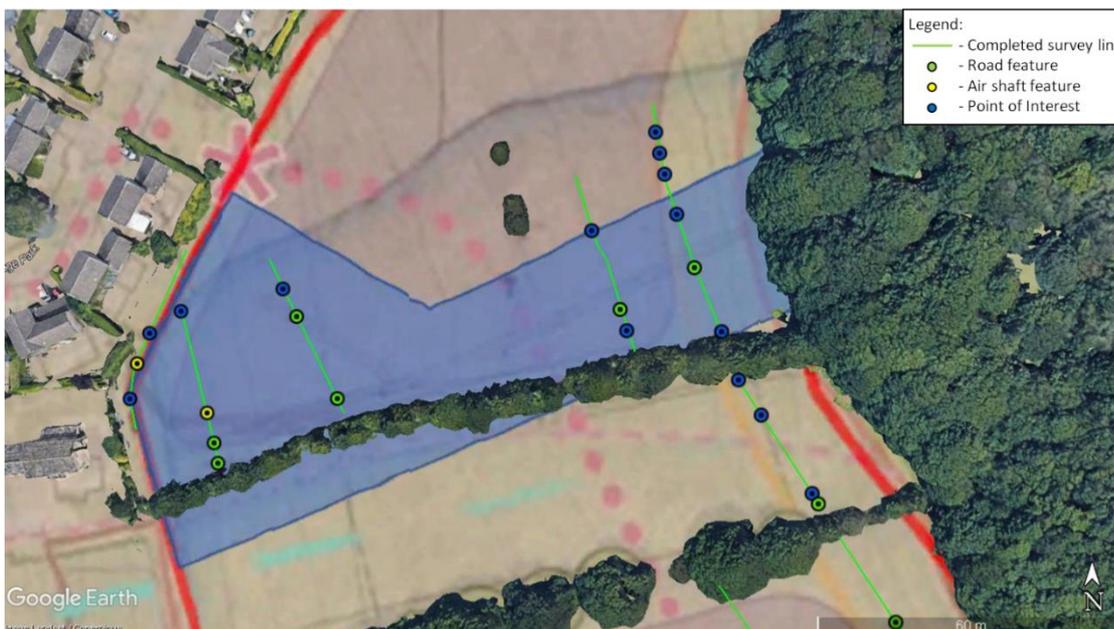
Fig 7.2: Surface locations of anticipated underground features and other POI within Zone 2.
