Black Rock House, Waingate, Linthwaite

Conversion into 3No Apartments - Heritage Statement

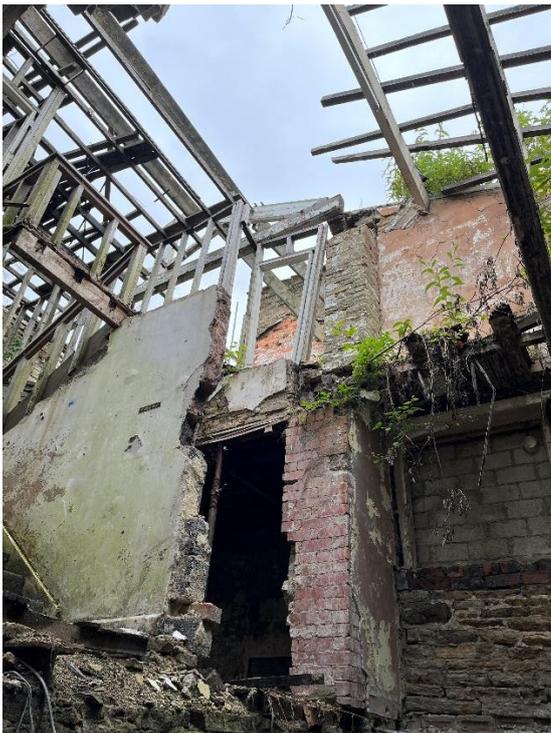
Internal view of the building from 2024

2.07 Internally the house has suffered since it became disused. The ruinous condition of the building precluded internal access as it is not considered safe to enter. However, a brief visual inspection of the interior of the building from the entrance did not reveal any historic internal decorative features. It is clear that the walls have been underpinned for stability recently but no other conversion works have taken place.

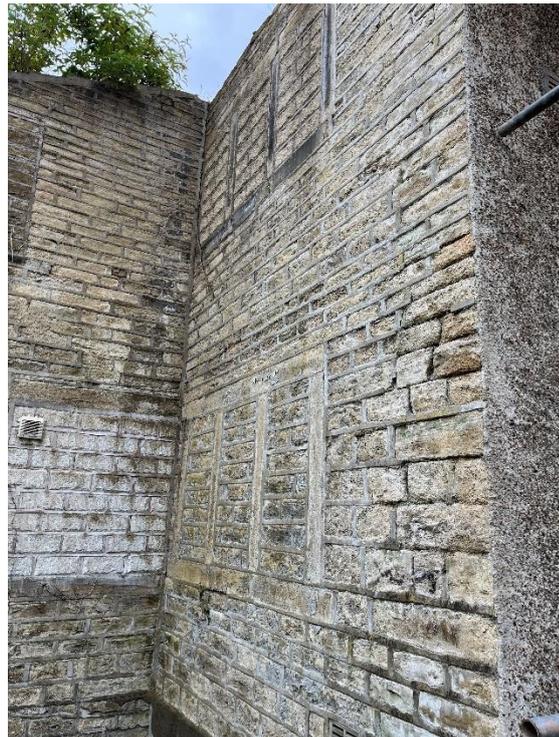
Historically blocked up windows to east elevation, probably from when the extension was erected

5.6 The main elevation to Black Rock House will be repaired using like for like materials and kept as is. However, in order to create three apartments within this large property, openings are required to the rear elevations for light and access. These will be the current blocked up openings and openings to a new external wall at the north of the link building. The floor plan has been lost, and so the harm to the plan from the proposals is limited.

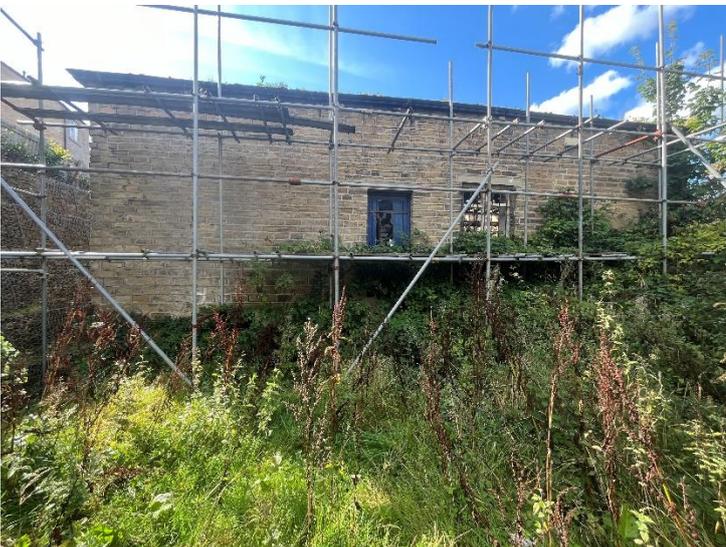
East elevations of the former workshop. A corbel table on the east wall and bricks under the roof line of the north elevation suggest that the roof may not be original or has been altered in the past.

2.08 The extension to Black Rock House is later in date and has a blue slate roof (originally with a long row of rooflights). It lacks the design details seen on the earlier buildings, such as the external treatment of windows. However, it does not display the more regularly coursed stone with fine joints characteristic of later 19th century buildings onwards in this area and most likely dates from the third quarter of the 19th century. It is shown on the 1892 Ordnance Survey map. It is connected to Black Rock House via a single bay three-storey link block with a ground level entry and external stairs to the first floor, below which are two stores of former outdoor WCs. It was probably added to provide a manufacturing workshop and consists of a large open first floor space above a ground floor (that is sunken into the rising topography). The first floor is effectively at ground floor level to the north and east and a large access opening on the north gable end has been blocked. The east wall could be reached via a series of stone steps from the yard to the rear (east) of the terrace. The roof structure/loft is well ventilated with external louvres and voids.

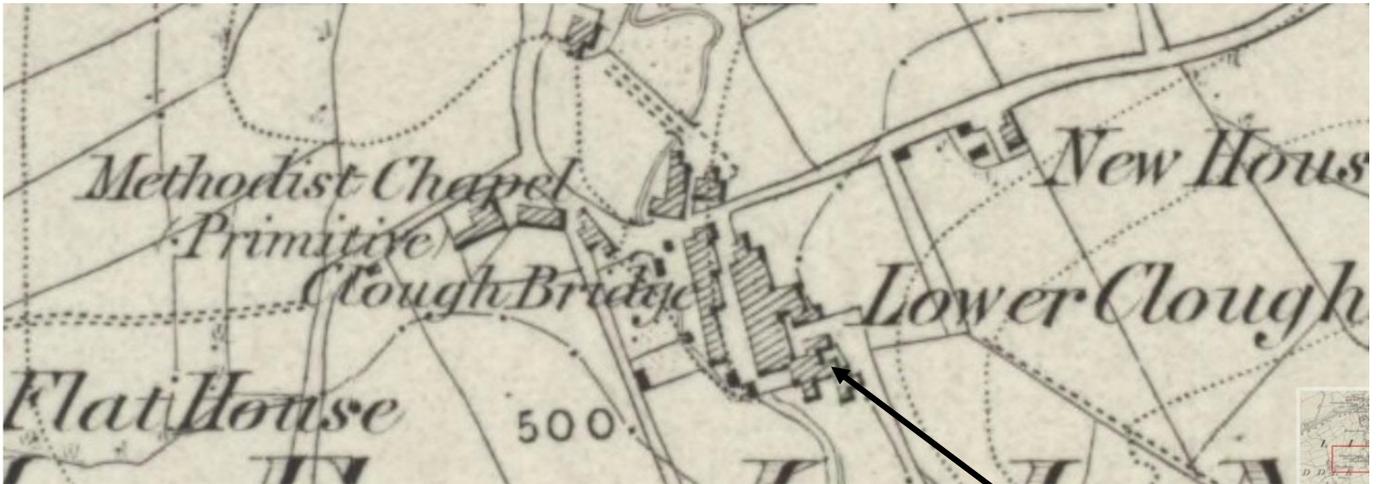
Ordnance Survey map, 1854: shows a group of buildings around a short street, leading south from Waingate and terminating in Black Rock House. 18 Waingate was part of a terrace on the eastern side of a narrow lane with another terrace on the opposite side (demolished in the c.1960s). Buildings (since demolished) are shown extending the surviving terrace to the north of 18 Waingate and to the south attaching to the corner of Black Rock House, which formerly had a series of wings, largely grouped around a rear courtyard

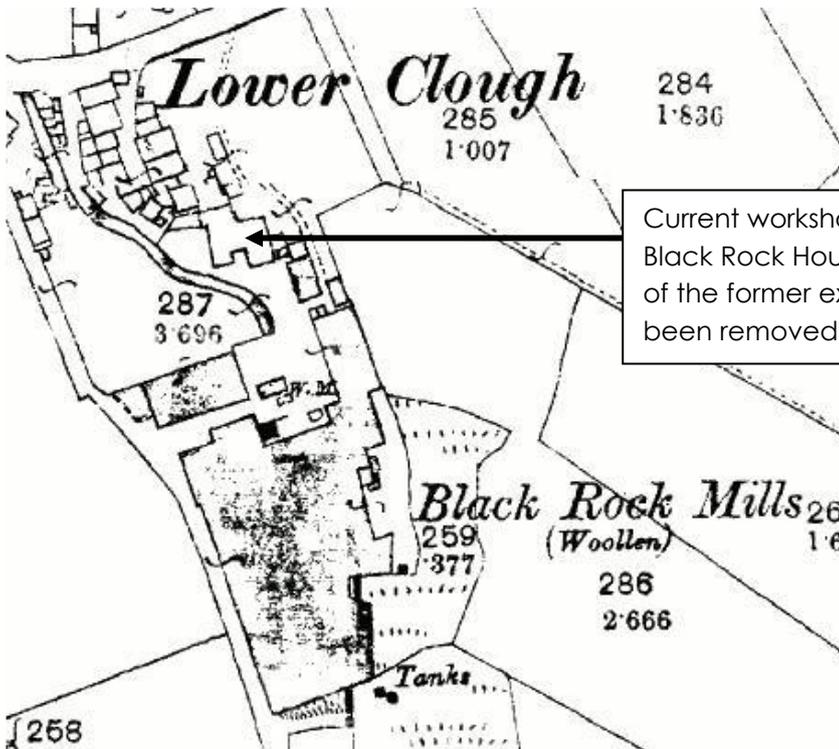
Current workshop extension to Black Rock House is shown. Most of the former extensions have been removed

Ordnance Survey map, 1892: most of the wings to Black Rock House have been replaced with the current extension to the east (which survives today). There is a further building attached to its east elevation that does not survive today. Given the steep terracing of the landscape here this building may have been set at a higher level. Note the construction of Black Rock Mills.

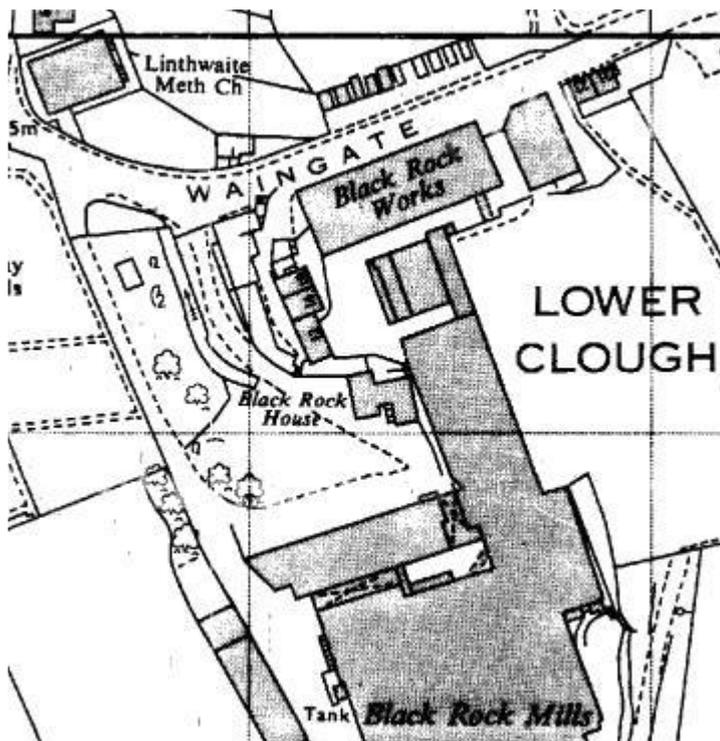
Ordnance Survey map 1978-1992: records the external stairs to the link block at Black Rock House, the reduction of the terrace containing 18 Waingate with buildings removed at the north end and the clearance of the western terrace (a process that had begun in the 1960s if not earlier as the 1968 map only partially records the terrace).

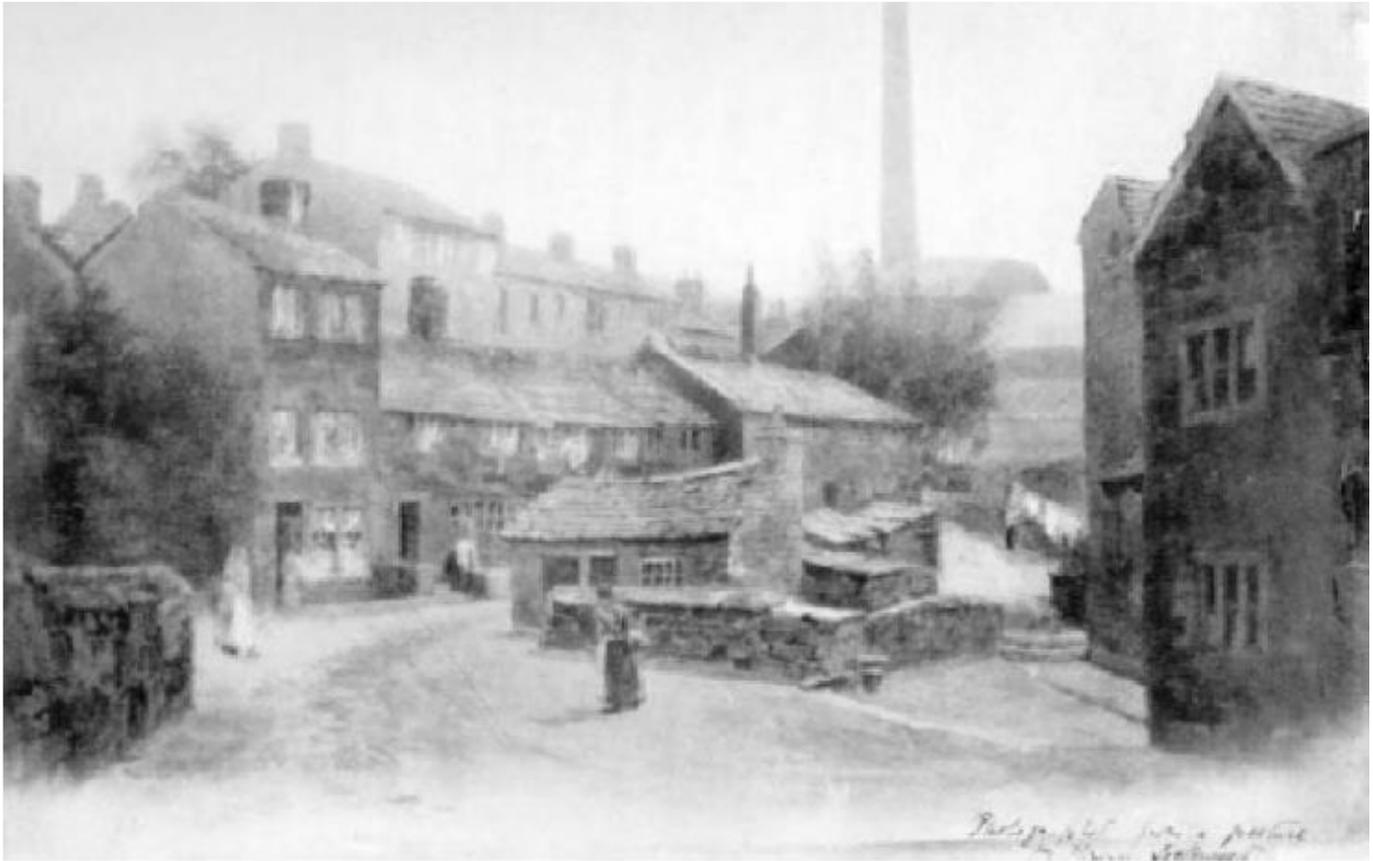
The approach to Black Rock House , past 18 Waingate and terrace, as sketched by Florence Lockwood in 1903. Although the elevational treatment is not entirely consistent with the fabric evidence today, such as the location of the doorway to No.18, this image captures the essential character and appearance of the site and former street scene in the early 20th century. The end building of the terrace was demolished in the mid-late 20th century as were the buildings on the other side of the street

4.3 Historic images of the site, in particular the illustration by Florence Lockwood dated 1903 and reproduced below and cartographic evidence, illustrates the historical development of the site which has high illustrative historical heritage values.
