Coach and Horses, Honley  
Bat Roost Inspection Survey

Client                   Cairn Cross  
Project Title           Coach and Horses, Honley  
Project Reference      RHE.4698  
Project Leader         Tim Palmer  
Contact Details        Tim@rachelhackingecology.co.uk

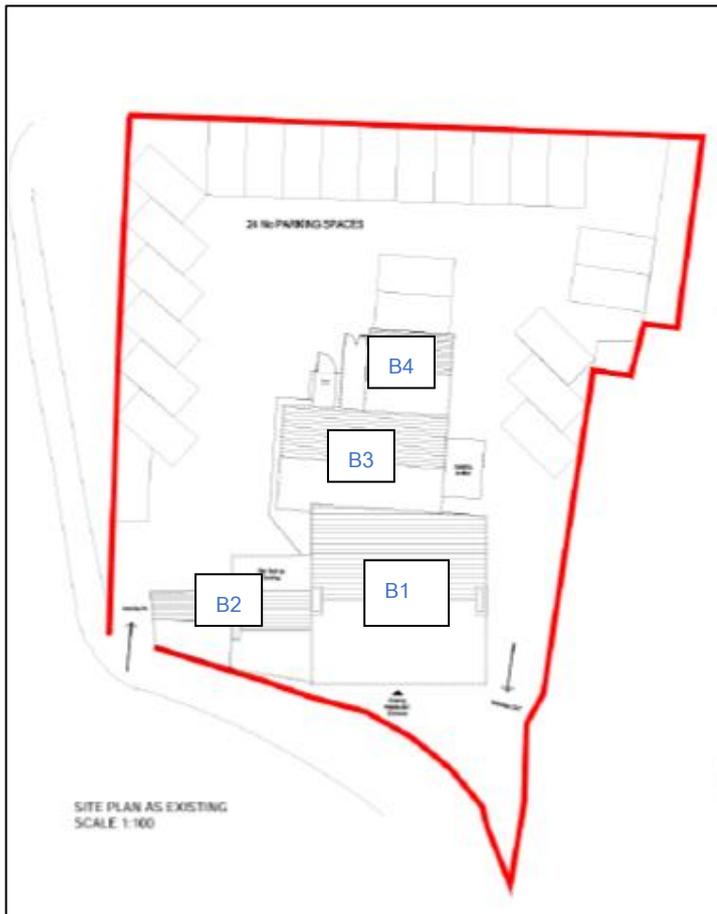
Plate 1: Building numbers (plan courtesy of Acumen Architects and Designers).

- 2.2.1 Surveys were undertaken in accordance with current guidelines<sup>2</sup>. Interpretation of survey findings and assessment of roosting suitability was undertaken using professional judgement and criteria described in published guidance<sup>2,3</sup>
- 2.2.2 The detailed inspection has allowed for a refinement of the assessment of building suitability, which is provided individually for all four of the buildings which collectively make up the footprint of the former public house.
- 2.2.3 The buildings are labelled in Plate 1 below.

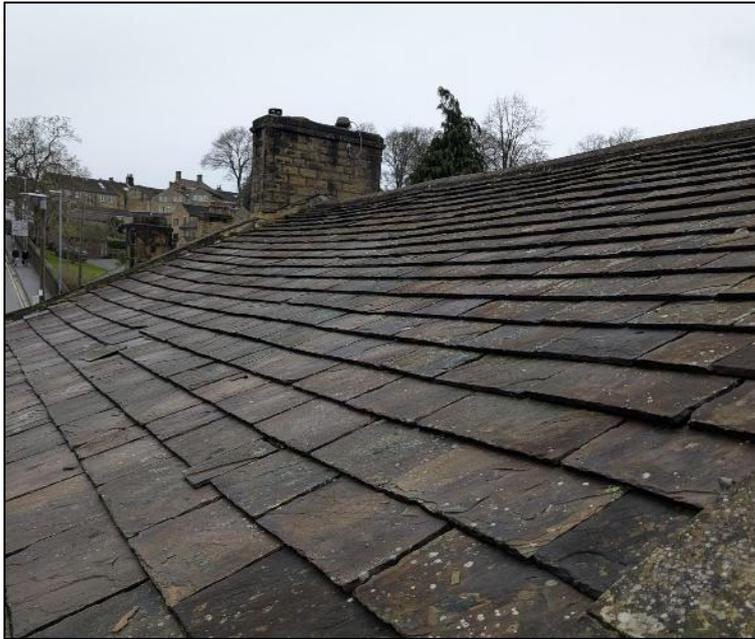
- 3.2.1 The main building which has a frontage on Eastgate. The walls are of coursed masonry with a gable ended pitched roof covered in Yorkshire stone tiles (see Plate 2). There are chimney stack protrusions to both gables. There are <10 lifted roof tiles, and pointing at gable eaves is intact. The building is co-joined with Building 2 (B2) which is set at a slightly lower ridge height but follows the same roof line. Building 3 is also joined to the northern edge of B1 and is also internally linked. B1 has no soffits/facia boards, the roof simply overhangs the eaves with guttering beneath. Coping stones are present along the gable tops and are all well sealed with no gaps. The wall masonry appears to have been relatively recently pointed. The walls, windows and doors are all intact.

Plate 2: Showing Yorkshire stone tiles on B1 (all buildings have the same roof covering).

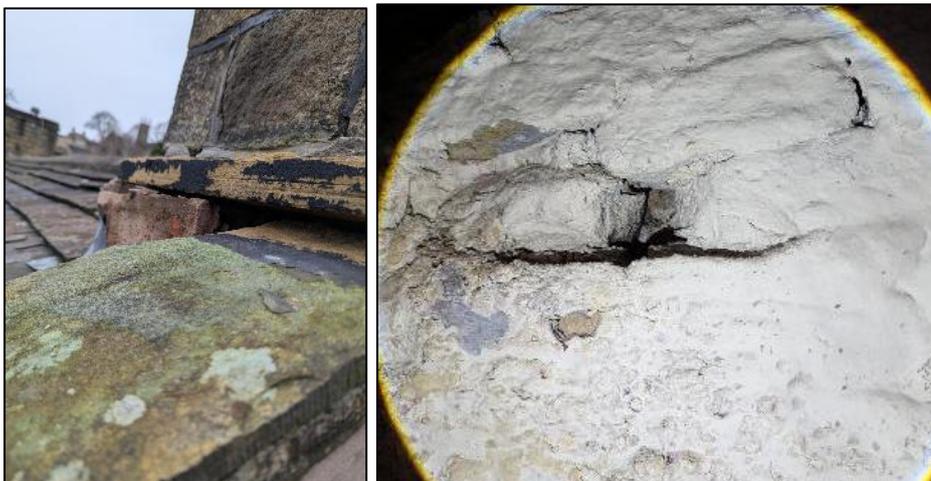
- 3.2.2 The chimney aprons/flashing are well sealed other than some masonry gaps present in the eastern one – where c.5 old bat droppings observed within the feature (see Plate 3).

Plate 3: Roost location B1.

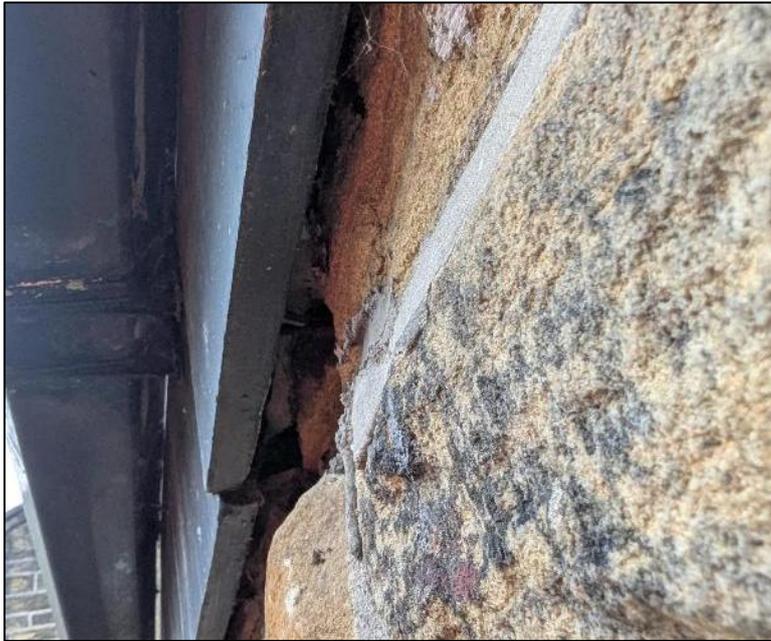
- 3.2.3 This building is smaller than B1 but is of a similar construction and age. The building lies next to B1 and is connected internally. A single chimney stack protrudes centrally, mid-way along the ridge. The roof is similarly clad in Yorkshire stone tiles of which c.40 are raised with gaps beneath. The roof ridge is intact and is well sealed with mortar throughout. There are minor gaps around the chimney aprons. The masonry appears to have been recently re-pointed with a render coating present on the western elevation.
- 3.2.4 There is a timber fascia board present to the rear of the building behind which c.30 bat droppings were recorded, observed stuck to the upper wall levels, clustered around the roost access point and internally behind the fascia board (see Plate 5).

Plate 5: B2 roost location, behind timer timber fascia.

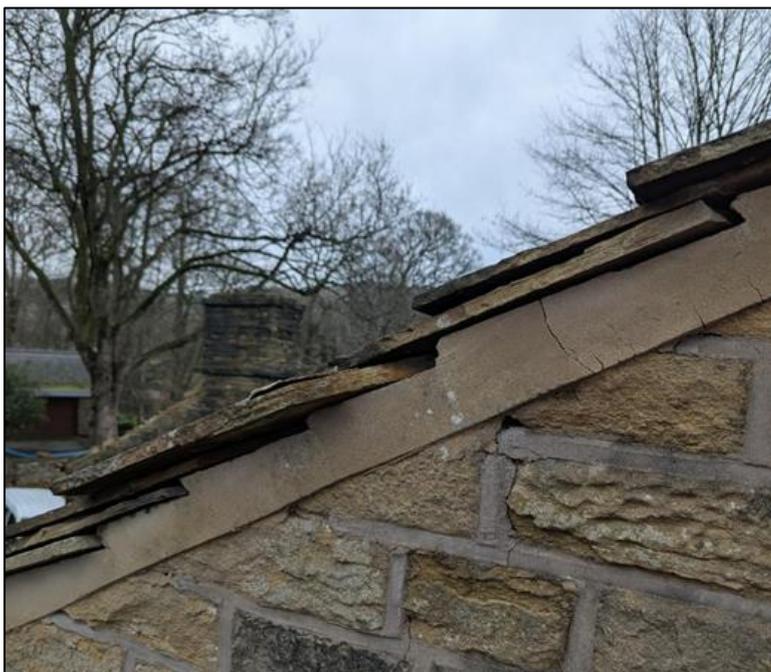
- 3.2.5 A further small addition to the rear of the property which forms an extension to B1 and is joined at roof level with a 'valley' between the two buildings. The building is of a similar construction/design and age, however there are no chimneys. The roof is intact and well maintained although there are a number of gaps beneath tiles. The lead flashing at the roof valley junction with B1 has been removed.
- 3.2.6 Approximately 20 bat droppings were present between overlapping roof tiles along the western gable eaves (see Plate 6).

Plate 6: B3 roost location, between overlapping roof tiles.

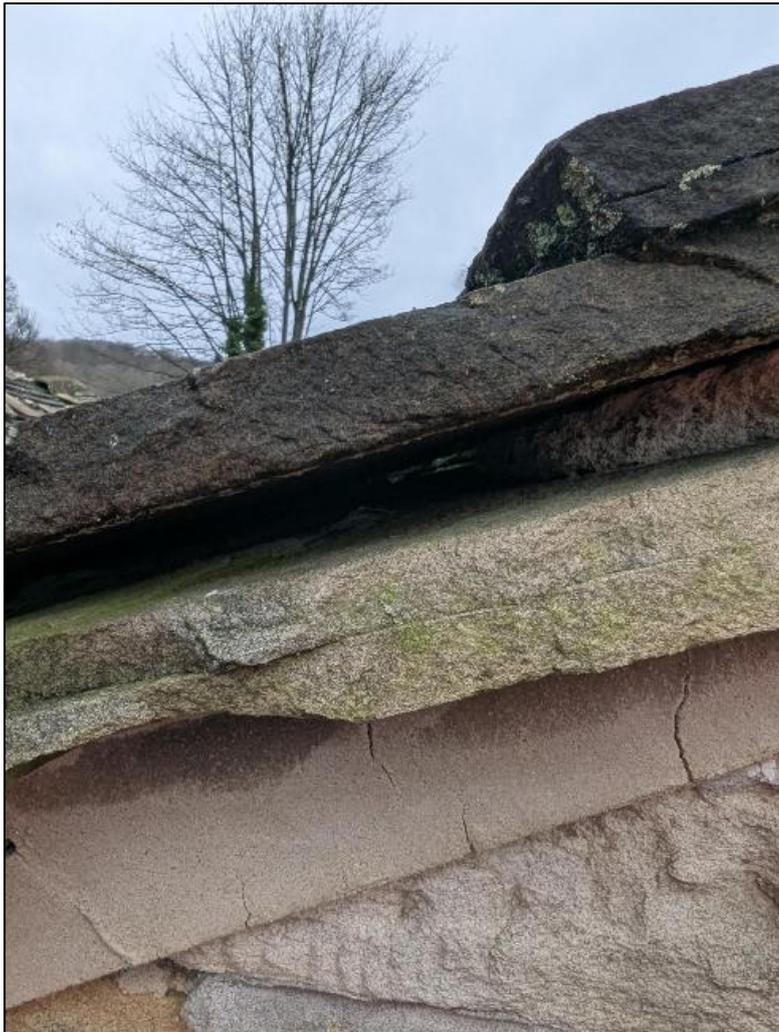
- 3.2.7 The smallest and potentially most recent addition to the buildings is also of a similar construction and design with a Yorkshire stone clad gable ended roof over coursed masonry walls. There was significant loss (theft) of Yorkshire stone tiles from the rear elevation of the building with c.30% of the roof area being exposed and felt membrane visible beneath.
- 3.2.8 Evidence of use by bats was recorded here with a cluster of 5 droppings within an eroded mortar fillet in the gable eaves on the western elevation and a small cluster of 8 droppings between overlapping tiles on the eastern elevation of the roof (see Plate 7).

Plate 7: B4 roost location between overlapping roof tiles.

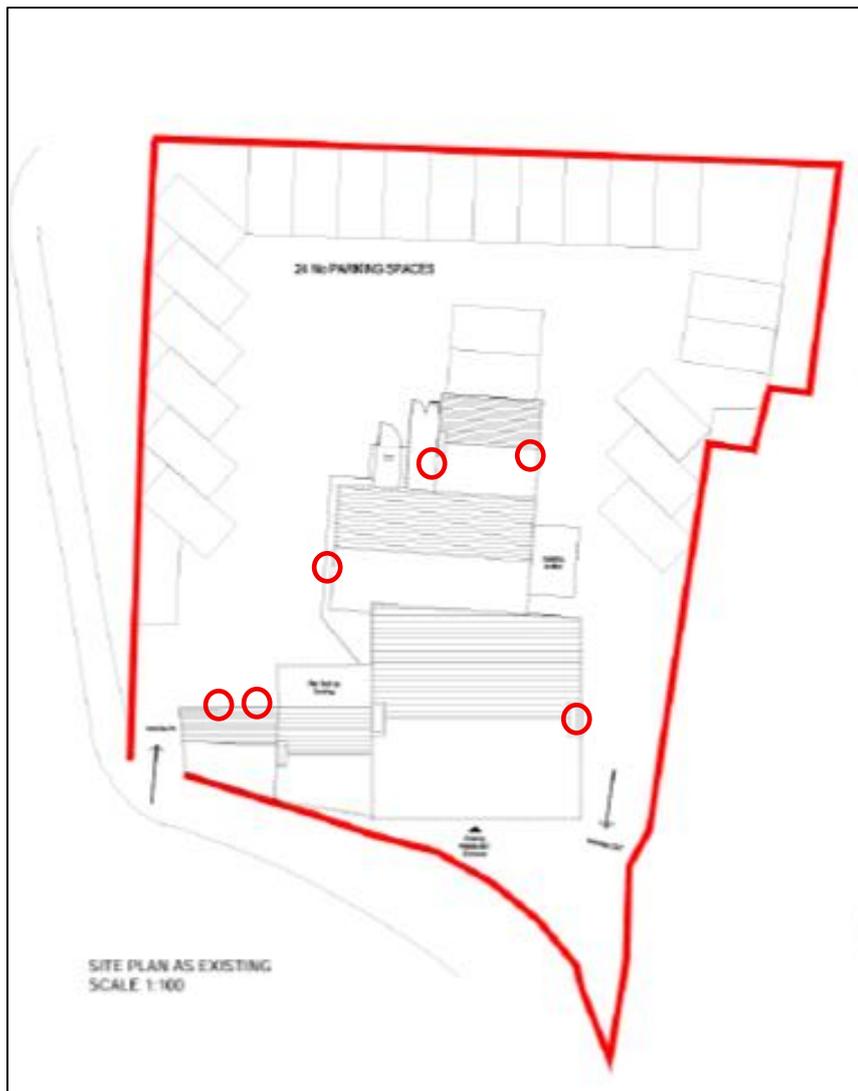
- 3.2.9 The locations of identified roosts are shown in Plate 8, below.

Plate 8: Roost locations (red circles).

- 4.1.3 The presence of low numbers of bat droppings at six locations within external roof niches of each of the buildings confirms the likely usage of the building by low numbers of bats, or more likely individual bats roosting opportunistically, exploiting several available roost niches; rather than their being any single aggregation of bats with a particular feature.

- Provision of a Licensed Ecologist to closely supervise works to the roof structure in the vicinity of known roosts to minimise the likelihood of harm to bats within the roosts.
- Hand demolition/removal of the roof structures (tiles, battens and membrane).
- Provision of six integral bat boxes and or roosting opportunities within the upper wall fabric of the retained buildings, to ensure equivalent roost capacity is maintained following the construction.
- Provision of a lighting scheme which ensures the new roost locations (integral bat boxes) and dark corridor along the River Holme is maintained.
- Completion of two confirmatory Emergence surveys using five surveyors and in line with the survey guidelines (Collins 2023). Surveys will be programmed for the period May- August (inclusive) and will be spaced at least 3 weeks apart.
