## Falledge Farm, Upper Denby

### Bat Survey Report

9<sup>th</sup> October 2025

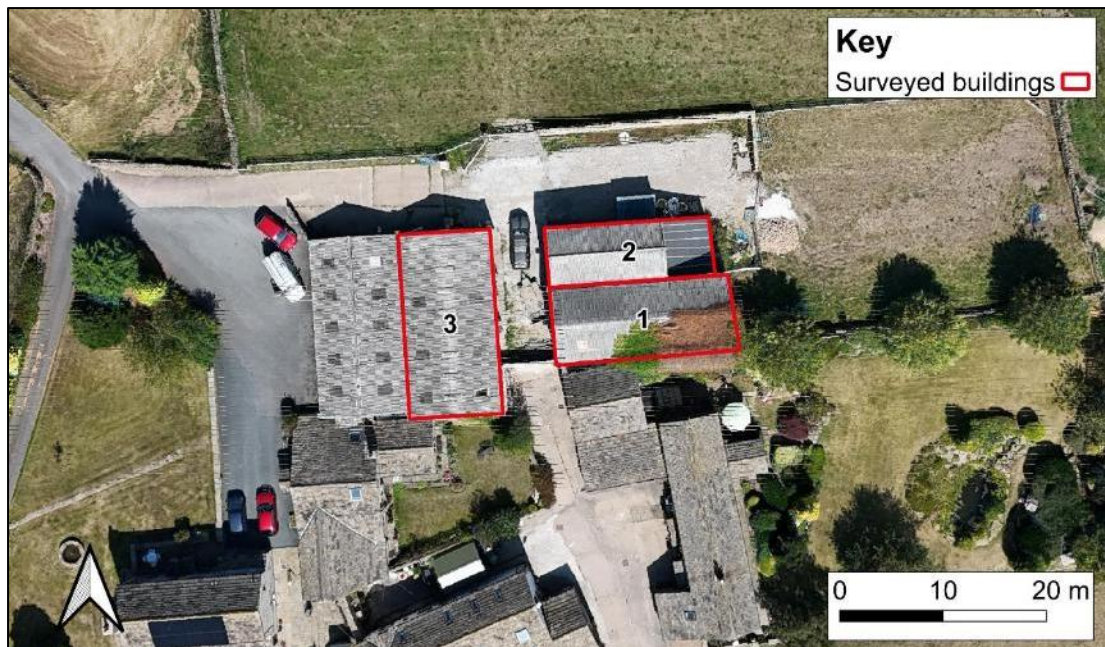
Figure 2. Drone image taken in August 2025, with surveyed buildings numbered

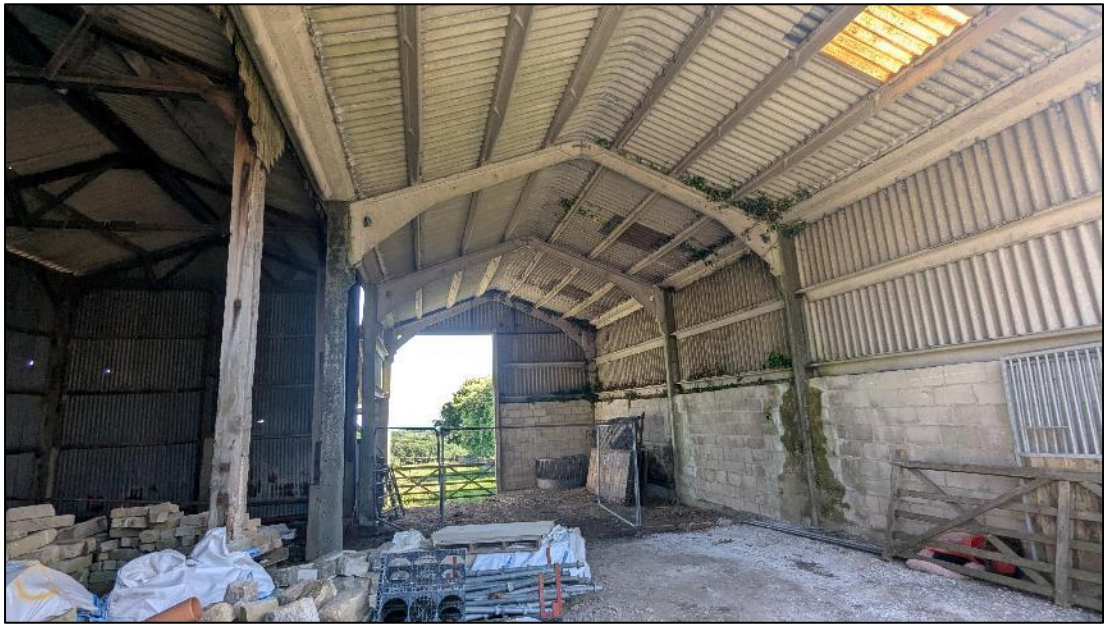
- 5.2.4 Internally the roof of the barn was open to the underside of sheeting, with no void present.

**Plate 5. Interior of B1**

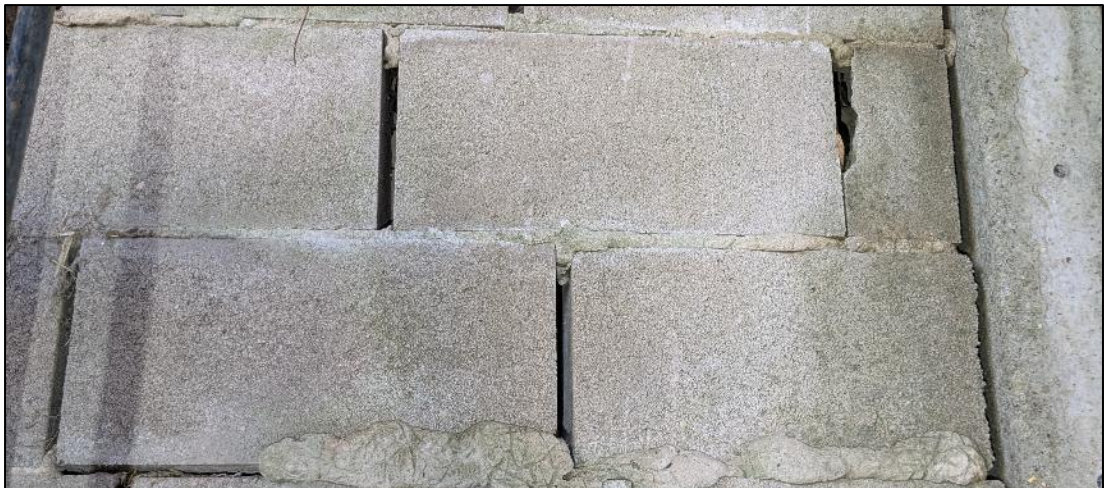
- Several gaps (to 2 cm wide) were present between blocks on the internal face of the south elevation blockwork wall (Plate 6). These cracks could all be fully inspected.
- Hollow blockwork on the south elevation was largely filled with cement with extensive debris within other hollow blocks in this wall.
- Gaps were present between the concrete frame and the corrugations of sheeting.
- Minor crevices were present between adjacent corrugated asbestos-cement sheets in places.
- Gaps were present between verge capping and the underlying corrugated sheets.
- Crevices were likely to be present between ivy stems and the corrugated sheeting.

**Plate 6. Gaps between concrete blocks in south elevation wall**

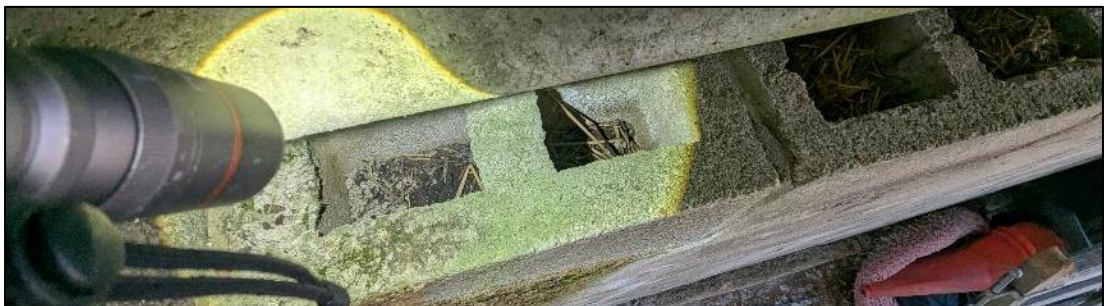
**Plate 7. Inspecting the top of the hollow concrete block wall in B1**

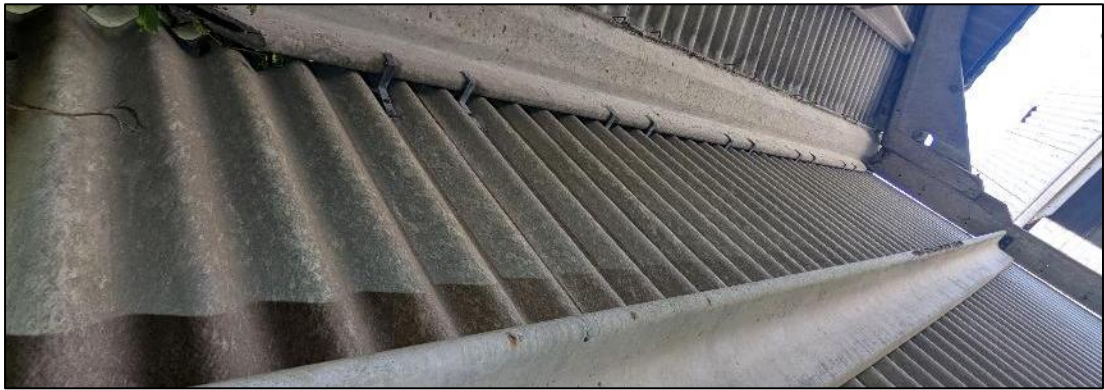
**Plate 8. Gaps between the concrete frame and corrugated panelling**

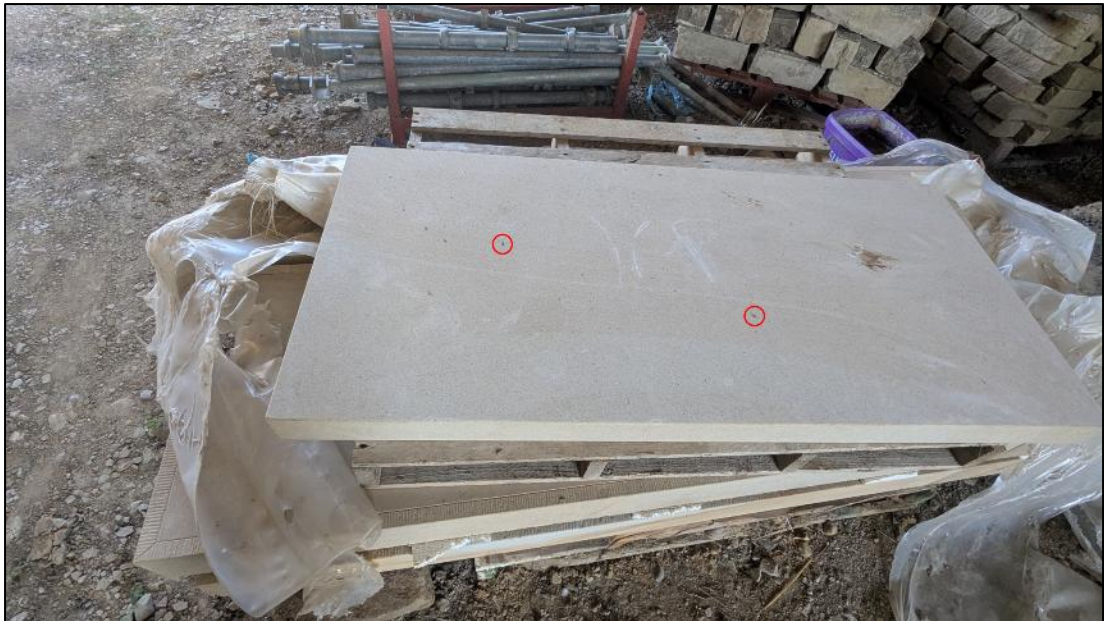
- 5.2.1 Five scattered bat droppings were recorded from stored stone on the interior of B1. The three surveyed buildings (B1, B2 & B3) were considered to display a low level of bat roost suitability.

- 5.2.5 Five scattered and small bat droppings were recorded from stored material within B1. No likely potential roost location could be identified above the droppings.

**Plate 9. Scattered bat droppings on stored stone in B1**

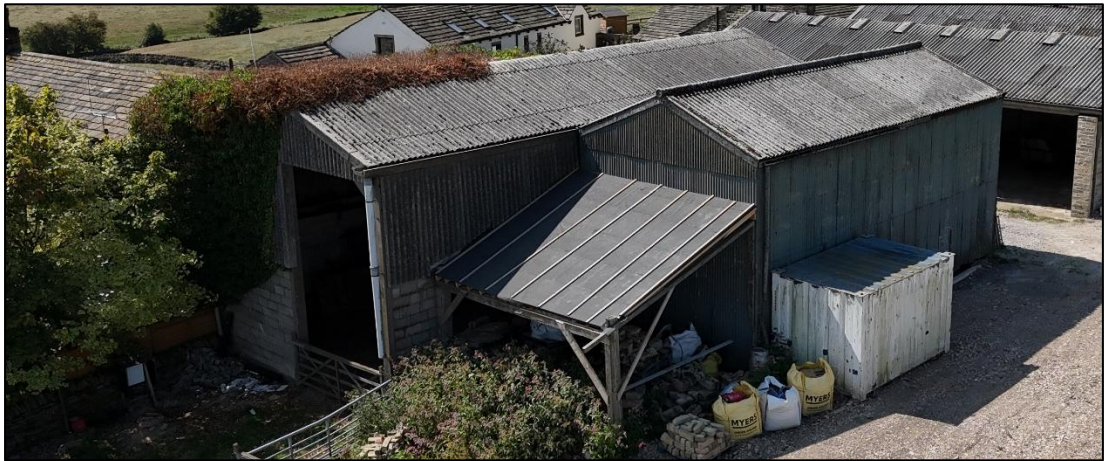
- 5.2.6 Building 2 comprised a wood-framed barn, connected to B1 on its south elevation (Plates 2, 3, 4 & 10). Building 2 had a dual-pitched asbestos-cement clad corrugated sheet roof. The north, east and west elevations were clad with corrugated metal sheet. An open-sided wood-framed store with a single-pitch felt covered roof, was present on the east elevation. Asbestos-cement verge capping was present on gables.
- 5.2.7 Potential bat roost locations recorded from B2 comprised the following:
- Gaps were present between verge capping and the underlying corrugated sheets.
- 5.2.8 Internally the roof of B2 was open to the underside of sheeting, with no void present (Plate 11).

**Plate 10. Building 2, viewed from north**

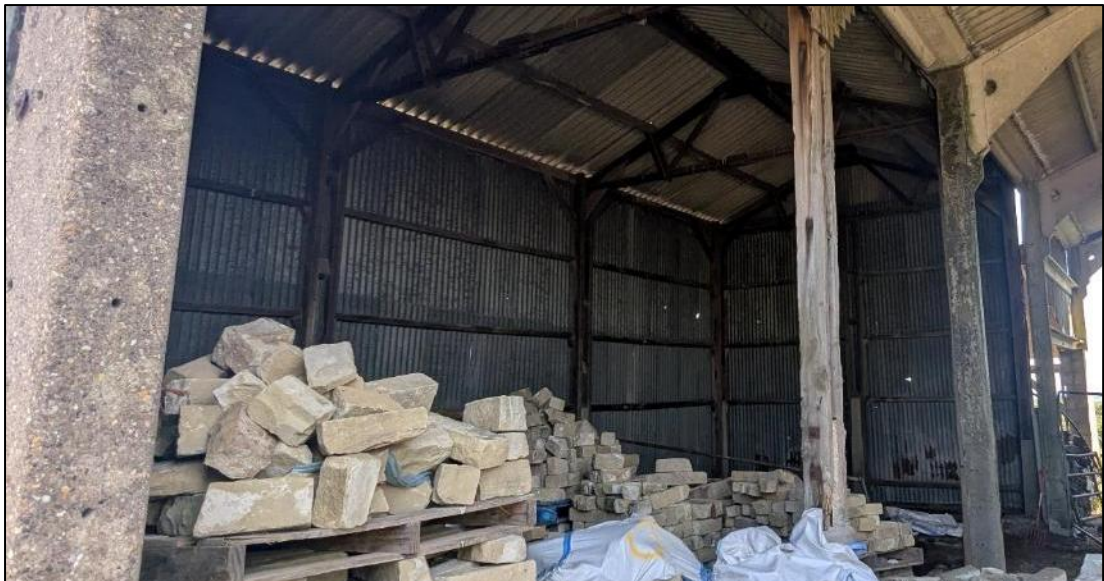
**Plate 11. Interior of B2**

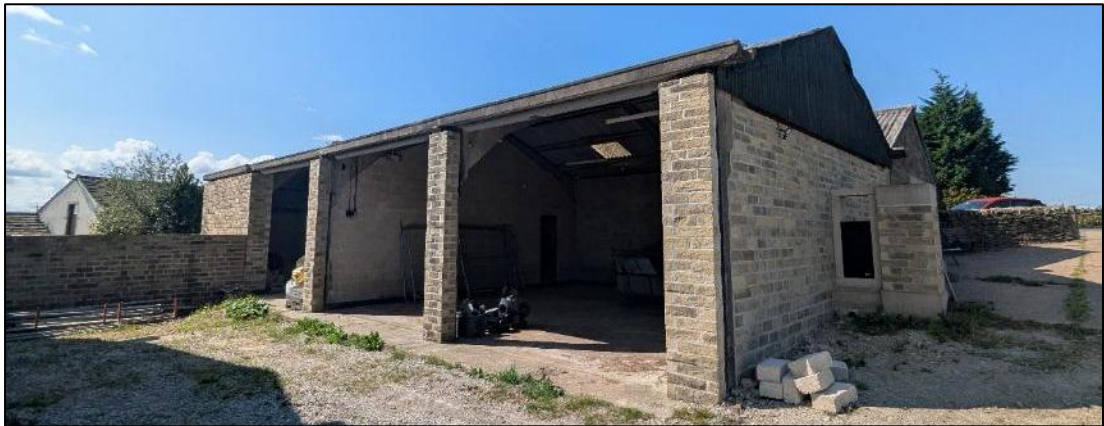
5.2.9 Building 3 comprised a single-storey stone and concrete block built barn, which was open sided on most of its east elevation (Plates 2 & 12). The walls of this building had been re-built within the last five years. The roof was dual-pitched and covered with asbestos-cement corrugated sheeting including vent panels in the ridge. Corrugated composite panels clad the upper section of the north gable, with asbestos-cement corrugated panels on the south gable.

- Minor crevices were present between adjacent corrugated asbestos-cement sheets in places.

**Plate 12. View of B3 from northeast**

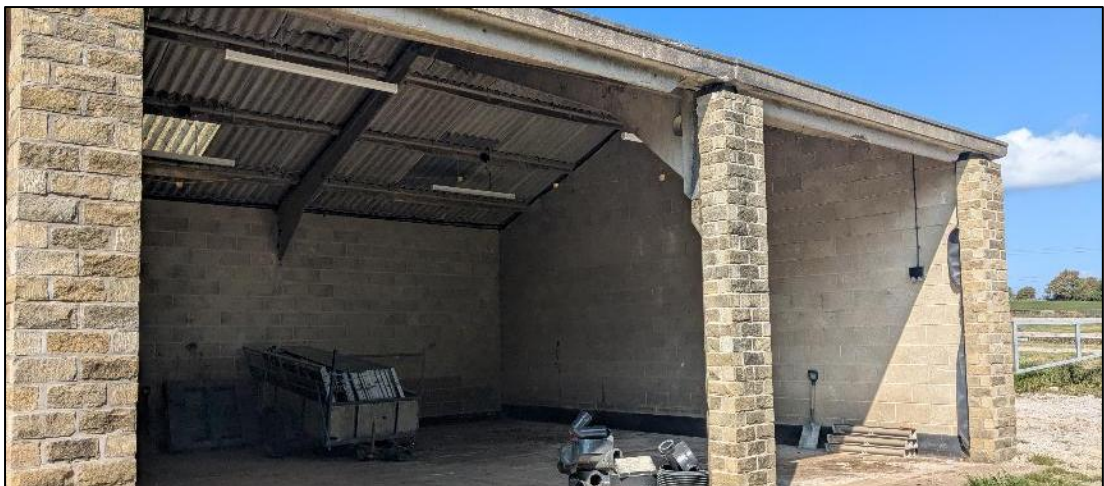
5.2.11 Internally the roof of B3 was suspended on a concrete frame and open to its underside, with no roof void present (Plate 13).

**Plate 13. Interior of B3**

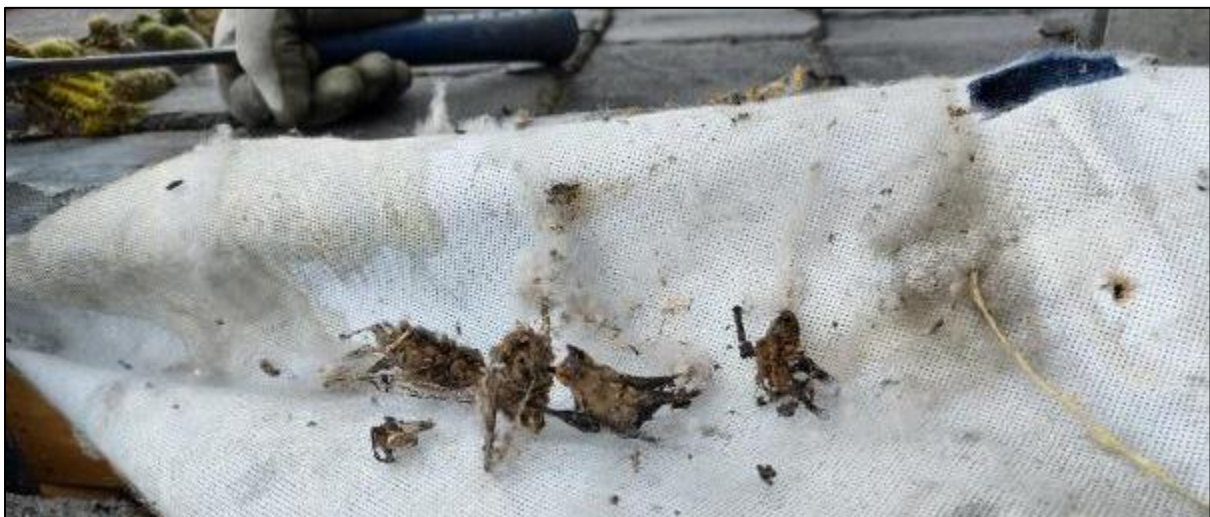
One example we have encountered comprised a pipistrelle roost which formed in a building extension constructed in 2009. Over the course of just 13 years the roofing felt degraded to the extent that it trapped and killed more than 10 bats. Fortunately, the problem in this roost was identified and remedial work was undertaken to replace the roofing membrane in 2022.

### Plate A1.1. Four dead pipistrelles tangled in breathable roofing felt

The best roofing membrane option for areas where bat roosts are expected is traditional Type 1F bitumen coated hessian backed roofing felt. Bitumen coated roofing felts have been widely and safely used as a secondary weather barrier since approximately the 1950s/1960s. Wooden sarking has also been used for many decades and if appropriately treated, is safe for

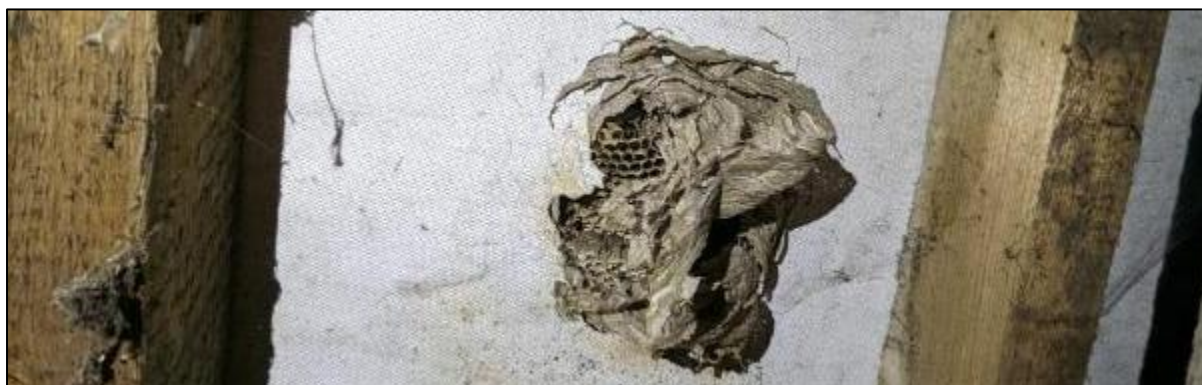
In recent years a fairly substantial proportion of the lofts we have surveyed which had existing breathable felt, were found to have been damaged by wasps (Plate A2.2). In these situations, the wasps appear to have chewed holes in the felt and formed nests in the holes. This doesn't appear to be a problem associated with the traditional bitumen coated roofing felt. Obviously, any holes within roofing felt would be likely to significantly reduce its functionality as a secondary weather barrier. Where bats or birds do come into contact with breathable roofing membranes, they can damage the membrane causing it to leak and they can also significantly reduce the breathability of the felt in that location.

#### **Plate A1.2. Damage to a breathable roofing membrane adjacent to a wasp nest**
