GROUND INVESTIGATION REPORT

**FOR
188 DEIGHTON ROAD,
HUDDERSFIELD,
WEST YORKSHIRE,
HD2 1JJ**

**REPORT NO. NE4118A
OCTOBER 2022**

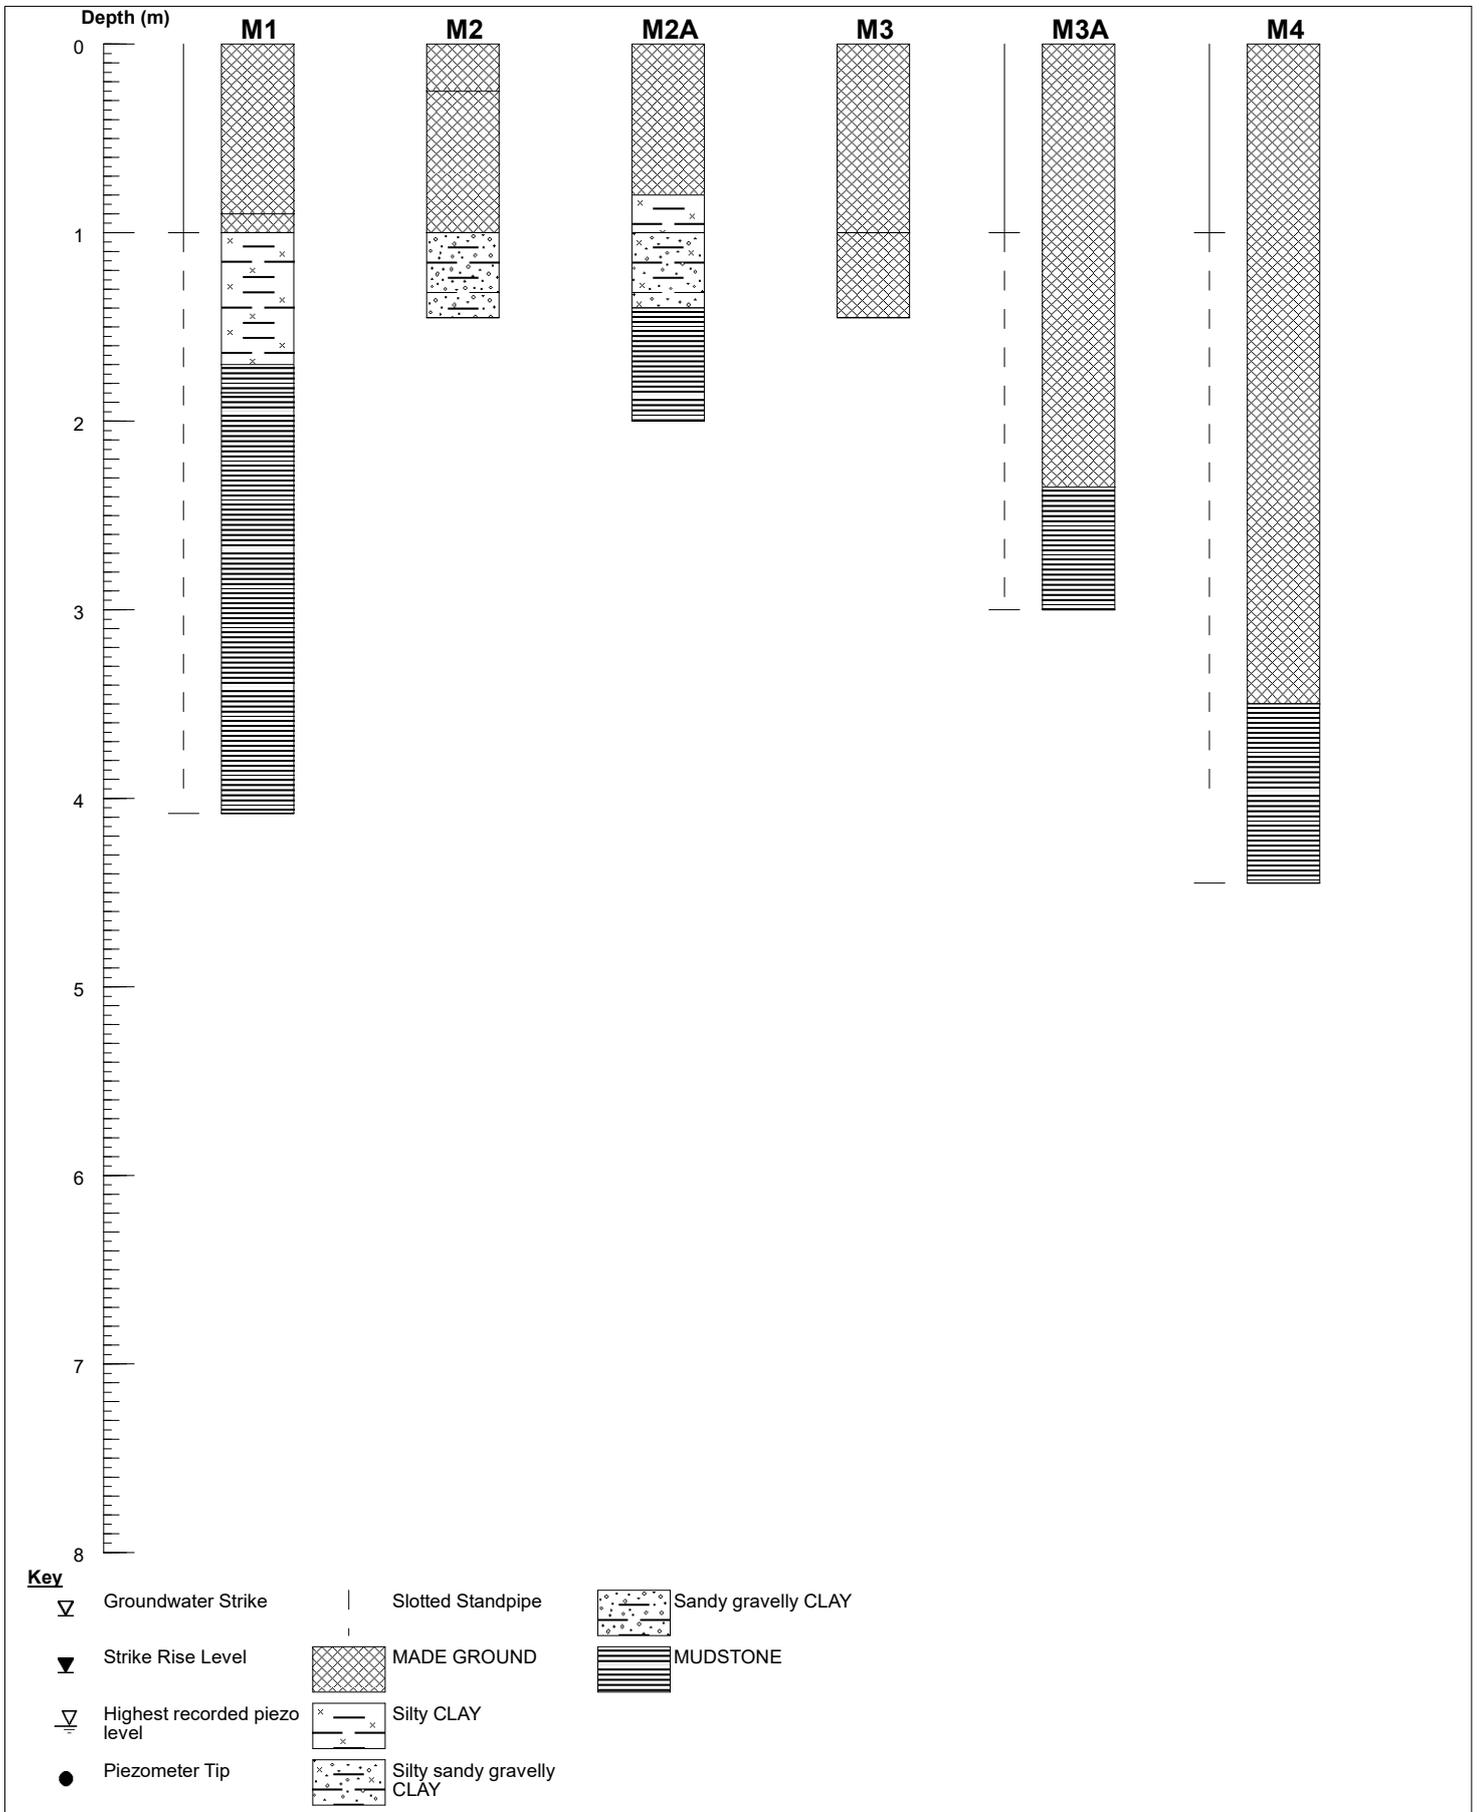
Depth (m)	Sample / Tests	Casing Depth (m)	Water Depth (m)	Field Records	Level (mOD)	Depth (m) (Thickness)	Description	Legend	Water	Instr
0.00-0.40	B						MADE GROUND: dark greyish brown very sandy clayey silty fine to coarse gravel sized fragments of sandstone, concrete, wood and brick with occasional cobble sized fragments of sandstone.			
0.50-0.90	B									
1.00-1.45 1.00-2.00	SPT(C) N=10 B			3,3/2,4,3,1						
2.00-2.45 2.00-2.45 2.00-3.00	SPT N=24 D B			2,3/8,8,3,5		(3.50)				
3.00-3.45 3.00-4.00 3.00-3.45	D C SPT N=32			3.00m to 4.00m - 90% Recovery 5,21/17,5,5,5		3.50	Extremely weak thinly bedded greyish brown and brownish grey highly to completely weathered MUDSTONE.			
4.00-4.45	SPT(C) N=42			7,7/8,11,11,12		(0.95)				
				19/04/2022:DRY		4.45	Complete at 4.45m

Remarks Hand dug inspection from GL to 1.00m to check for services. Core diameter: 64mm to 4.00m. No groundwater encountered. On completion backfilled with gravel and installed a 50mm dia hdpe gas monitoring standpipe with a gas valve and a gravel surround to 4.00m, a Bentonite seal from 1.00m to 0.20m and a concreted in lockable steel protective cover from 0.20m to GL.	Scale (approx)	Logged By
	1:25	LMB/VW
Figure No. NE4118A.M4

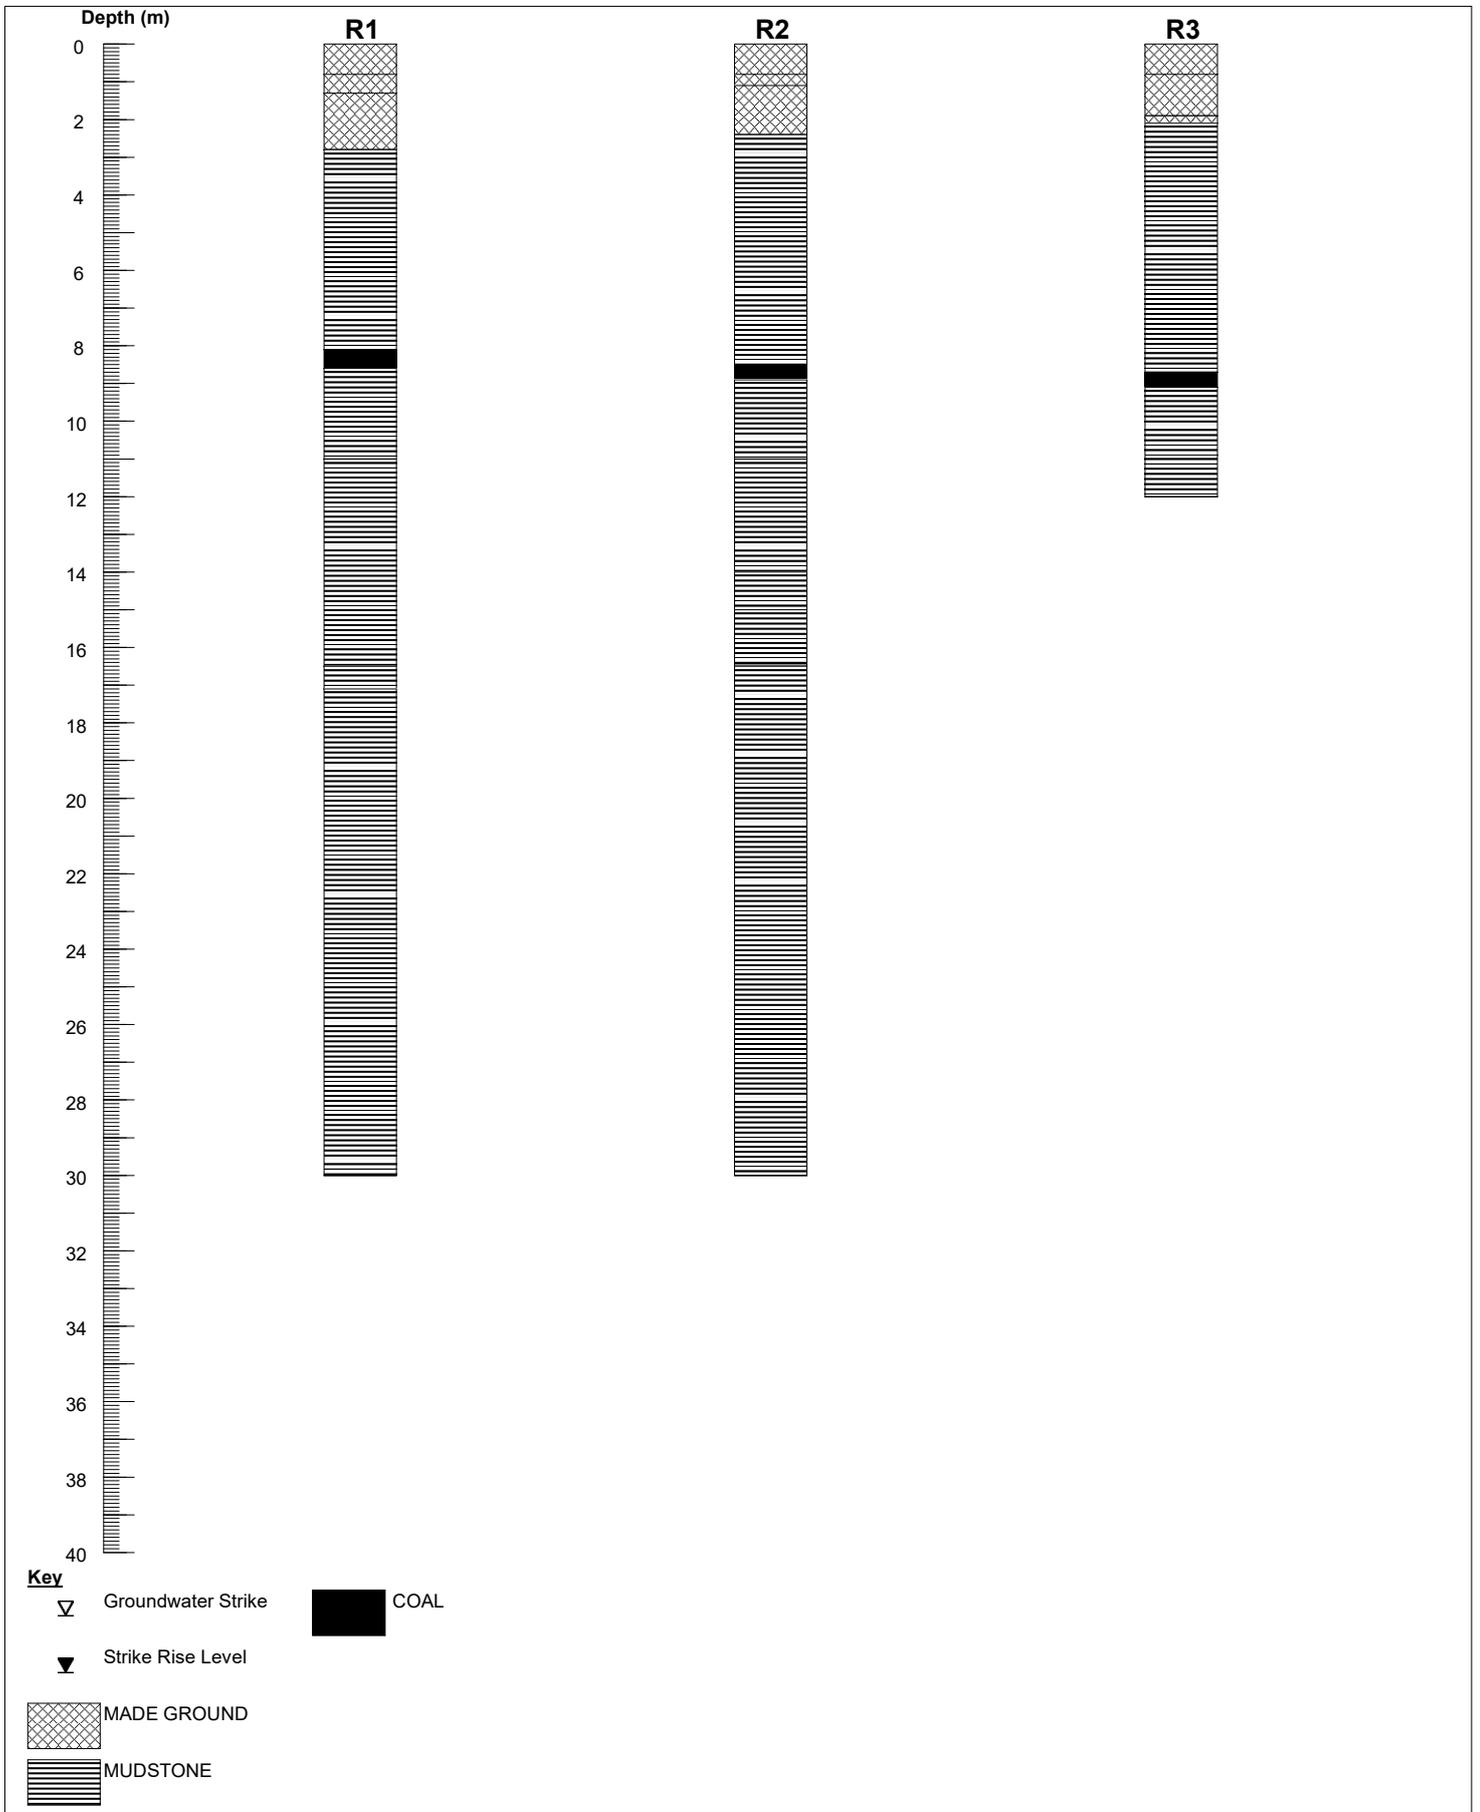
Depth (m)	TCR (%)	SCR (%)	RQD (%)	FI	Field Records	Level (mOD)	Depth (m) (Thickness)	Description	Legend	Water
							(0.80)	MADE GROUND: compact dark brown soil with orange sandstone rubble and brick earth, some large sandstone blocks.		
							0.80			
							(1.10)	MADE GROUND: dense orange brown sandstone lumps (possible cellar).		
							1.90			
							2.10	MADE GROUND: very dense orange brown sandstone/siltstone.		
								Soft greyish brown mudstone/clay over strong mudstone.		
							(6.60)			
							8.70			
							(0.40)	Strong black brown (dirty) coal.		
							9.10	Strong dark grey mudstone.		
							(1.80)			
							10.90	Strong grey to light grey mudstone.		
							(1.10)			
							12.00	Complete at 12.00m		
					30/09/2022: DRY

Remarks Description based upon foreman drillers records of water flush returns. Foreman driller recorded no voids, broken ground or loss of flush returns. On completion backfilled with arisings and grout.	Scale (approx)	Logged By
	1:100	LMB/VW
	Figure No. NE4118A.R3

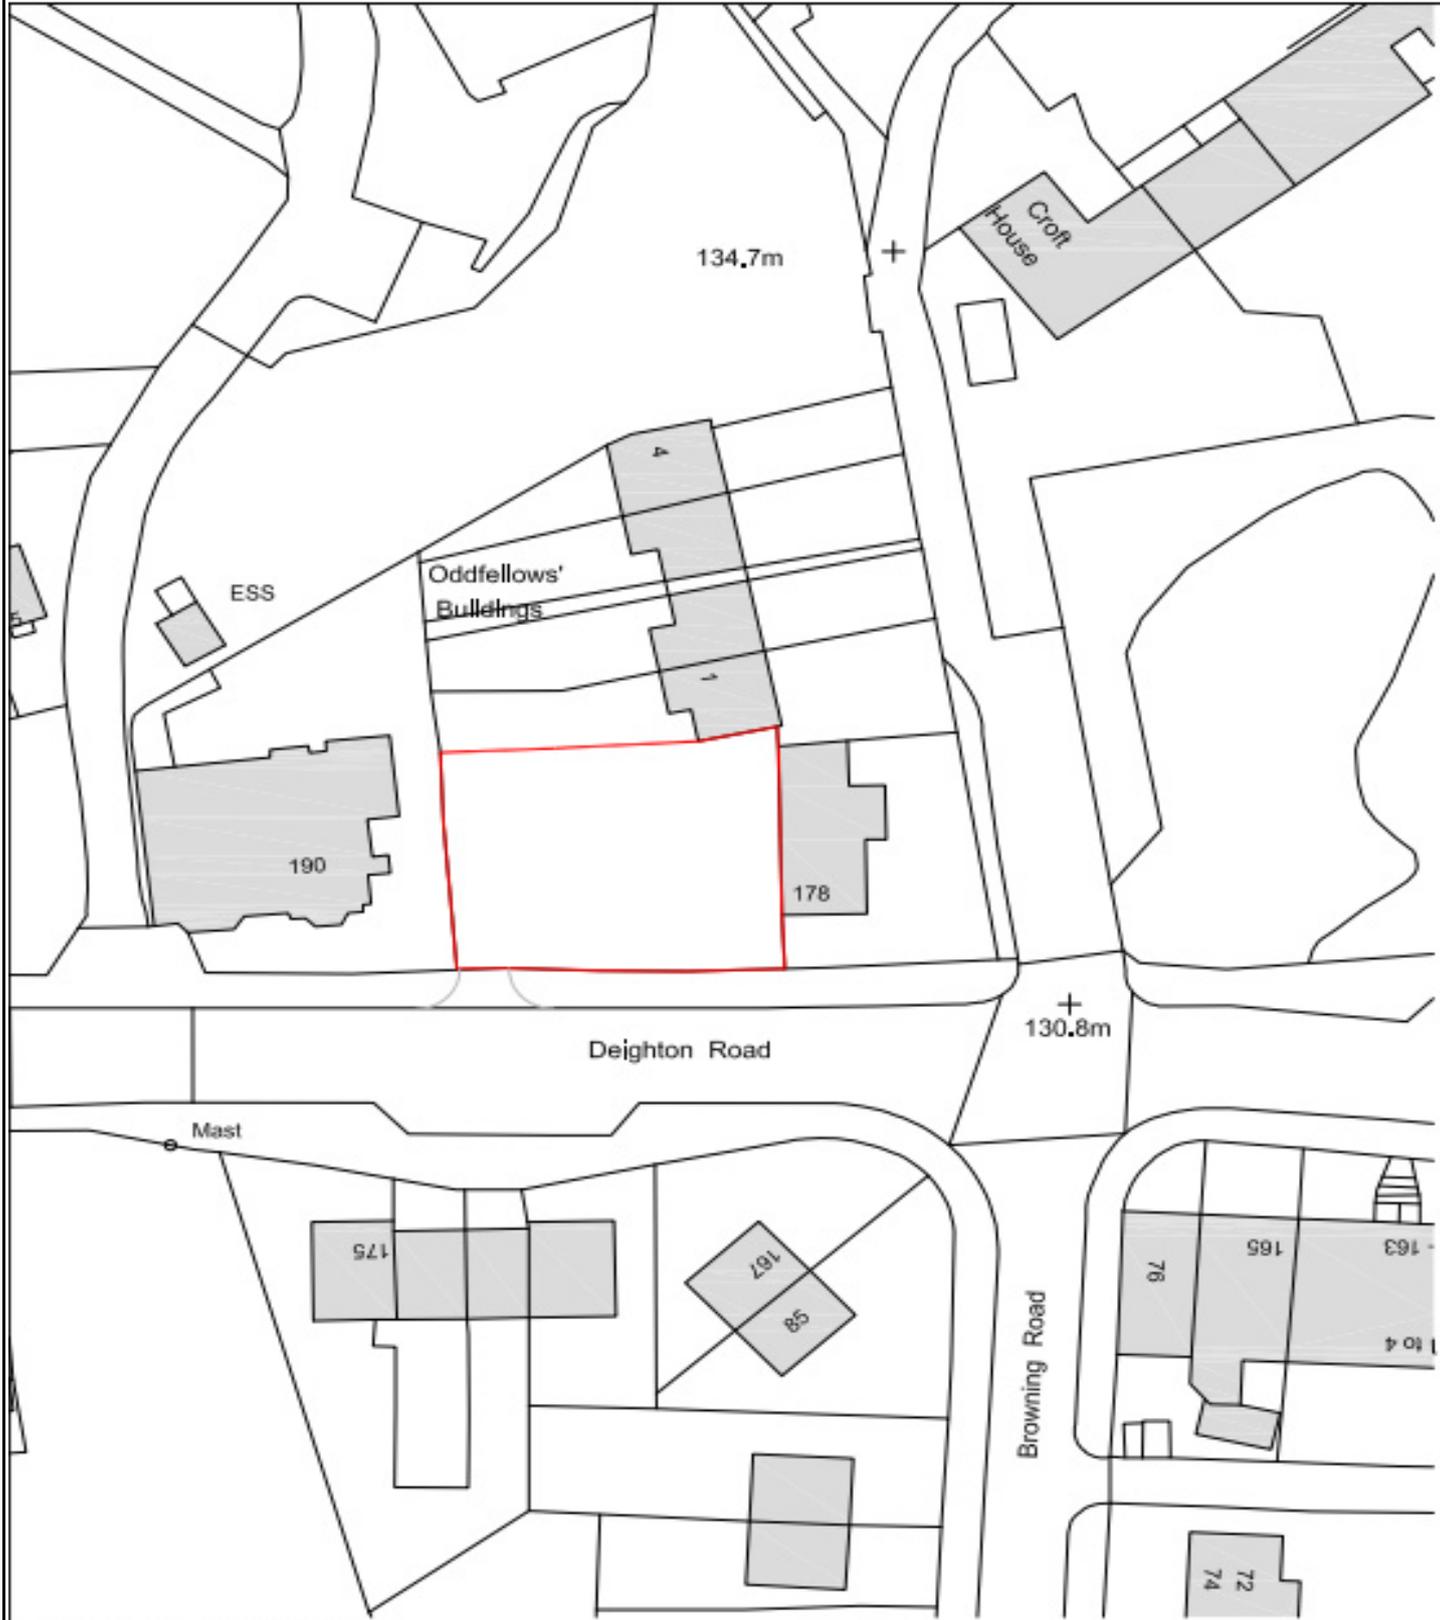
Location Plan (1:500 @ A3)

As shown on Figure 2, the about 0.04 hectare roughly rectangular shaped site is bounded to the east by No. 178 Deighton Road, to the north by the grounds of No. 1 Oddfellows Buildings, to the west by No. 190 Deighton Road, and to the south by Deighton Road. The site is currently partially concrete, partially hardcore surfaced, with areas which are overgrown, generally used for storage of building material waste, and slopes gently down to the south.

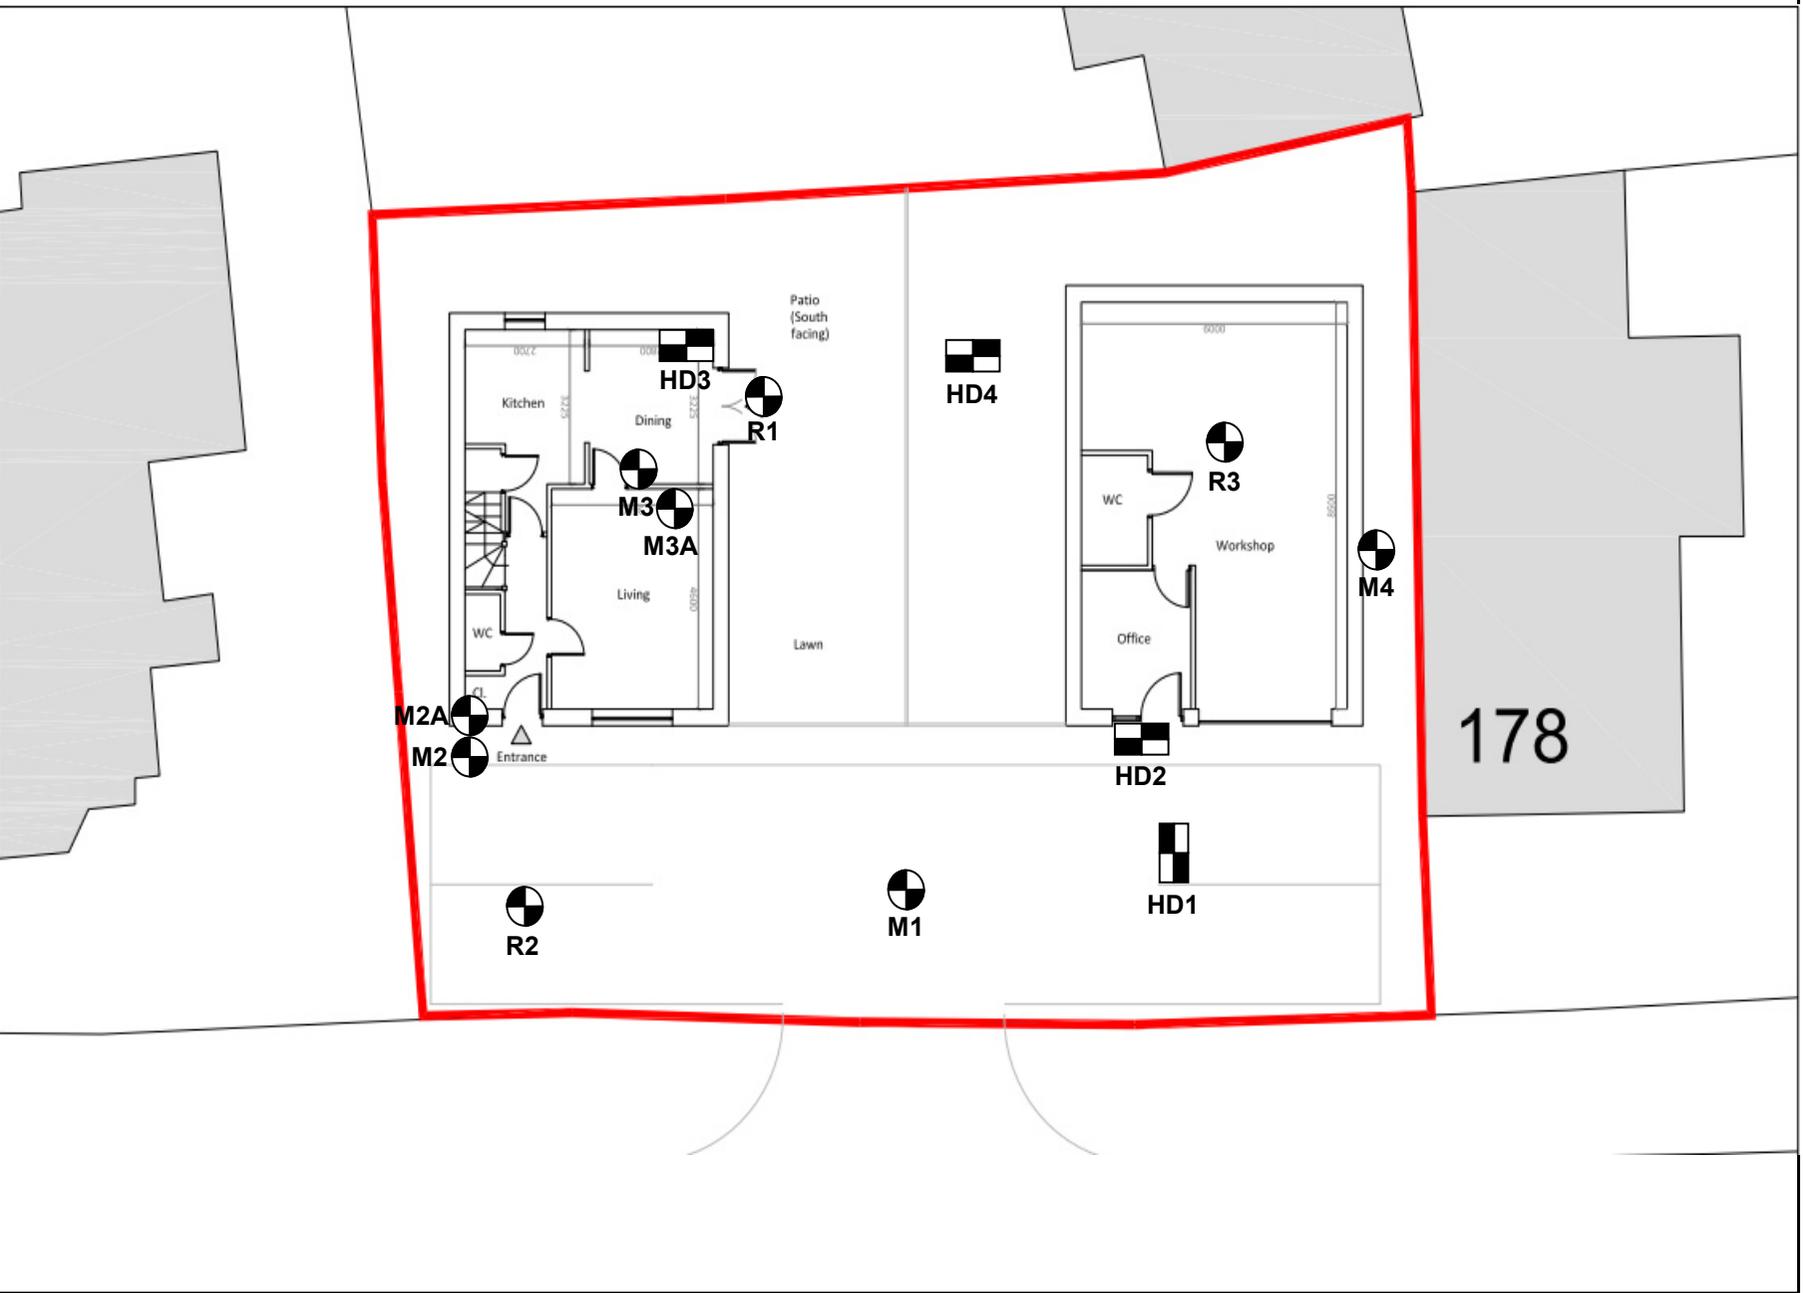
Site	188 DEIGHTON ROAD, HUDDERSFIELD, WEST YORKSHIRE, HD2 1JJ			
Client	JAMIE TULLY			
Date Drawn	19-Oct-22	Date Checked		Job No.
Drawn By	LMB	Checked By		NE4118A
Scale	—	Orientation		Figure No.
				3

Proposed Development Plan

We understand that it is proposed to construct a residential property and a detached workshop. However, at the time of writing this report no specific details regarding the building layout, proposed foundations and design loadings were available and consequently the recommendations given are in general terms only.
