**ARBORICULTURAL REPORT
AND
ARBORICULTURAL IMPACT ASSESSMENT
to BS5837:2012
at
Oakenshaw Cross
Cross Street
Oakenshaw
West Yorkshire
BD12 7EA**

Client:
Kirklees Council

JCA Ref:
23498/ChC

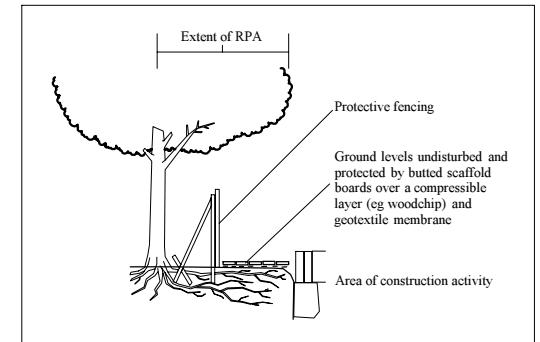
An example of a walkway within the RPA

4.4.3.1 The proposed development entails the construction of an access path within the RPA of **T1**. In order to prevent foreseeable damage to tree roots, a 'reduced-dig' method of construction will be implemented.

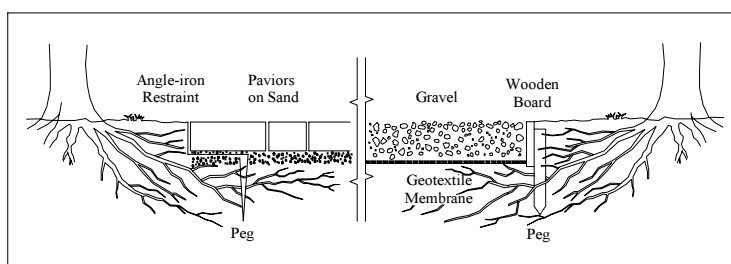
Examples of the 'minimum dig' construction

4.4.3.2 First, the top layer of existing turf will be removed using hand tools only. This stripping away of the top surface should not exceed 75mm or go into the soil where the roots from **T1** will be present. This must not proceed until the tree protective measures are in place and this operation should be supervised by an appointed Arboriculturist

4.4.3.3 Following this, a thin geotextile membrane will be placed on the soil and pegged/pinned into position. A 3D cellular confinement system will be installed over the geotextile membrane and filled with no-fines, washed angular stone, no less than 4mm in diameter and to a minimum depth of 100mm. This may then be compacted using a plate compactor (wacker-plate).
