## TECHNICAL NOTE: PRELIMINARY BAT ROOST ASSESSMENT & ECOLOGY WALKOVER

| PROJECT ADDRESS | Lower Carr Farm, Carr Lane, Shepley, Huddersfield, HD8 8BR |
| PROPOSED PLANS | Demolition of attached outbuildings and erection of two-storey extension to create dwelling forming annex accommodation associated with Lower Carr Farm, Carr Lane, Shepley, Huddersfield, HD8 8BR |
| ISSUE DATE | 24 February 2026 |

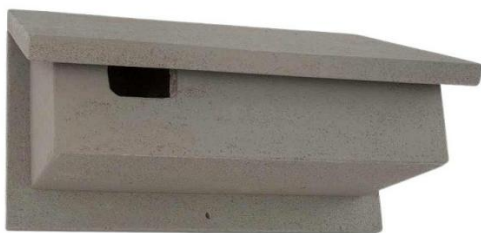
| COMMON SWIFT BOXES | |
|---|---|
| <b>Model</b> | <p>2no. Woodstone® Swift façade nest box</p> <div> <p>Available from <a href="https://www.nhbs.com">https://www.nhbs.com</a></p> <p>These external Woodstone® Swift boxes are an ideal alternative nesting location for swifts that can be mounted on the external surface of a building. It has a sloping roof to help deflect rain and options for either a bottom or front entrance which allow you to tailor the type of box to the scenario in which it is being installed.</p> </div> |

The development does present an opportunity to provide ecological enhancements for bats and birds via the fixing of boxes on the new build. Two common swift boxes are recommended along with one bat box as outlined in the tables below.

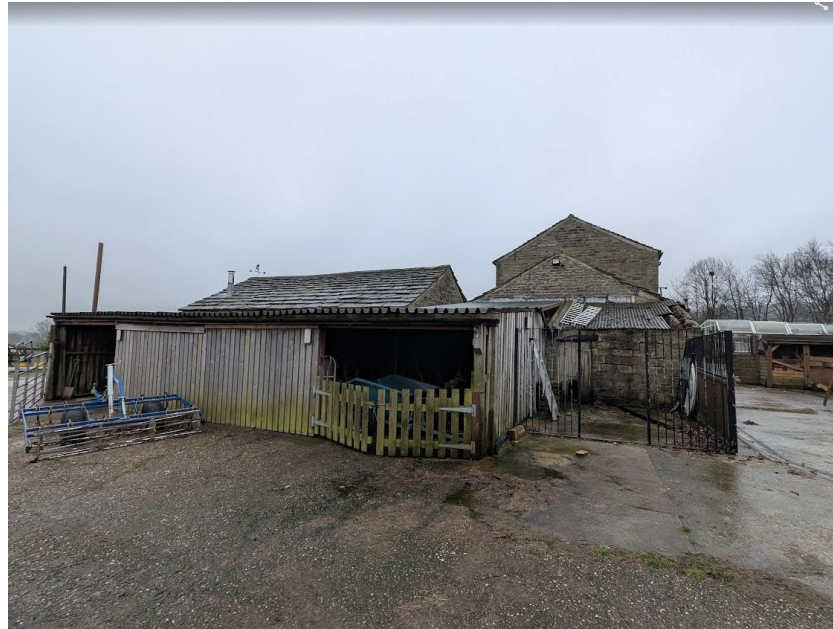
**Photo 1.**

North aspect.

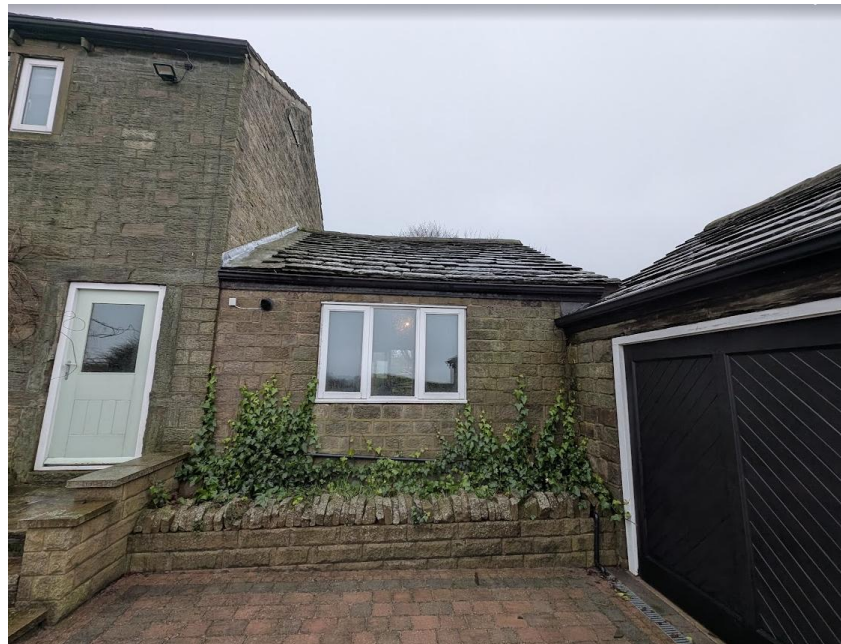
**Photo 2.**

East aspect with adjacent garage.

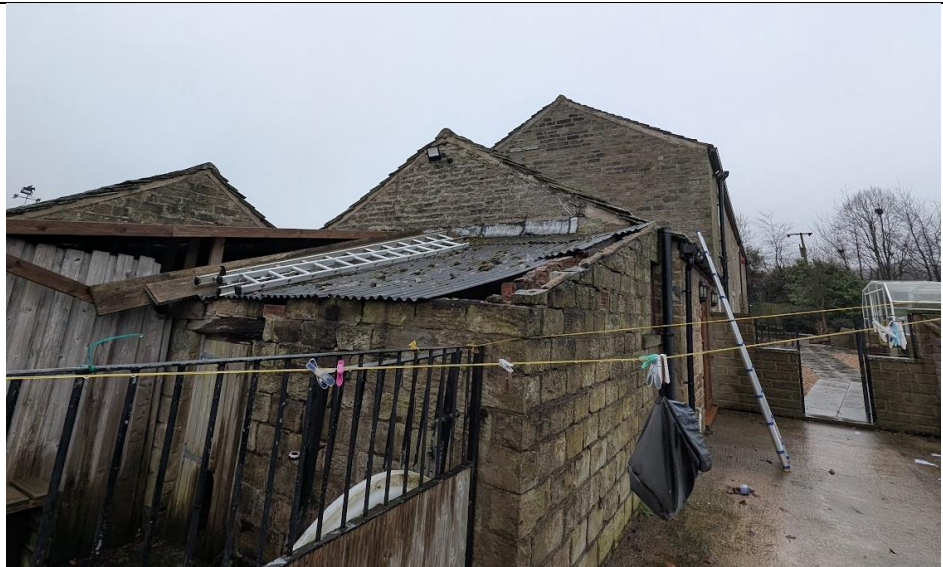
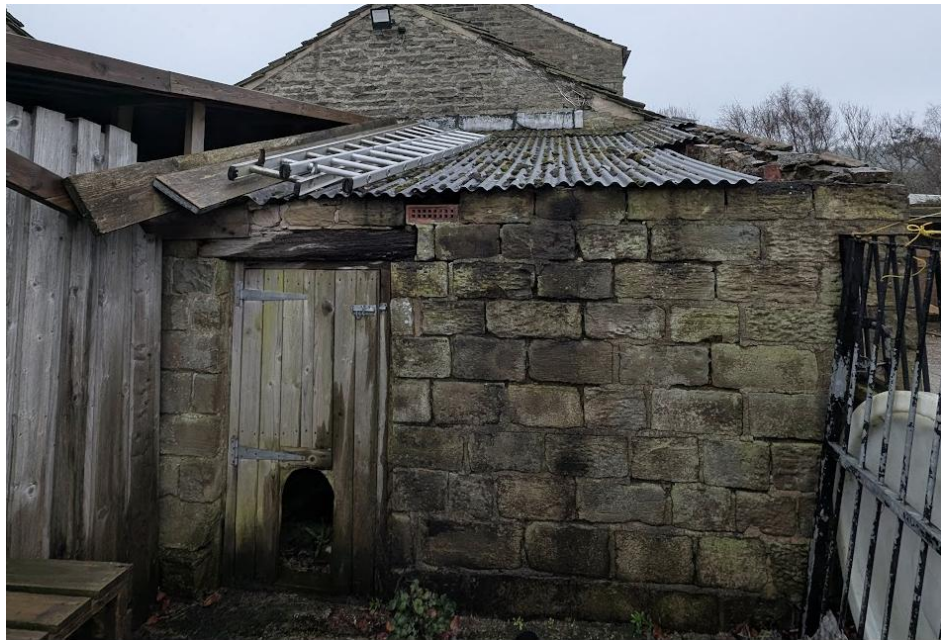
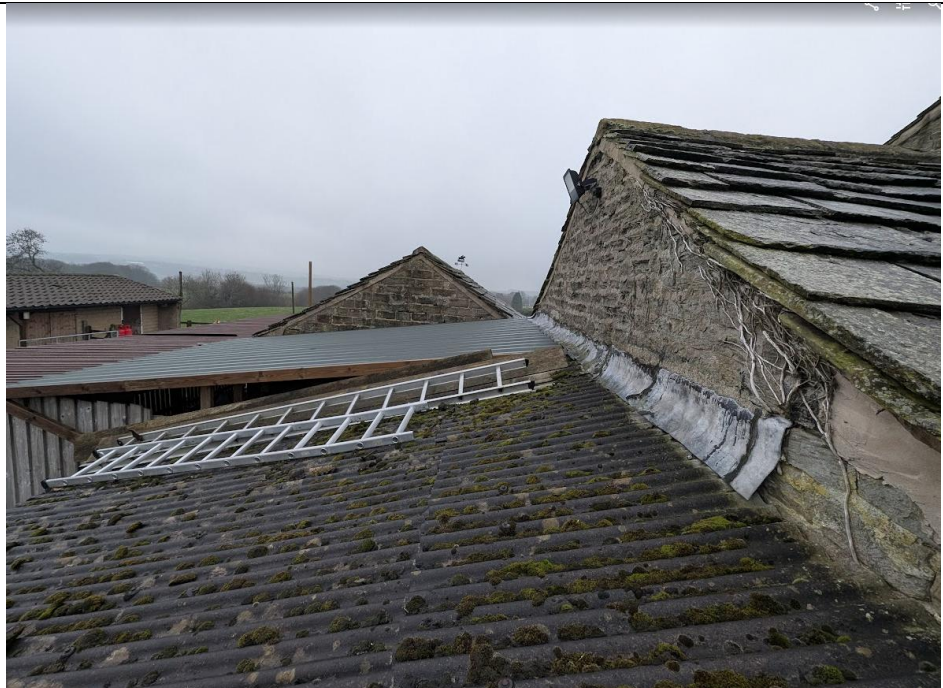
**Photos 3a & 3c.**

The stone-built lean-to, formerly used as a dog kennel, is located on the north side of the extension. It was in poor condition, with much of the roof missing. The remaining roof comprised corrugated sheets. The stonework itself was in good repair. No potential roost features were observed.

North-west elevations of extension with dog kennel and view of roofs.

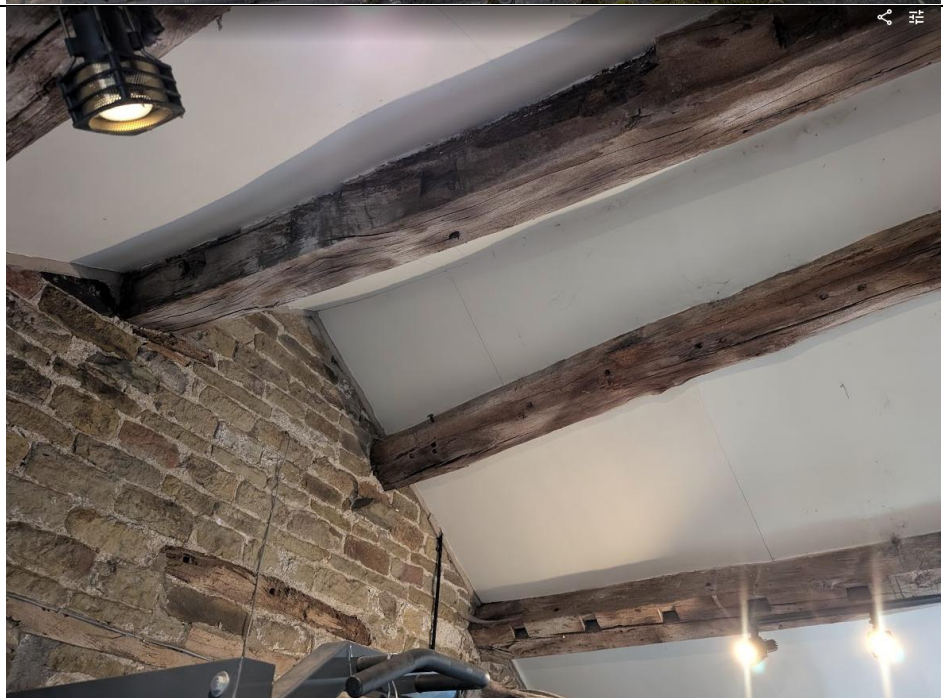
**Photo 4.**

The stonework of the single-storey extension was in good repair, with no recessed cavities within the mortar lines. The fascia boards on the west and east elevations were tightly sealed to the walls. The extension has a shallow pitched roof comprising traditional stone slates. As is typical for such roof types in the region, multiple gaps were present between the slates due to misshapen and slightly lifted slates. The extension contains a vaulted ceiling and therefore no roof void is present.

Internal view of extension.

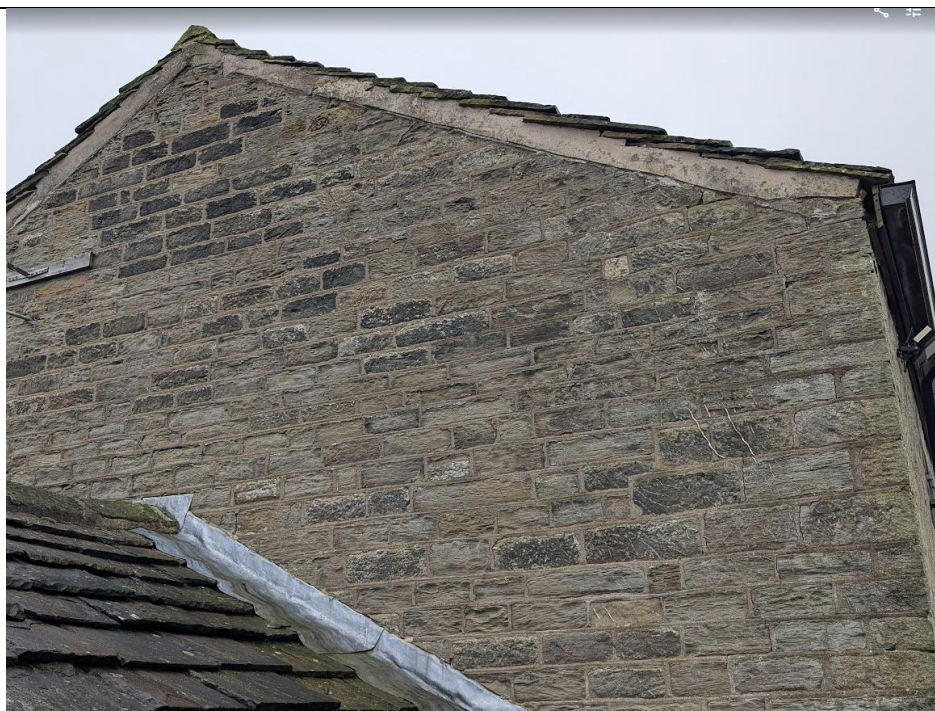
**Photo 5.**

It was also confirmed that no potential roost features were present on the north gable of the farmhouse (the area of the proposed extension). The verge mortar pointing was solid, and the roof slates appeared to be well-set along the verge.

Gable of main house.

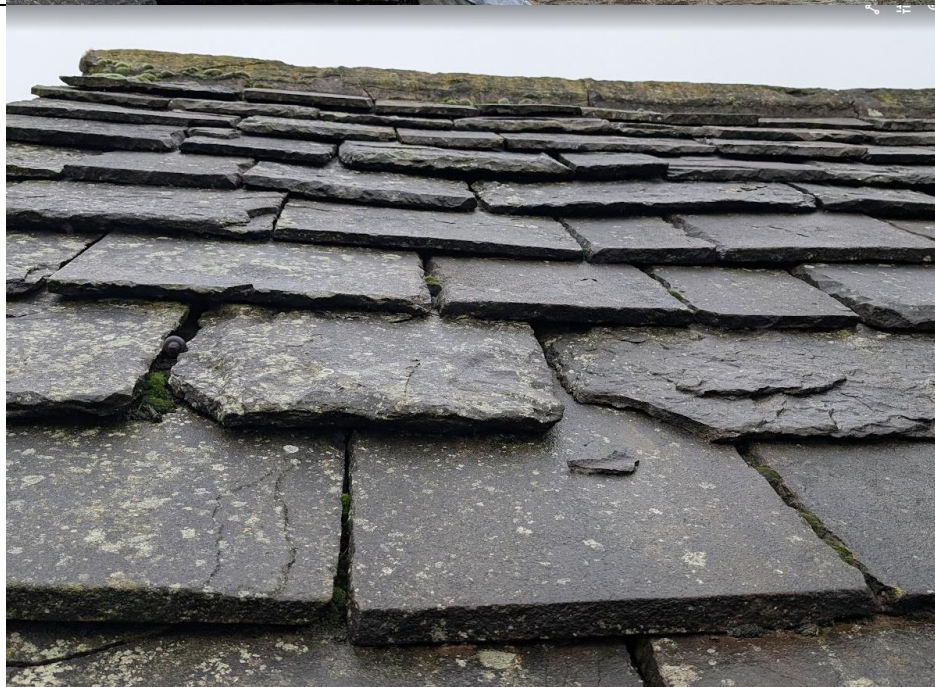
**Photo 6.**

No bats or evidence of bats were recorded. In consideration of the presence of multiple gaps in the (shallow pitched) roof, the property was considered to have a **low roost suitability**.

Example of gaps in roof of extension.

- The stone roof slates are to be carefully removed by hand and fully checked for bats and evidence of bats before being stacked. The ecologist is to monitor this roof removal until a satisfactory conclusion can be reached that all residual risk has been mitigated.
