# GEO-ENVIRONMENTAL REPORT

job number	C5334/25/E/8207	date	28.11.2025
------------	-----------------	------	------------

site address	Hinchliffe Mill
	Water Street
	Holmbridge
	HD9 2NY

# Report on a Phase 2 Geo-environmental Investigation

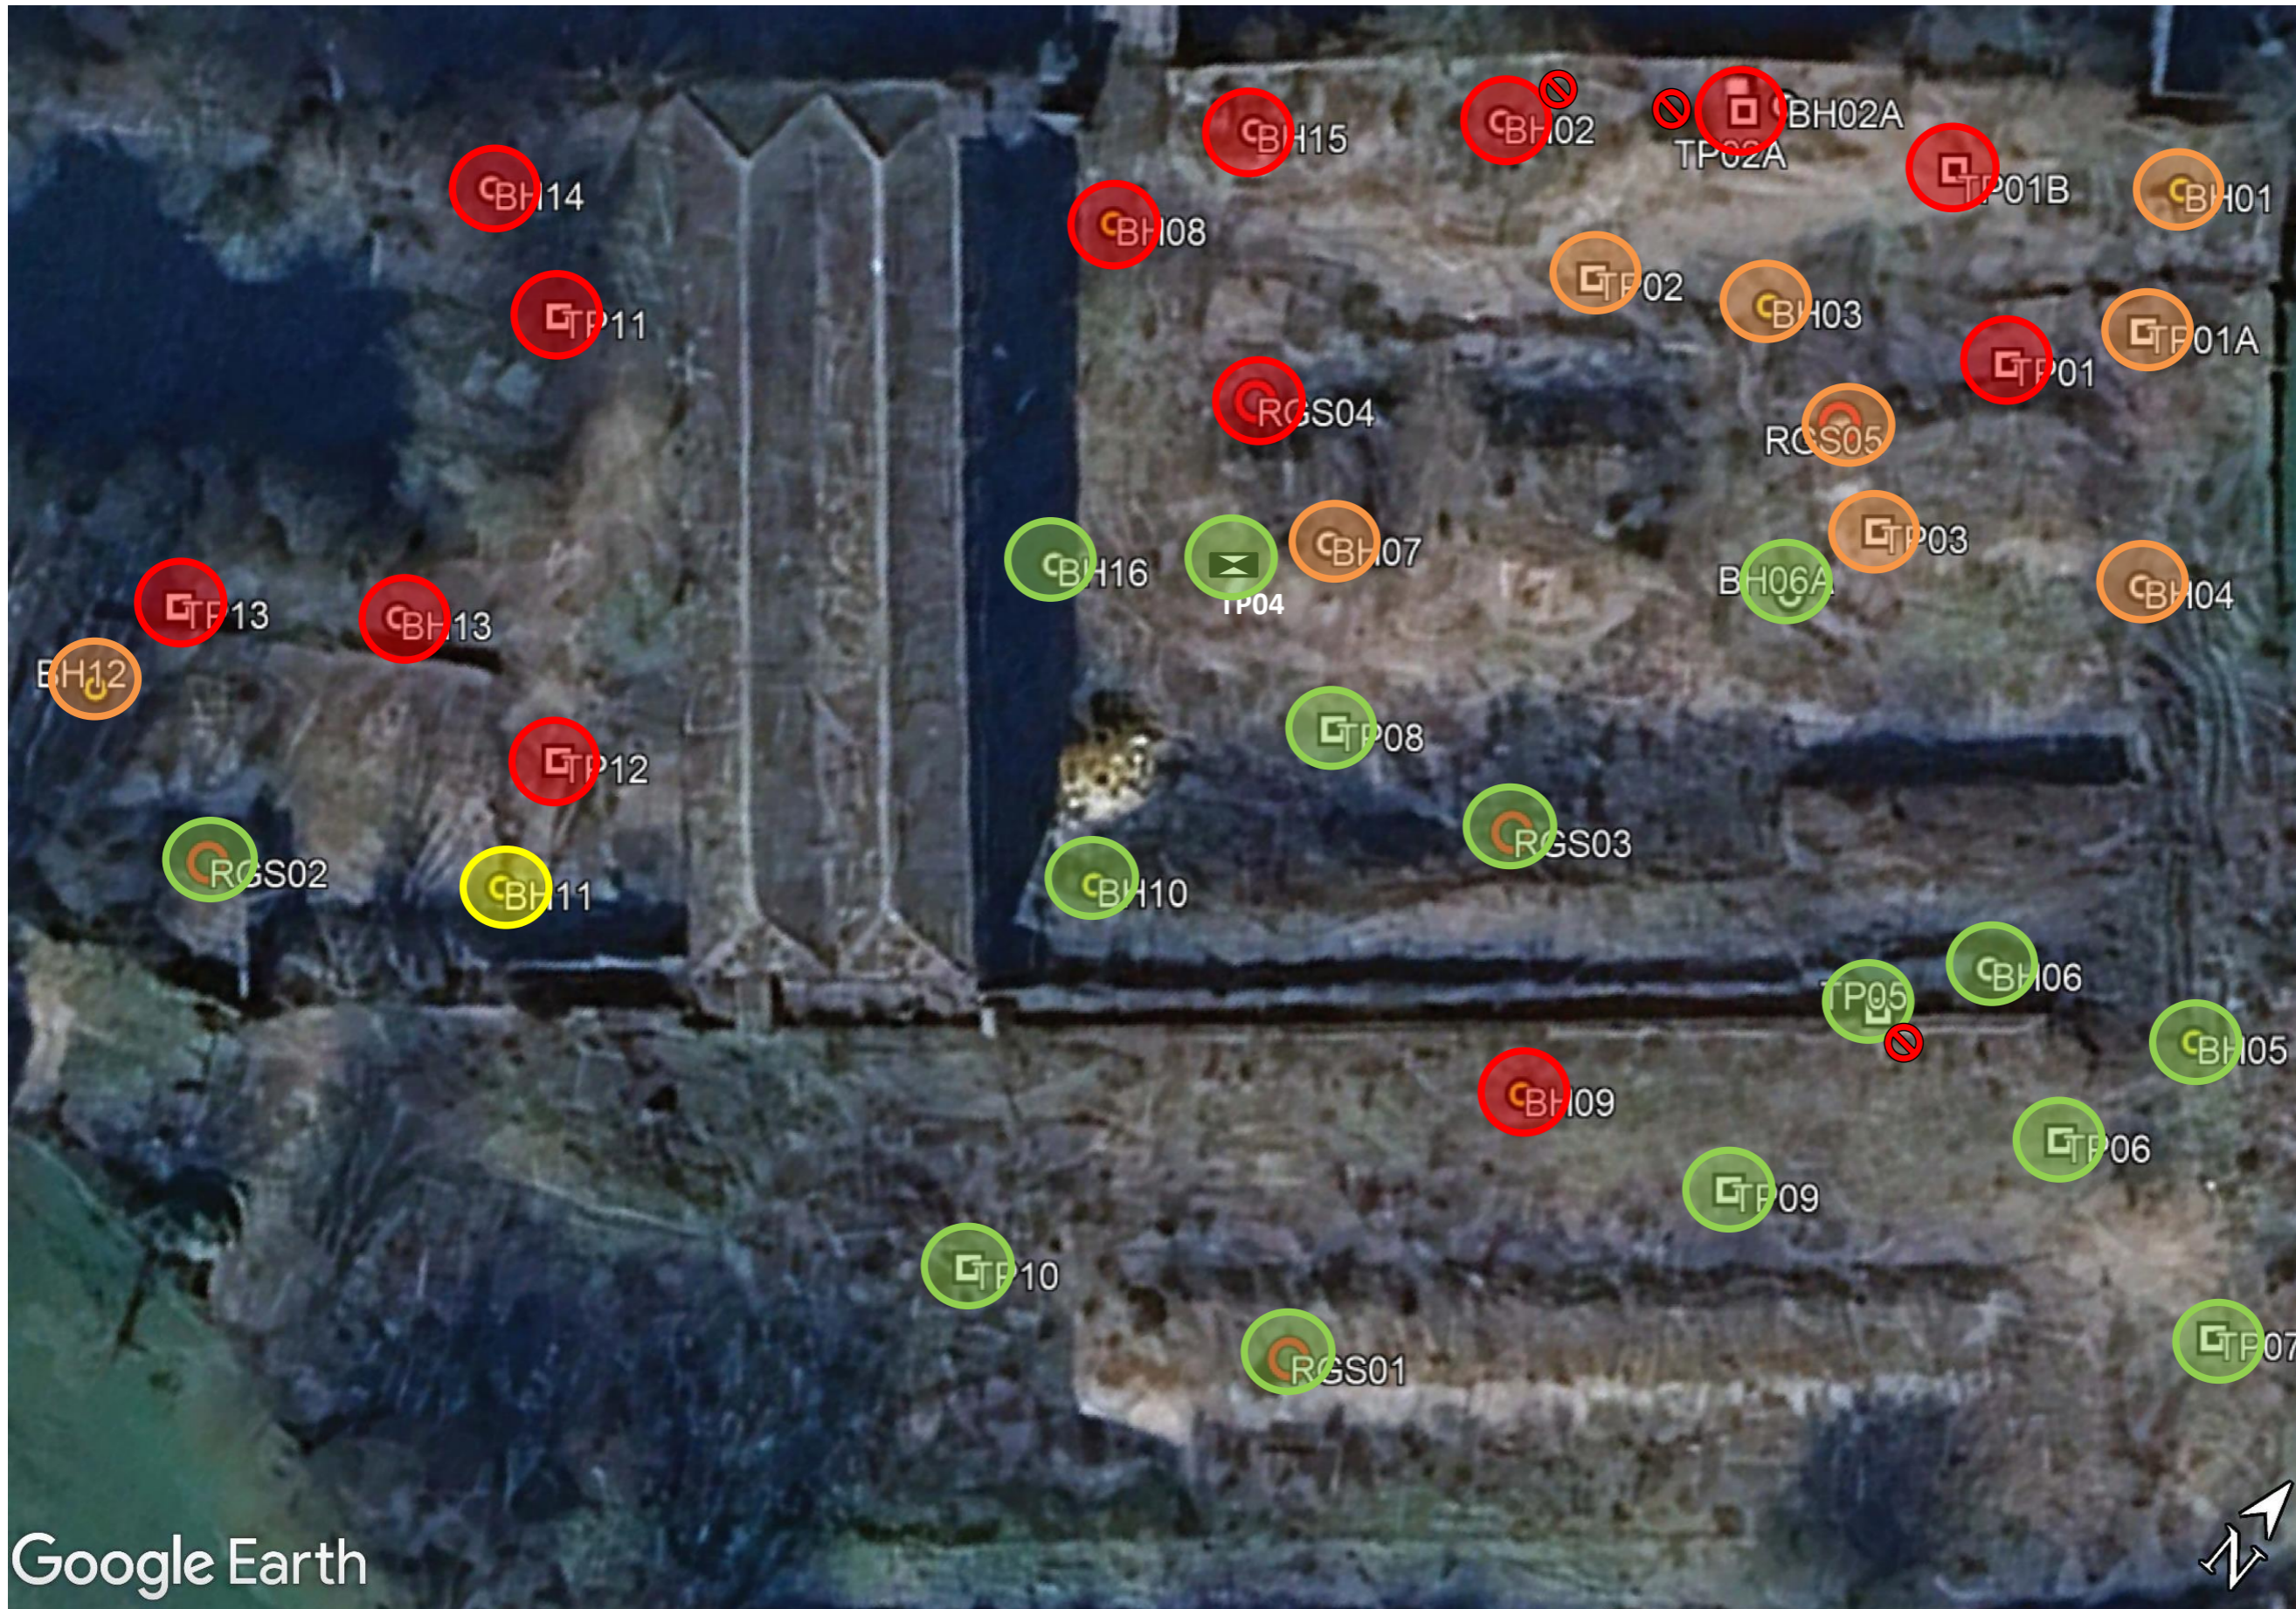
Foundation Summary: RGS vs ARC Investigatory Locations

Shallow Foundations Viable
-

Piled Foundations Required
-

Buried obstruction, foundation or wall identified

A site plan with a colour scheme associated with foundation depths is presented in Appendix 1. The following table presents a summary of anticipated foundation depths on a plot by plot basis:

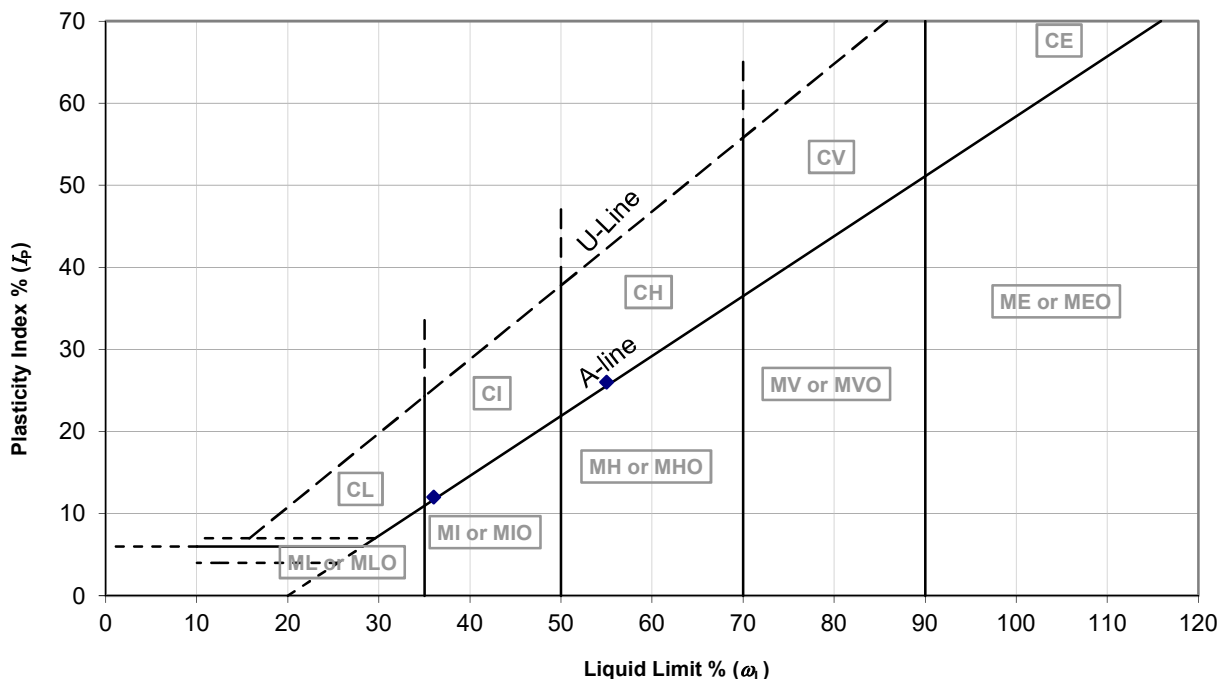
Interpretation graph based on BS EN ISO 14688-2:2018 any interpretations are expressed outside of our UKAS Accreditation.

It should be appreciated that the cohesive soils revealed at this site possess a medium volume change potential under the guidance of the NHBC standards. Therefore, it will be necessary to ensure that the depths of the foundations are designed in accordance with the Chapter 4.2 of the NHBC standards<sup>5</sup>. The methodology provided in the guidance will require the identification of any trees, still present at, or recently removed from, the site and the distance from the proposed foundations. This may result in foundation depths greater than those given above and the requirement for heave protection to be employed against footings and below the underside of the floors and beams.
