**ARBORICULTURAL IMPACT ASSESSMENT
to BS 5837:2012
at
Reliance Precision
Peniston Road
Fenay Bridge
Huddersfield
West Yorkshire
HD8 0LE**

Client:
Reliance Precision Ltd

JCA Ref:
21398-C/AJB

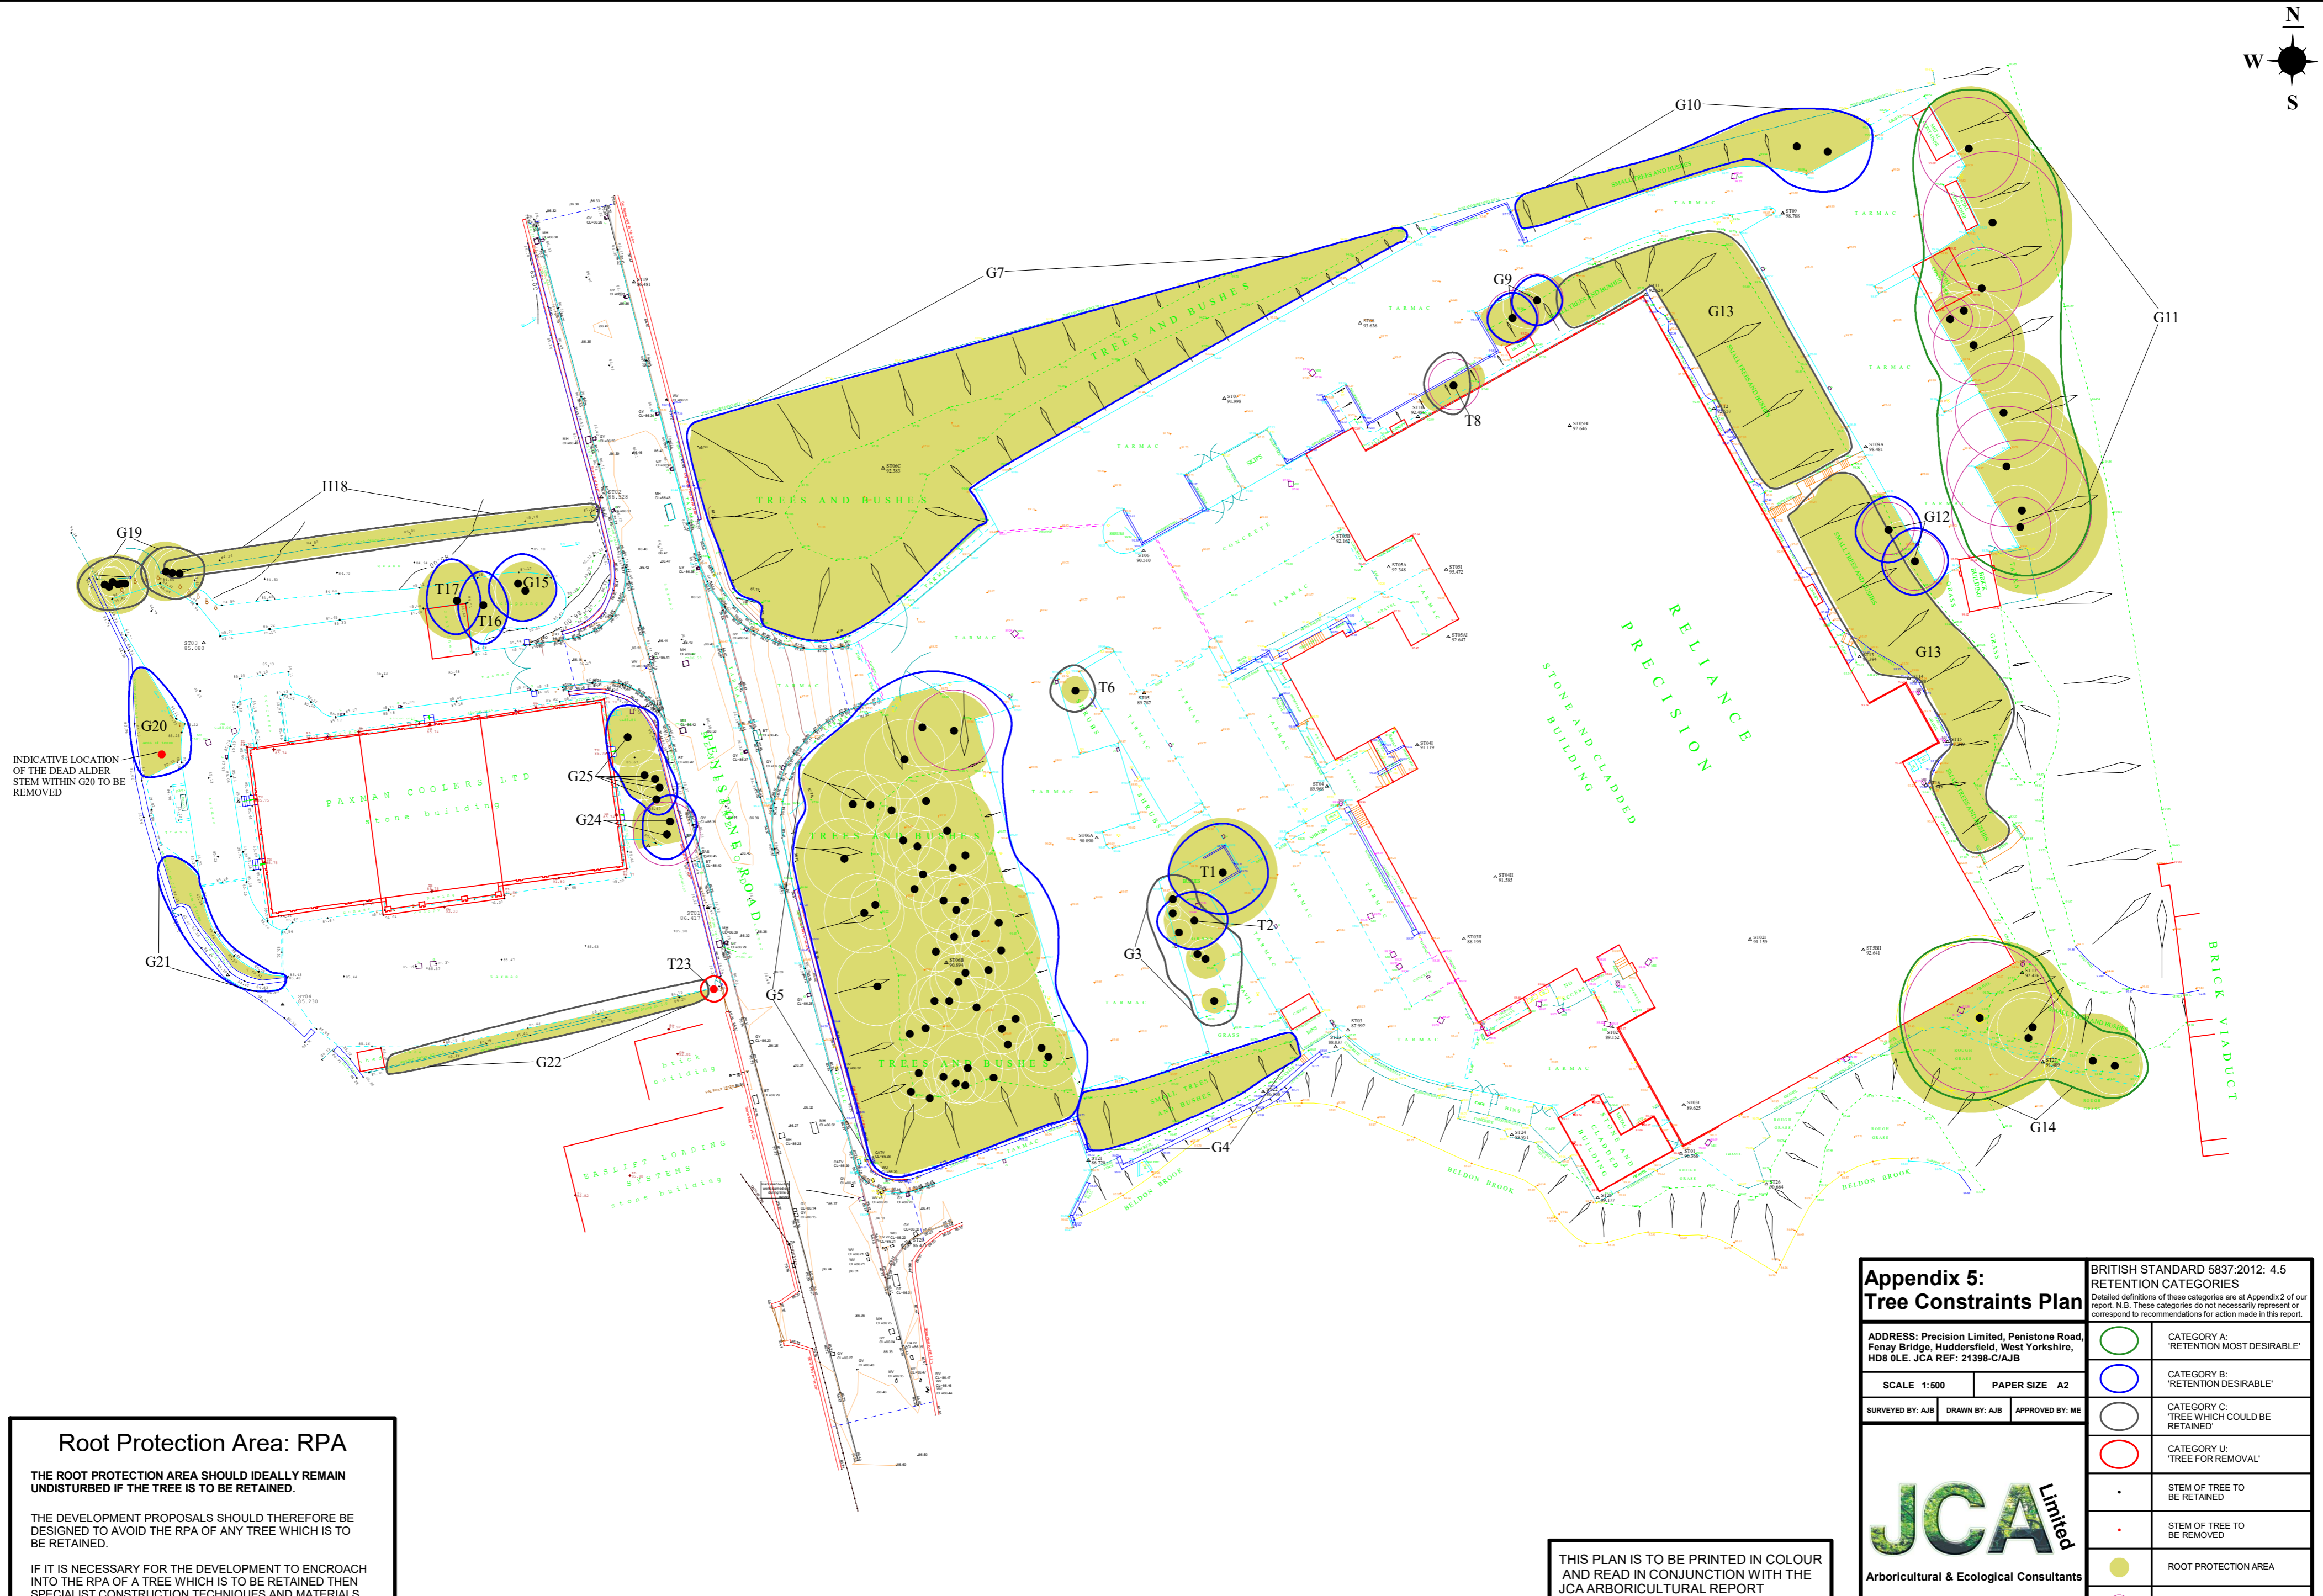
INDICATIVE LOCATION OF THE DEAD ALDER STEM WITHIN G20 TO BE REMOVED

Root Protection Area: RPA

THE ROOT PROTECTION AREA SHOULD IDEALLY REMAIN UNDISTURBED IF THE TREE IS TO BE RETAINED.

THE DEVELOPMENT PROPOSALS SHOULD THEREFORE BE DESIGNED TO AVOID THE RPA OF ANY TREE WHICH IS TO BE RETAINED.

IF IT IS NECESSARY FOR THE DEVELOPMENT TO ENCRANCH INTO THE RPA OF A TREE WHICH IS TO BE RETAINED THEN SPECIALIST CONSTRUCTION TECHNIQUES AND MATERIALS MUST BE CONSIDERED.

- 2.1 The tree information recorded during the original survey is detailed in the tables at **Appendix 1**. A full explanation of the tables can be found at **Appendix 2**. Please refer also to the Tree Constraints Plan at **Appendix 5** for tree locations.

- 4.7 The protection of retained trees can be achieved by the creation of a Construction Exclusion Zone based on the Root Protection Area of a tree. The Root Protection Area of each tree or group is marked on the Tree Constraints Plan at **Appendix 5**.

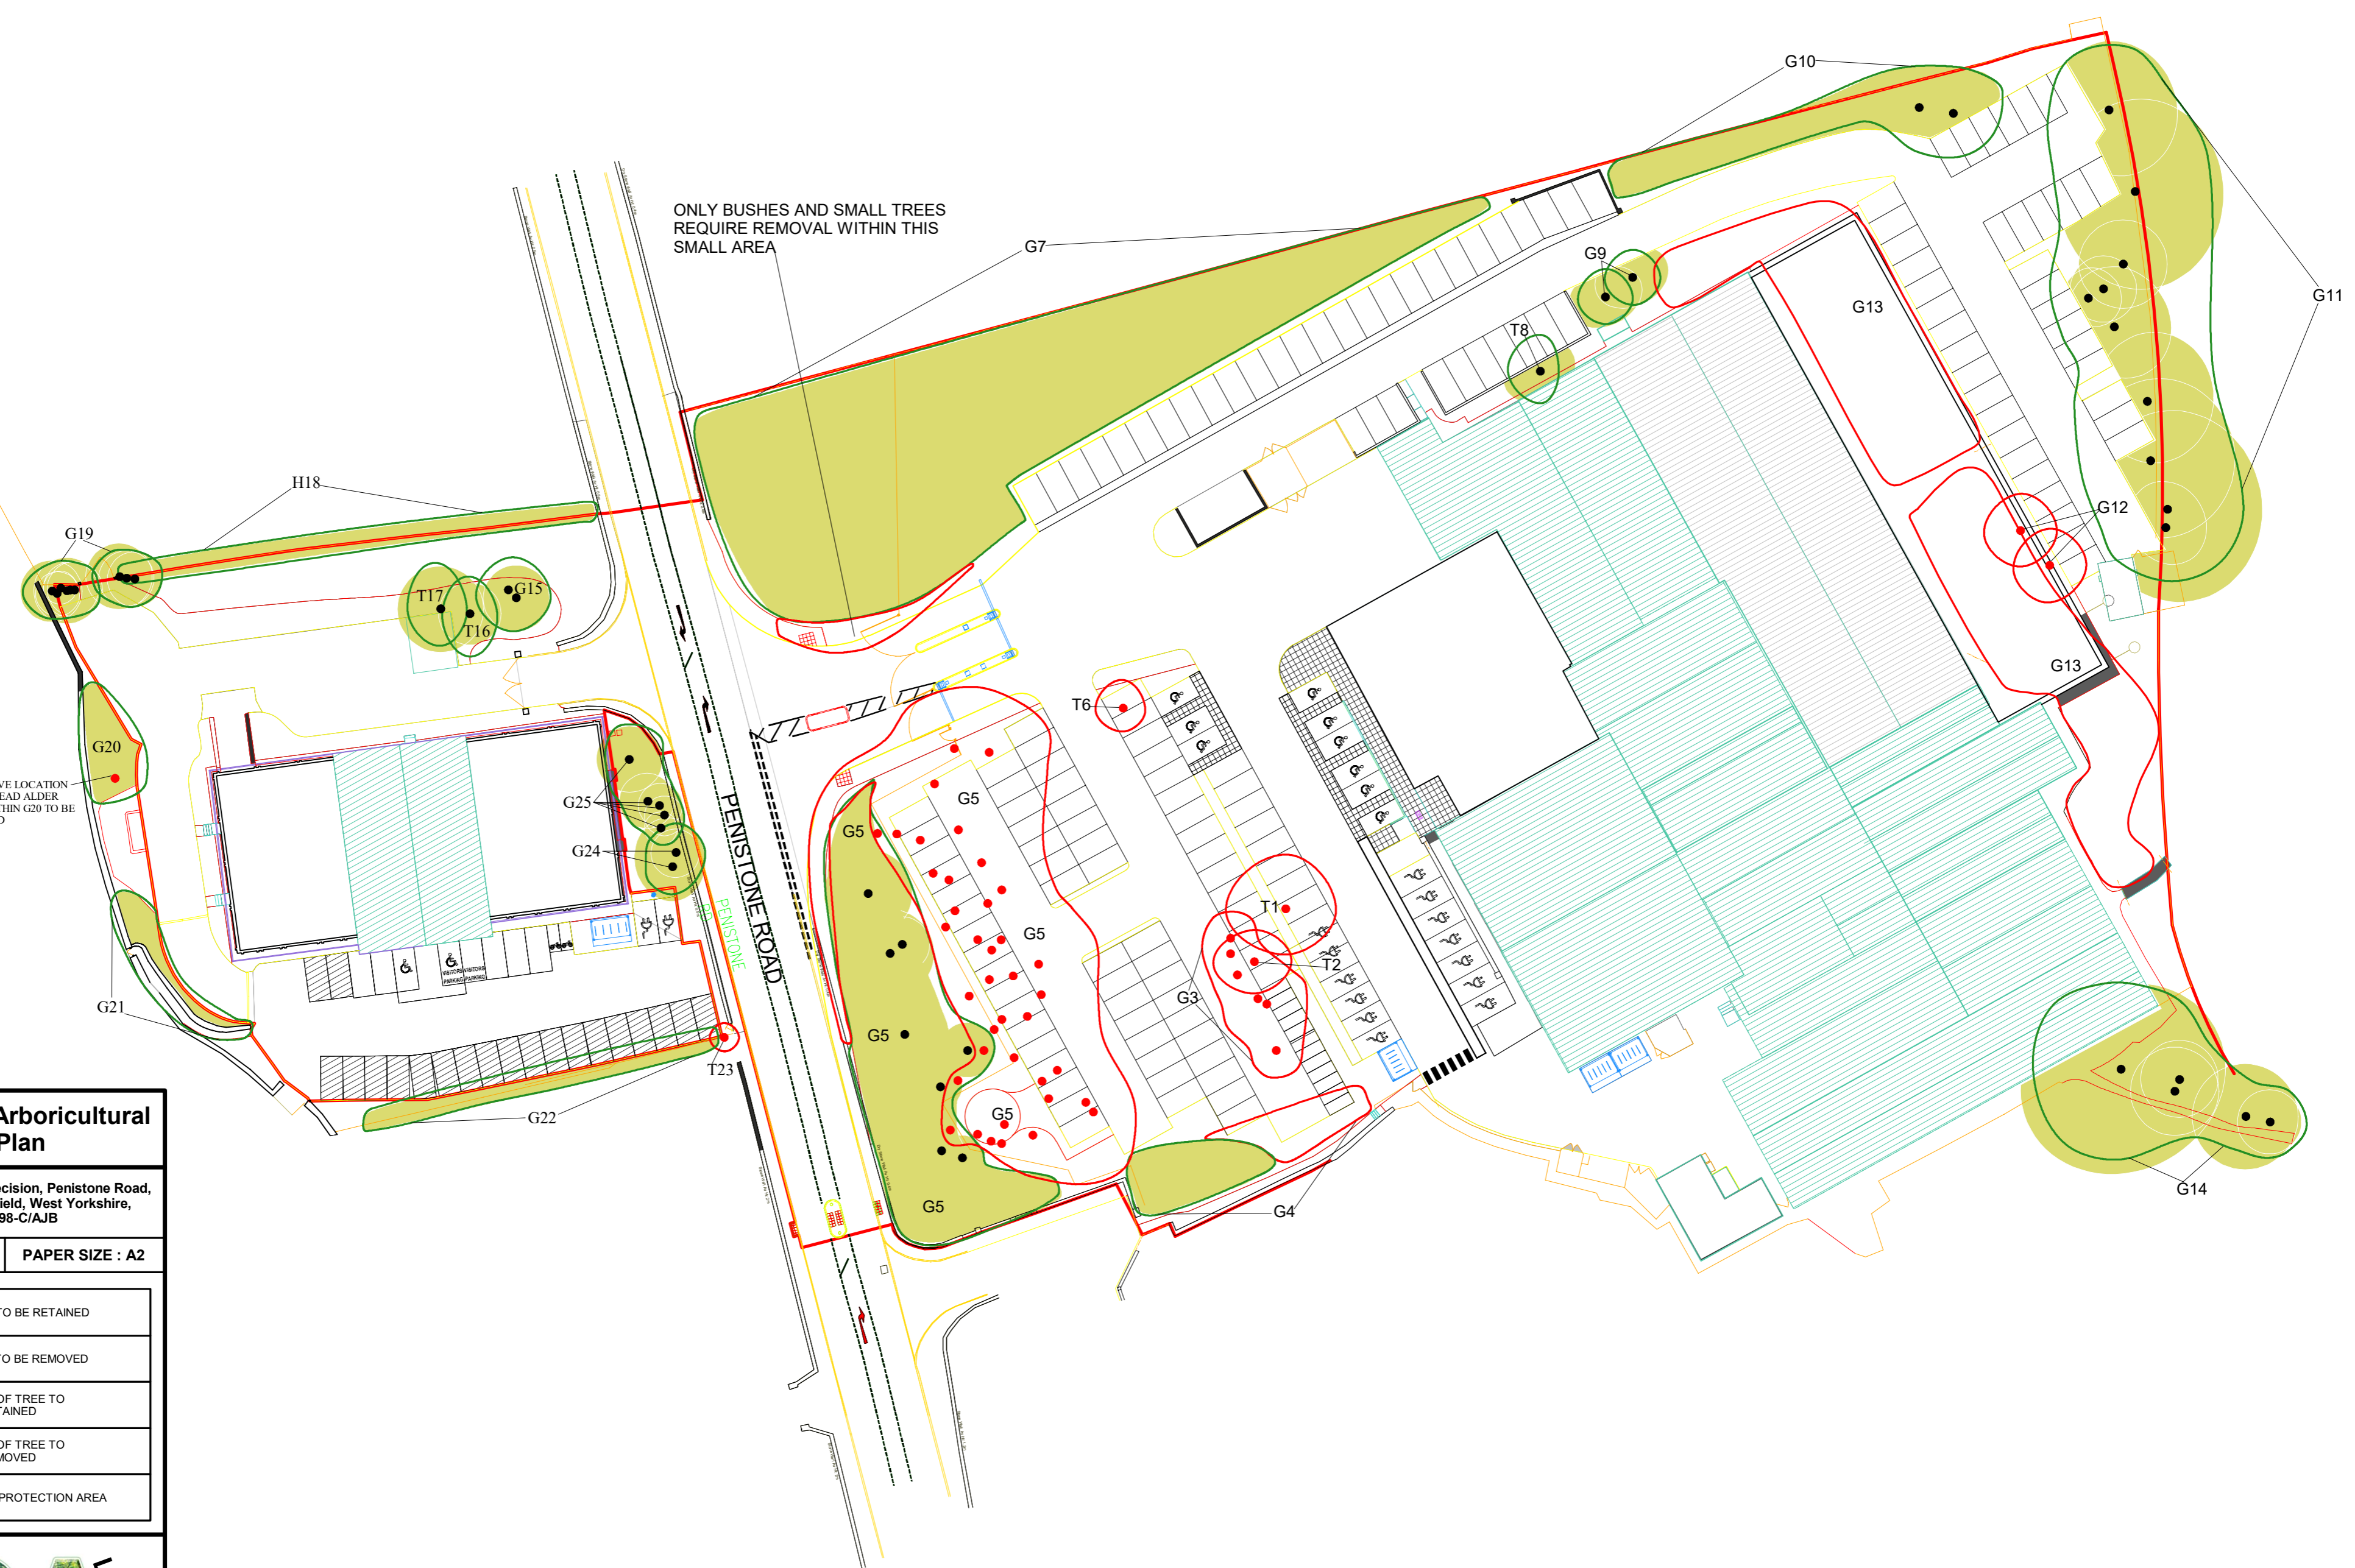
Appendix 6: Arboricultural Implications Plan

ONLY BUSHES AND SMALL TREES
REQUIRE REMOVAL WITHIN THIS
SMALL AREA

INDICATIVE LOCATION
OF THE DEAD ALDER
STEM WITHIN G20 TO BE
REMOVED

TREE TO BE RETAINED
	TREE TO BE REMOVED
	STEM OF TREE TO BE RETAINED
	STEM OF TREE TO BE REMOVED
	ROOT PROTECTION AREA

- 3.2.1 In order to facilitate the proposed development, it will be necessary to remove **T1**, **T2**, **G3**, a section of **G4** (as shown in red on the plan at **Appendix 6**), a section of **G5** (as shown in red on the plan at **Appendix 6**), **T6**, a small section of **G7** (as shown in red on the plan at **Appendix 6**), **G12** and **G13**.
- 3.2.2 The removal of trees for development can often be mitigated (either partially or entirely) by the planting of suitable specimens within a landscaping scheme. Whilst not always necessary, the planting of trees can improve the aesthetic value of the surrounding area and may be conditioned in the usual manner.

- 4.4 The arboricultural implications of the development have been considered and are discussed in **Section 3**.
- 4.5 **T1, T2, G3**, a section of **G4**, a section of **G5, T6**, a small section of **G7, G12** and **G13** require removal in order to facilitate the proposed development. Tree works required to accommodate the proposals are detailed in **italics** in the tables at **Appendix 1**. Those trees requiring removal are shown in red on the Arboricultural Implications Plan at **Appendix 6**, where the proposals can also be viewed.
