Phase 2 Intrusive Site Investigation Report

LOCATION	Land at Boothroyd Lane, Dewsbury, WF12 2LF
ISSUE DATE	October 2025
FOR	Horizon Healthcare Homes Ltd
CLIENT REF.	
OUR REF.	G25193b

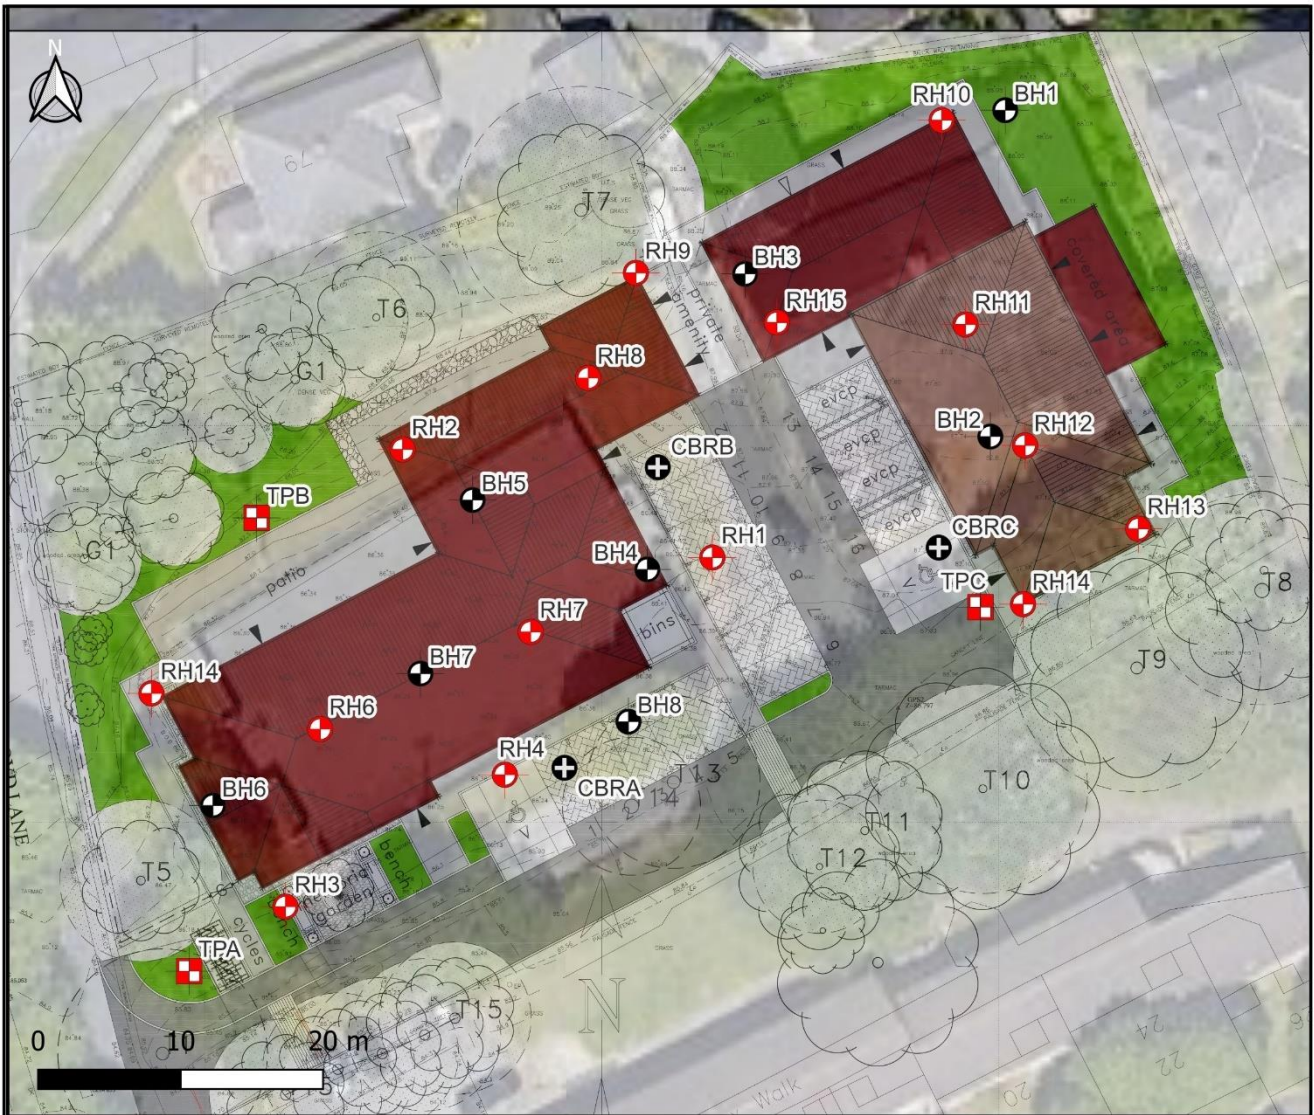
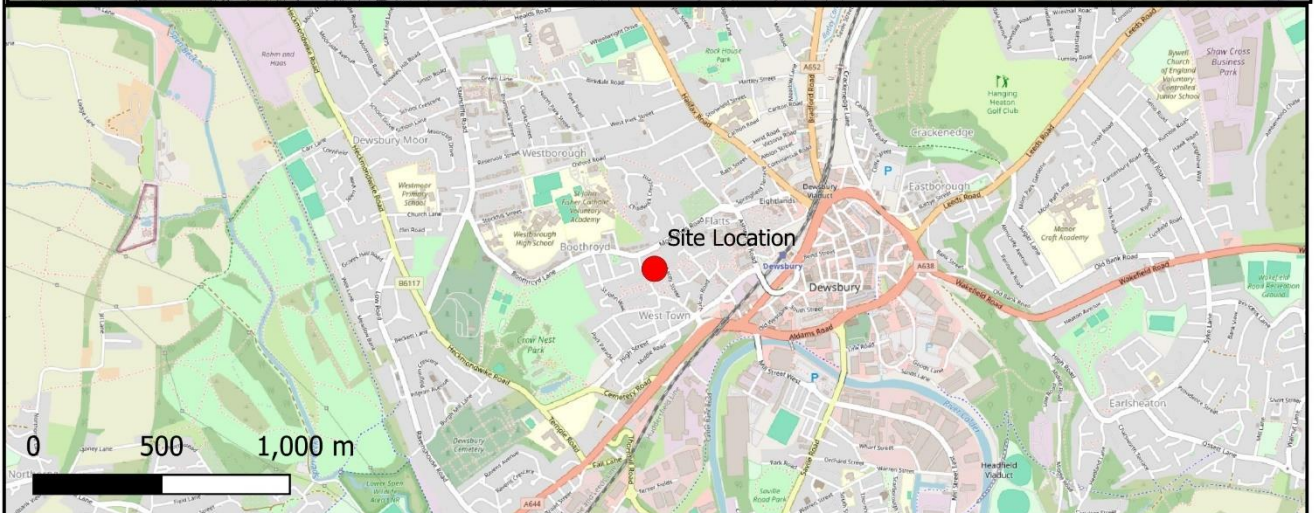
CLIENT Homewood Design		TITLE Site Plan		Legend ● Window Samples ■ Hand Dug Trial Pit ● Rotary Borehole ⊕ CBR Location
PROJECT Land at Boothroyd Lane, Dewsbury, WF13 2LF		Notes:		
PROJECT NUMBER G25193		SCALE: NTS	DRAWN: LR DATE: 11/02/25	DRAWN: LR DATE: 11/02/25 CHECK: LR DATE: 11/02/25 REV: 0 DATE: 11/02/25
				GeoInvestigate Ltd GeoInvestigate House Terry Dicken Industrial Estate Ellerbeck Way Stokesley TSS 7AE Tel: 07795 845

The borehole positions were chosen to give an indication of the ground conditions generally throughout the site, both in terms of geotechnical appraisal and assessment of soil contamination. The soils encountered in the boreholes are considered to be broadly representative of soils throughout the site. The hand excavated trial pit positions were specifically chosen to target proposed areas of soft landscaping or gardens.
