Phase 2 Intrusive Site Investigation Report

LOCATION	Land at Boothroyd Lane, Dewsbury, WF12 2LF
ISSUE DATE	October 2025, Revised May 2026
FOR	Horizon Healthcare Homes Ltd
CLIENT REF.	
OUR REF.	G25193b

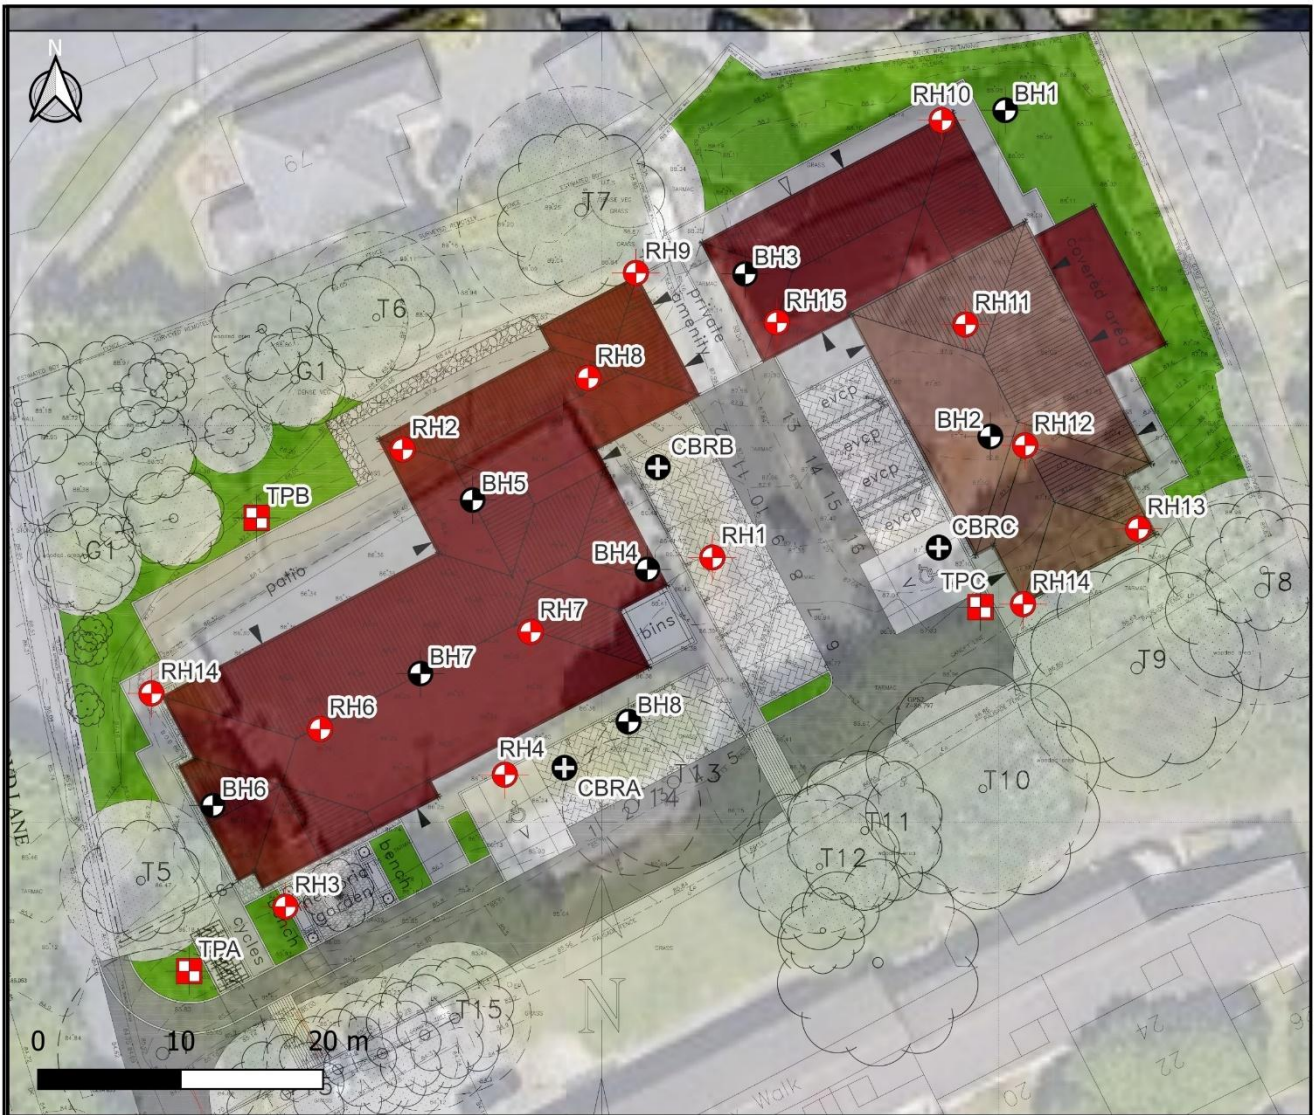
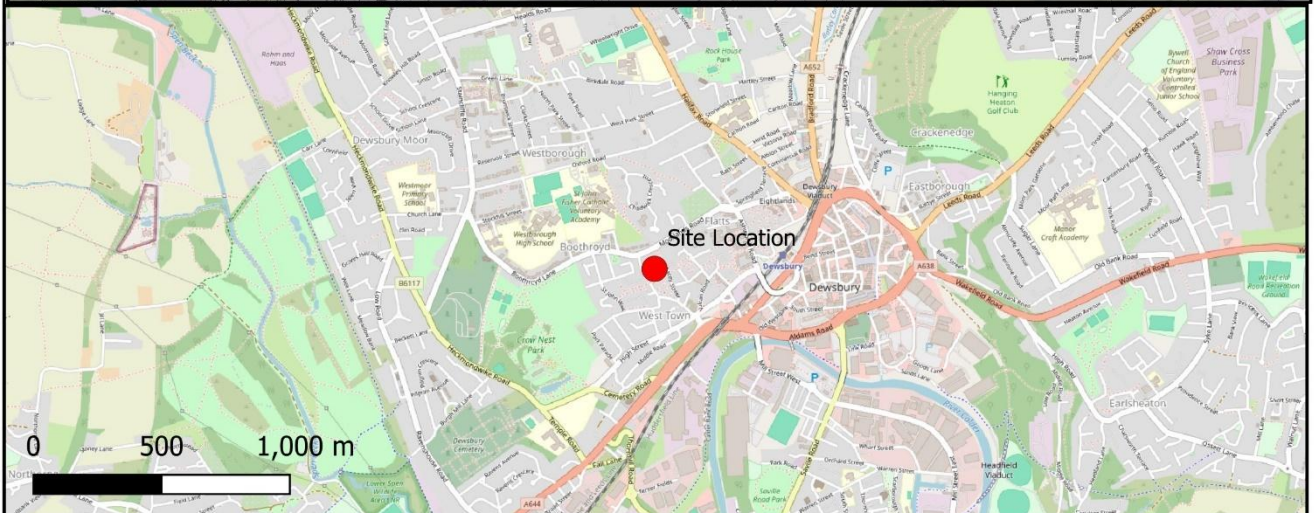
CLIENT Homewood Design		TITLE Site Plan		Legend <ul style="list-style-type: none"> Window Samples Hand Dug Trial Pit Rotary Borehole CBR Location 	
PROJECT Land at Boothroyd Lane, Dewsbury, WF13 2LF		Notes:		 GeoInvestigate Ltd Geoinvestigate House Terry Dicken Industrial Estate Ellerbeck Way Stokesley TSS 7AE Tel: 07795 845	
PROJECT NUMBER G25193		SCALE: NTS	DRAWN: LR DATE: 11/02/25

The borehole positions were chosen to give an indication of the ground conditions generally throughout the site, both in terms of geotechnical appraisal and assessment of soil contamination. The soils encountered in the boreholes are considered to be broadly representative of soils throughout the site. The hand excavated trial pit positions were specifically chosen to target proposed areas of soft landscaping or gardens.

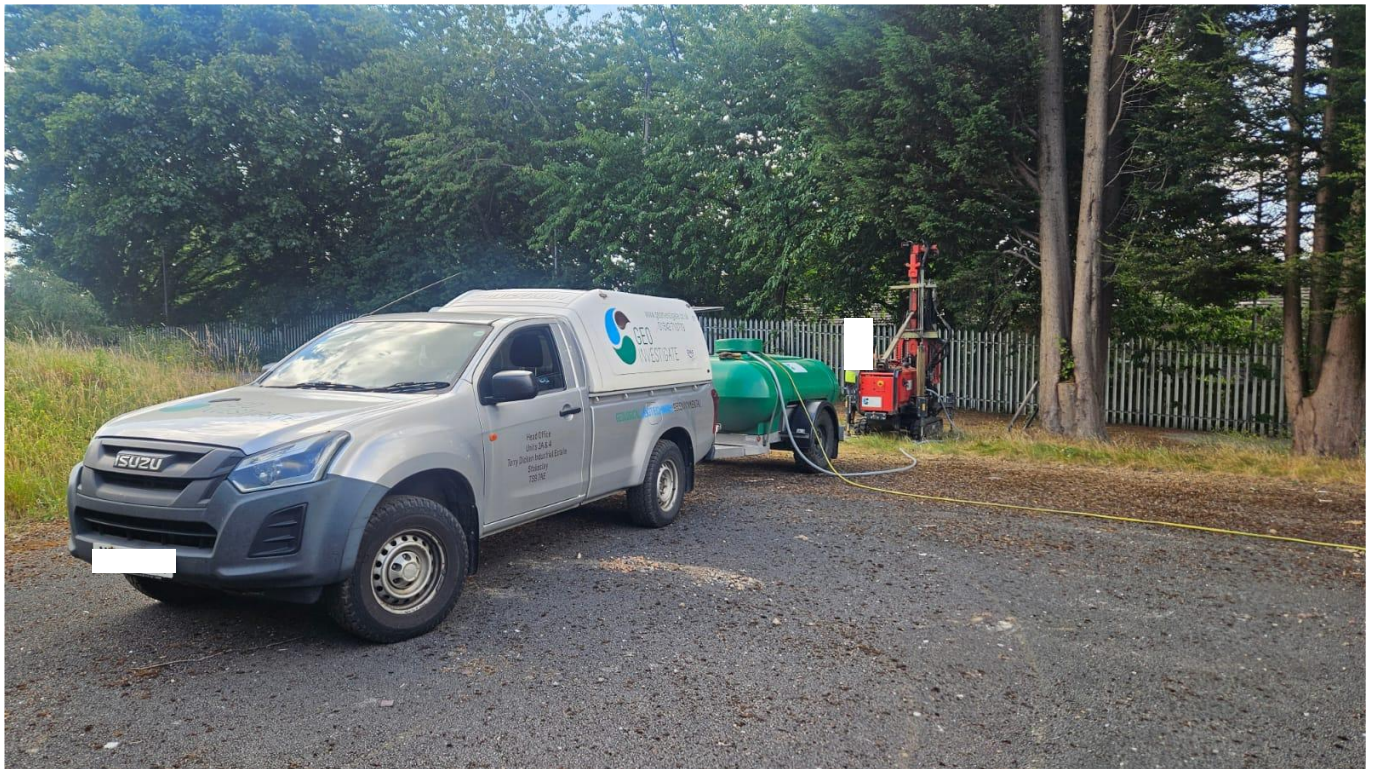
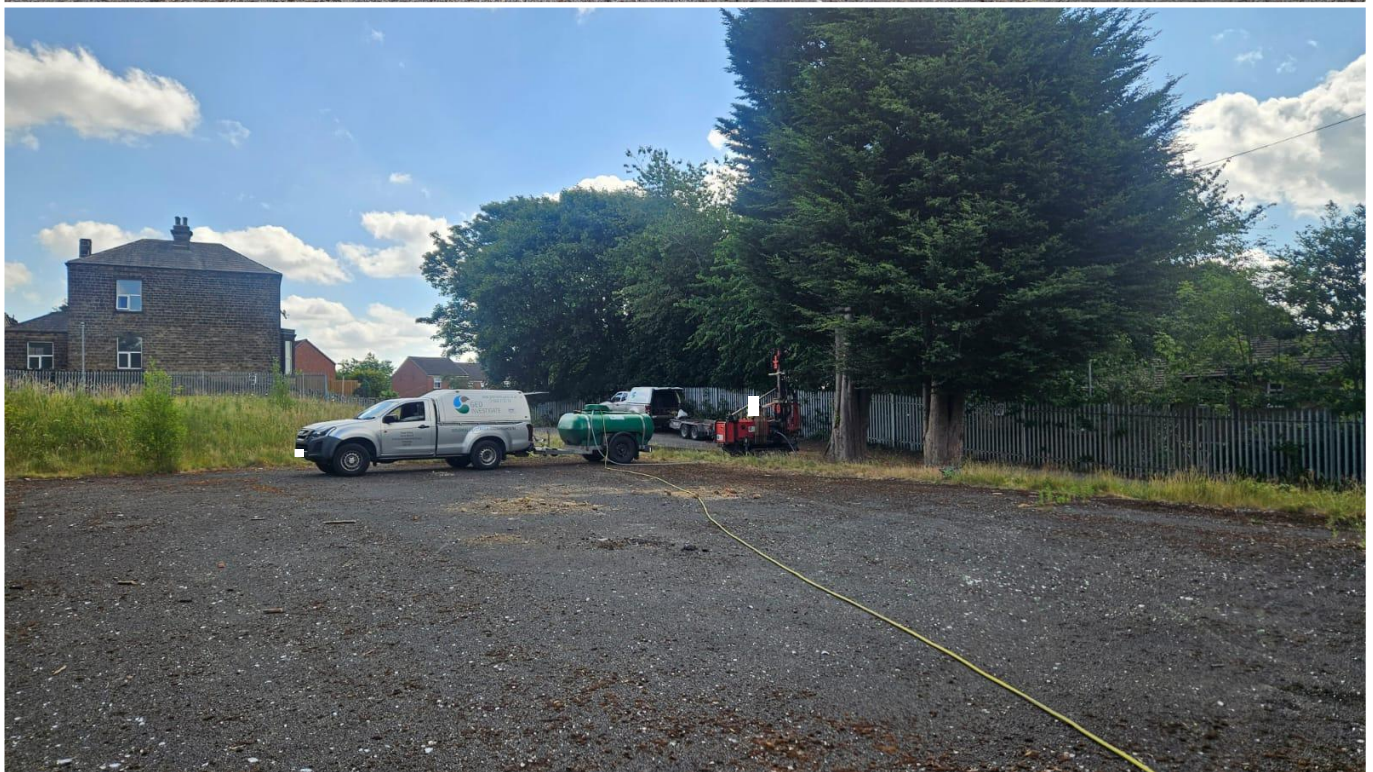
Client Ref: Our Ref: G25193 Date: 03/10/2025 Location: Land at Boothroyd Lane, Dewsbury WF13 2LF Comments:			RH 8 <i>Sheet No 1 of 1</i>	
Depth (m)	Description of Strata	Thickness	Legend	Flush	Depth (m)	
1.10	TARMAC / brown DRIFT.	1,100				
4.10	Light brown SILTSTONE.	3,000			2.50	
8.50	Grey MUDSTONE.	4,400			5.00 7.50	
10.70	Light grey SANDSTONE.	2,200			10.00	
11.20	Dark grey and black shaley COAL	500				
15.00	Light grey SANDSTONE.	3,800		Full flush	12.50 15.00	
	Rotary hole terminated at 15.00m					
Remarks: Casing to 1.50m Microdrill rotary open hole borehole to 15.00 m No cores recovered from borehole No gas detected from borehole on completion Full flush maintained. No voids encountered.				RH 8 Drilled by: AM Logged by: AM

Client Ref: G25193 Our Ref: G25193 Date: 08/09/2025 Location: Land at Boothroyd Lane, Dewsbury WF13 2LF Comments:			RH 9 Sheet No 1 of 1	
Rotary Borehole Log						
Depth (m)	Description of Strata	Thickness	Legend	Flush	Depth (m)	
1.80	TARMAC / brown DRIFT.	1,800				
7.90	Light brown SILTSTONE.	6,100			2.50 5.00 7.50	
15.20	Light grey SANDSTONE. > Becoming very weak with intermittent flush from 11.50m.	7,300		Intermittent from 11.50m Flush lost at 14.20m	10.00 12.50	
15.50	Very weak SHALEY COAL.	300			15.00	
20.00	MUDSTONE.	4,500			17.50	
	Rotary hole terminated at 20.00m				20.00	
Remarks: Casing to 1.50m Microdrill rotary open hole borehole to 20.00 m No cores recovered from borehole No gas detected from borehole on completion Full flush maintained. No voids encountered.				RH 9 Drilled by: AM Logged by: AM

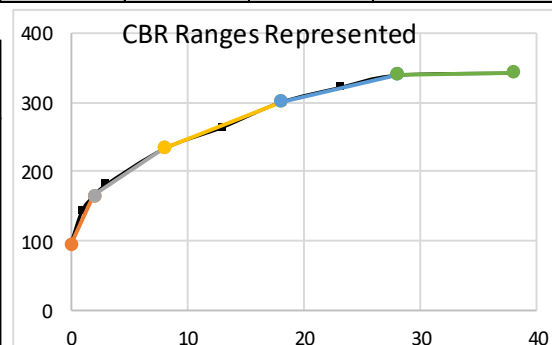
DCP Test Result

Site	Boothroyd Lane, Dewsbury WF13 2LF	
Job no.	G25193	
Test no.	1	
Date	17/06/2025

Raw DCP Data		
No. blows (8kg Weight)	Cumulative Blows	Penetration (mm)
0	0	95
1	1	145
1	2	166
1	3	182
5	8	234
5	13	265
5	18	301
5	23	322
5	28	340
10	38	343

Start (depth)	End (depth)	mm per blow	Log ₁₀ (CBR)
95	166	35.5	0.84141
166	234	11.3	1.36554
234	301	6.7	1.60684
301	340	3.9	1.85524
340	343	0.3	3.03268

Depth (mm)	CBR Value (%)
95-166	6.9
166-234	23.2
234-301	40.4
301-340	71.7
340-343	1078.2

Therefore, a CBR value of 5% for natural material would be a reasonable, conservative value to use for design purposes, but it should be noted that wet or winter weather and site trafficking may detrimentally affect the CBR rating of the soil once works are commenced, and CBR values may vary seasonally and with moisture content.
