Ref: Shallow Mining Investigation on land at Flockton Green Club, 153 Barnsley Road, Flockton, Huddersfield, WF4 4AA

1. Introduction

**COAL MINING RISK ASSESSMENT,
DESKTOP STUDY**

Report Reference: 4678-24 CMRA

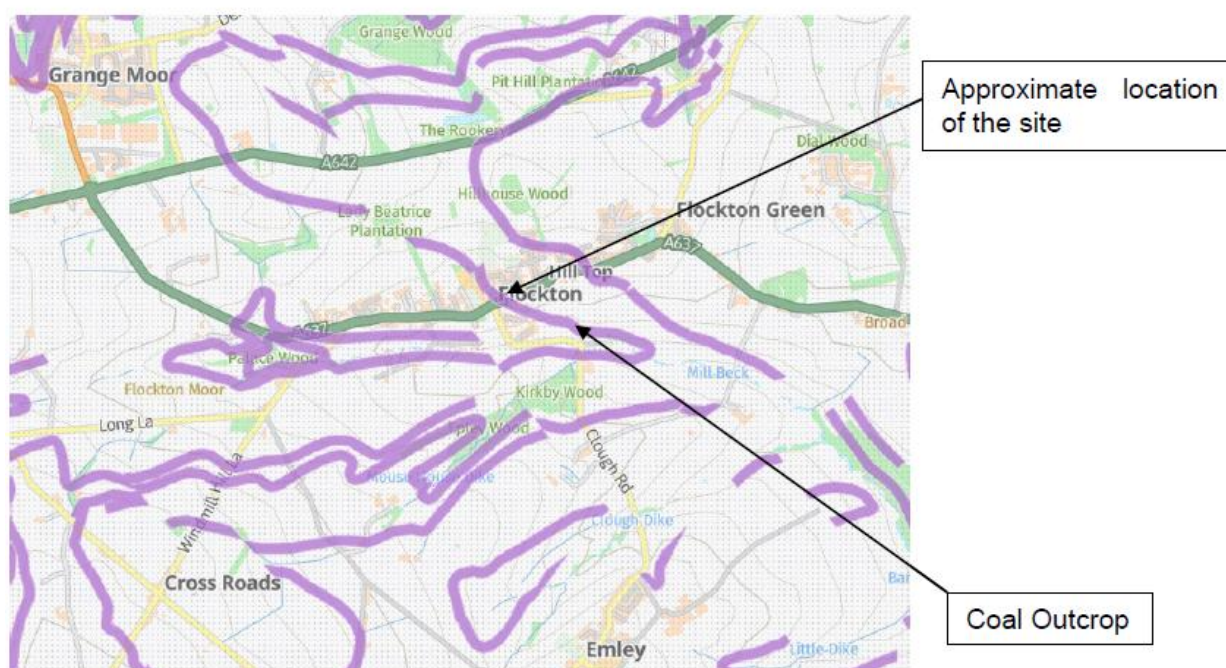
Figure 4.1: Approximate Location of Coal Outcrops

The Coal Authority Interactive Viewer provides an indication as to the proximity of coal outcrops to the site, an excerpt is shown as Figure 4.1, below.

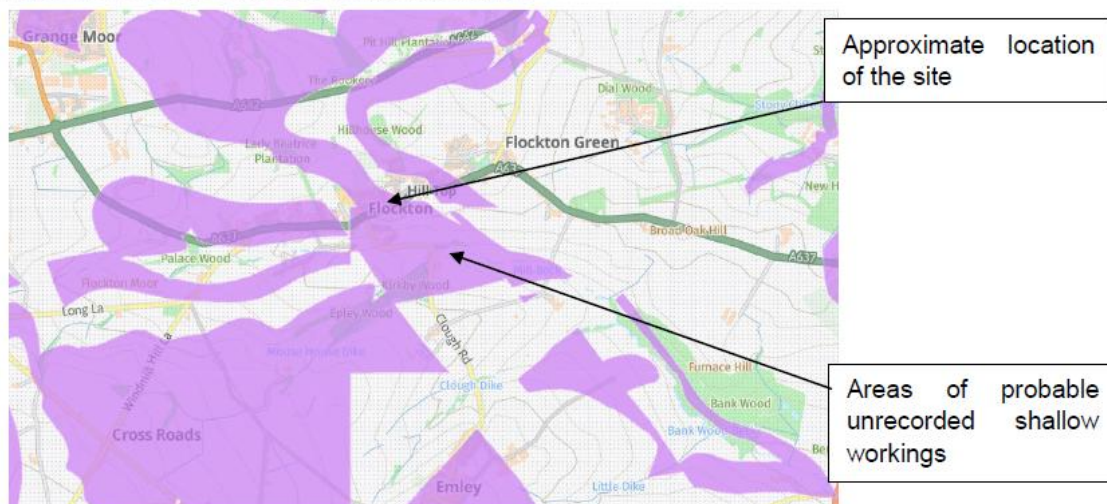
Figure 4.5: Probable Unrecorded Shallow Workings

The CACR identifies that probable unrecorded shallow workings are present within influencing distance of the site.

Reference to Coal Authority Interactive Viewer provides an indication as to the most probably areas where unrecorded shallow workings took place within influencing distance of the site and is shown on Figure 4.5, below:

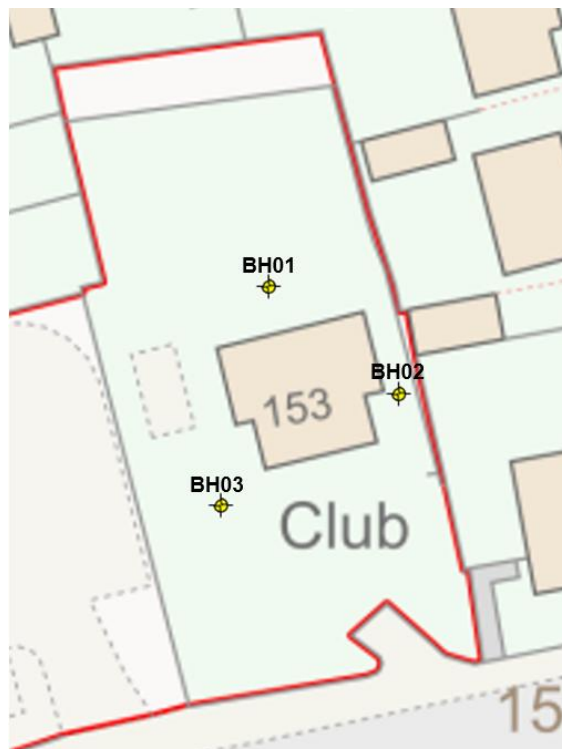
The fieldwork was carried out on the 27th May 2025 and comprised the drilling of three rotary open-holes, referenced BH01 to BH03 inclusive, which were drilled to depths of between 10.0 m and 30.0 m below ground level (bgl), to allow logging of the soils and solid strata through examination of flush returns and rate of penetration of the drill bit. Drilling was initially progressed using 150mm diameter augers through the superficial soils, and a casing set into the underlying bedrock, to aid flush returns.

The locations of the exploratory holes are shown below.

Based on the findings of this investigation, which the driller records likely shallow workings as 'void lost water returns' in boreholes BH01 and BH03 at depths of between 7.4 and 7.7 m bgl and upto 1.2 m in thickness. Over a similar depth range, the Driller records 'coal' in BH02 between 7.5 m and 8.6 m bgl. It is therefore considered that there is insufficient rock cover above the likely worked seam (assuming as a general rule of thumb used to assess the risk from pillar and stall mining, the rule is 10x seam thickness for competent rock cover) and that therefore remedial action is warranted prior to any development works being undertaken. The recommendation of this report is that these shallow workings are stabilised by means of drilling and grouting.

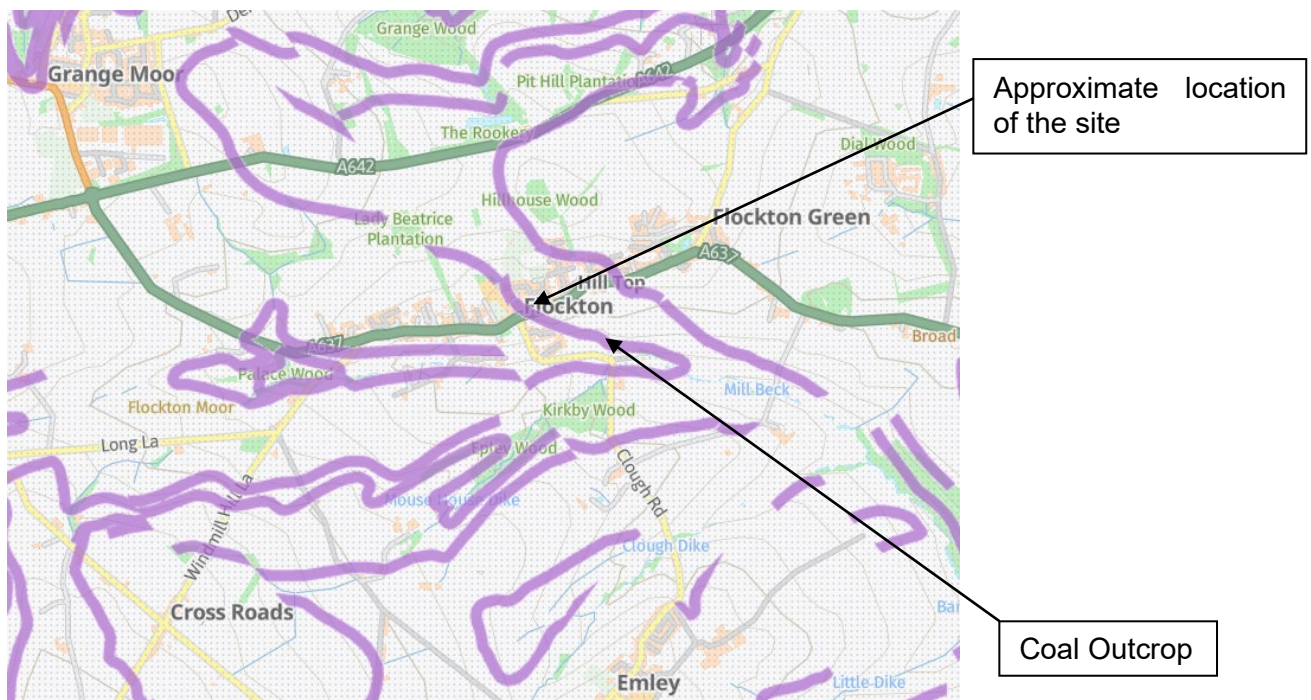
Figure 4.1: Approximate Location of Coal Outcrops

The Coal Authority Interactive Viewer provides an indication as to the proximity of coal outcrops to the site, an excerpt is shown as Figure 4.1, below.

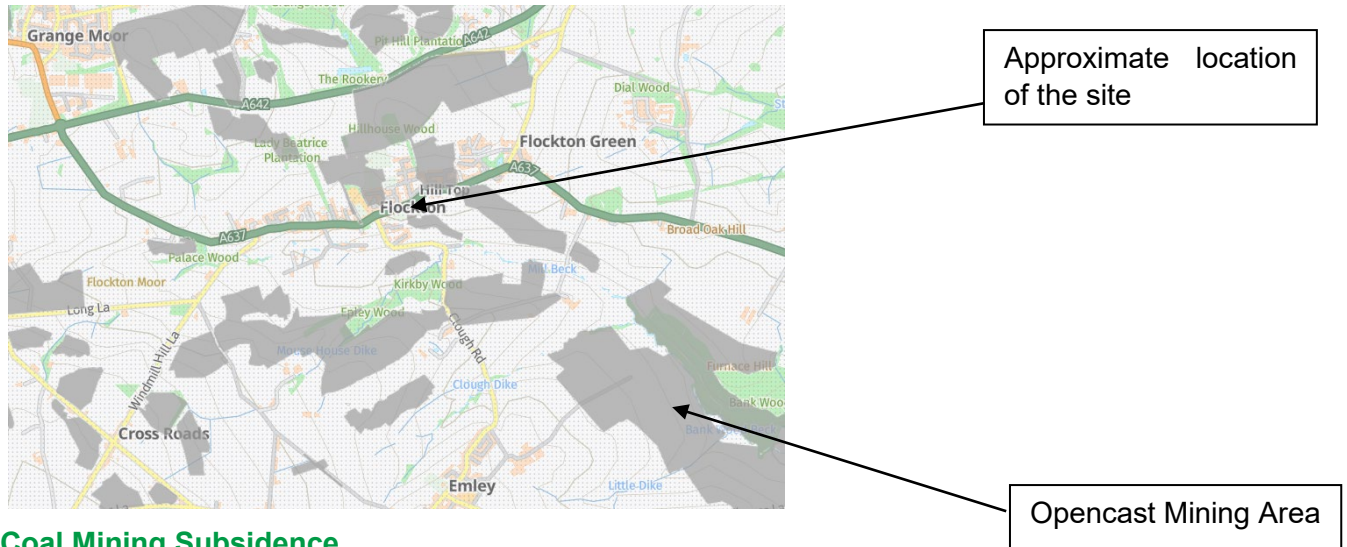
Figure 4.3: Proximity of Opencast Mining

Reference to Coal Authority Interactive Viewer provides an indication as to the proximity of opencast mining and is shown on Figure 4.3, below:

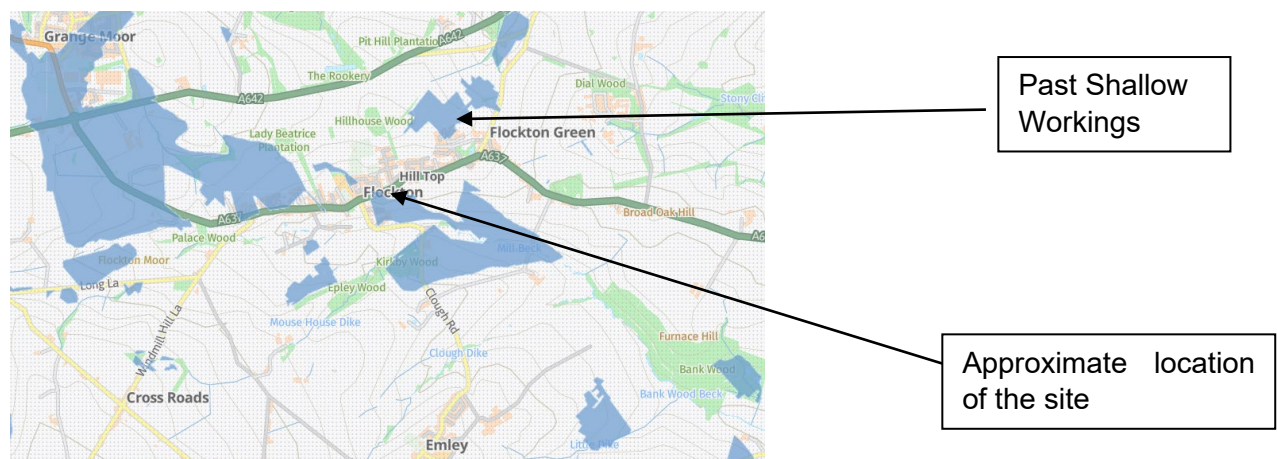
Figure 4.4: Past Shallow Workings

Reference to Coal Authority Interactive Viewer provides an indication as to the most probably areas where unrecorded shallow workings took place within influencing distance of the site and is shown on Figure 4.4, below:
