PHASE 2

GEO-ENVIRONMENTAL REPORT

job number	C3779/23/E/5733	date	14/10/2024
site address	Longley Farm, Longley Lane, Holmfirth, West Yorkshire, HD9 2JD		
written by	S. Hale	checked by	I. Sakoor
issued by	S. Hale

Report on a Phase 2 Geo-environmental Investigation

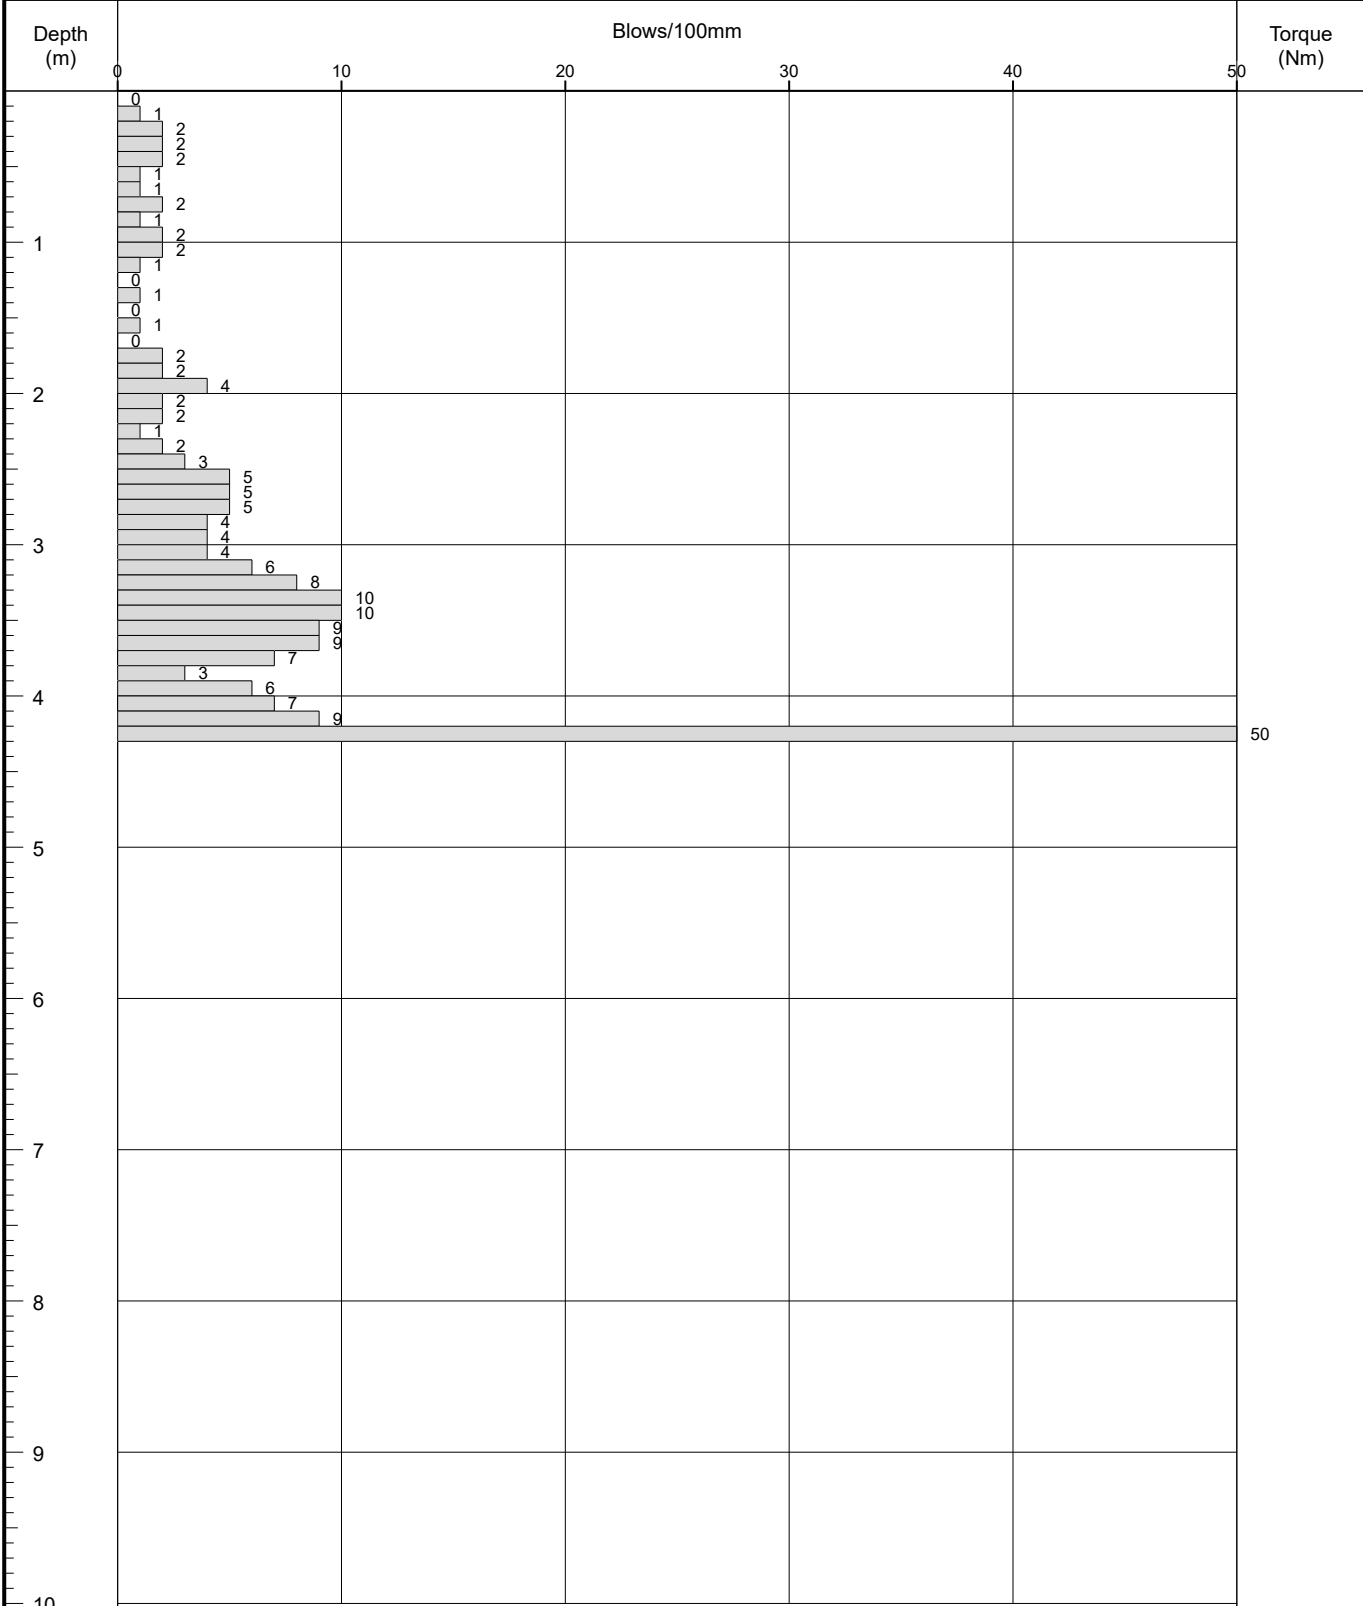
Sheet 1 of 1

Project Name: Longley Farm	Project No. C3779/23/E/5733	Co-ords:	Hole Type DCP
Location: Longley Lane, Holmfirth, West Yorkshire, HD9 2JD	Level:		Scale 1:50
Client: J & E Dickinson	Dates: 05/09/2024		Logged By SH

Remarks:	Fall Height	750mm	Cone Base Diameter	50.5mm
	Hammer Wt	63.5kg	Final Depth	4.2m
	Probe Type	DPSH-B

Dynamic penetration tests were undertaken adjacent to windowless sample borehole WS02 in accordance with the procedure given in BS EN ISO 22476: Part 2: 2005 +A1: 2011, using the super heavy penetrometer (DPSH). This probe consists of a 63.5kg mass falling through 750mm onto an anvil, which drives a 50mm diameter cone into the ground. The number of blows required to drive the cone through successive 100mm increments are recorded as the N_{100} values. The results of the dynamic penetration tests are tabulated and presented as bar charts of N_{100} values versus depth in Appendix 3.

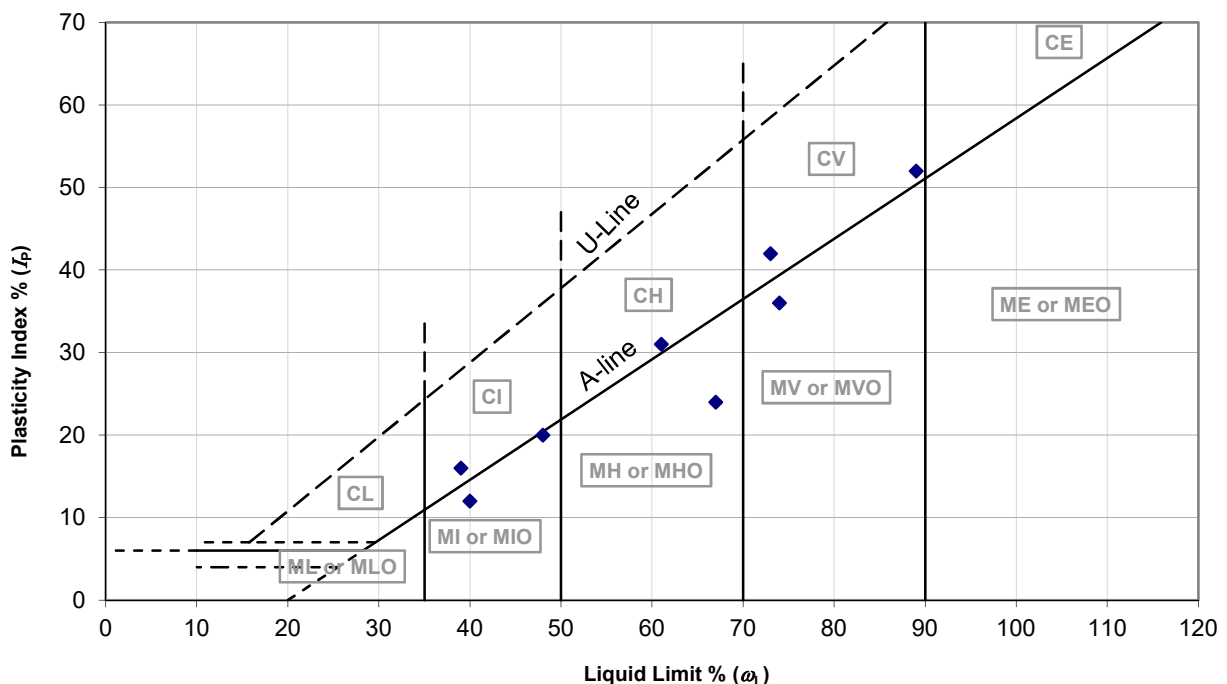
Location	Depth (m)	Water Content (ω) (%)	Liquid Limit (ω_L) (%)	Plastic Limit (ω_P) (%)	Plasticity Index (I_P) (%)	Retained by 0.425mm (%)	Modified (ω) (ω') (%)	Modified (I_P) (I_P') (%)	Liquidity/ Consistency		Casagrande Class	N.H.B.C Class (%)
									(I_L) (%)	(I_C) (%)		
WS01	1.00	43	89	37	52	0	43	52	0.1	0.9	C V	HIGH
WS01	2.00	15	48	28	20	0	15	20	-0.7	1.7	M I	MEDIUM
WS01	2.60	21	61	30	31	27	29	23	-0.3	1.3	C H	MEDIUM
WS02	1.00	48	73	31	42	0	48	42	0.4	0.6	C V	HIGH
WS02	2.00	46	67	43	24	0	46	24	0.1	0.9	M H	MEDIUM
WS02	3.00	19	40	28	12	0	19	12	-0.8	1.8	M I	LOW
WS03	1.00	19	39	23	16	2	19	16	-0.3	1.3	C I	LOW
WS03	1.00	37	74	38	36	6	39	34	0.0	1.0	M V	MEDIUM
