## Building Adjacent to 1A Field Head, Shepley

### Bat Survey Report

10<sup>th</sup> June 2026

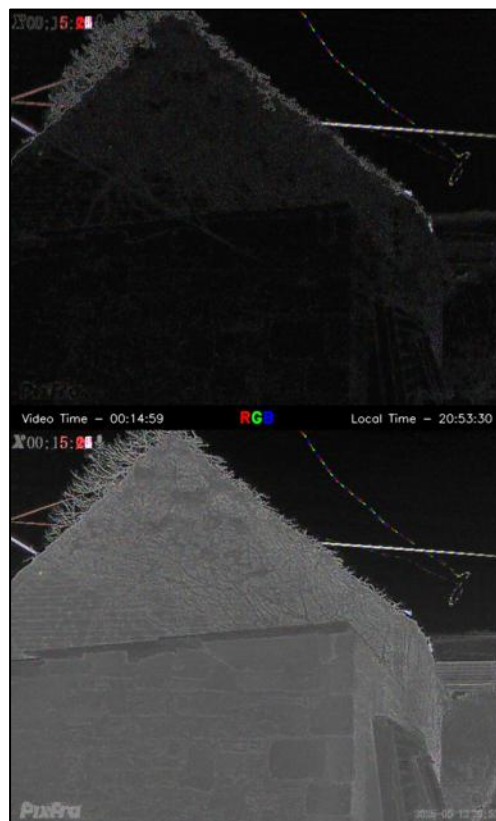
Plate 1. Example 30 second summary image from unmanned camera position to southwest of B3 on 12<sup>th</sup> May 2026, with flying bird indicated by dotted red-green-blue line

4.3.5 Camera footage from the unmanned survey position was initially analysed using software produced by [Wildlife Imaging Systems](#). The software identified movement within the footage on a frame-by-frame basis and produced a set of images showing movement traces for each 30-second section of video. These images were subsequently reviewed by Robert Bell and, where a trace was identified that could potentially represent bat flight activity, the relevant section of video footage was reviewed in full. Example images produced by the software from the unmanned survey position on both survey occasions are shown in Plates 1 & 2.

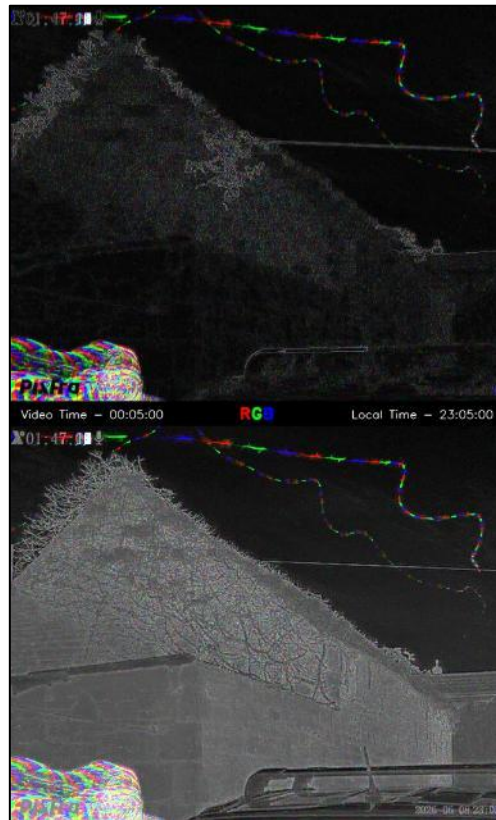
**Plate 2. Example 30 second summary image from unmanned camera position to southwest of B3 on 8<sup>th</sup> June 2026, with bat indicated by dotted red-green-blue line**

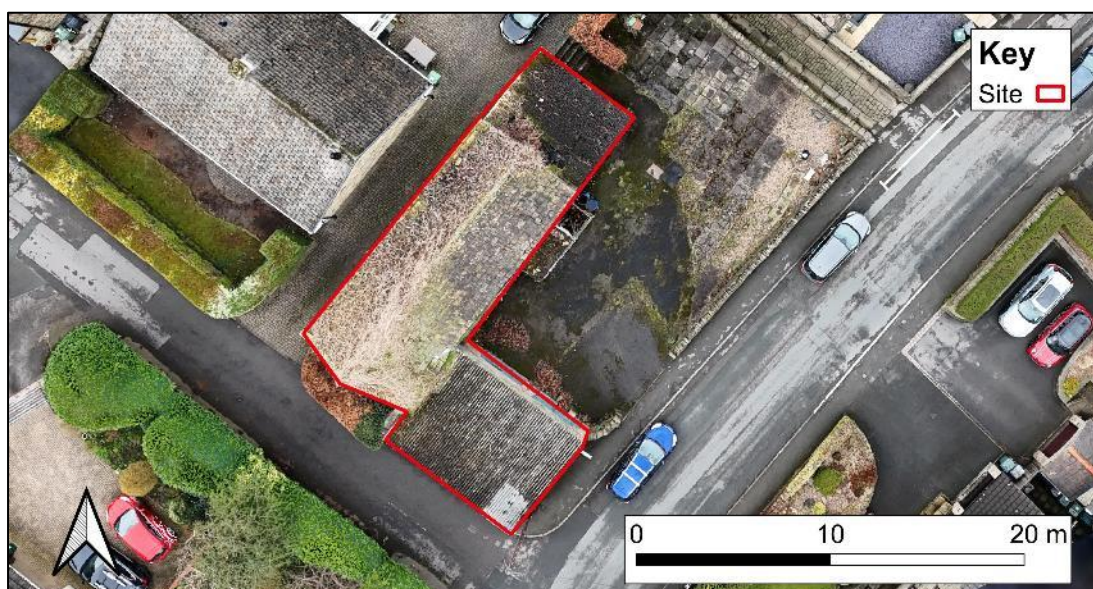
**Figure 4. Aerial image of building on day of survey**

5.2.3 The original barn comprised a C19th stone-built structure with a dual-pitched stone slate roof, featuring a mortar-filled verge on the northeast gable and stone coping on the southwest gable (Figure 4; Plates 2-5). A dense mat of dead climbing plant stems was present on the northeast gable and northwest roof slope. A large timber double door with a wooden lintel was present on the façade (southeast elevation), and the barn was fitted with plastic gutters.

5.2.4 Adjoining the northeast gable of the original barn was a single-storey stone extension with timber doors and a gently sloping, flat roof clad in corrugated asbestos-cement sheets. A second single-storey extension adjoined the southwest end of the façade, again with timber doors and a single-pitch roof clad in corrugated asbestos-cement sheets. A further extension comprised a small timber-framed, timber-clad fuel store with a single-pitch corrugated asbestos-cement sheet roof.

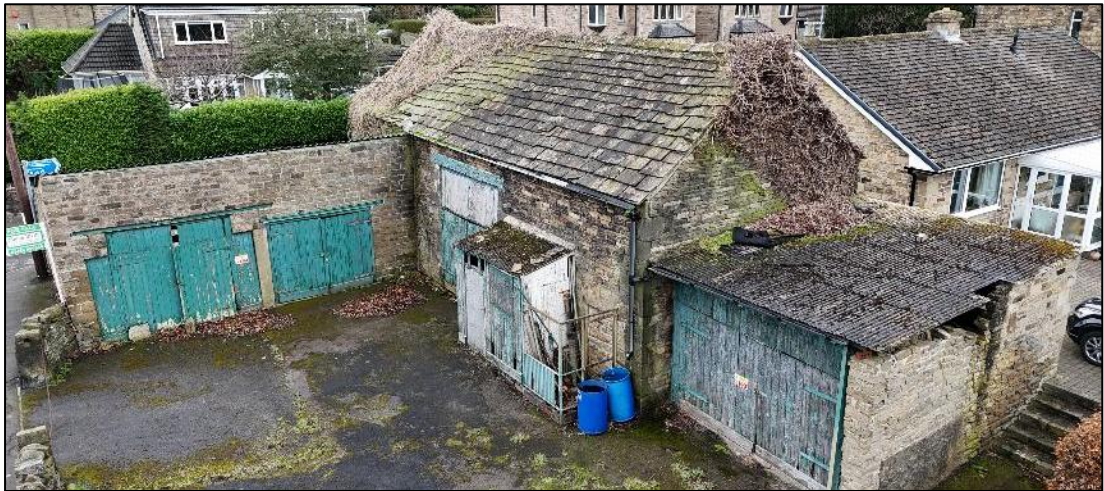
**Plate 3. Building, viewed from east**

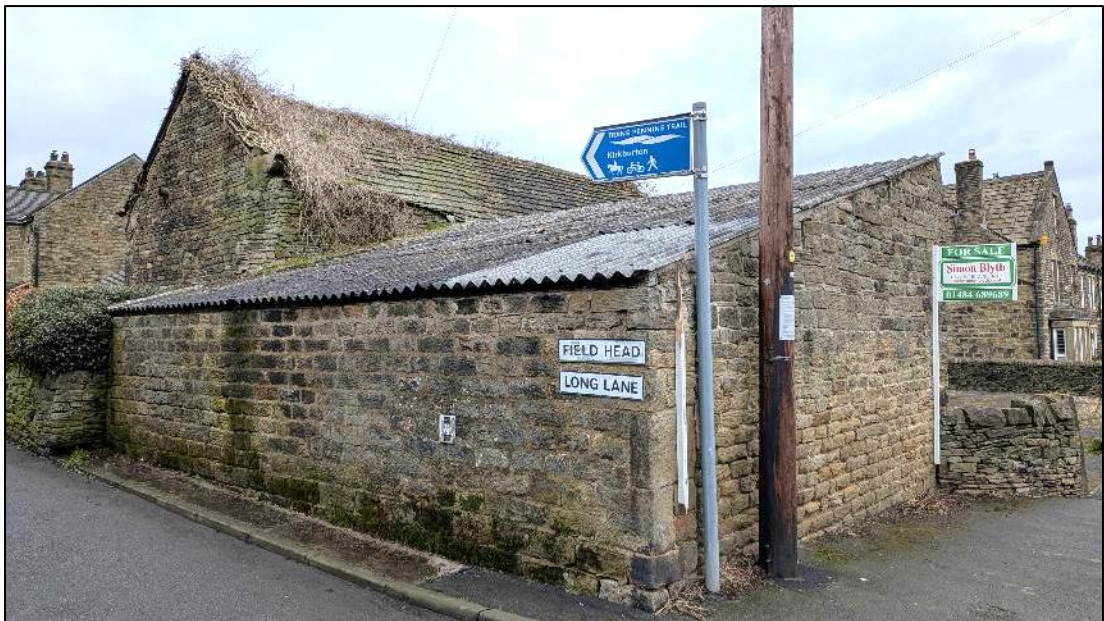
**Plate 4. Building, viewed from south**

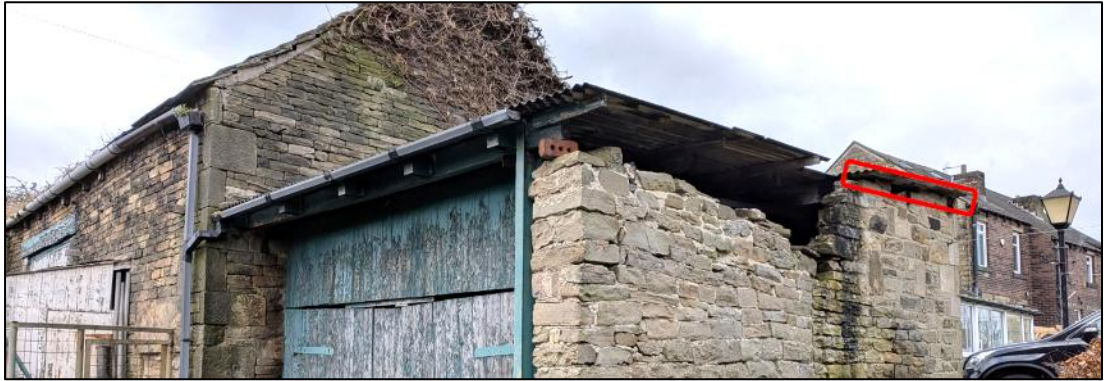
- Access to wall tops (Plate 7).
- Bats could potentially access the interior of the building via openings around timber doors or damaged sections of stone walls.

**Plate 7. Access to wall top of single storey extension to northeast gable**

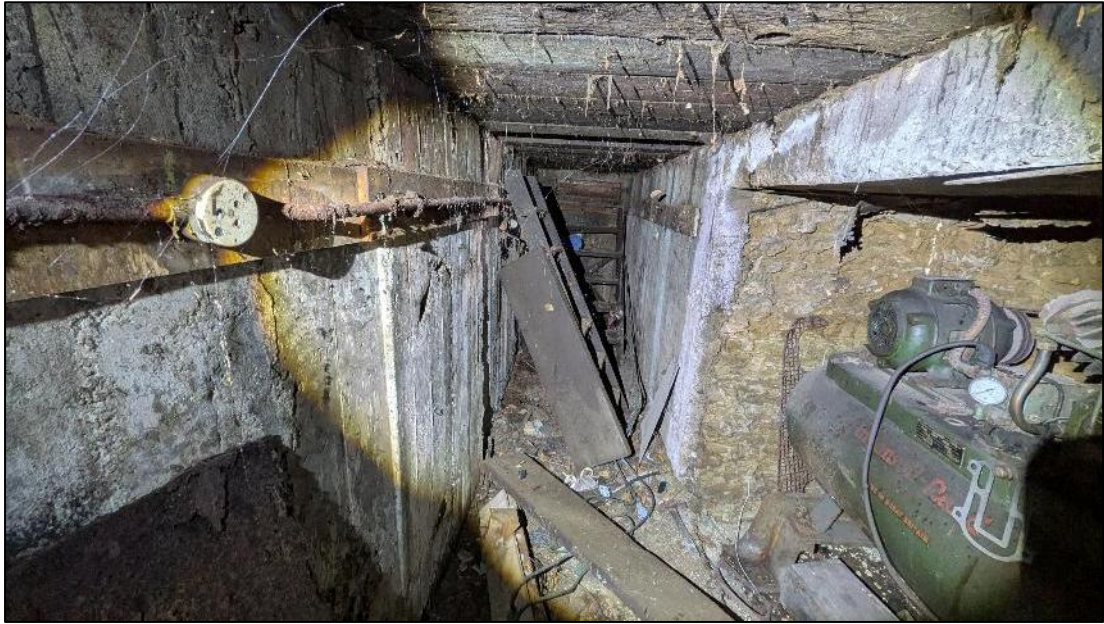
**Plate 9. Inspection pit in main barn**

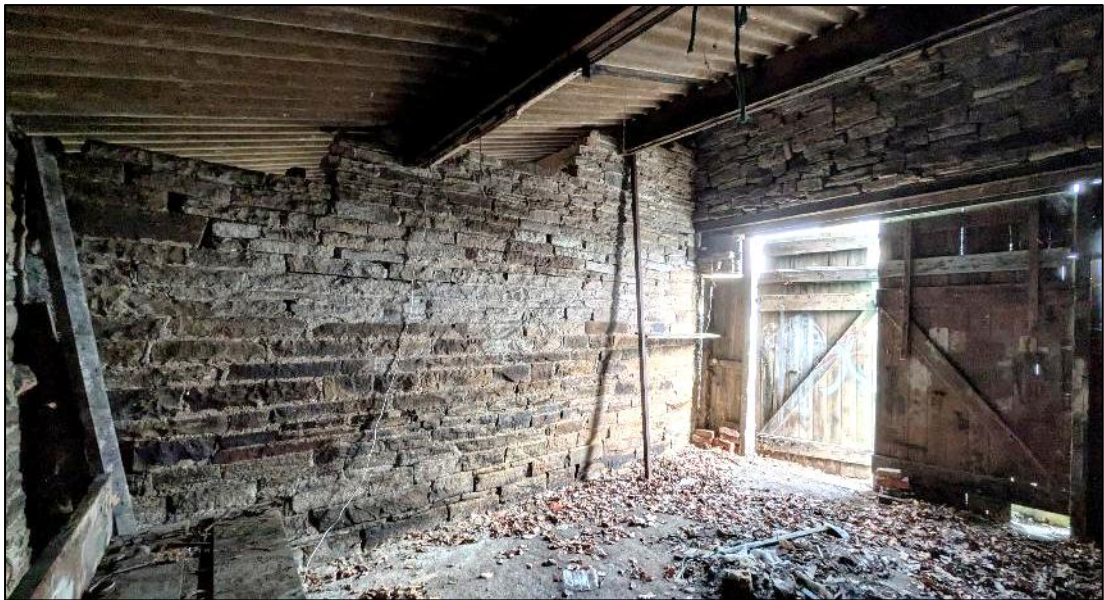
**Plate 10. Interior of southern extension**

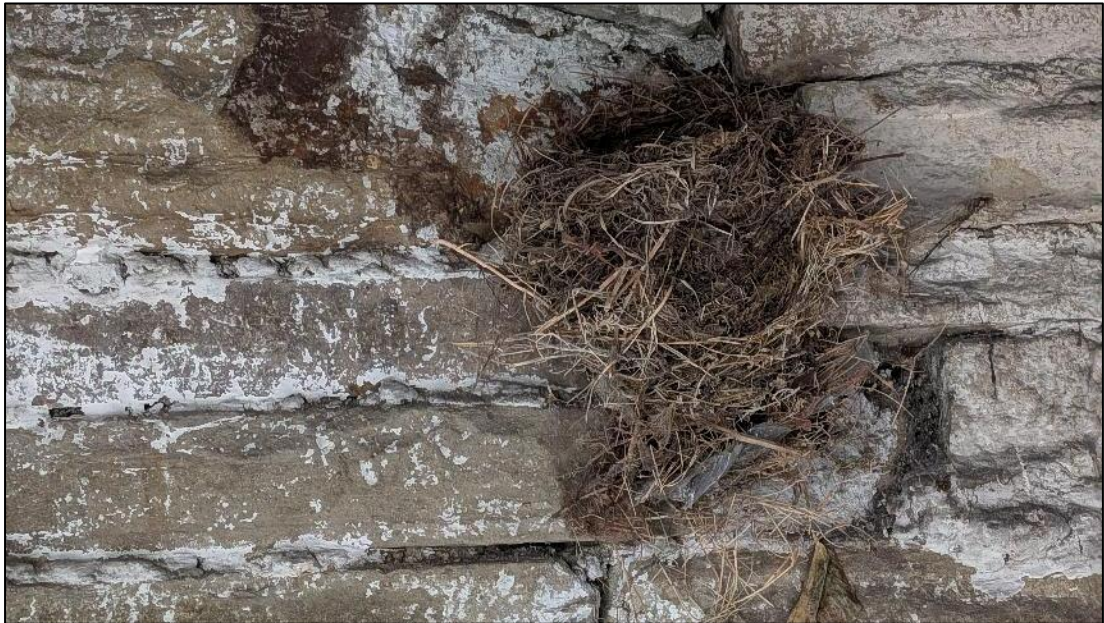
5.2.2 A single probable blackbird *Turdus merula* nest was recorded from the southern extension.

**Plate 11. Suspected former blackbird nest, recorded from interior of southern extension**

- 6.3.5 If works are to commence during the main bird nesting period (March to August inclusive), then works should be preceded by a nesting bird check, to be undertaken by an ecologist.
- 6.3.6 In accordance with the aims of the National Planning Policy Framework, it is recommended that one integrated swift *Apus apus* box (i.e. S Brick) be installed within each new building (see Figure 5). These boxes should be fitted at the gable apexes to maximise the drop from the nest box, which increases the appeal for swifts. Studies have shown that swift boxes are used by other bird species that utilise buildings and consequently this measure will provide potential nesting space for house sparrows *Passer domesticus* and starlings *Sturnus vulgaris*, in addition to potentially providing future nest space for swift.

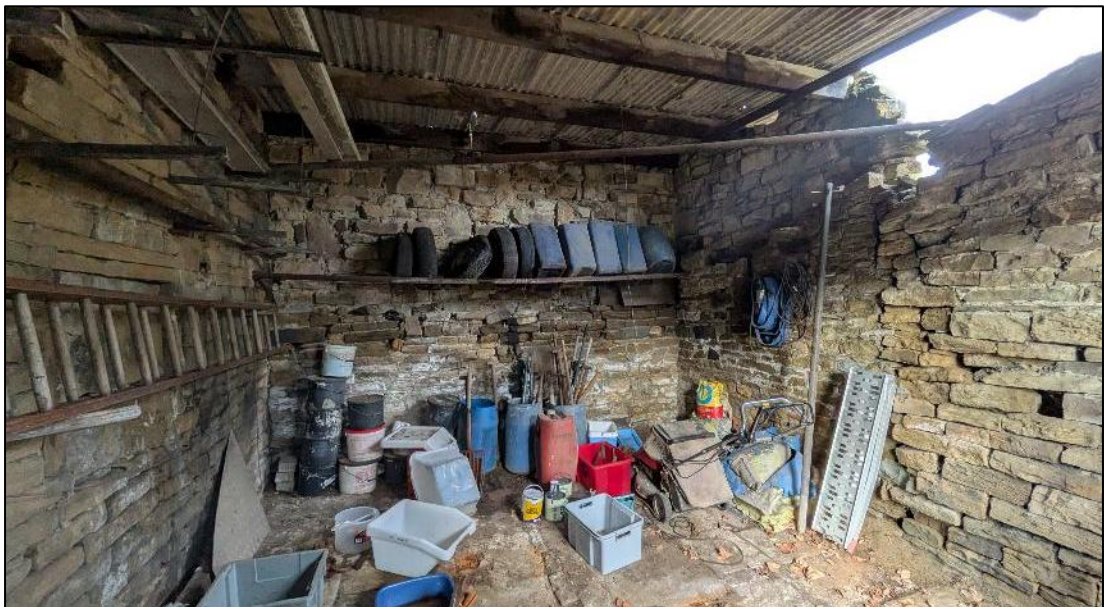
**Plate 12. Interior of extension to northeast gable**
