## An assessment of timber and damp at

NEW MILLS, MARSDEN HD7 6AZ

- BROUGHAM ROAD BUILDING

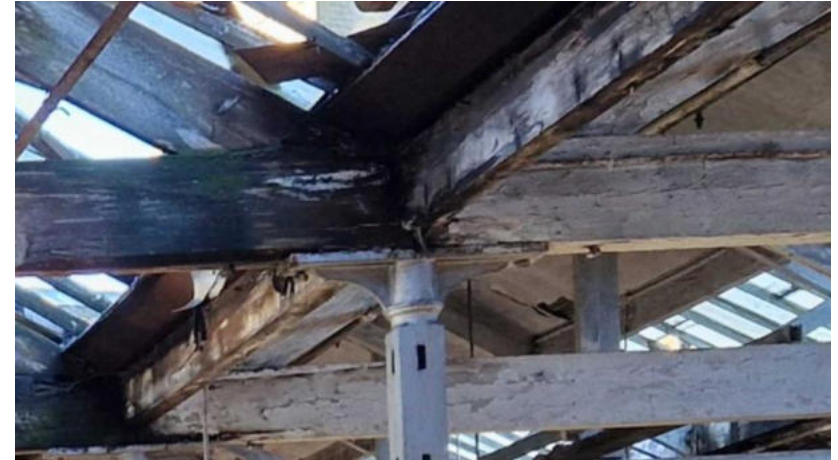
The building has a M-shaped roof with a central valley and two ridges. There is a total of 16 bays, with 30 trusses. The E end of the building has a hipped roof. A valley beam runs between each set of trusses and supports a metal box gutter. The N pitch of each roof has glass panels, which are in varying condition.

The central valley column has a shoe for each truss bearing and the two valley beams slot into the connection. The shoe does not cover the tie beam, and packers have been inserted below the tie beam at approximately 2/3 of the connections.

The trusses bear into the wall head at the N and S elevations. Purlins have individual metal shoes for each connection to the principal rafters and bear into the wall head at the W end of the building. The E end has hips which are supported by dragon ties and two rafter plates run parallel to the E wall.

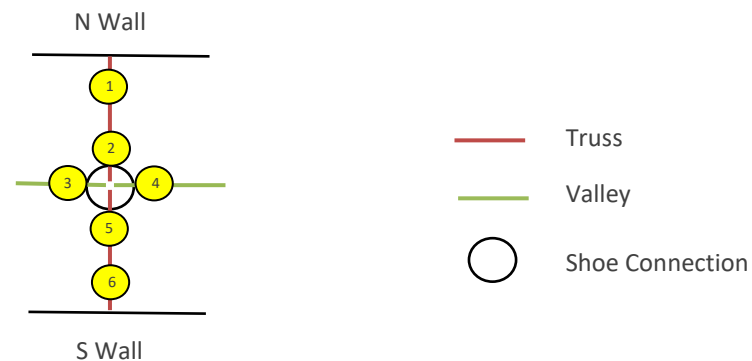
The roof structure was divided into 16 grids (as number on the plans) running from W to E. The purlins lines were lettered from A-H (as shown on the plans). For each grid there was 6 locations which refer to key connections.

- 1 – Truss bearing into N wall
- 2 – Shoe and N truss bearing
- 3 – Shoe and W valley beam bearing
- 4 – Shoe and E valley beam bearing
- 5 – Shoe and S truss bearing
- 6 – Truss bearing into S Wall

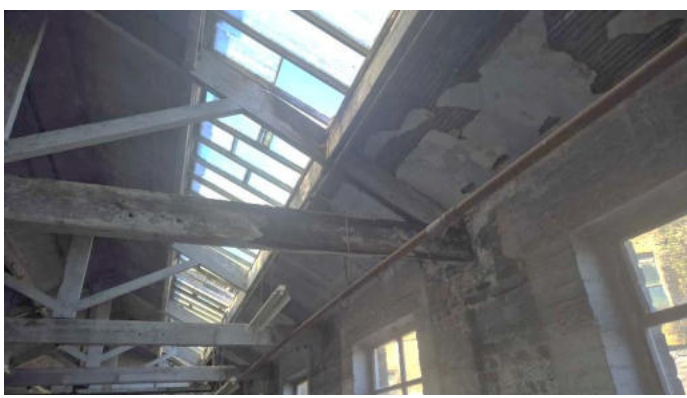
<p>1 Purlin bearing E &amp; F (circled in yellow) were not accessible for investigation due to condition of floor and leftover materials.</p>	 	<p>2 Shoe connection (Grid 1) was not accessible for investigation due to condition of floor and leftover materials</p>	 
<p>3 Broken window above the truss connection, has led to water staining to tie beam and principal rafter, although both are sound.</p>

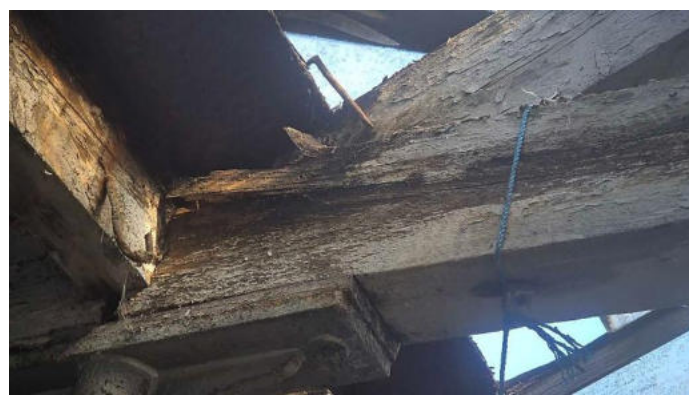
<p>4 The top of the tie beam has decayed and splintered. The principal rafter connection is extinct, and the top of the principal rafter is decayed for 75mm depth for 500mm from connection.</p>

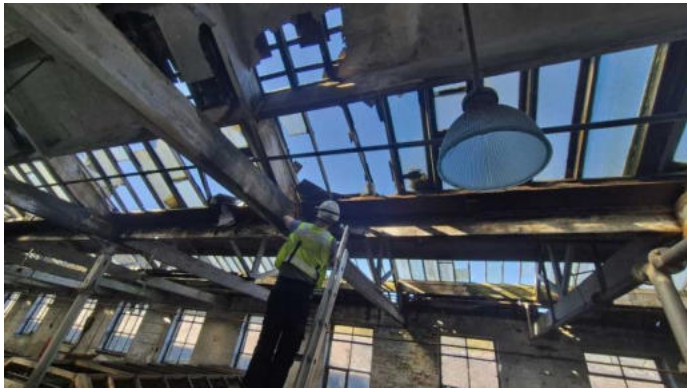
<p>General Comment  The top 1/3 of the valley beams have decayed, for the majority of the valley beams.</p>

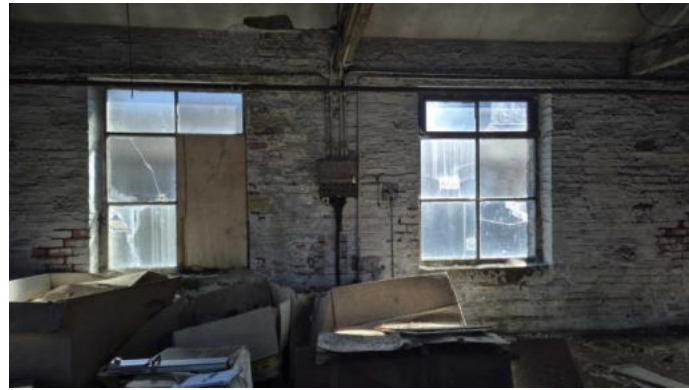
<p>5 The S truss bearing was not accessible due to leftover materials, it appeared to be sound.</p>

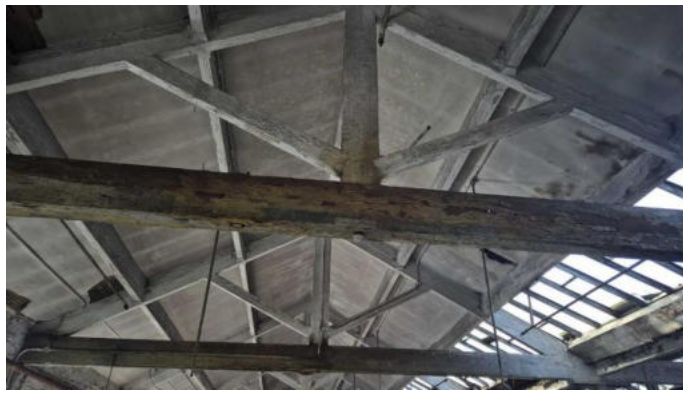
<p>6 Tie beam is showing a change of colour. This is linked to previous use of the space, and not to water ingress or decay.</p>

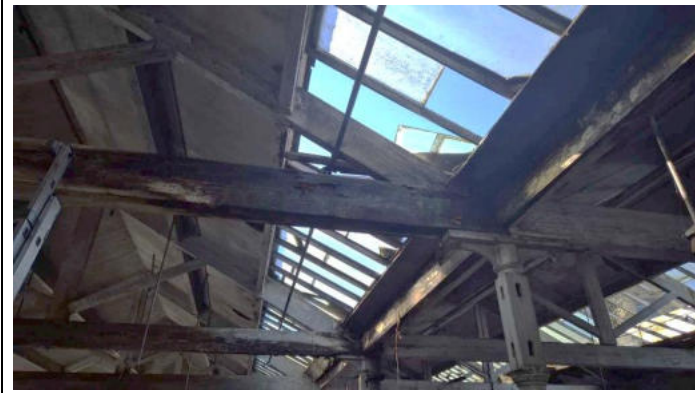
<p>7 Broken window above the truss shoe connection has resulted in water staining and decay to tie beam and principal rafter.</p>

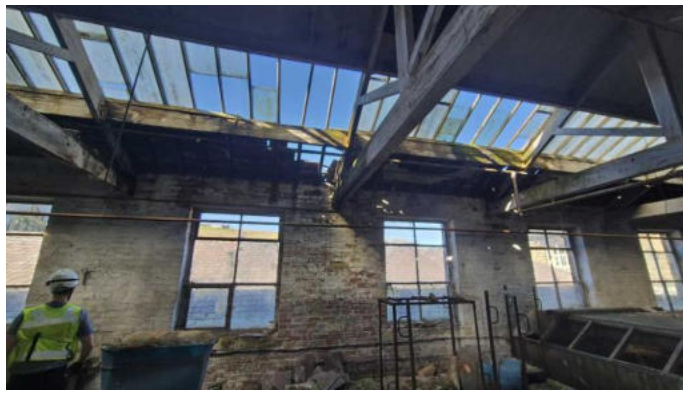
<p>8 The N truss bearing of grid 12 was not accessible due to the poor condition of the floor. It appeared to be decayed.</p>

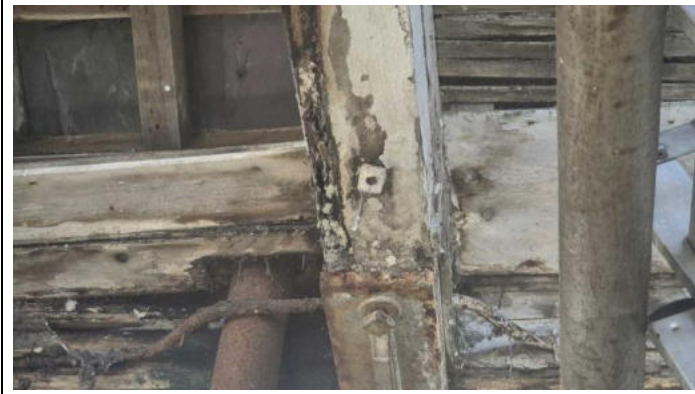
<p>9 Decay to the edge of the tie beam.</p>

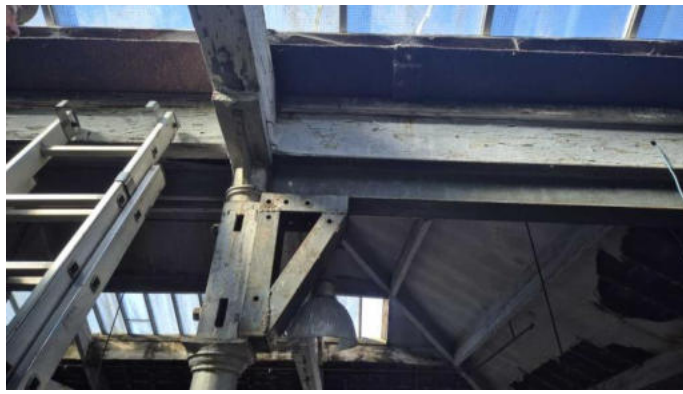
<p>11 The truss N bearing of grid 15 could not be accessed due to machinery.</p>

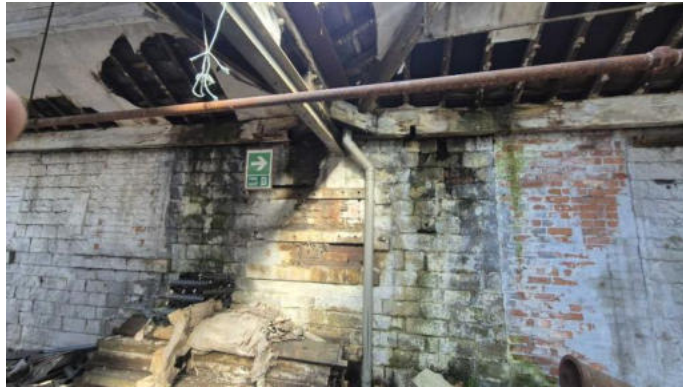
12  
Valley, hip and rafter plate connection could not be accessed due to poor condition of the floor.

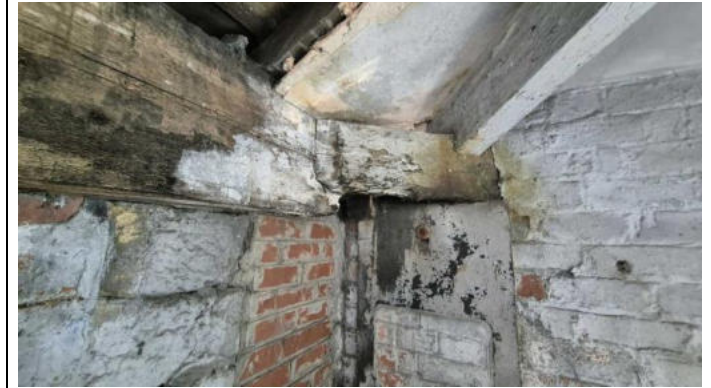
13  
The connection is wet and soft. The rafter plate appears to be floating but the top third remains.

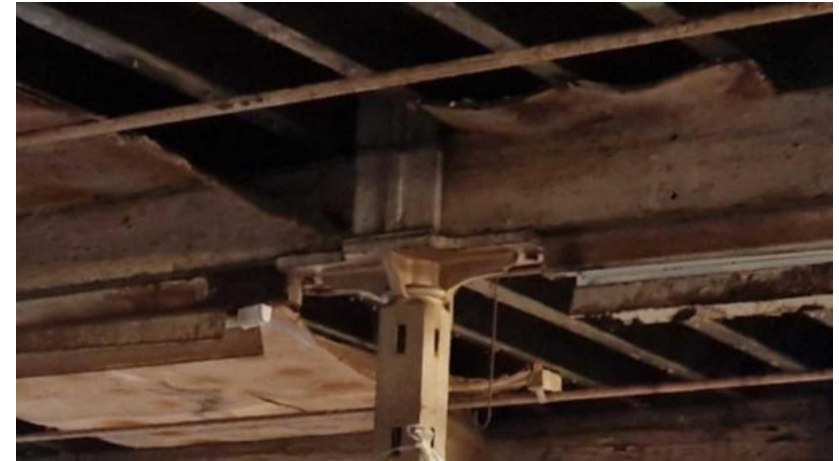
The first-floor structure consists of 16 bays, with 30 principal floor beams. The central column has a shoe for each floor beam. The shoe does not completely conceal the bearing of the floor beam. The floor beams bear into the walls of the N and S elevations of the building, except for N bearing of grid 9-15 where the floor beam bears into a shoe. The floor beams in grid 1-5 were covered in cladding.

The first-floor structure was divided into 15 grids (as number on the plans) running from W to E. For each grid there was 6 locations which refer to key connections.

- 1 – Floor beam bearing into N wall
- 2 – Shoe and N floor beam bearing
- 3 – Shoe and S floor beam bearing
- 4 – Floor beam bearing into S Wall

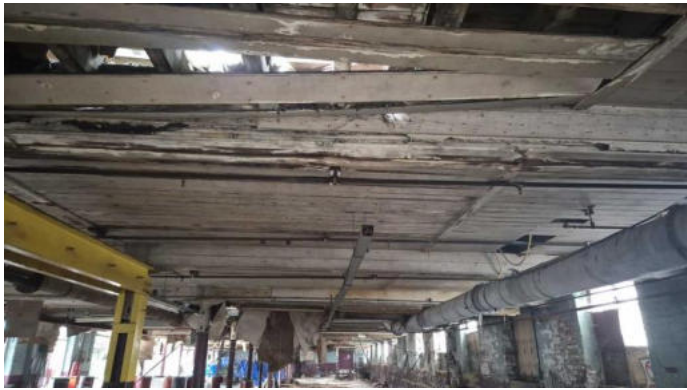
<p>14 The beams on grid 1-4 have cladding. The ceiling is also cladded, and decay to joist has been marked on the plans where it can be observed.</p>

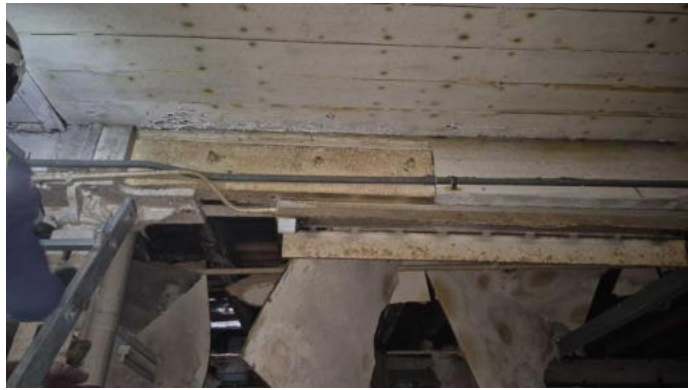
<p>15 The beam has had remedial work completed on the bearing with steel either side which is notched into the beam, and there is a fracture which runs from the bearing.</p>

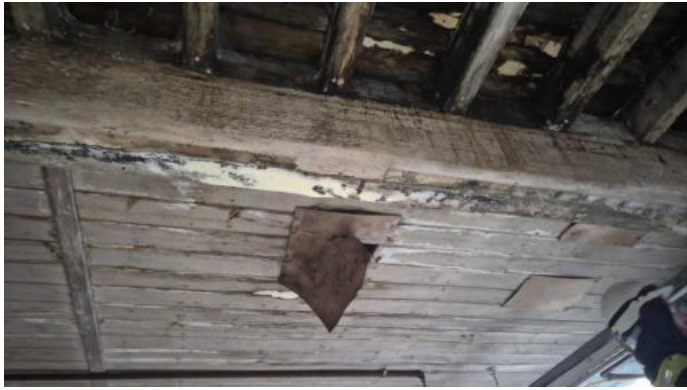
<p>16 There is fungal growth on the beam, cladding, floorboards and joists. This is below Ob. 3 where there is a broken window in the roof allowing water ingress.</p>

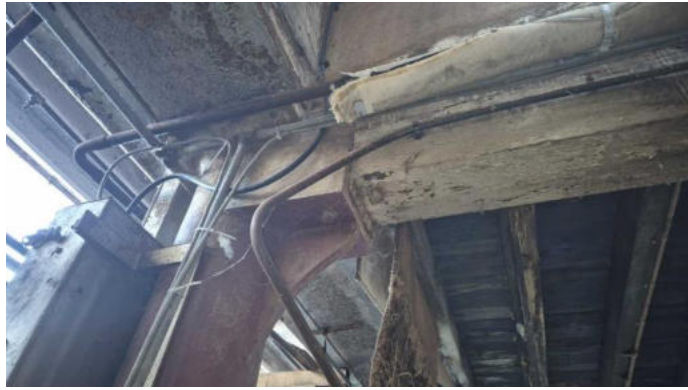
<p>17 The N beam bearing is into a metal shoe and not into the wall (as grid 1-8), and this continues for the remaining grids for the N Beam bearing.</p>

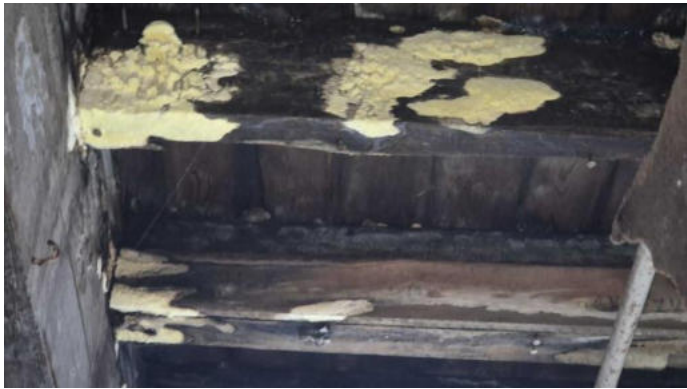
<p>18 The joists have fungal growth and are decayed in their bearings.</p>

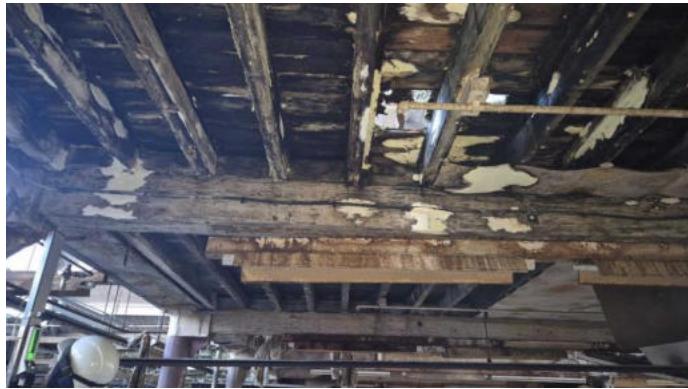
<p>19 The beam and surrounding joists and floorboards have active fungal growth. The beam has decayed at its other end and should be replaced.</p>

Beam N Bearing	The beam is decayed in its bearing and does not regain full section at shoe+4M which is over half its length, therefore it may be justifiable to replace the whole beam (Ob.19).
Shoe Connection	Both connection bearings are sound. The N beam has lost decay in over 50% of its section from its N bearing and therefore could be considered for replacement.
Beam S Bearing	Sound.
<b>GRID 13</b>	
Beam N Bearing	Sound
Shoe Connection	Both connection bearings are sound. The N Beam has a section of decay at its top edge which may be linked to a sapwood margin (Ob. 21). This decay does not impact the beam structurally.
Beam S Bearing	Sound.
<b>GRID 14</b>	
Beam N Bearing	Sound
Shoe Connection	Both connection bearings are sound.
Beam S Bearing	Sound.
<b>GRID 15</b>	
Beam N Bearing	Sound
Shoe Connection	Both connection bearings are sound.
Beam S Bearing	Sound.

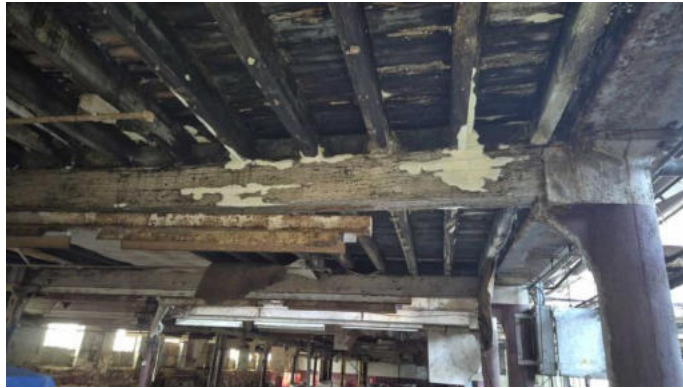
20

The beam and surrounding joists and floorboards have fungal growth.

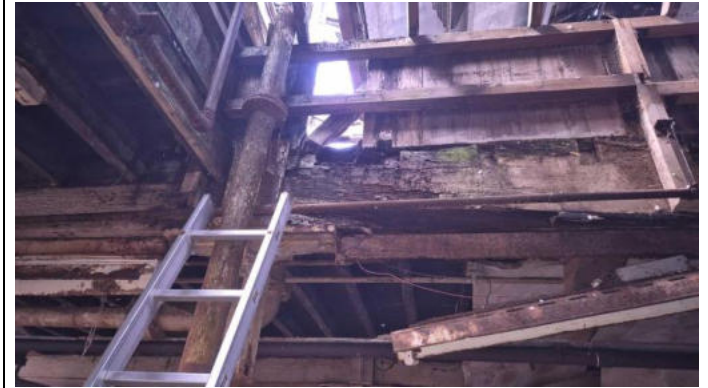
21

The top of the beam above the bearings is very wet with active decay. This may be a sapwood margin as the bearing and remaining section of the beam is sound.

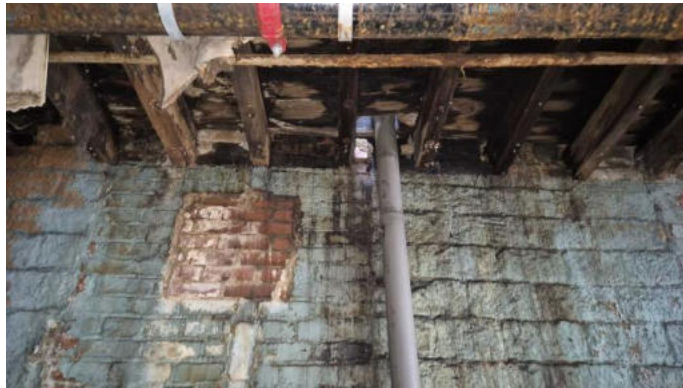
22

The joists bearings have decayed, resulting from the internal downpipe which has led to the wall being damp.

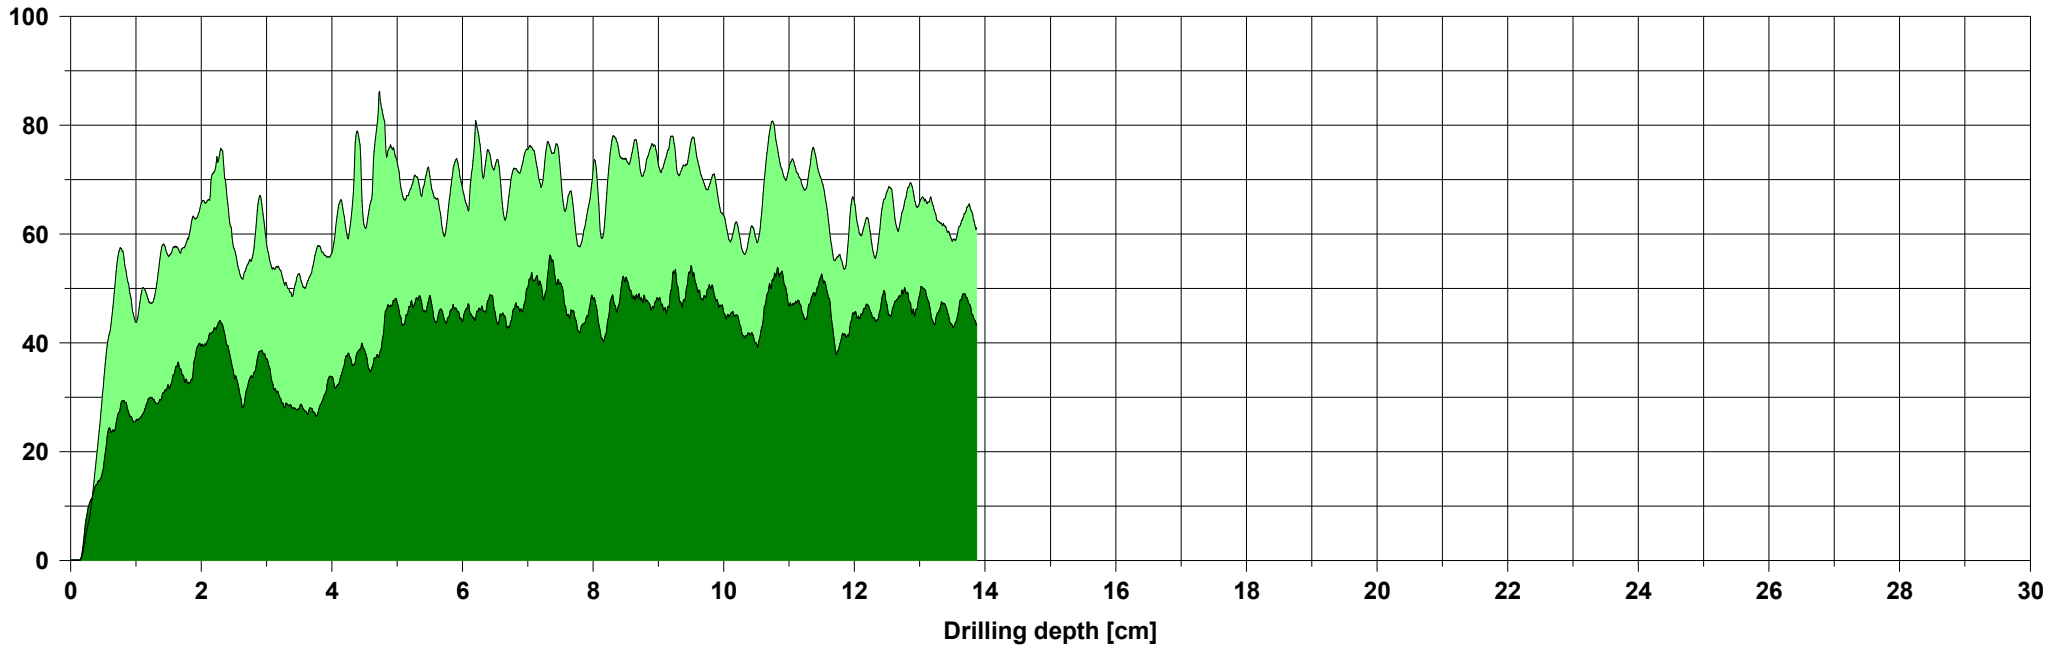
Measurement no.:	1	Speed	: 2500 r/min	Diameter:	
ID number	: BR.R.1.1A	Needle state:	---	Level	:
Drilling depth	: 13,87 cm	Tilt	: +66°	Direction:	
Date	: 01.04.2025	Offset	: 139 / 276	Species	:
Time	: 10:11:28	Avg. curve	: off / off	Location	:
Feed	: 100 cm/min	Name	:

Graph #	Graph ID	Grid	Connection	Position	Comments
1	BR.R.1.1A	1	Truss N bearing	A - Bearing	Trace shows sound timber.
2	BR.R.1.6A	1	Truss S bearing	A - Bearing	Trace shows sound timber.
3	BR.R.2.1A	2	Truss N bearing	A - Bearing	The truss had slight water staining and surface softness. Trace shows sound timber, with resistance increasing in first 100mm.
4	BR.R.2.2A	2	Shoe N Truss	A - Bearing	Trace shows 150mm sound timber.
5	BR.R.2.5A	2	Shoe S Truss	A - Bearing	Trace shows 150mm sound timber.
6	BR.R.2.6A	2	Truss S Bearing	A - Bearing	Trace shows sound timber.
7	BR.R.3.1A	3	Truss N bearing	A - Bearing	Trace shows sound timber.
8	BR.R.3.2A	3	Shoe N Truss	A - Bearing	Trace shows 80mm pocket of decayed timber with 30mm of sound timber either side. The timber was water stained.
9	BR.R.3.2A10	3	Shoe N Truss	A10 - Shoe+1M	Trace shows sound timber with slight decrease in resistance at 140mm drilling depth.

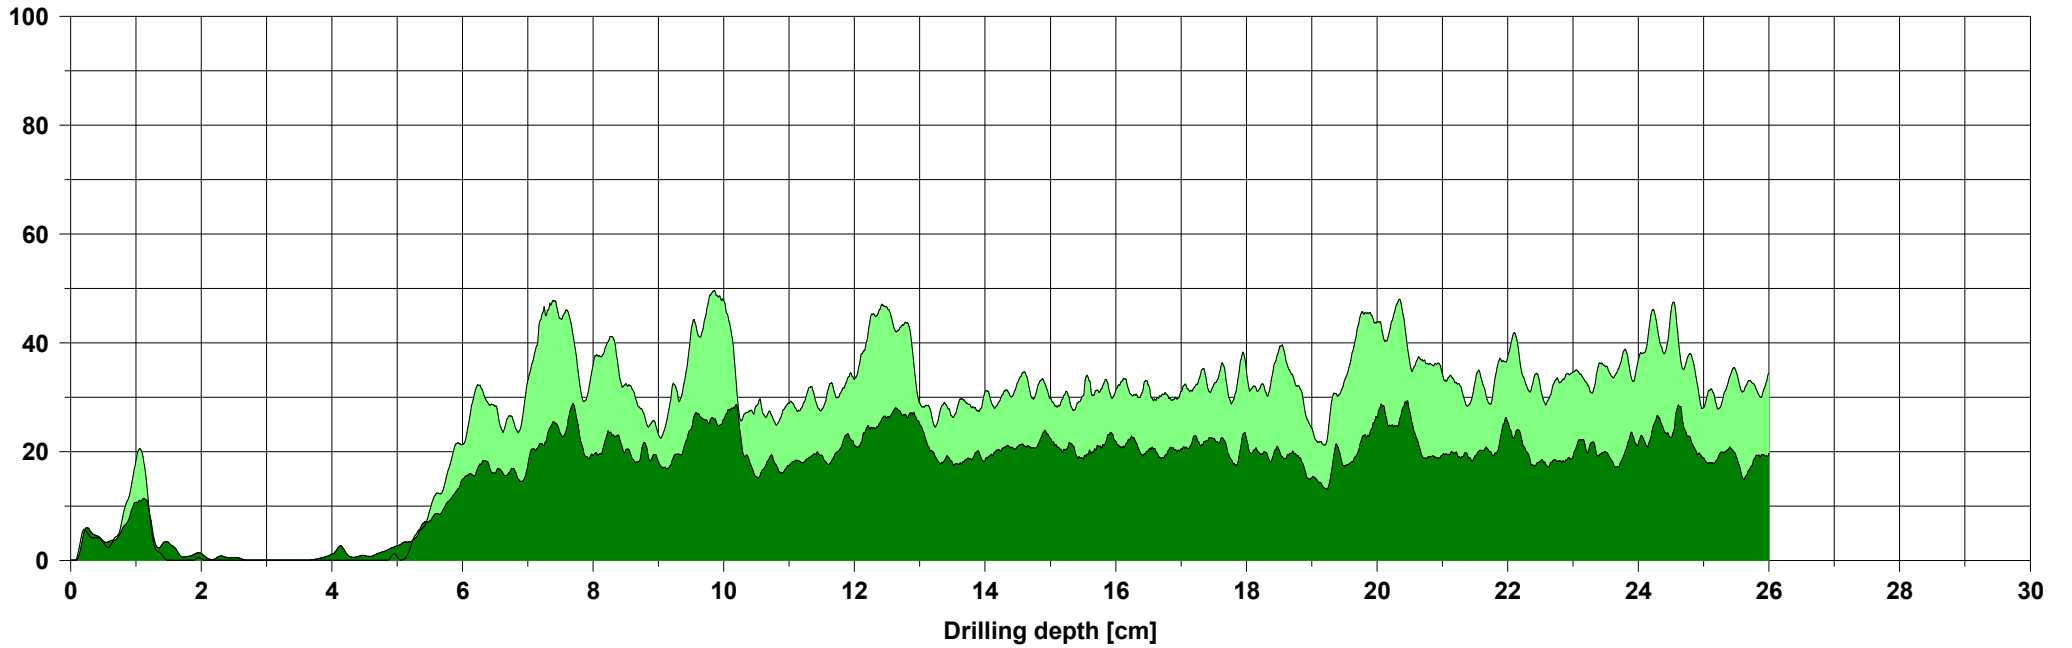
Measurement no.:	12	Speed	: 2500 r/min	Diameter:	
ID number	: BR.R.3.5A3	Needle state:	---	Level	:
Drilling depth	: 26,00 cm	Tilt	: +90°	Direction:	
Date	: 01.04.2025	Offset	: 128 / 261	Species	:
Time	: 10:29:49	Avg. curve	: off / off	Location:	
Feed	: 100 cm/min	Name	:

12	BR.R.3.5A3	3	Shoe S Truss	A3-Shoe+300mm	Trace shows decayed timber for first 50mm with remaining timber sound.
13	BR.R.3.5A6	3	Shoe S Truss	A3-Shoe+600mm	Trace shows sound timber.
14	BR.R.3.6A	3	Truss S Bearing	A - Bearing	Trace shows sound timber.
15	BR.R.4.1A	4	Truss N Bearing	A - Bearing	Trace shows sound timber.
16	BR.R.4.2A	4	Shoe N Truss	A - Bearing	Trace shows 150mm sound timber.
17	BR.R.4.4A	4	Shoe E Valley	A - Bearing	Trace shows sound timber, and the drill exits the timber at 90mm drilling depth.
18	BR.R.4.5A	4	Shoe S Truss	A - Bearing	Trace shows 150mm sound timber.
19	BR.R.4.6A	4	Truss S Bearing	A - Bearing	Trace shows sound timber with high resistance.
20	BR.R.5.1A	5	Truss N Bearing	A - Bearing	Trace shows sound timber. There was a broken window above this bearing and the tie beam and principal rafter had water staining (Ob. 3).
21	BR.R.5.2A3	5	Shoe N Truss	A3-Shoe+300mm	Trace shows sound timber for full section. Tie beam, packer and principal rafter connection was decayed. Principal rafter regained full section after connection.

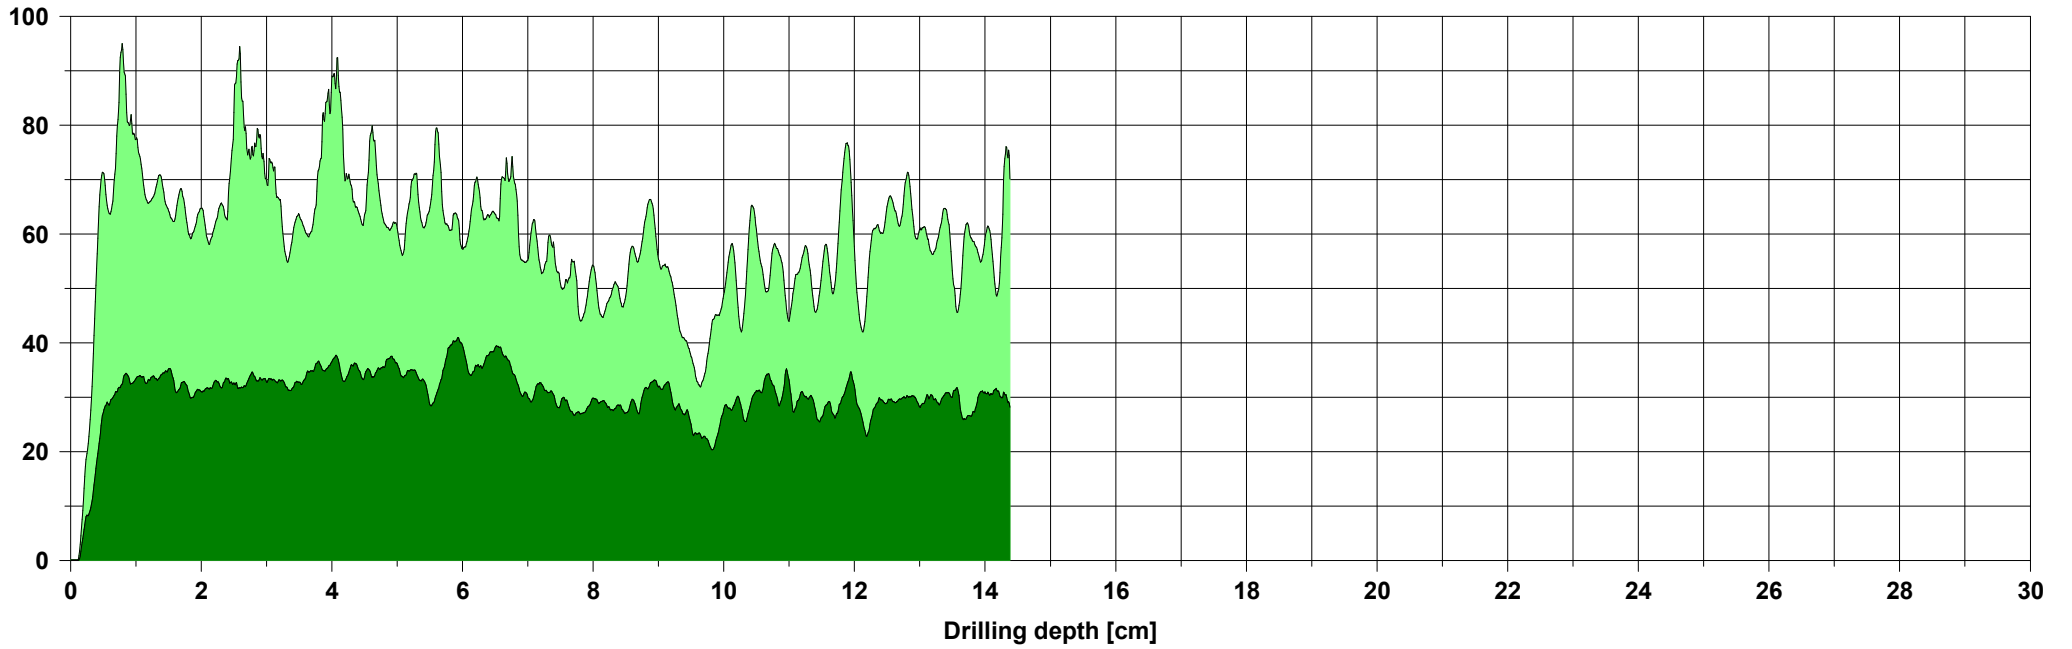
Measurement no.:	24	Speed	: 2500 r/min	Diameter:	
ID number	: BR.R.5.5A	Needle state:	---	Level	:
Drilling depth	: 14,38 cm	Tilt	: +1°	Direction:	
Date	: 01.04.2025	Offset	: 103 / 258	Species	:
Time	: 11:06:05	Avg. curve	: off / off	Location	:
Feed	: 100 cm/min	Name	:

22	BR.R.5.3A	5	Shoe E Valley	A - Bearing	Trace shows 20mm of sound timber, with remaining section decayed.
23	BR.R.5.3A2	5	Shoe E Valley	A2-Shoe+200mm	Trace shows sound timber but with lower resistance.
24	BR.R.5.5A	5	Shoe S Truss	A - Bearing	Trace shows 150mm sound timber. The packer was decayed.
25	BR.R.5.5B	5	Shoe S Truss	B – PR connection	Trace shows an enlarged connection between principal rafter and tie beam. The foot of the principal rafter was decayed, and the top 70mm of the tie beam was decayed for approximately 200mm.
26	BR.R.5.5A0	5	Shoe S Truss	A0 – Bearing 45°	Trace shows sound timber for 210mm.
27	BR.R.5.6A	5	Truss S Bearing	A - Bearing	Trace shows sound timber.
28	BR.R.6.1A	6	Truss N Bearing	A - Bearing	Trace shows sound timber.
29	BR.R.6.2A	6	Shoe N Truss	A - Bearing	Trace shows a 50mm pocket of decay.
30	BR.R.6.2A	6	Shoe N Truss	A1-Shoe+100mm	Trace shows 140mm of sound timber, before the drill bit hits a hard object and retracts.

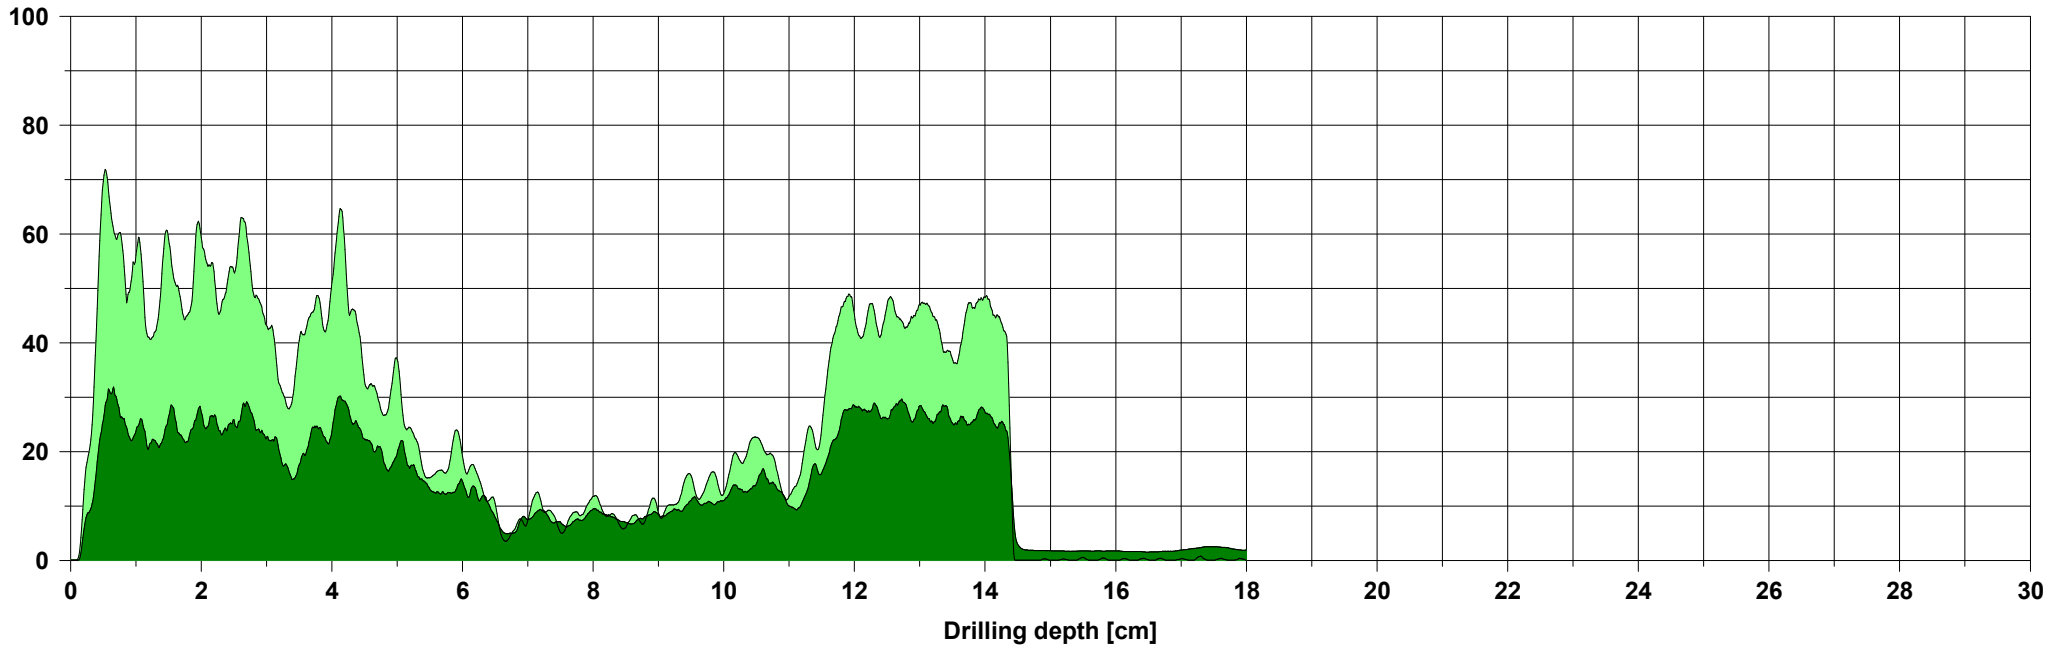
Measurement no.:	32	Speed	: 2500 r/min	Diameter:	
ID number	: BR.R.6.2B	Needle state:	---	Level	:
Drilling depth	: 18,00 cm	Tilt	: +6°	Direction:	
Date	: 01.04.2025	Offset	: 94 / 271	Species	:
Time	: 11:33:35	Avg. curve	: off / off	Location	:
Feed	: 100 cm/min	Name	:

32	BR.R.6.2B	6	Shoe N Truss	B – PR connection	Trace shows a drop in resistance at the connection point.
33	BR.R.6.5A	6	Shoe S Truss	A - Bearing	Trace shows two small pockets of decay of 20mm each, with sound timber between. The packer was sound.
34	BR.R.6.5A1	6	Shoe S Truss	A1-Shoe+100mm	Trace shows sound timber.
35	BR.R.6.5B	6	Shoe S Truss	B – PR connection	Trace shows sound timber with a slightly enlarged connection between 60-80mm drilling depth. The top of the principal rafter had fungal growth.
36	BR.R.6.6A	6	Truss S Bearing	A - Bearing	Trace shows sound timber.
37	BR.R.7.1A	7	Truss N Bearing	A - Bearing	Trace shows sound timber for 180mm, until the drill bit hits a hard object and retracted. The top of tie beam was wet and soft on the surface.
38	BR.R.7.2A	7	Shoe N Truss	A - Bearing	Trace shows 150mm sound timber.
39	BR.R.7.4A	7	Shoe E Valley	A - Bearing	Trace shows 110mm of sound timber, before the drill bit exits.
