Bat Survey Report

New Mills, Marsden

Presented to: Crowther Bruce and Co Limited

Issued: October 2025

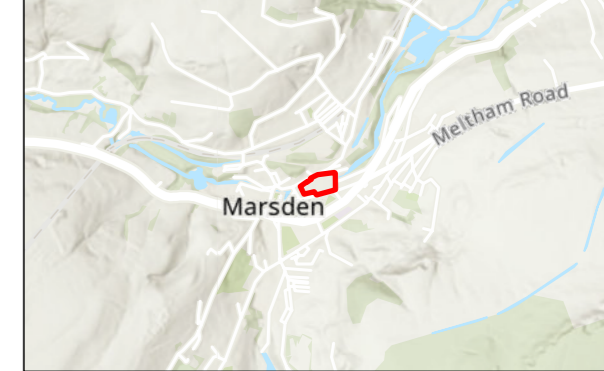
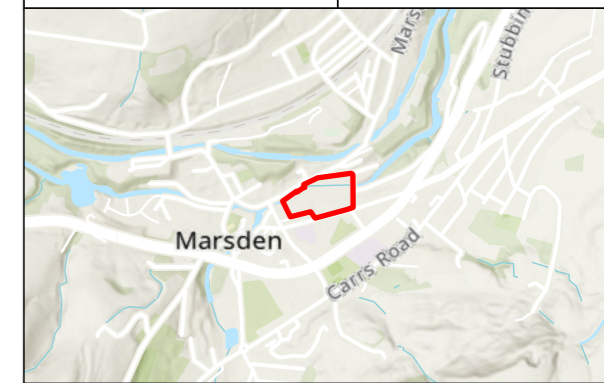
Figure 4 – Location of Surveyors and Results of the Dusk Emergence Survey on the 25th of June 2025

Figure Location of Surveyors and Results of the Dusk Emergence Survey on the 25th of June 2025			
Job New Mills, Marsden			
Client Rex Procter & Partners			
Figure No.	4	Revision	A
		Date	21/10/2025
Drawn	GC	Checked	JG
		Scale	1:750 @ A3
Job No.	133460.678976		Central GR 405022E 411696N

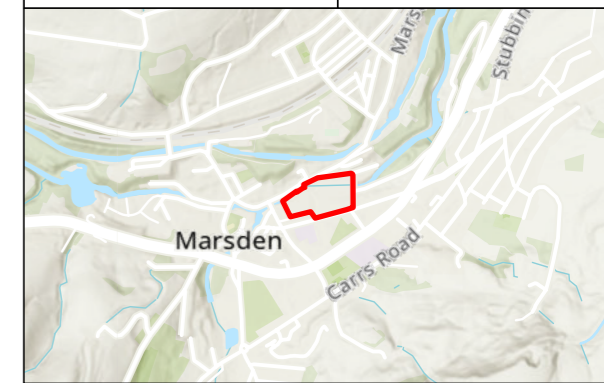
Figure 8 – Bat Roost Locations 2025

Seven confirmed and potential roosts were recorded during the surveys, details of which are provided in Table 3 below, and are shown in Figure 8.

Roost Reference	Location	Species	Peak count	Roost Classification	Photograph Reference
1	Building BC / BD.1	Common pipistrelle	17	Possible maternity roost	Photograph 1
2	Building BL	Pipistrelle	1	Day roost	Photograph 2
3	Building BG	Common pipistrelle	2	Day roost	
4	Building BE.1*	Common pipistrelle	1	Day roost	Photograph 3
5		Common pipistrelle	1	Day roost	Photograph 3
6	Building BF.1	Common pipistrelle	2	Day roost	
7	Building BD.1	Common pipistrelle	1	Day roost	Photograph 1
