GEO-ENVIRONMENTAL REPORT

Report on a Phase 2 Geo-environmental Investigation

Location:	Spa Fields Industrial Estate Slaithwaite, Huddersfield	
For:	DM Textile Machinery Ltd.	
Consultants:	Farrar Bamforth Associates Ltd.	
Report No.	C4272/24/E/6581	Report date: March 2025

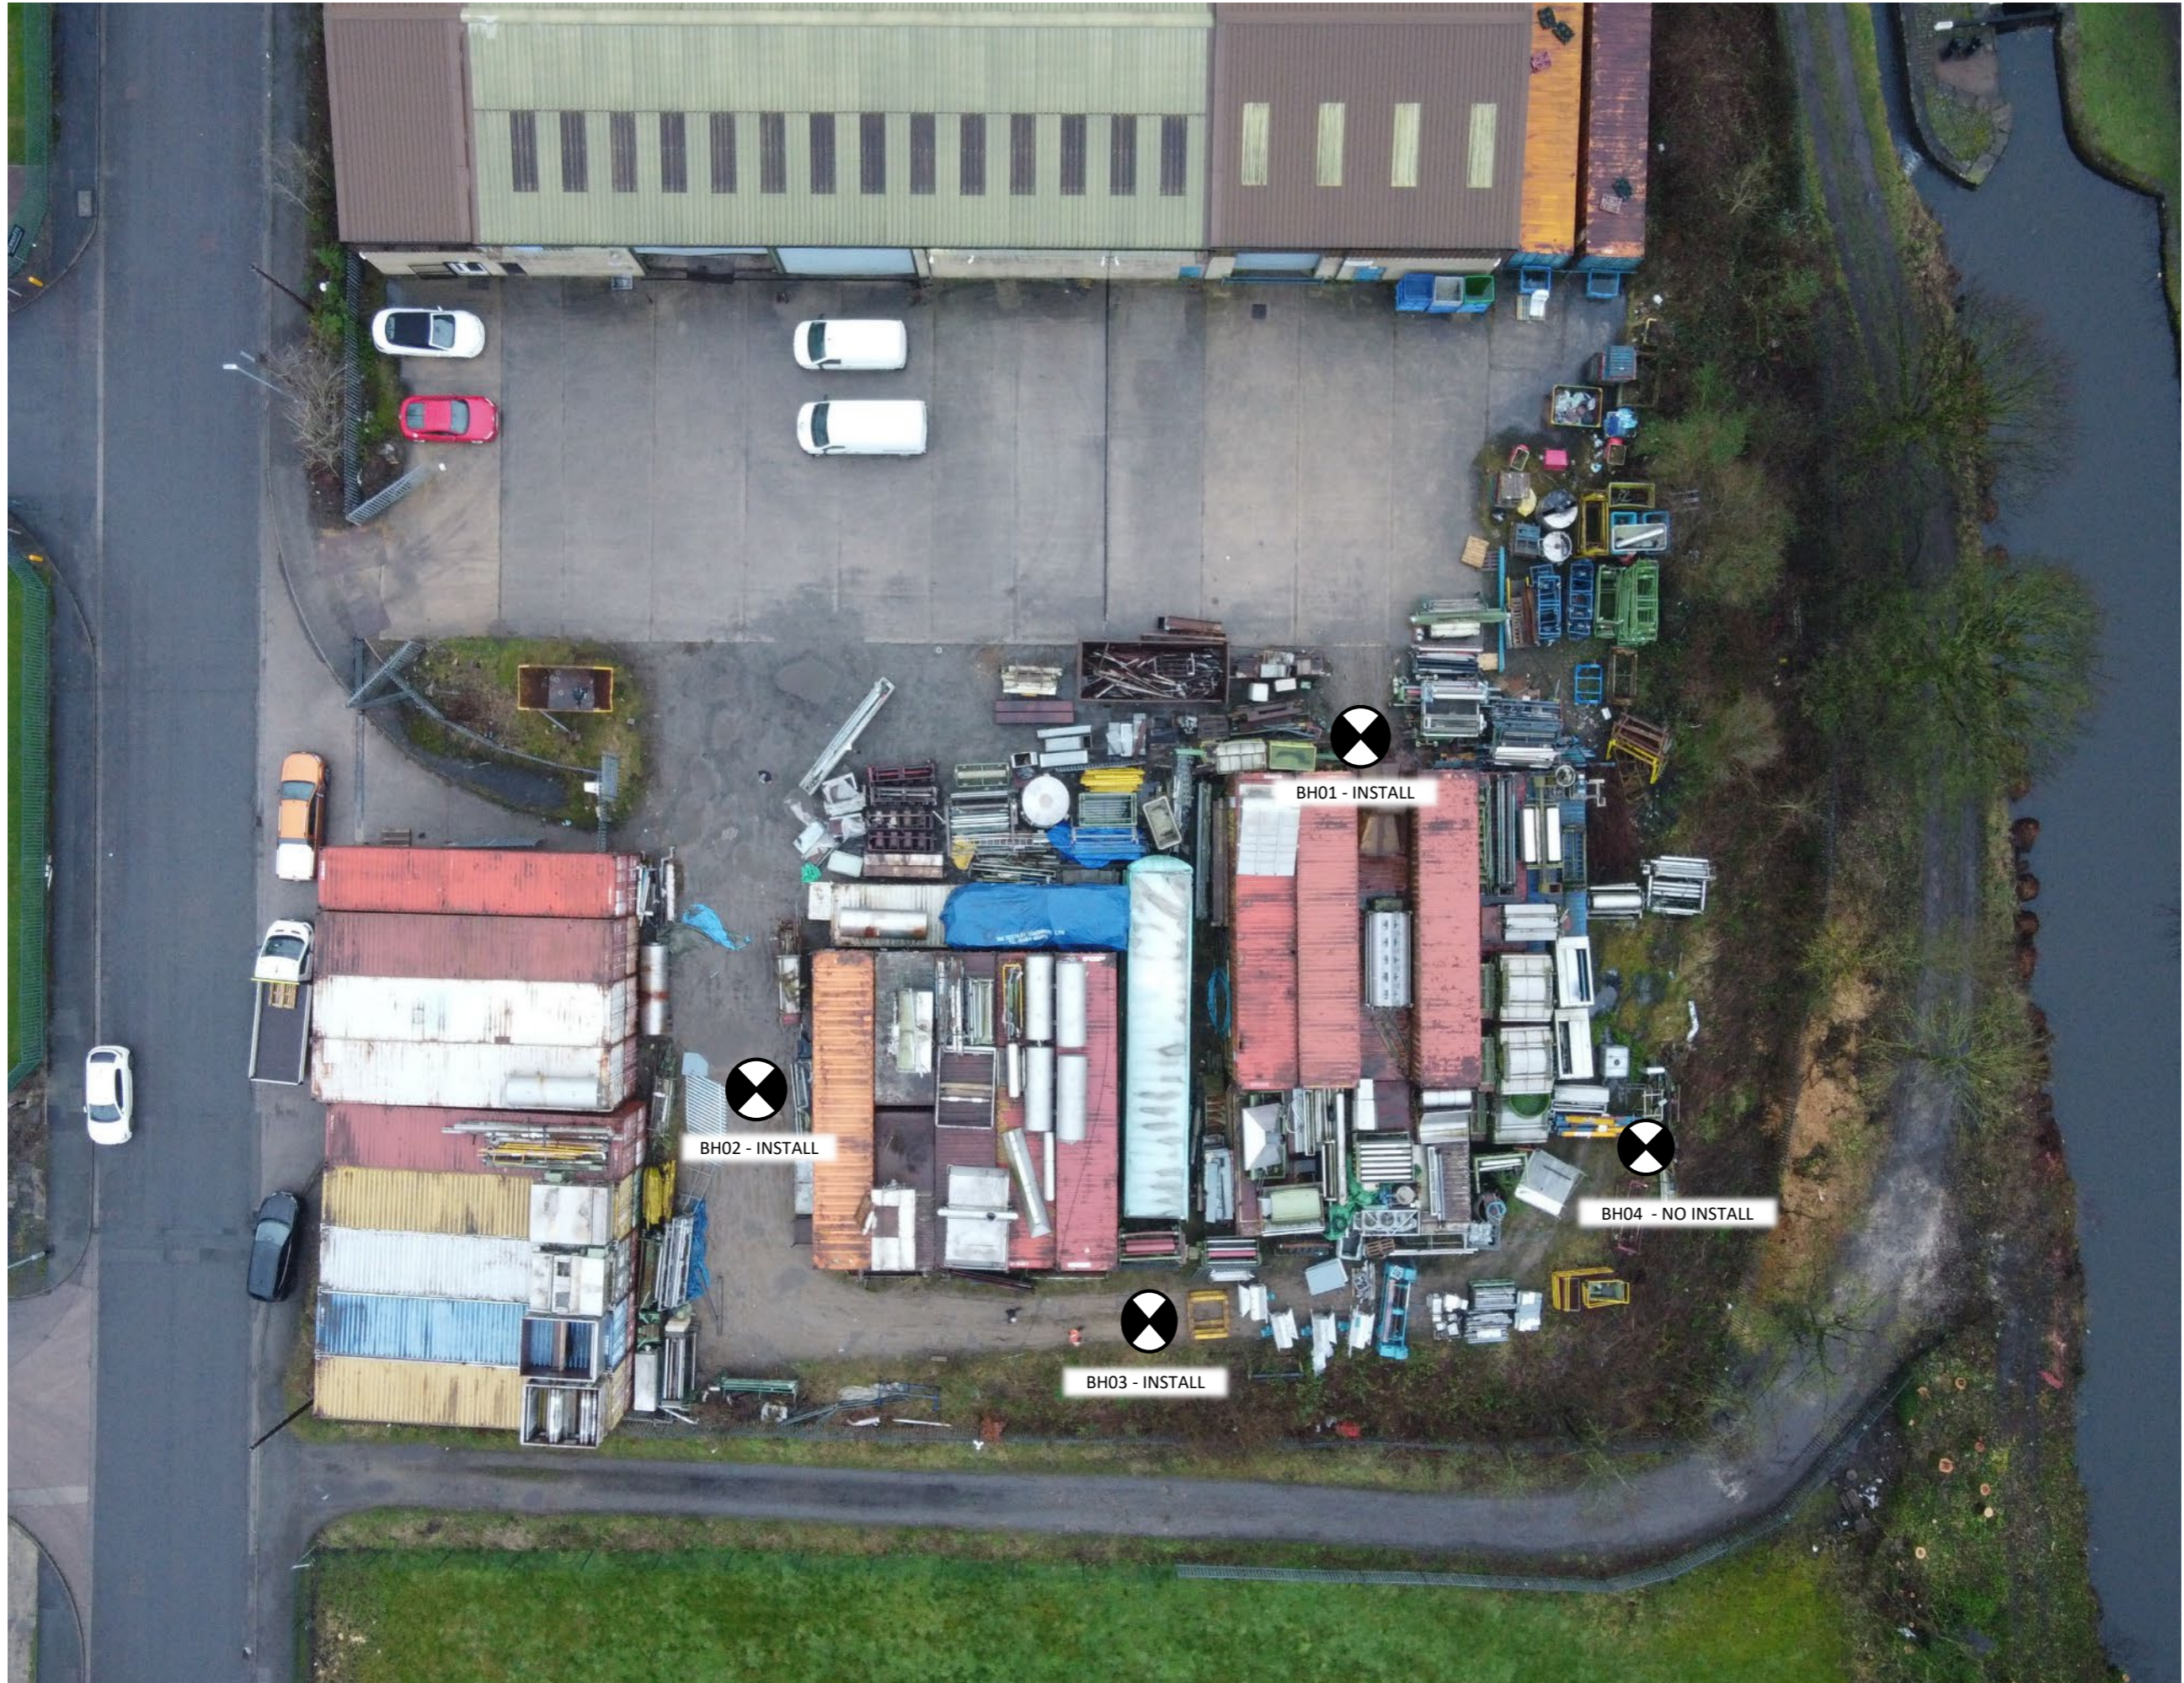
Site Plan

Investigation positions approximated from site operative's notes.

The investigatory locations are shown on the site plan which is presented in Appendix 1 to this report.
