## 1.0 EXECUTIVE SUMMARY

- 2.2 ARP Geotechnical Ltd was appointed by Gleeson Homes Ltd to carry out the investigation, which involved a desk study assessment of the geological and coal mining aspects, Ordnance Survey archive maps, radon gas, indicative flood risk, hydrogeology, landfill, and other environmental issues, primarily by assessment of a Landmark Envirocheck Report. This was supplemented by an intrusive investigation to assess the ground conditions.

Project	COCKLEY HILL, KIRKHEATON	
Client	GLEESON HOMES LTD	
Title	SITE LOCATION PLAN	
Date	AUGUST 2025	
Drawn	OG	Scale AS SHOWN
Job No.	GHO/11

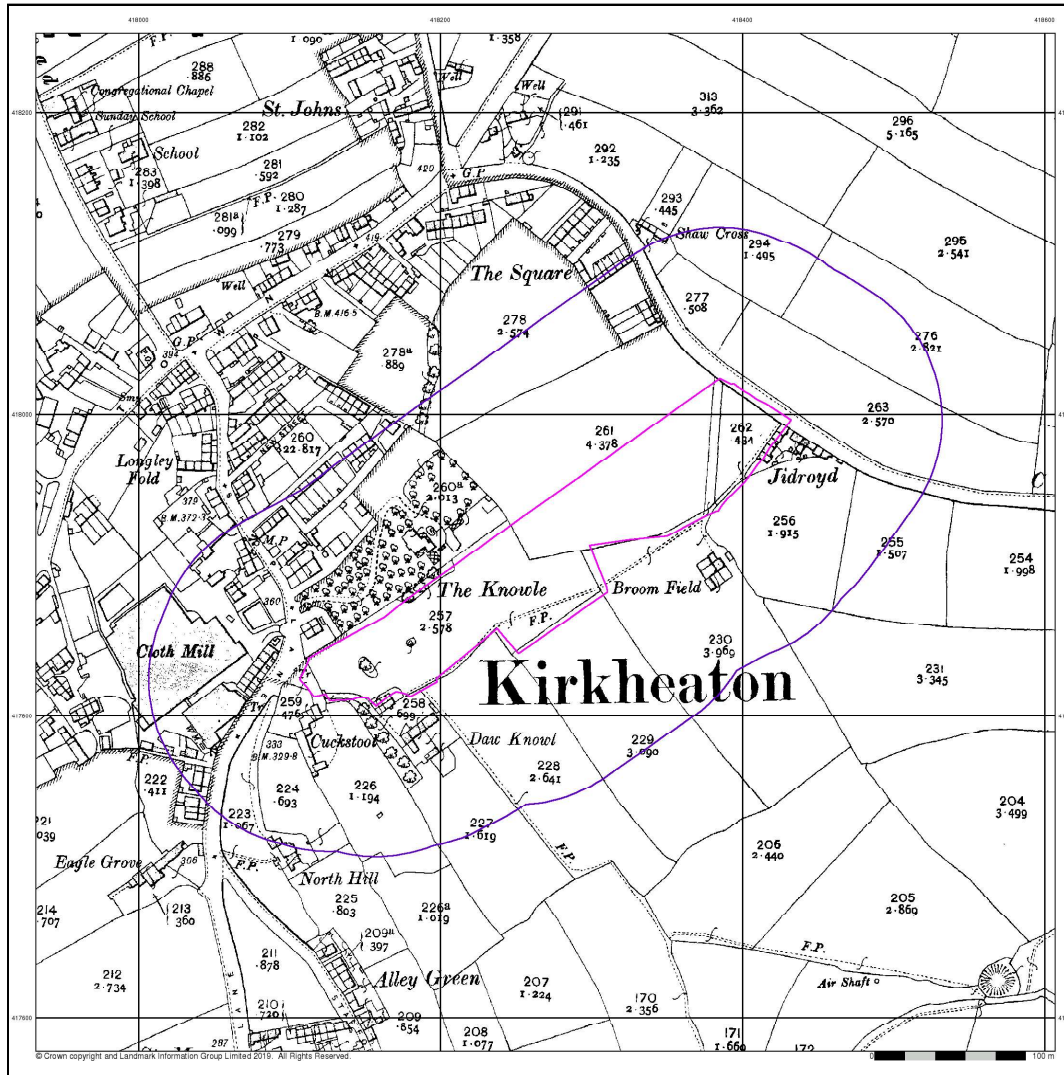
**Yorksire**  
**Published 1907**  
**Source map scale - 1:2,500**

The historical maps shown were reproduced from maps predominantly held at the scale adopted for England, Wales and Scotland in the 1840's. In 1854 the 1:2,500 scale was adopted for mapping urban areas and by 1886 it covered the whole of what were considered to be the cultivated parts of Great Britain. The published date given below is often some years later than the surveyed date. Before 1938, all OS maps were based on the Cassini Projection, with independent surveys of a single county or group of counties, giving rise to significant inaccuracies in outlying areas.

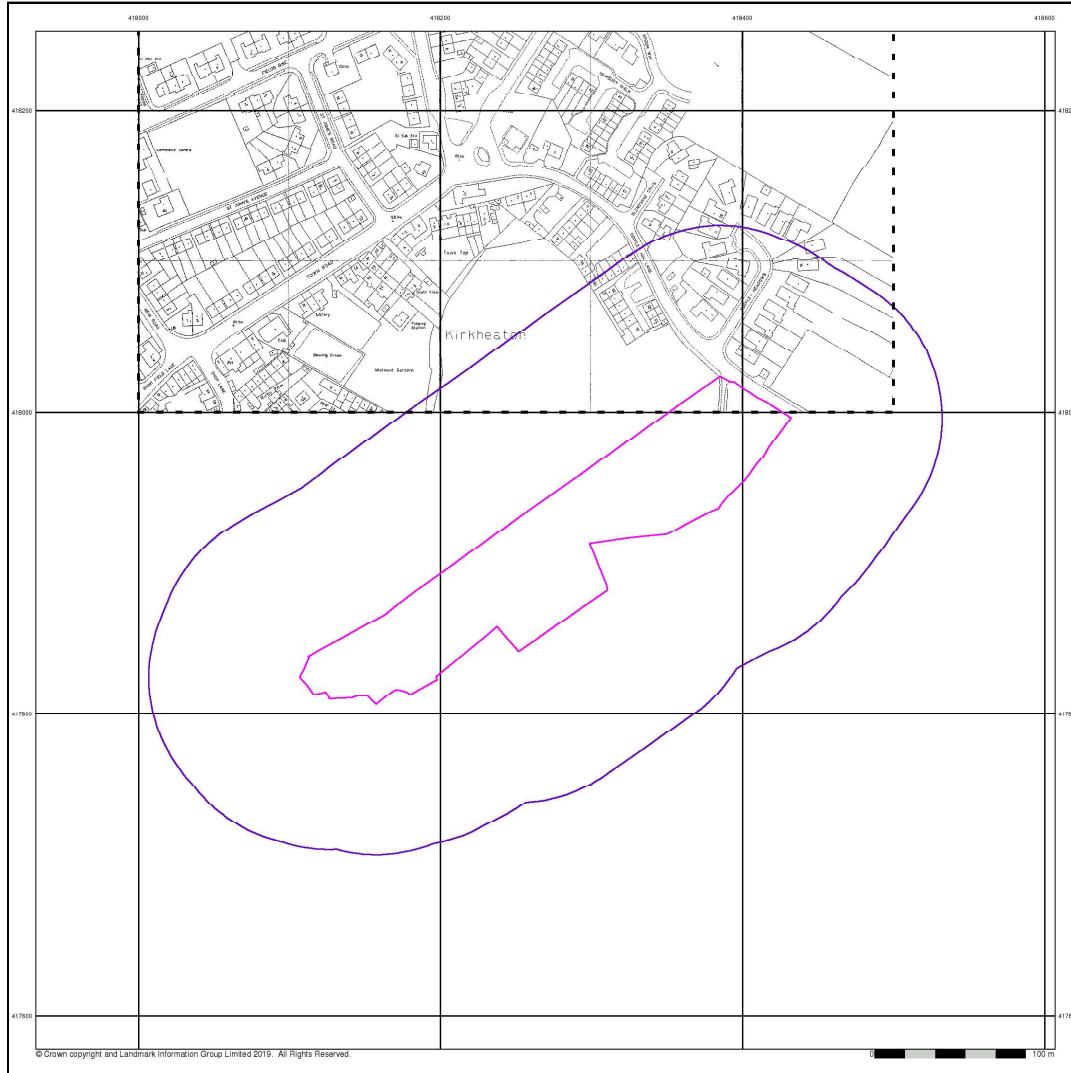
**Large-Scale National Grid Data**  
**Published 1994**  
**Source map scale - 1:1,250**

'Large Scale National Grid Data' superseded SIM cards (Ordnance Survey's 'Survey of Information on Microfilm') in 1992, and continued to be produced until 1999. These maps were the fore-runners of digital mapping and so provide detailed information on houses and roads, but tend to show less topographic features such as vegetation. These maps were produced at both 1:2,500 and 1:1,250 scales.

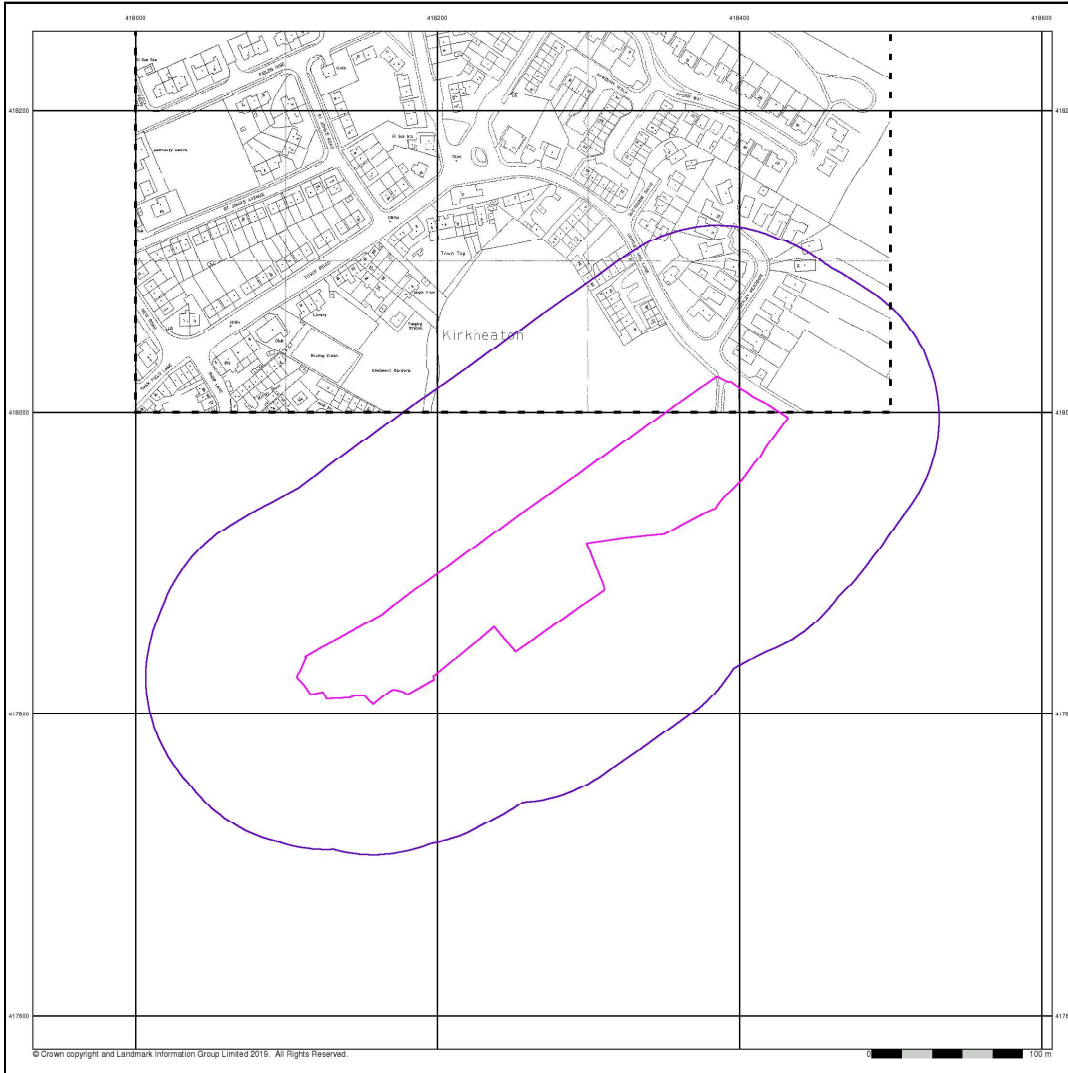
**Large-Scale National Grid Data**  
**Published 1995**  
**Source map scale - 1:1,250**

'Large Scale National Grid Data' superseded SIM cards (Ordnance Survey's 'Survey of Information on Microfilm') in 1992, and continued to be produced until 1999. These maps were the fore-runners of digital mapping and so provide detailed information on houses and roads, but tend to show less topographic features such as vegetation. These maps were produced at both 1:2,500 and 1:1,250 scales.
