Rev	Details	By	Date
P1	Preliminary Issue	MKN	21.01.2025
<b>masonclarkassociates</b> civil and structural engineering consultants			
Client: Kirklees Council			
Project: Oakwell Hall			
Title: Drainage Defects GA - Sheet 1 of 2			
Drawn: MKN	Checked: CB	Date: Jan 2026	
Scale @ A1: 1:200			
Drawing No: 22333-Y-DR-201			Rev: P1

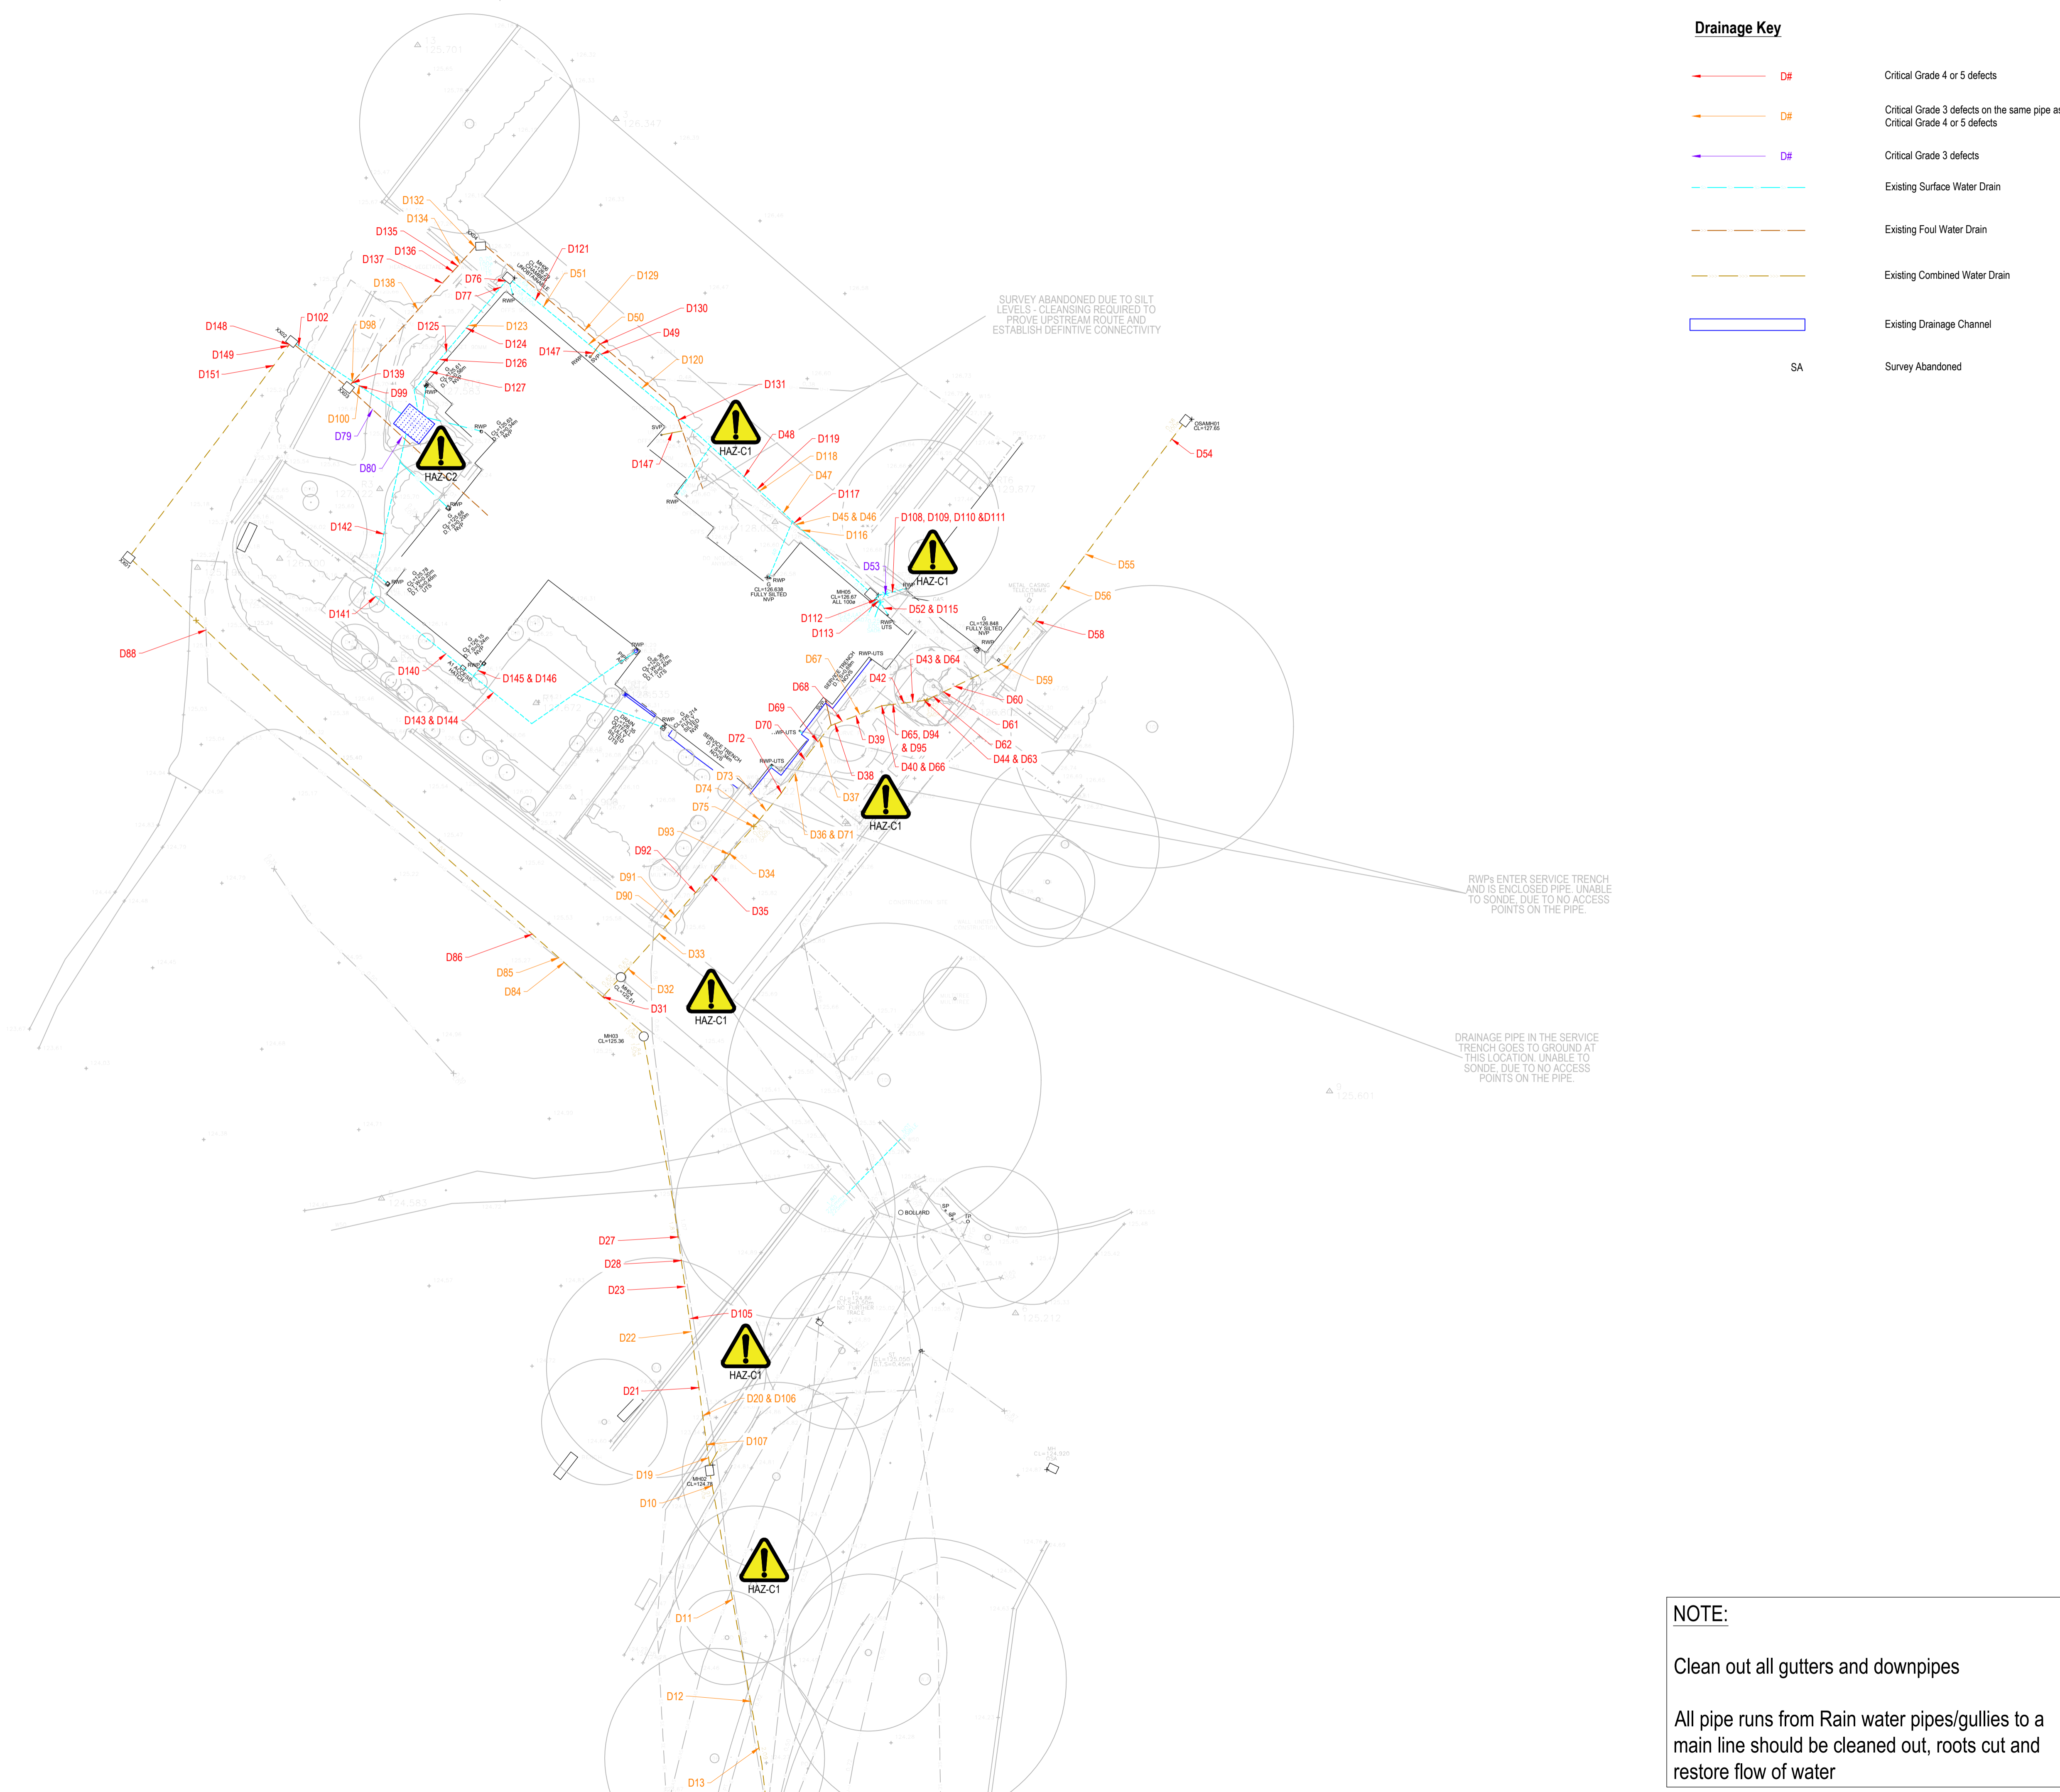
D#	Critical Grade 4 or 5 defects
	D#	Critical Grade 3 defects on the same pipe as Critical Grade 4 or 5 defects
	D#	Critical Grade 3 defects
		Existing Surface Water Drain
		Existing Foul Water Drain
		Existing Combined Water Drain
		Existing Drainage Channel
	SA	Survey Abandoned

- This Drawing only includes defects categorised as Grade 3 or higher within the CCTV Surveys as per the Defect Grade Description in the Met Consultancy Group Ltd CCTV report. The grade is shown both on this plan and in the Critical drainage remediation schedule.

- Where CCTV does not indicate an upstream MH reference, for example at SVPs, a branch connection from the downstream chamber has been marked but the actual pipe run is to be confirmed on site.

RWP'S ENTER SERVICE TRENCH AND IS ENCLOSED PIPE. UNABLE TO SONDE, DUE TO NO ACCESS POINTS ON THE PIPE.

DRAINAGE PIPE IN THE SERVICE TRENCH GOES TO GROUND AT THIS LOCATION. UNABLE TO SONDE, DUE TO NO ACCESS POINTS ON THE PIPE.

Clean out all gutters and downpipes

All pipe runs from Rain water pipes/gullies to a main line should be cleaned out, roots cut and restore flow of water
