# Phase 2: Site Investigation

Milnsbridge, Huddersfield

Dempsey & Gannon

S240420

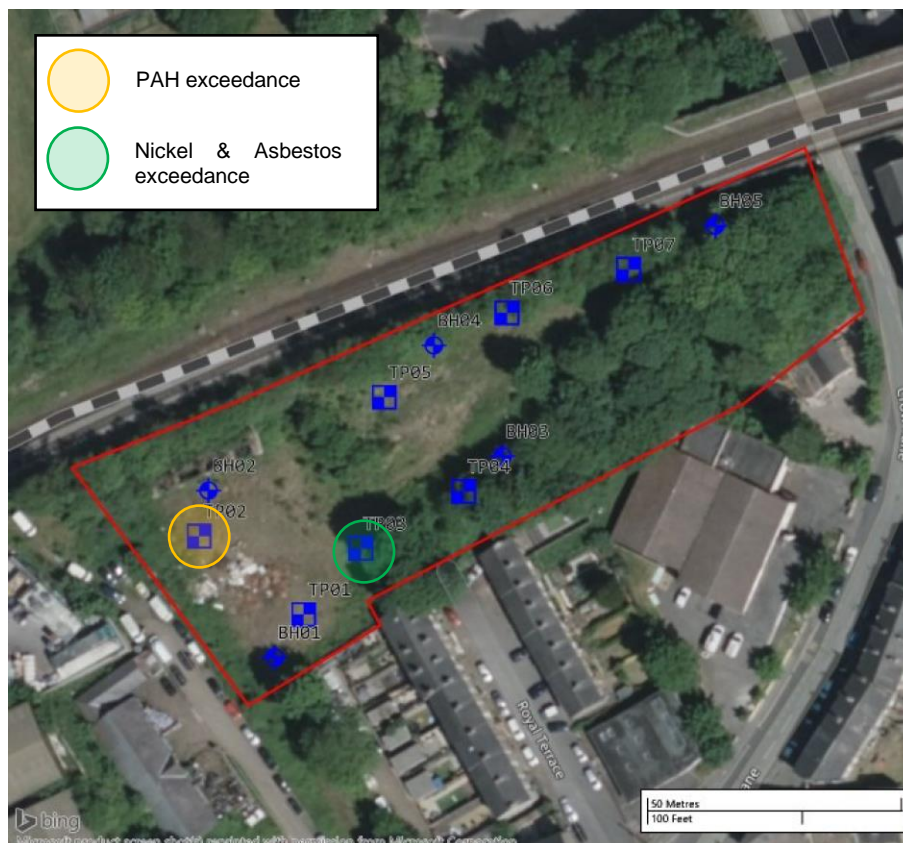
**FIGURE B: ELEVATED CONTAMINATION LOCATIONS**

- TP02 - 0.10-0.20m (Made Ground – granular) recorded elevated benzo(b)fluoranthene, benzo(a)pyrene, dibenz(a,h)anthracene and total PAH
- TP03 - 1.00-1.10m (Made Ground – granular) recorded elevated levels of nickel and asbestos (chrysotile)

The location of the samples which recorded elevated contamination are shown below on Figure B, based on the 6no samples tested to date.

The new development is expected to comprise industrial units with associated access roads and parking. Based on the **shallow** soil contamination testing, it is considered that the levels of contamination are unlikely to pose a risk to future users of the site, as all contaminated areas will be covered either by buildings or hardstanding.

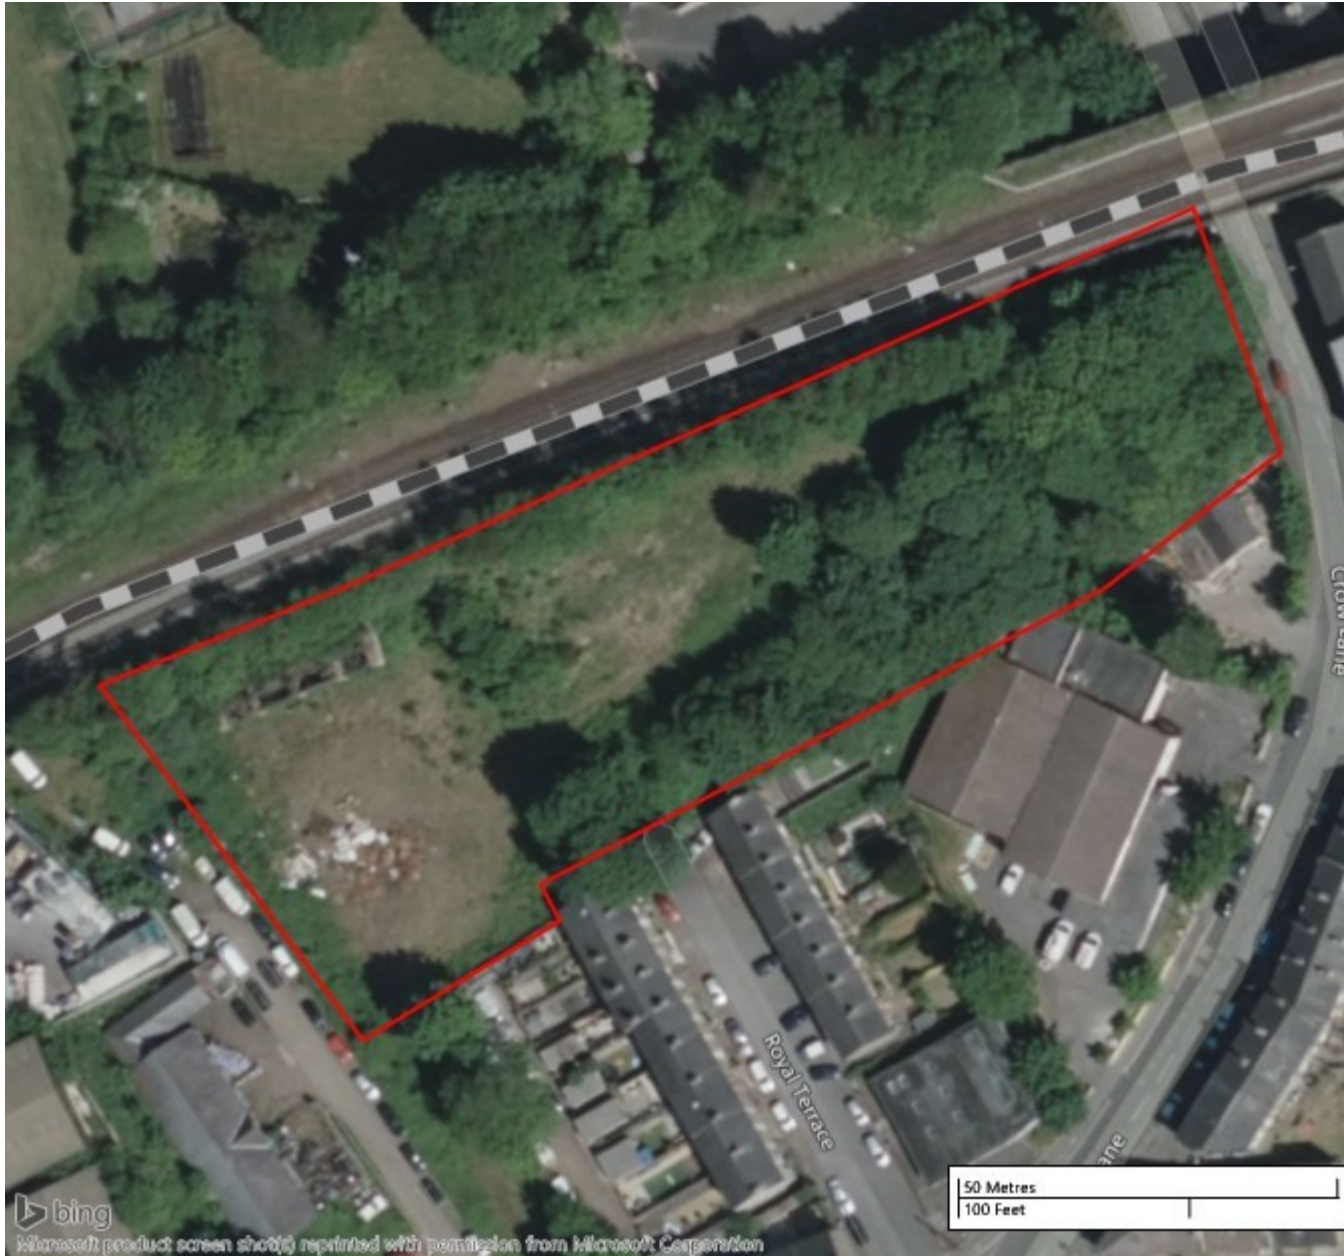
<b>Figure Title</b>
Site Boundary
<b>Project Number</b>
S240420
<b>Project Name</b>
Milnsbridge, Huddersfield
<b>Client</b>
Dempsey and Gannon
<b>Date</b>
June 2024
<b>DRG Number</b>
Figure 1
<b>Scale</b>
1:1000 @ A4 [DO NOT SCALE]

The site investigation described in this report was carried out by Solmek to the instructions of Dempsey & Gannon, on land located at Royal Terrace, Milnsbridge, Huddersfield, HD3 4PL (Figure 1).

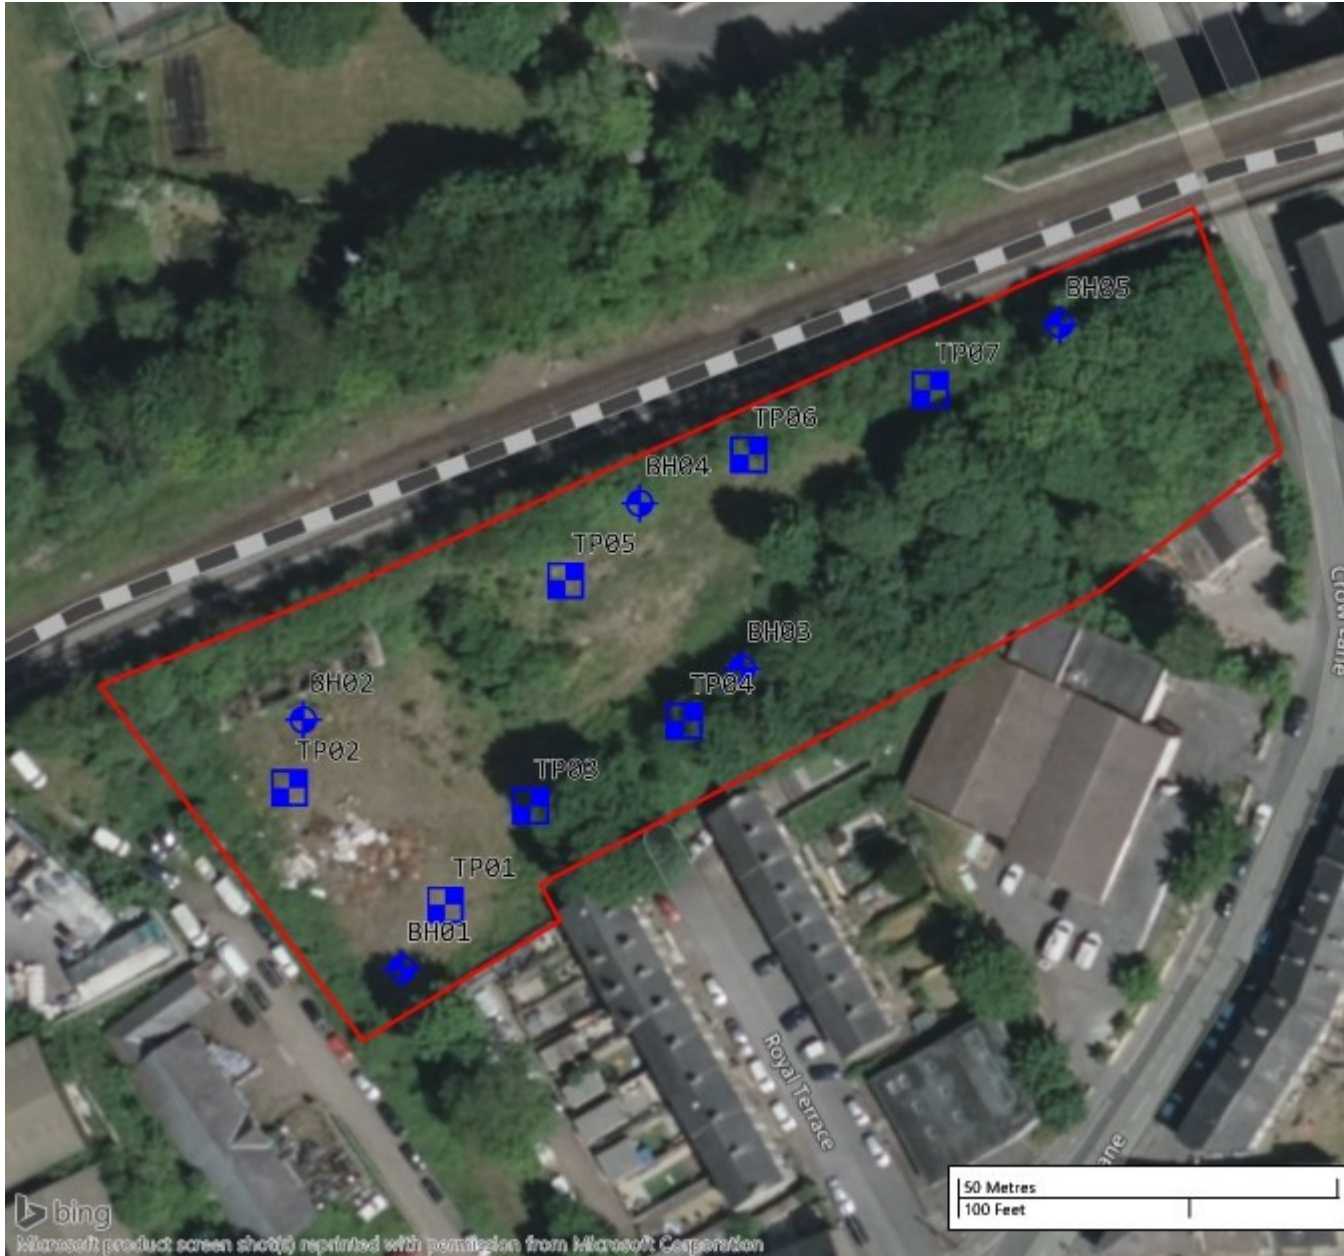
A plan showing the location of the boreholes and trial pits can be found in Appendix A (Figure 2).

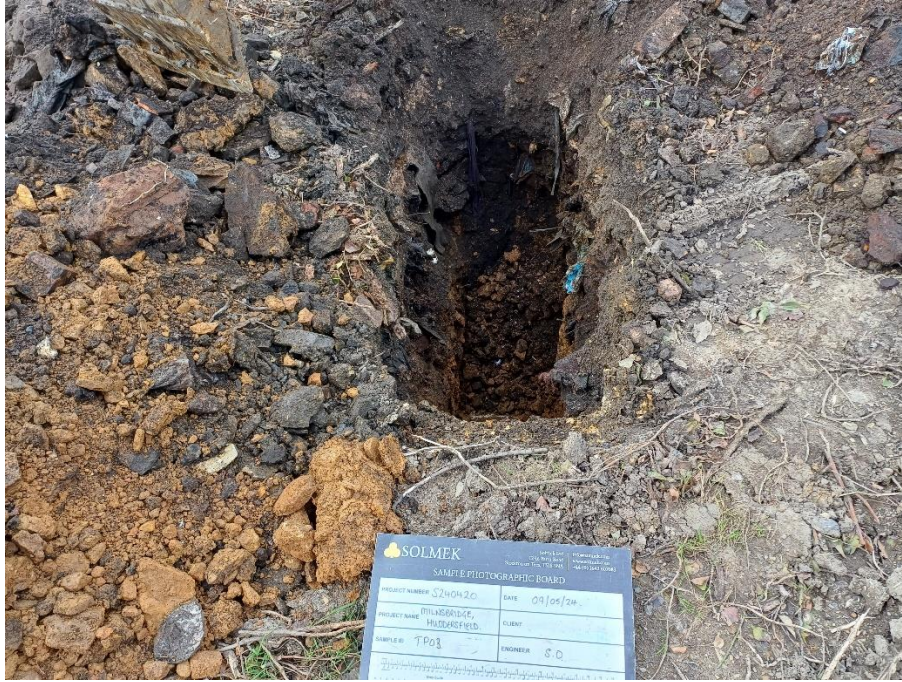
TP03 - Pit

From the six samples subject to asbestos screening, asbestos fibres were recorded in one sample TP03 – 1.00-1.10mbgl. The asbestos fibres found comprised Chrysotile (white) fibre bundles. The sample was sent for quantification testing, with the results indicating the samples comprised 0.005% asbestos by mass.

Based on the guidance set forth in the Interdepartmental Committee for the Redevelopment of Contaminated Land (ICRCL), 1990, Guidance note 64/85 *Asbestos on Contaminated Sites* asbestos contaminated soil should be considered as a hazardous waste if the percentage by mass exceeds 0.1%. Should it have a mass of >0.001% it is considered as a risk to human health. Given that the sample showed 0.005% by mass it is possible that the soil may present a risk to human health.

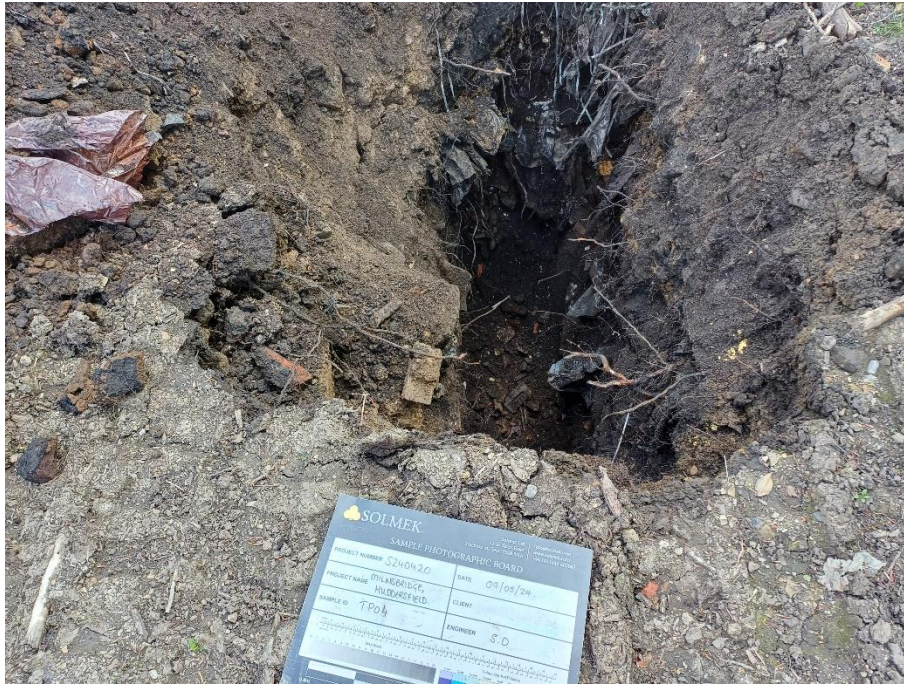
TP04 - Pit

Towards the centre of the site along the southern boundary, made ground was noted from surface to between 1.30 and 3.50m in thickness with composition akin to landfill. Within BH03 and TP04, the base of the made ground was not proven, with these positions terminating at 1.60 and 3.50mbgl, respectively.

Locally (TP03, TP04 & BH03 in the south of the site) deeper made ground was recorded to at least 3.50mbgl with the base not proven. It is understood that no buildings are proposed for this area, however, should the site layout change, mini-piled foundations will be required.

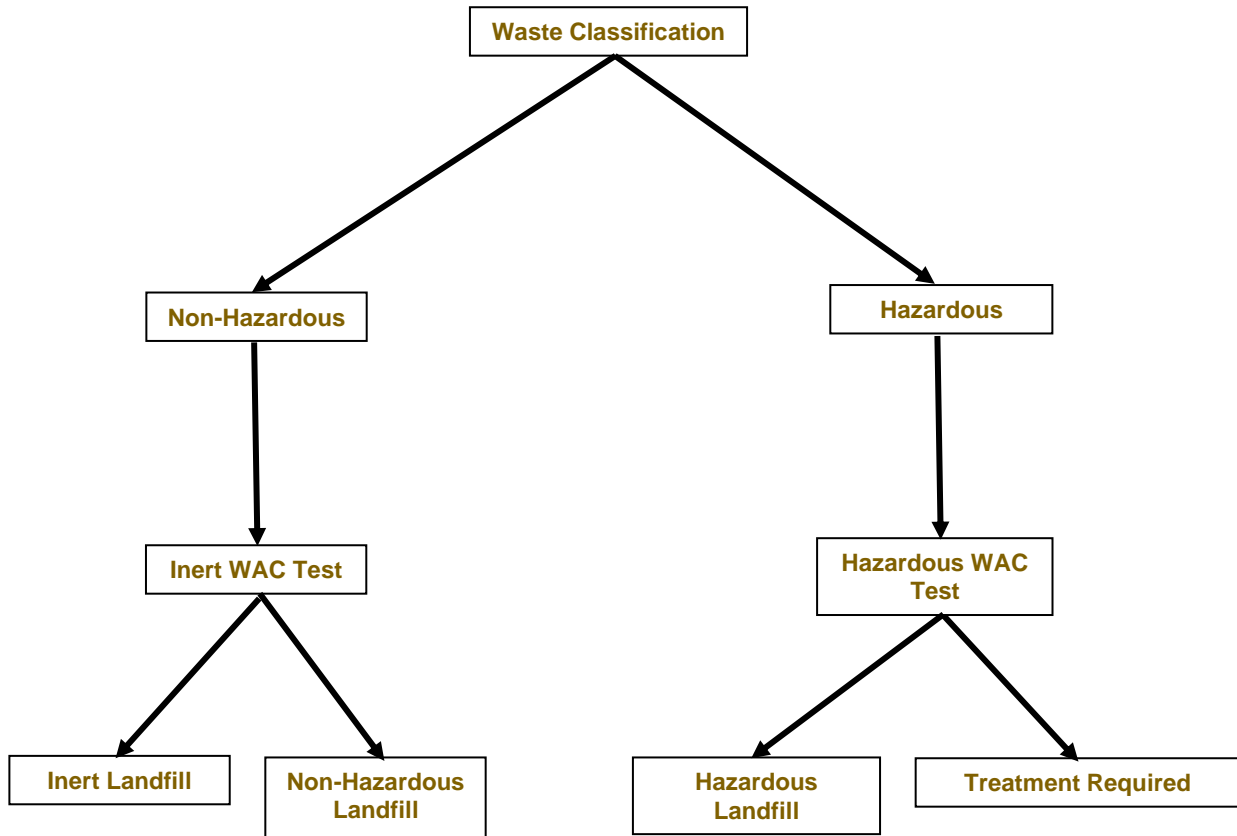
The below flow chart provides further information on the waste classification process.
