**COMBINED STAGE 1/STAGE 2
GEO-ENVIRONMENTAL REPORT**

**AT
COCKLEY HILL LANE
KIRKHEATON

ON BEHALF OF
GLEESON HOMES LTD**

CLIENT: GLEESON HOMES LTD
JOB NUMBER: GHO/11
PROJECT: COCKLEY HILL LANE, KIRKHEATON
REPORT TYPE: COMBINED STAGE 1/STAGE 2 GEO-ENVIRONMENTAL REPORT
REPORT REFERENCE: GHO/11r1

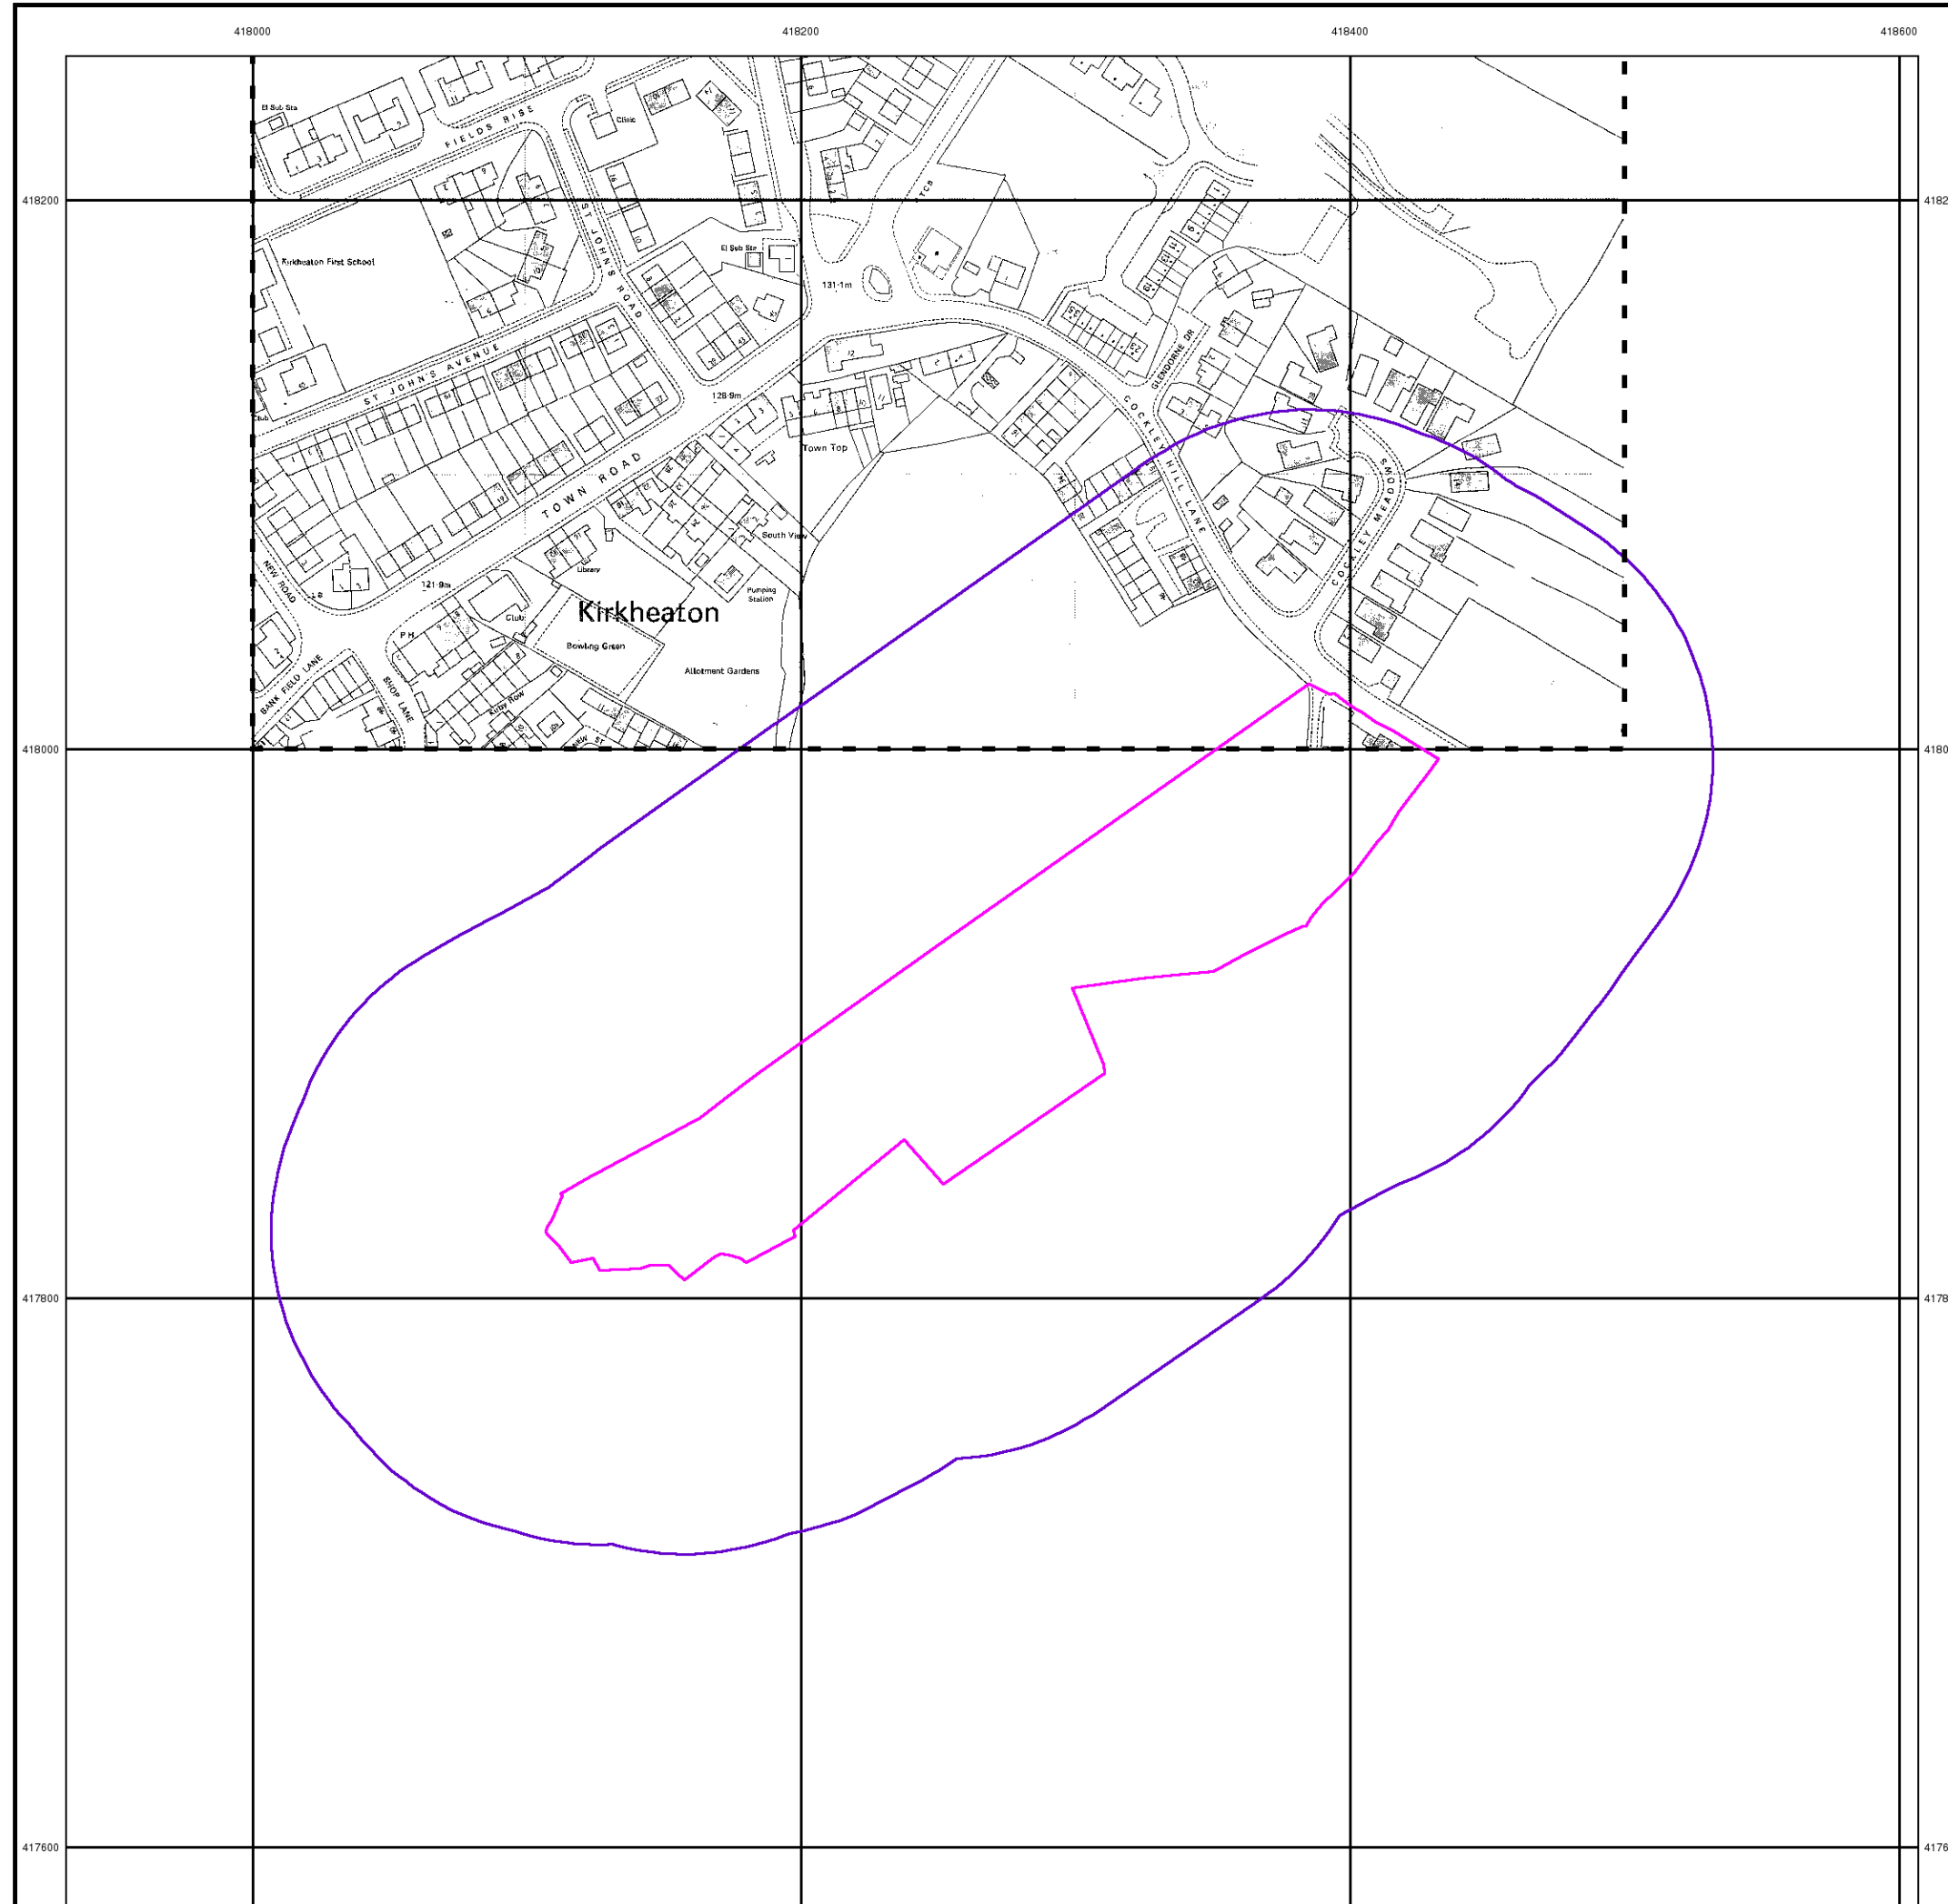
**Additional SIMs
Published 1992
Source map scale - 1:1,250**

The SIM cards (Ordnance Survey's 'Survey of Information on Microfilm') are further, minor editions of mapping which were produced and published in between the main editions as an area was updated. They date from 1947 to 1994, and contain detailed information on buildings, roads and land-use. These maps were produced at both 1:2,500 and 1:1,250 scales.

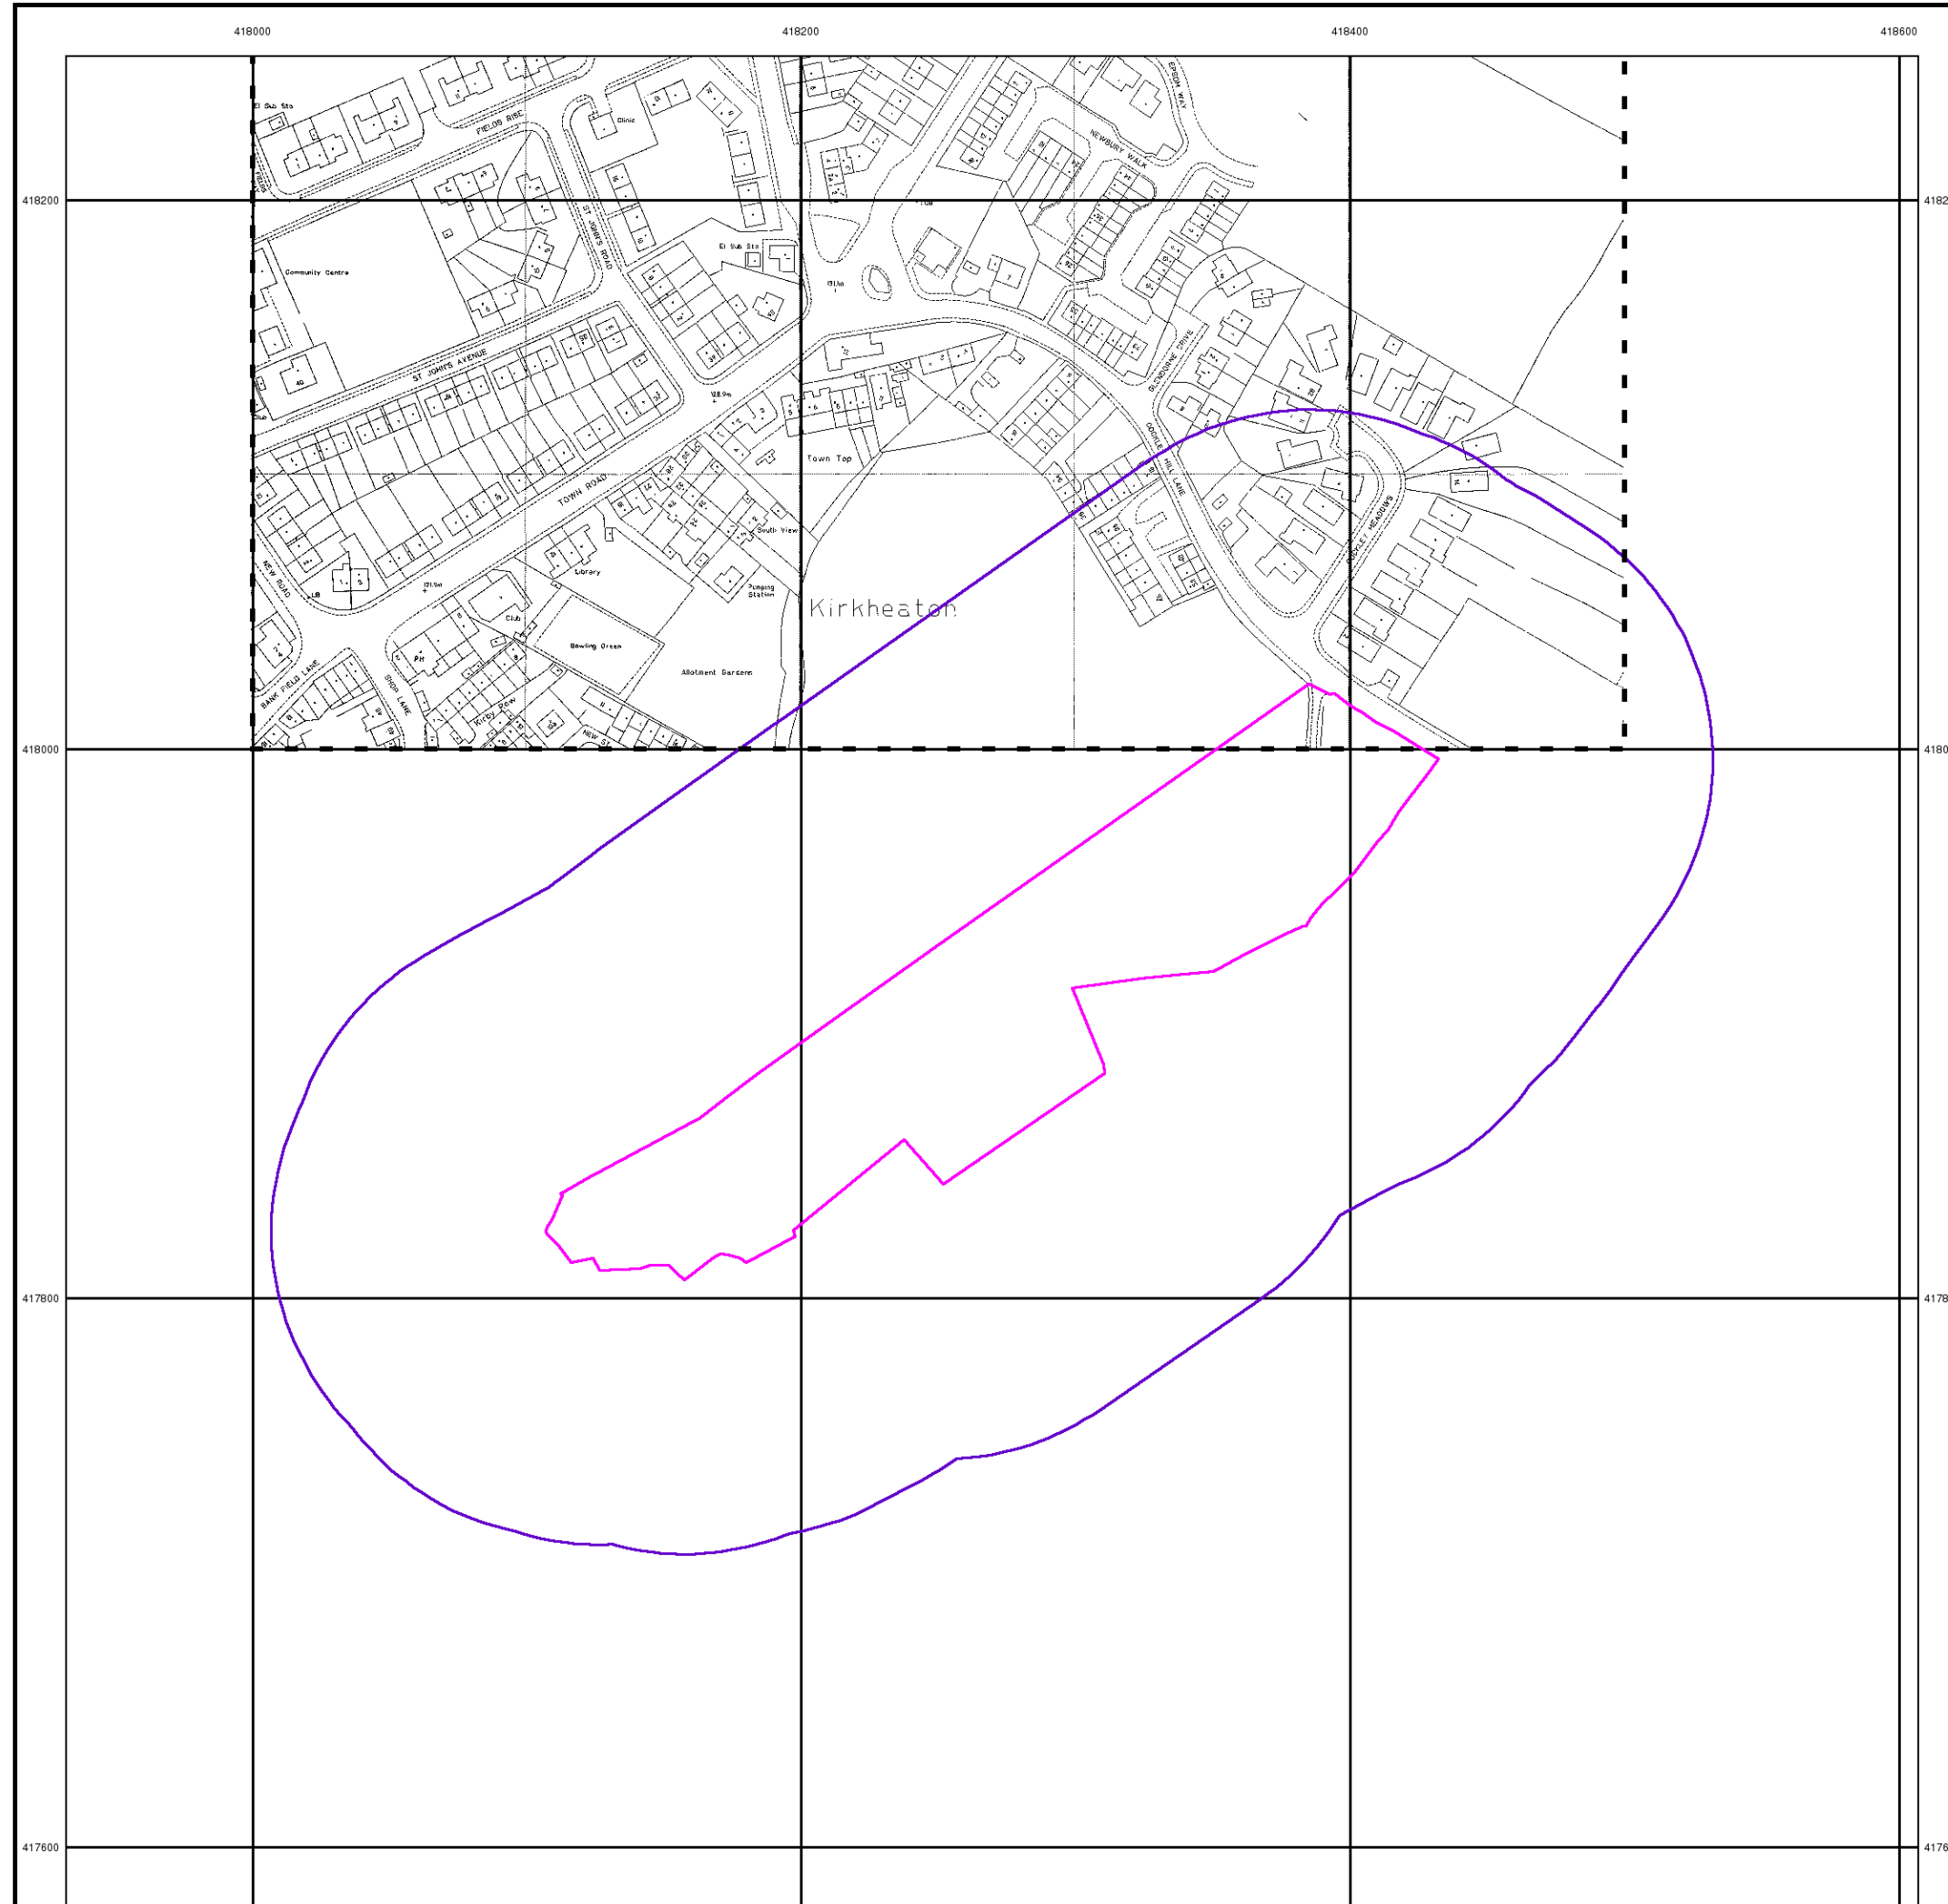
Large-Scale National Grid Data
Published 1994
Source map scale - 1:1,250

'Large Scale National Grid Data' superseded SIM cards (Ordnance Survey's 'Survey of Information on Microfilm') in 1992, and continued to be produced until 1999. These maps were the fore-runners of digital mapping and so provide detailed information on houses and roads, but tend to show less topographic features such as vegetation. These maps were produced at both 1:2,500 and 1:1,250 scales.
