## Preliminary Ecological Appraisal & Preliminary Roost Assessment

49 Cross Bank Road, Batley, West Yorkshire, WF17 8PN

**Project:**

This report is prepared to inform a planning application with Kirklees Council. This proposal can be described as the construction of a detached stable with extensions to the existing dwelling and the demolition of the existing garage & out-buildings.

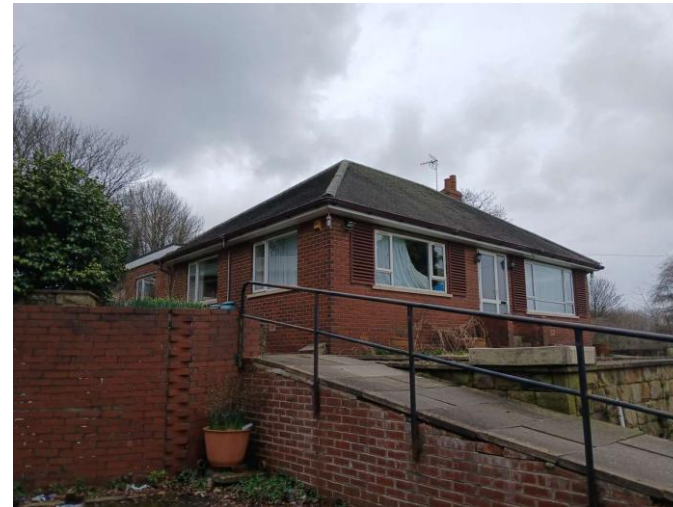
*B1 - residential property, northeastern elevation*

B1 is a single-storey, detached, brick-built dwelling. The building features a hipped roof clad with clay tiles. Minor defects were noted to the roof covering, including slipped or worn tiles. Internal voids were recorded within the building. No bat evidence was found during the survey.

In line with Good Practice Guidelines (Collins, J (Ed) 2023), B1 is assessed to have **low habitat value** for roosting bats due to low numbers of suitable features are present for individual crevice dwelling bat species.

The roof for building 1 will be removed during its conversion from a bungalow to a two-storey home, and all the outbuildings, including building 6 will be demolished as part of the proposed works. This could result in destruction of any bat roosts present within the identified features within the roof structures of both B1 and B6 and could cause disturbance, death or injury to bats. T3 and T4 will be retained.

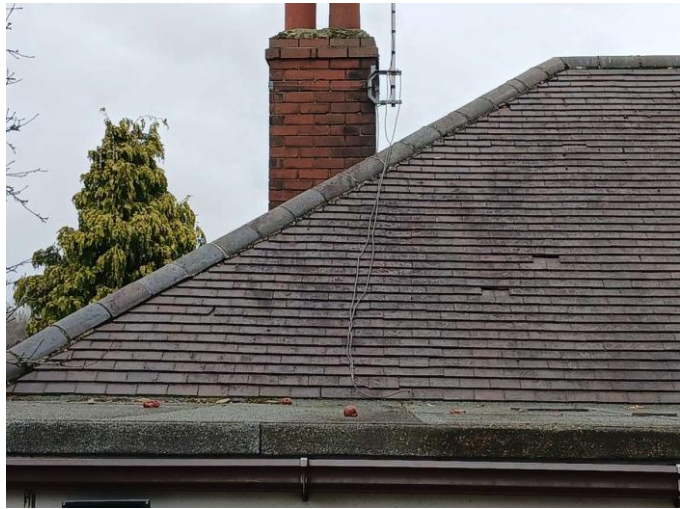
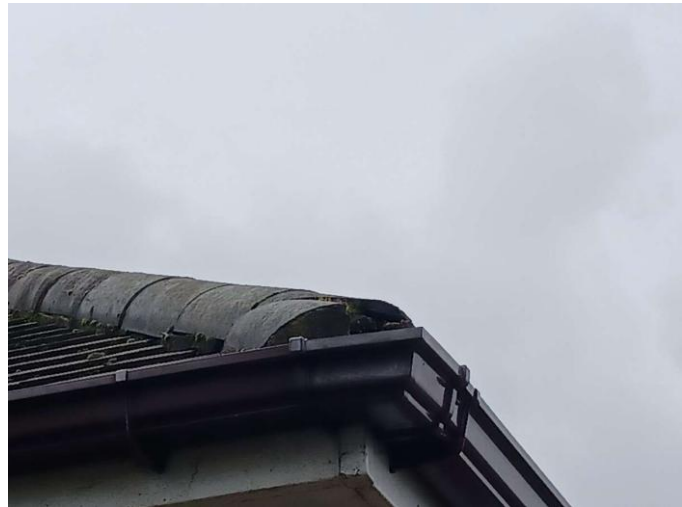
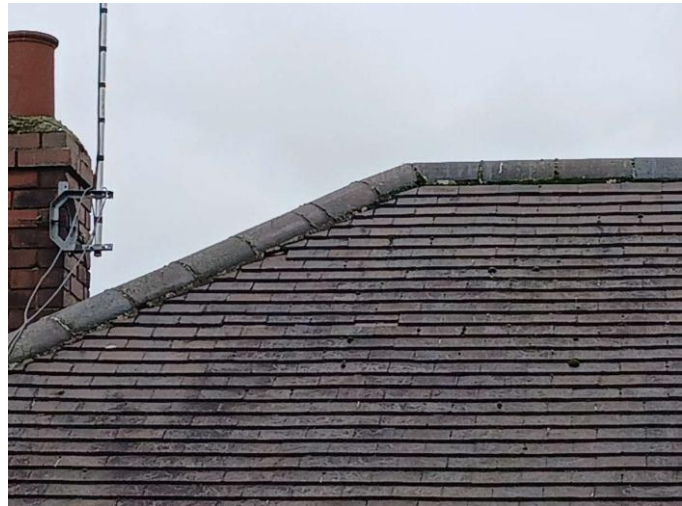
| Feature | Materials | Condition/Suitability | Photographs |
|---|---|---|---|
| Roof | Clay tiles | The hipped roof is clad with clay tiles. Minor defects were noted, including missing tiles and missing mortar. Potential roosting features were identified, comprising missing tiles on the southwestern and northeastern elevations, and missing mortar under the ridge tiles on the southwestern elevation, as well as missing mortar under the terminal ridge tile along the northeastern elevation. These features are suitable for crevice dwelling bat species. No suitable access points for void dwelling bat species were identified. | <p><i>Missing tiles present on B1.</i></p> |

| | | | | <div data-bbox="1160 207 1839 715"></div> <div data-bbox="1400 710 1594 750"><p><i>Missing mortar</i></p></div> <div data-bbox="1160 764 1839 1272"></div> <div data-bbox="1408 1267 1581 1307"><p><i>Missing tiles.</i></p></div> | |

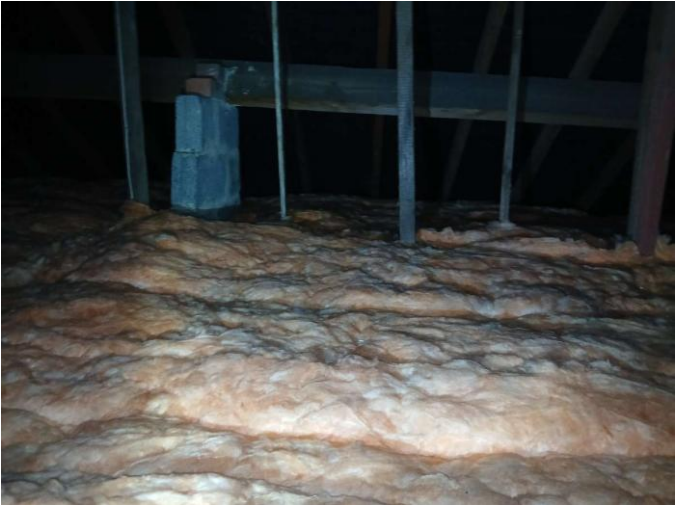
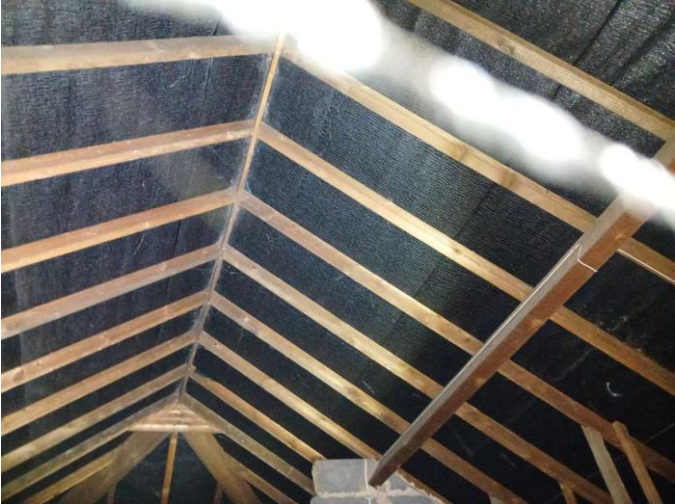
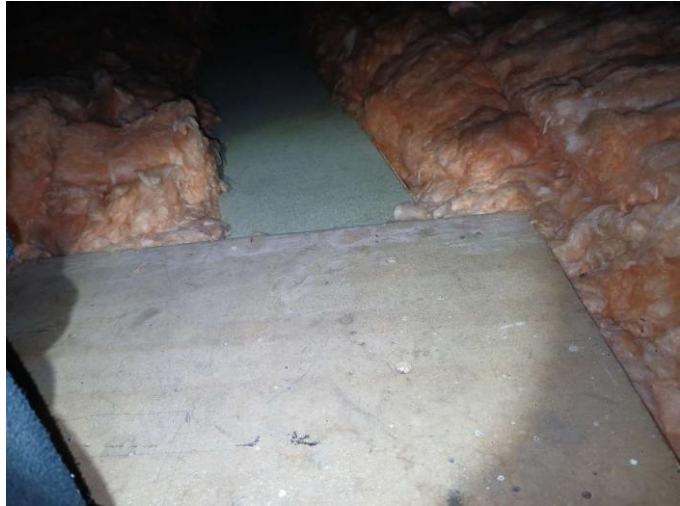
| Voids | Bitumen felt | <p>An accessible attic void was recorded within B1. The void has a bitumen felt lining and measures approximately 6m in length, 5m in width, and 3m in height, with an estimated area of 30m<sup>2</sup>. The internal temperature was recorded at 18°C with a relative humidity of 68.3%. No specific roosting features or bat evidence were identified within this void.</p> | <p><i>Mineral wool insulation</i></p> <p><i>Timber beams and intact lining</i></p> | |

| | | | <p><i>Visible boarding</i></p> | |

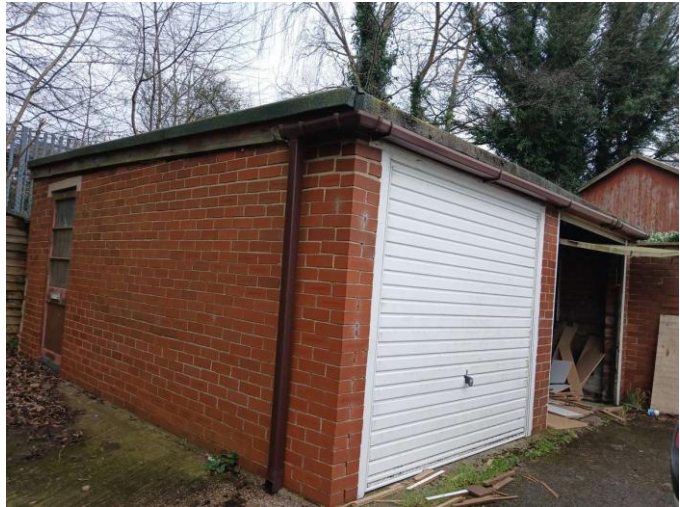
| <p>B2 is a single-storey, detached, brick-built out-building. The main roof is flat and constructed of bitumen felt. No internal voids were recorded. No bat evidence was found anywhere within the building.</p> <p>In line with Good Practice Guidelines (Collins, J (Ed) 2023), B2 is assessed to have <b>negligible</b> habitat value for roosting bats due to the garage has no suitable roosting features for crevice dwelling bat species and no suitable access or roosting features for void dwelling bat species.</p> | | | | |

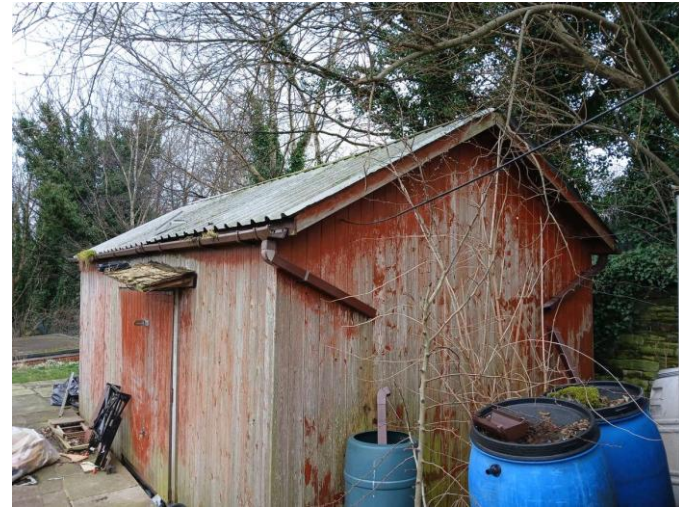
B3 is a single-storey, detached, timber-framed out-building. The main roof is gabled and clad with metal sheeting. No internal voids were recorded. No bat evidence was found anywhere within the building.

In line with Good Practice Guidelines (Collins, J (Ed) 2023), B3 is assessed to have **negligible** habitat value for roosting bats due to the metal sheeting for the roof of the workshop had insulation under each ridge negating the suitability of any access points or roosting features for bats.

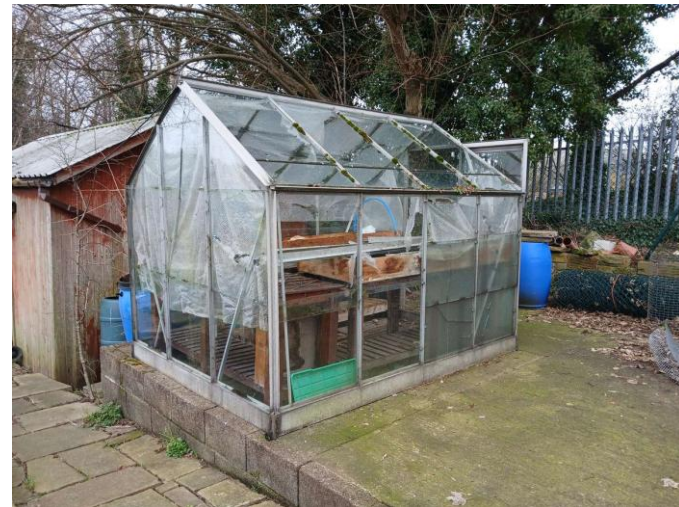
B4 is a single-storey, detached, glass greenhouse. The structure features a gabled glass roof. No internal voids were recorded. No bat evidence was found anywhere within the building.

In line with Good Practice Guidelines (Collins, J (Ed) 2023), B4 is assessed to have **negligible** habitat value for roosting bats due to no features suitable for roosting bats.

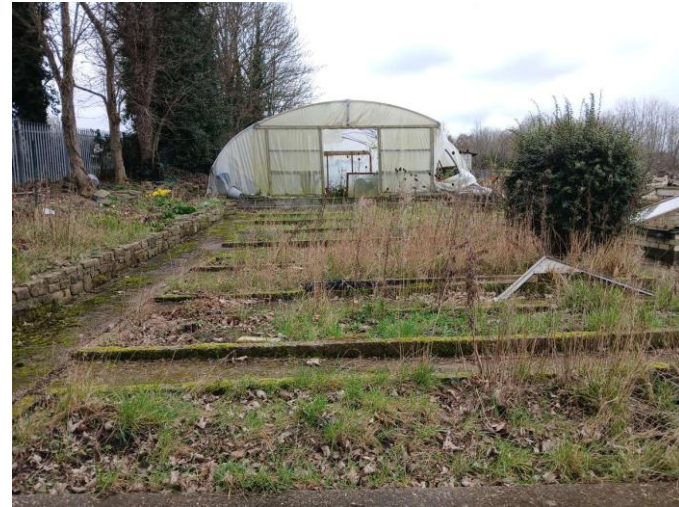
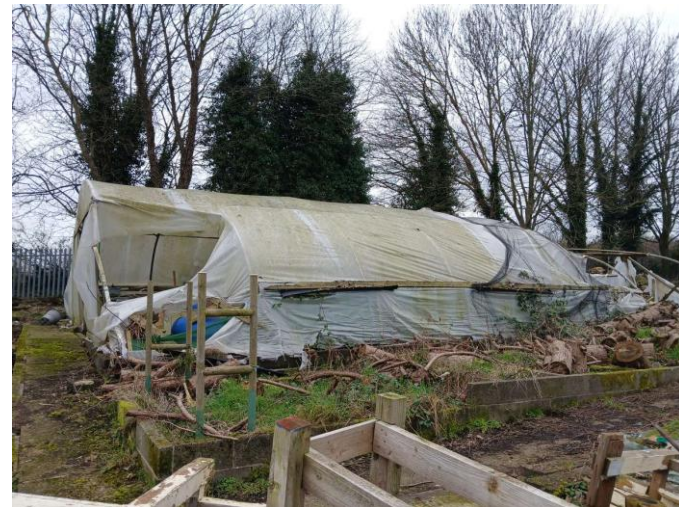
B5 is a plastic polytunnel structure used for horticultural purposes. The building features a curved roof constructed from plastic sheeting. No internal voids were recorded.

In line with Good Practice Guidelines (Collins, J (Ed) 2023), B5 is assessed to have **negligible** habitat value for roosting bats due to the polytunnel is in a state of disrepair and has no suitable access or roosting features for bats.

Continued picture of polytunnel, to show the disrepair.

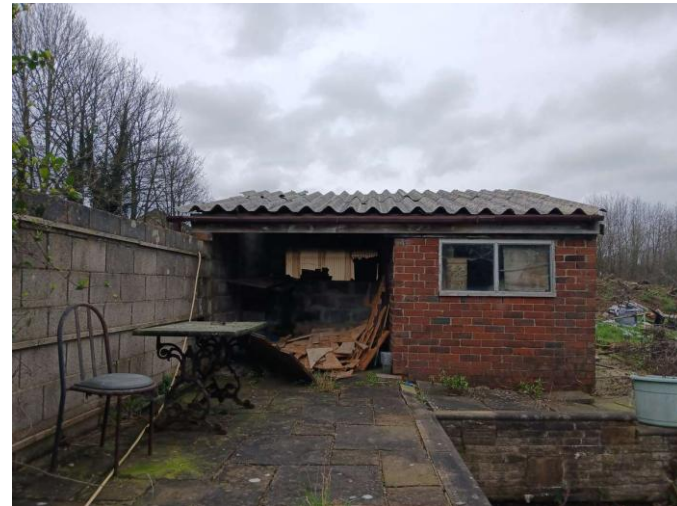
*B6 - eastern elevation*

B6 is a single-storey, detached storage shed used as a wood shed. The building has a lean-to roof constructed of tiles, which has open gaps and lifted tiles. No bat evidence was found within the building. No internal voids were recorded.

In line with Good Practice Guidelines (Collins, J (Ed) 2023), B6 is assessed to have **low habitat value** for roosting bats due to the opportunities for crevice dwelling bats to roost in the hanging tiles on the western elevation. The suitability of the building for void dwelling bats has been reduced due to the internal space being well lit through transparent panels and exposed to the elements due to the metal roofing being in a state of disrepair.

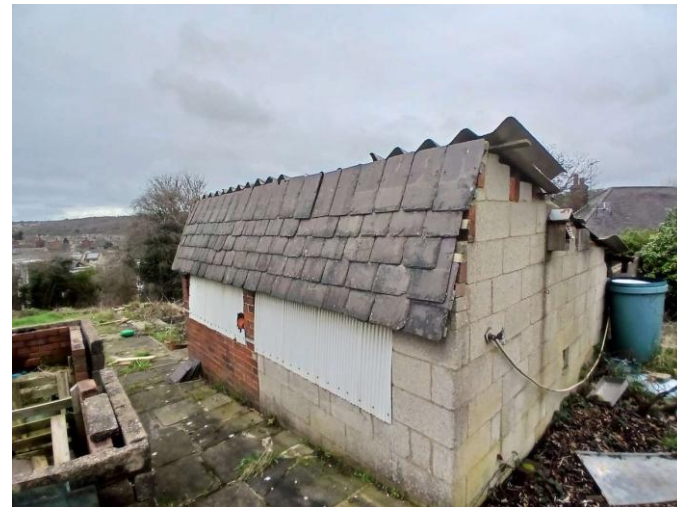
*B6 - western elevation*

The hanging tiles do provide gaps underneath due to the natural slate irregularities, these gaps provide roosting opportunities for individual crevice dwelling bats.

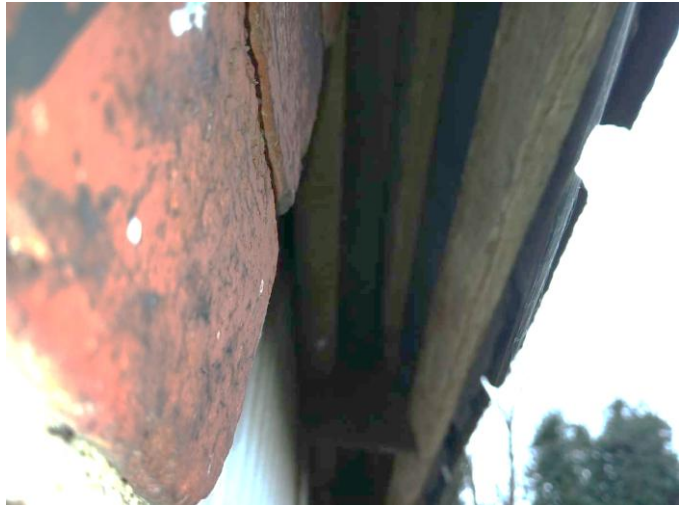
| Feature | Materials | Condition/Suitability | Photographs |
|---|---|---|---|
| Roof | Tiles | The roof structure is a lean-to, constructed of tiles. There are gaps noted under the hanging slate tiles on the western elevation. These provide potential roosting opportunities for crevice-dwelling bat species, despite the internal space being exposed to increased light ingress. | |

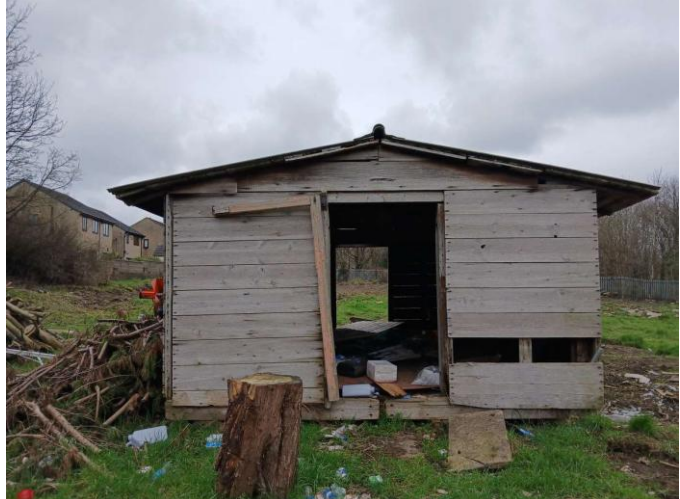
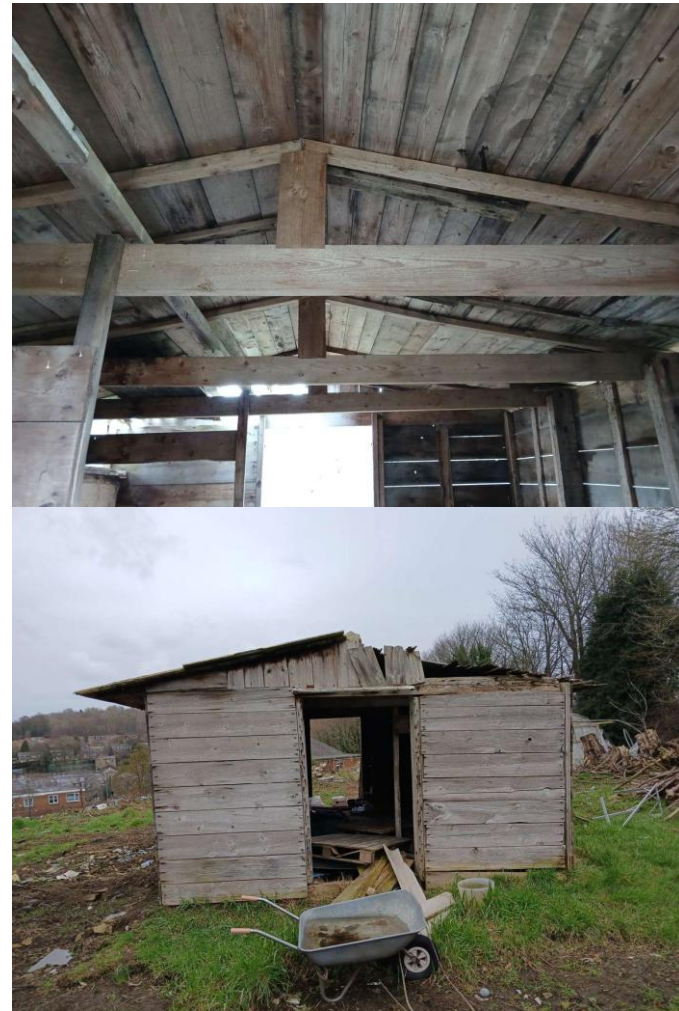
| Feature | Materials | Condition/Suitability | Photographs |
|---|---|---|---|
| <p>B7 is a single-storey, detached, timber-framed storage shed. The main roof is gabled with wooden boards. No internal voids were recorded and no bat evidence was found anywhere within the building.</p> <p>In line with Good Practice Guidelines (Collins, J (Ed) 2023), B7 is assessed to have <b>negligible habitat value</b> for roosting bats due to absence of any suitable roosting features.</p> | | | |

Whilst the internal space is of a suitable size for void dwelling bat species the amount of light, wind and rain exposure greatly reduces the suitability.

The roof is in a state of disrepair and there are no tiles, lining or insulation present that would provide suitable roosting features for crevice dwelling bat species.

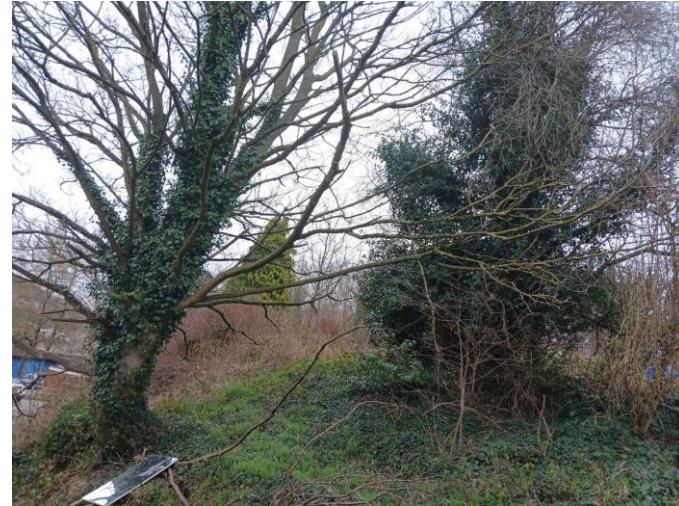
T3 and T4 are medium sycamores located in the northern section of the garden. The dense coverage of ivy on the stems could provide roosting suitability to low numbers of crevice dwelling bats. Due to the trees ages and maturity the ivy is not anticipated to obscure any other suitable features.

*T3 is the tree to the left, and T4 to the right.*

The current plans show that T3 and T4 are to be retained. If for any reason the plans change and these trees are to be impacted the below recommendations are to be followed.
