Kirklees Council
Huddersfield Bus Station Canopy
Huddersfield

Geotechnical Design Report

Document Number:	HBS-BWB-XX-XX-T-G-0003_GDR	
BWB Reference:	221692	
Author:	Simon Steel BSc	Senior Geotechnical Engineer
Reviewer:	Ralph Sibley BSc PhD CGeol FGS RoGEP Advisor	Technical Director
Approver:	Jamie Rushton Beng CEng MICE	Associate

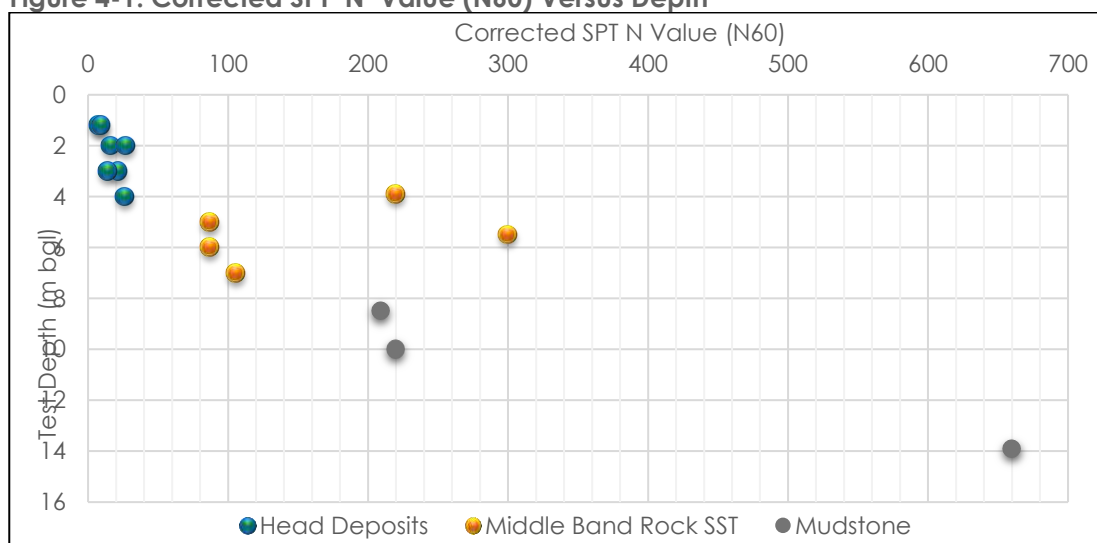
Figure 4-1: Corrected SPT 'N' Value (N₆₀) Versus Depth

- 4.4 From in situ SPTs, corrected 'N₆₀' values have been derived, and a plot of N₆₀ value vs. depth (in m bgl) is presented as **Figure 4-1** below. N₆₀ values within the cohesive Head Deposits were recorded ranging from 8 to 28 blows. N₆₀ values with the rock recorded >50blows before the full 300mm penetration. These blow counts have been extrapolated to estimate the number of blows for the full 300mm test. These are conservative values based on the penetration rate for 50 blows. There is a general increase in N values with depth. Estimated blow counts within the sandstone range from 87 to 300 blows, the deeper mudstones range from 209 to 660 blows.

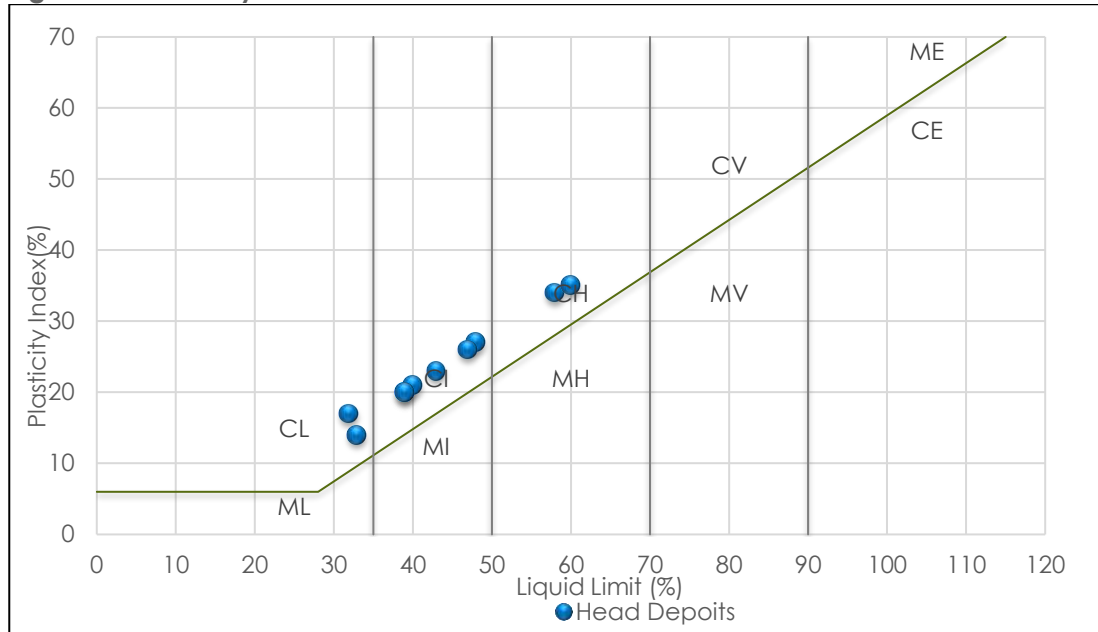
Figure 4-2 Plasticity Chart

- 4.5 Where cohesive soils were encountered and sampled, geotechnical laboratory testing included the determination of Atterberg Limits and Plasticity Index (PI) values. A Plasticity Chart is presented as **Figure 4-2**. This indicates PI values for the Head deposits to be in the range 15% to 26% (low to high plasticity).

- 6.14 From the ground investigation, the groundwater levels at the site are at depth (indicated to be at least 6.0m). Laboratory testing of natural subgrade materials (Head Deposits) gave plasticity index values of 17% to 34% at 1.2m to 1.6m. From Table C1 of TRRL 1132 (Structural Design of Bituminous Roads) according to guidance in National Highways document CD225, "Design for New Pavement Foundations" a long term CBR value of 3.0% should be used for preliminary design purposes. This equates to an SSM value of 30MPa.

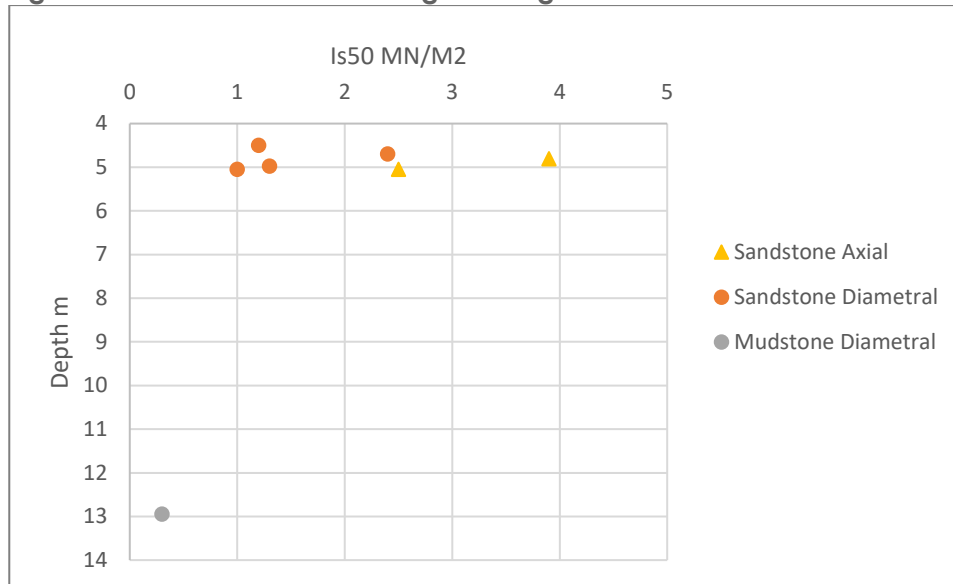
Figure 5-1 Point load Index strength testing

5.12 The unconfined compressive strength of the intact rock has been derived from the correlation with point load test results (see **Figure 5-1**). Due to poor core recoveries, it has not been possible to establish a site-specific correlation, and the relationship “UCS = $I_s (50) \times k$ ”, where k is taken as 20 after Norbury, has been adopted as a cautious estimate from the available point load I_{s50} data.

5.13 Estimate of the drained modulus (E') values in rock are estimated from point load strength index testing and core indices RQD and log descriptions following Bieniawski's Rock Mass Rating (RMR) system and its relationship with rock mass modulus by Serafim & Pereira 1983.

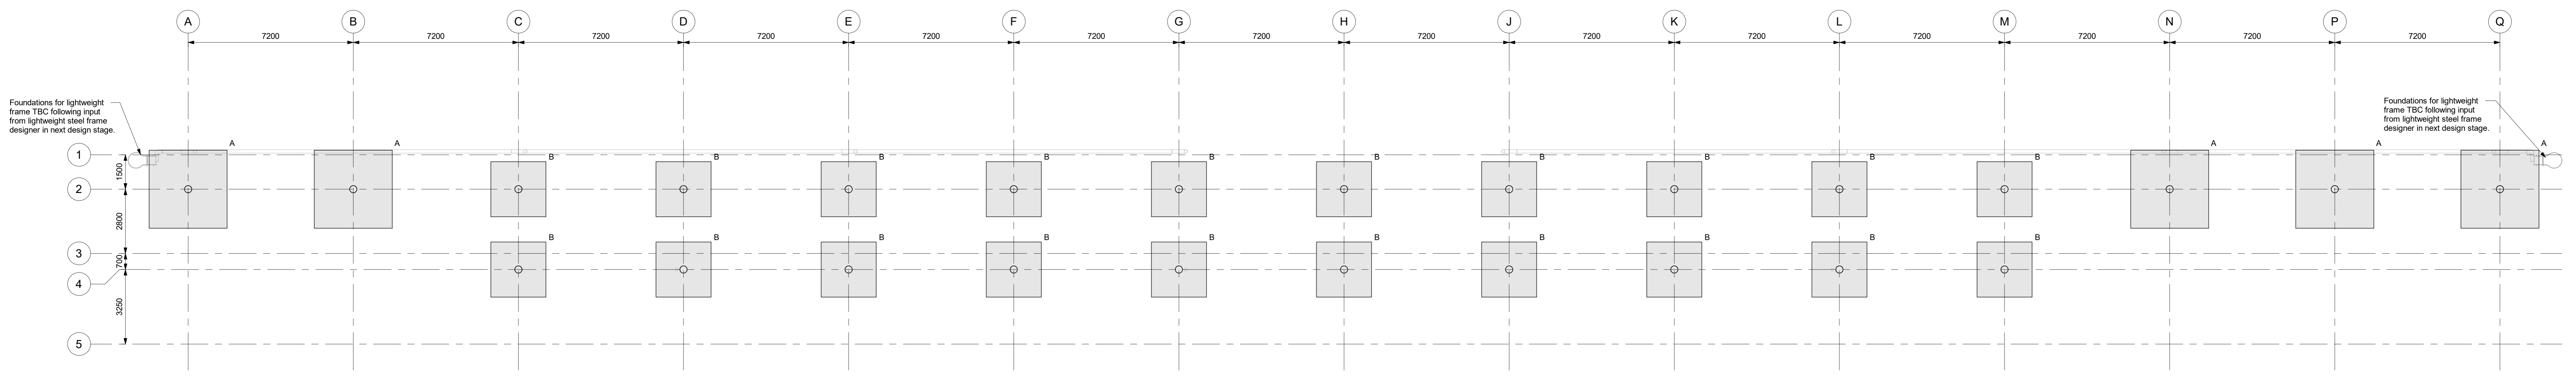
Foundation GA
1 : 100

**Drawing 2: Drawing 2 HBS-BWB-ZZ-FN-DR-S-1001-Foundation General
Arrangement_P05**

FOUNDATION SCHEDULE						
Type Mark	Width	Length	Depth	Volume	Count	Reinforcement
A	3400	3400	1000	11.56m³	5	2 layers A393 mesh bottom, 1 layer A393 mesh top
B	2400	2400	500	2.88m³	20	1 layer A393 mesh top & bottom

- 2.3 The proposed development is to comprise the construction of a new glass canopy extension, with light weight green roof (0.8kN/m^2), new pedestrian paving zone, and landscaping, along the eastern side of the bus station building. A development Masterplan, reference, 202335-SGP-ZZ-ZZ-DR-A-131000-P08-Proposed Site Plan is presented as **Drawing 1**. The works are indicated to include formation of shallow ($2.4 \times 2.4\text{m}$) and ($3.4 \times 3.4\text{m}$) pad footings carrying columns with pressures of 100kN/m^2 (Foundation Plan Drawing, HBS-BWB-ZZ-FN-DR-S1001) **Drawing 2**.

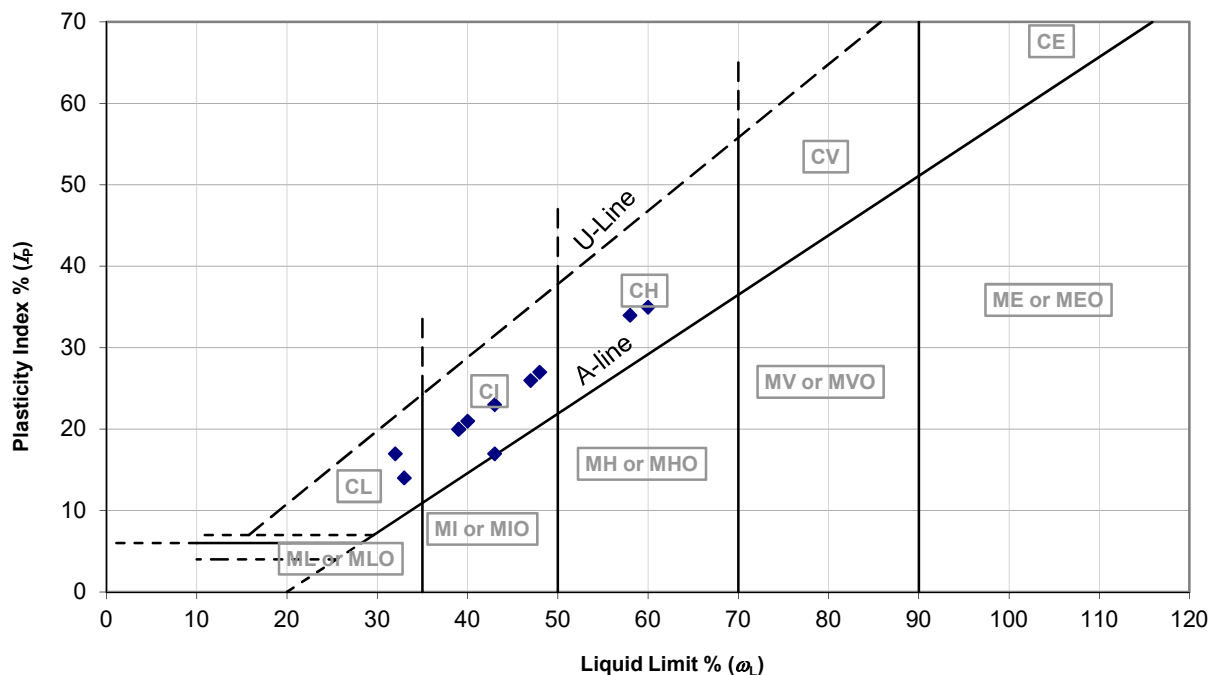
Location	Depth (m)	Water Content (ω) (%)	Liquid Limit (ω_L) (%)	Plastic Limit (ω_P) (%)	Plasticity Index (I_P) (%)	Retained by 0.425mm (%)	Modified (ω) (ω') (%)	Modified (I_P) (I_P') (%)	Liquidity/ Consistency		Casagrande Class	N.H.B.C Class (%)
									(I_L) (%)	(I_C) (%)		
BH01	1.20	19	43	26	17	19	23	14	-0.4	1.4	C I	LOW
BH01	1.60	26	58	24	34	3	27	33	0.1	0.9	C H	MEDIUM
BH01	1.80	24	60	25	35	9	26	32	0.0	1.0	C H	MEDIUM
BH01	2.50	19	48	21	27	18	23	22	-0.1	1.1	C I	MEDIUM
BH01	2.80	19	47	21	26	23	25	20	-0.1	1.1	C I	MEDIUM
BH01	3.50	17	39	19	20	45	31	11	-0.1	1.1	C I	LOW
BH01	3.80	16	40	19	21	25	21	16	-0.1	1.1	C I	LOW
BH01	4.60	20	33	19	14	8	22	13	0.1	0.9	C L	LOW
BH03	1.70	16	39	19	20	4	17	19	-0.2	1.2	C I	LOW
BH03	2.50	14	32	15	17	9	15	15	-0.1	1.1	C L	LOW
BH03	2.80	17	43	20	23	35	26	15	-0.1	1.1	C I	LOW

Interpretation graph based on BS EN ISO 14688-2:2018 any interpretations are expressed outside of our UKAS Accreditation.

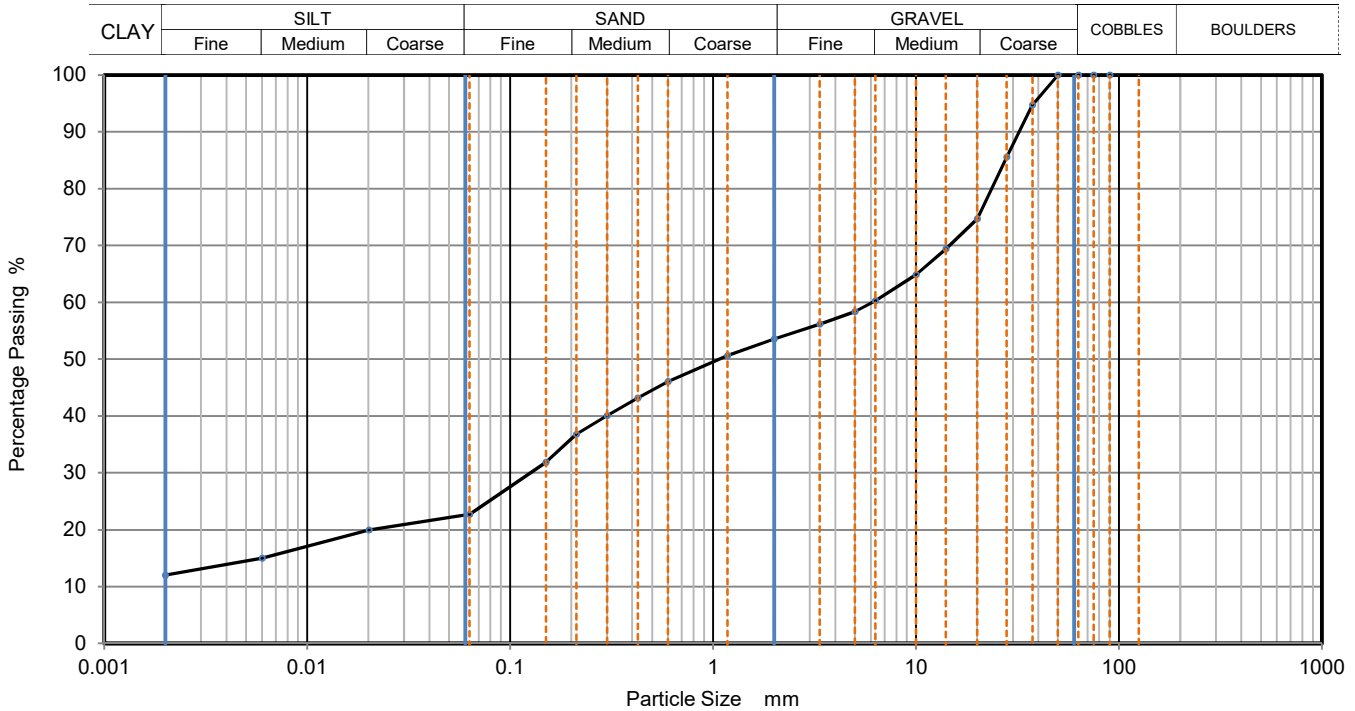
PARTICLE SIZE DISTRIBUTION

Specimen Reference **11** Specimen Depth **4.4** m Sample Type **C**

Test Method **ISO 17892 -4, by sieving and pipette sedimentation** KeyLAB ID **RGS_2025062413**

Sieving		Sedimentation	
Particle Size mm	% Passing	Particle Size mm	% Passing
125	100	0.0201	20
90	100	0.0060	15
75	100	0.0020	12
63	100		
50	100		
37.5	95		
28	86		
20	75		
14	69		
10	65		
6.3	60		
5	58		
3.35	56		
2	54		
1.18	51		
0.6	46		
0.425	43	Particle density (assumed) 2.65 Mg/m ³	
0.3	40		
0.212	37		
0.15	32		
0.063	23
