Kirklees Council  
Huddersfield Bus Station Canopy  
Huddersfield

Phase 2 Geo-Environmental Assessment

| <b>Document Number:</b> | HBSC-BWB-XX-XX-T-G-0001_Ph2 | |

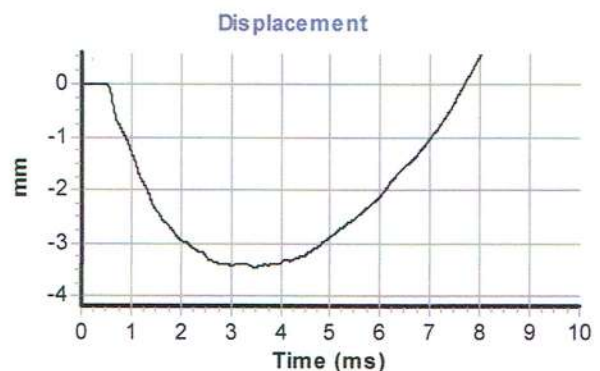
Hammer Mass  $m$  (kg): 63.5  
Falling Height  $h$  (mm): 760  
SPT String Length  $L$  (m): 10.0

Area of Rod A ( $\text{mm}^2$ ): 983  
Theoretical Energy  $E_{\text{theor}}$  (J): 473  
Measured Energy  $E_{\text{meas}}$  (J): 314
