PHASE 2

GEO-ENVIRONMENTAL REPORT

Report on a Phase 2 Geo-environmental Investigation

Location:	Land Adjacent to 21 Westcliffe Rise Cleckheaton, West Yorkshire, BD19 5HX	
For:	Alex Senior	
Report No.	C5245/25/E/8048	Report date: August 2025

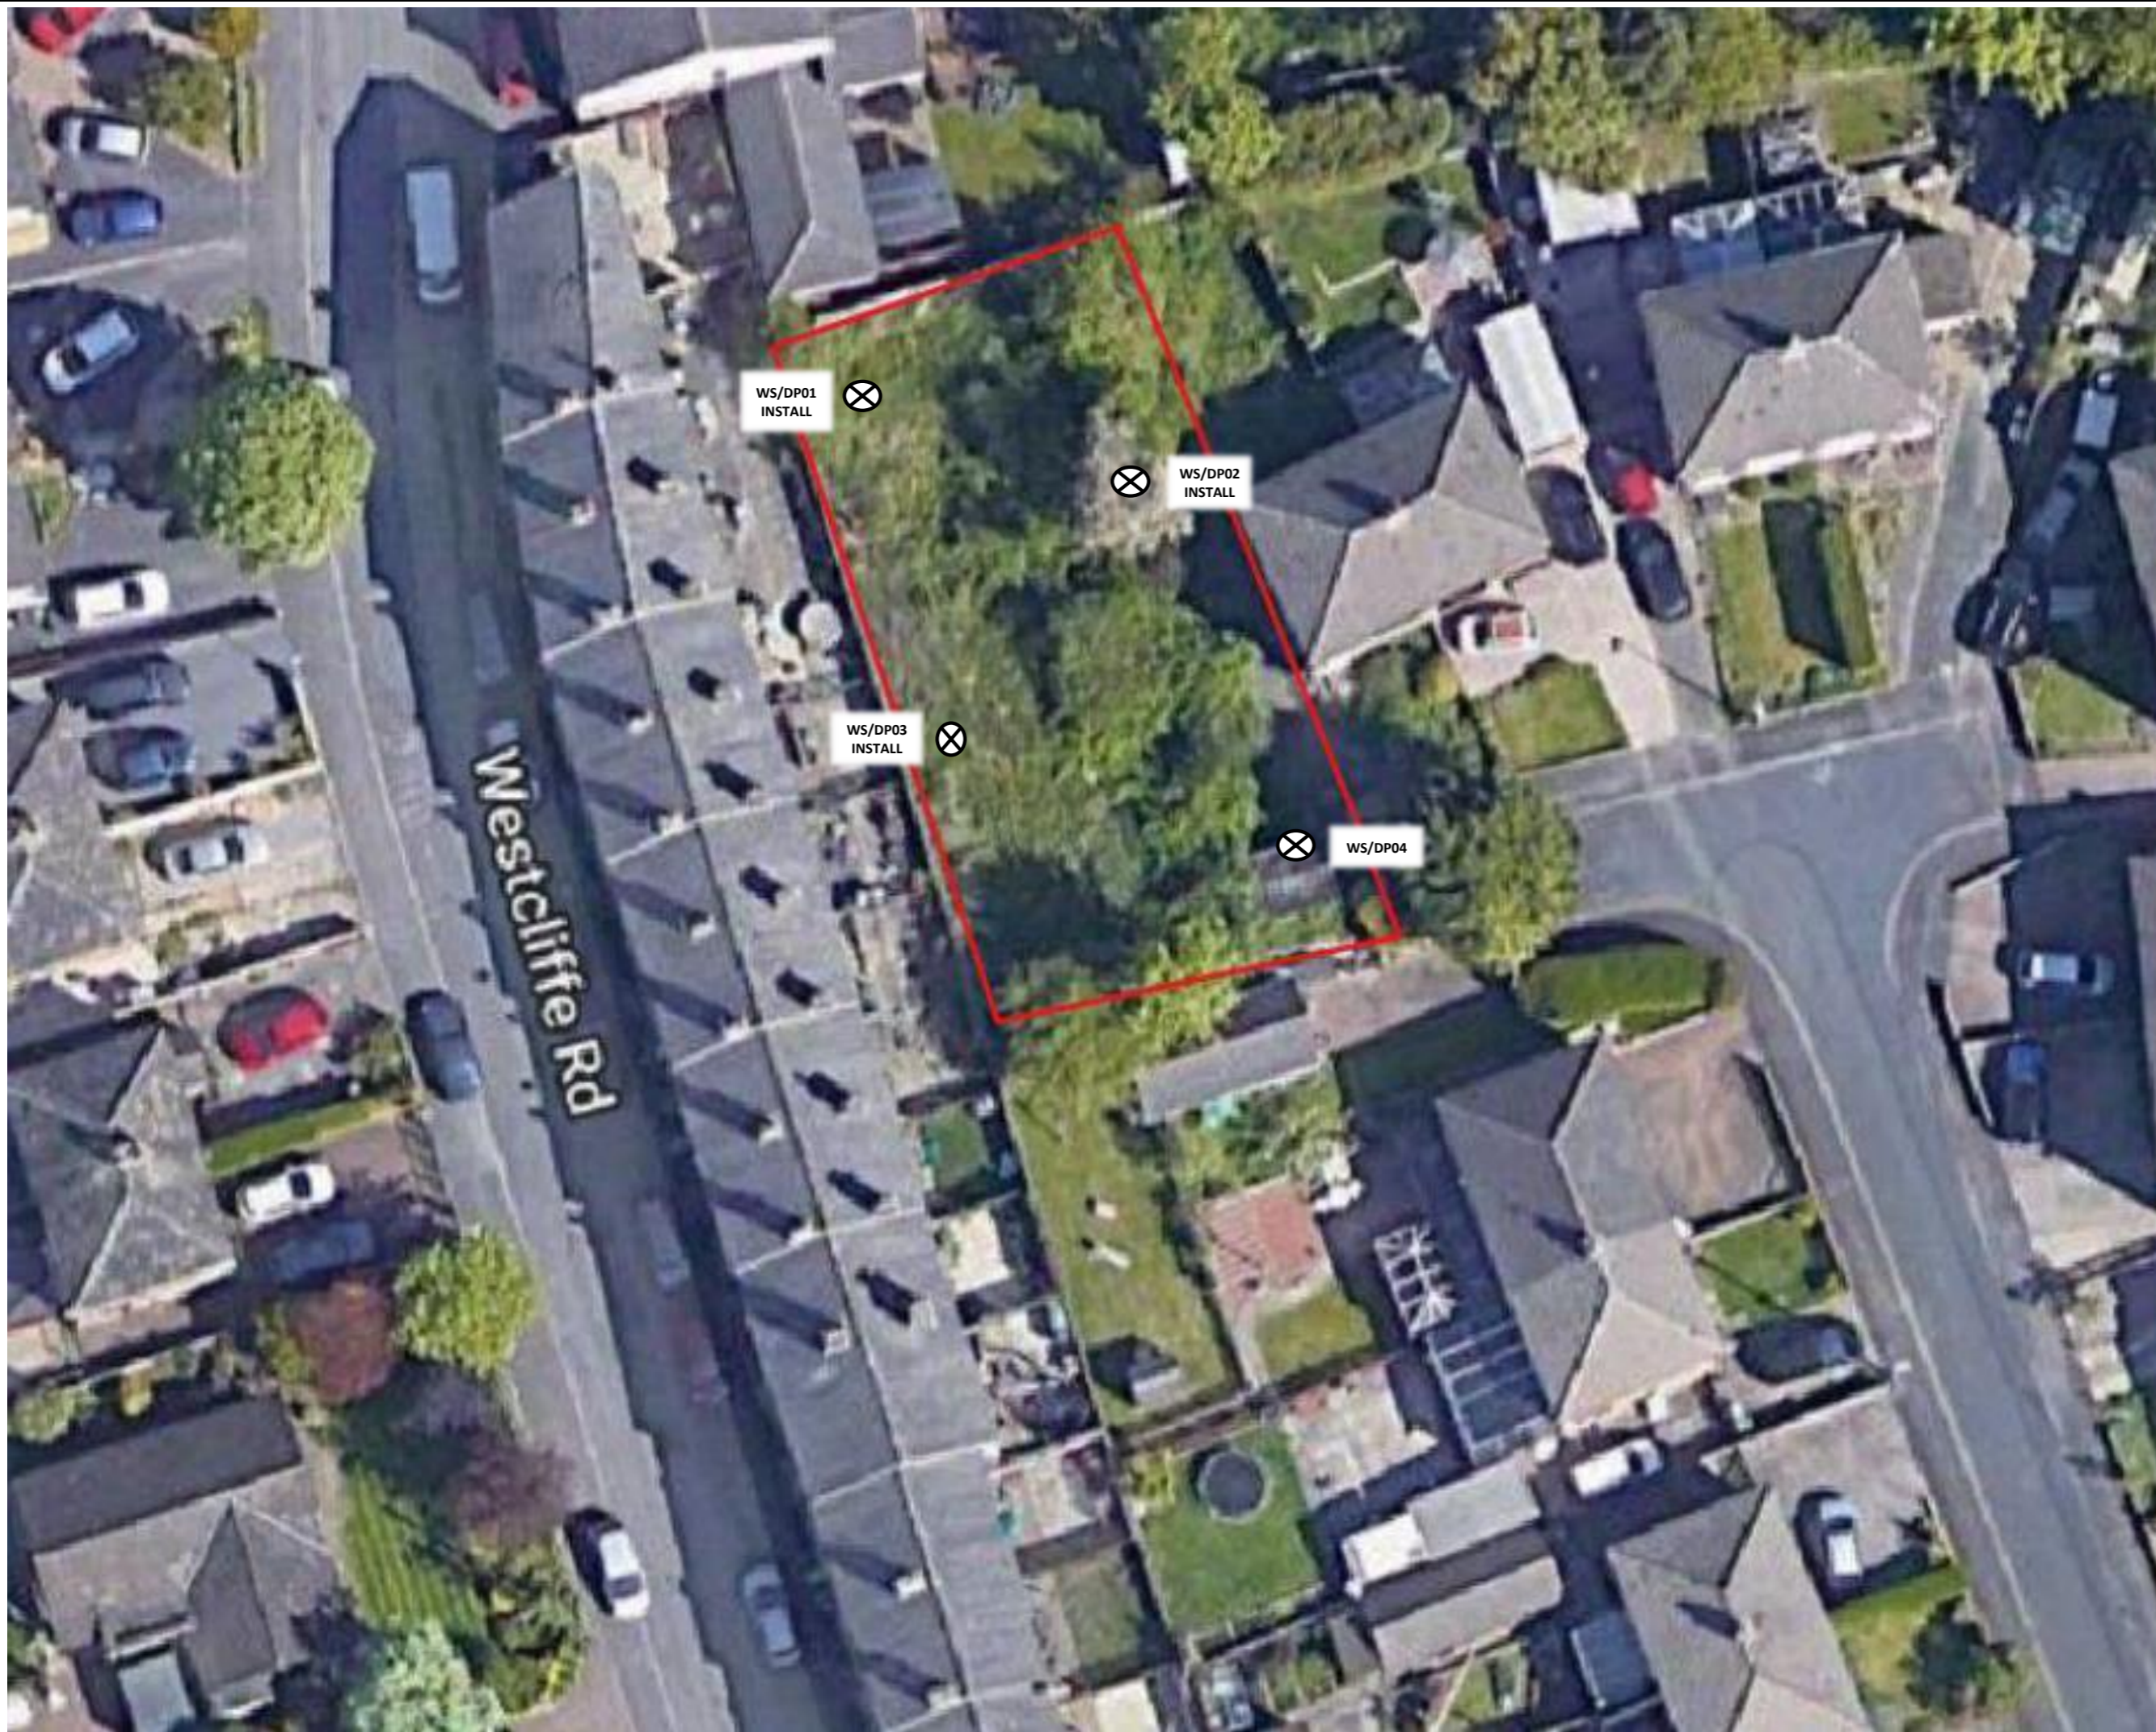
Site Plan

Investigation positions approximated from site operative's notes.

The investigatory locations are shown on the site plan which is presented in Appendix 1 to this report.

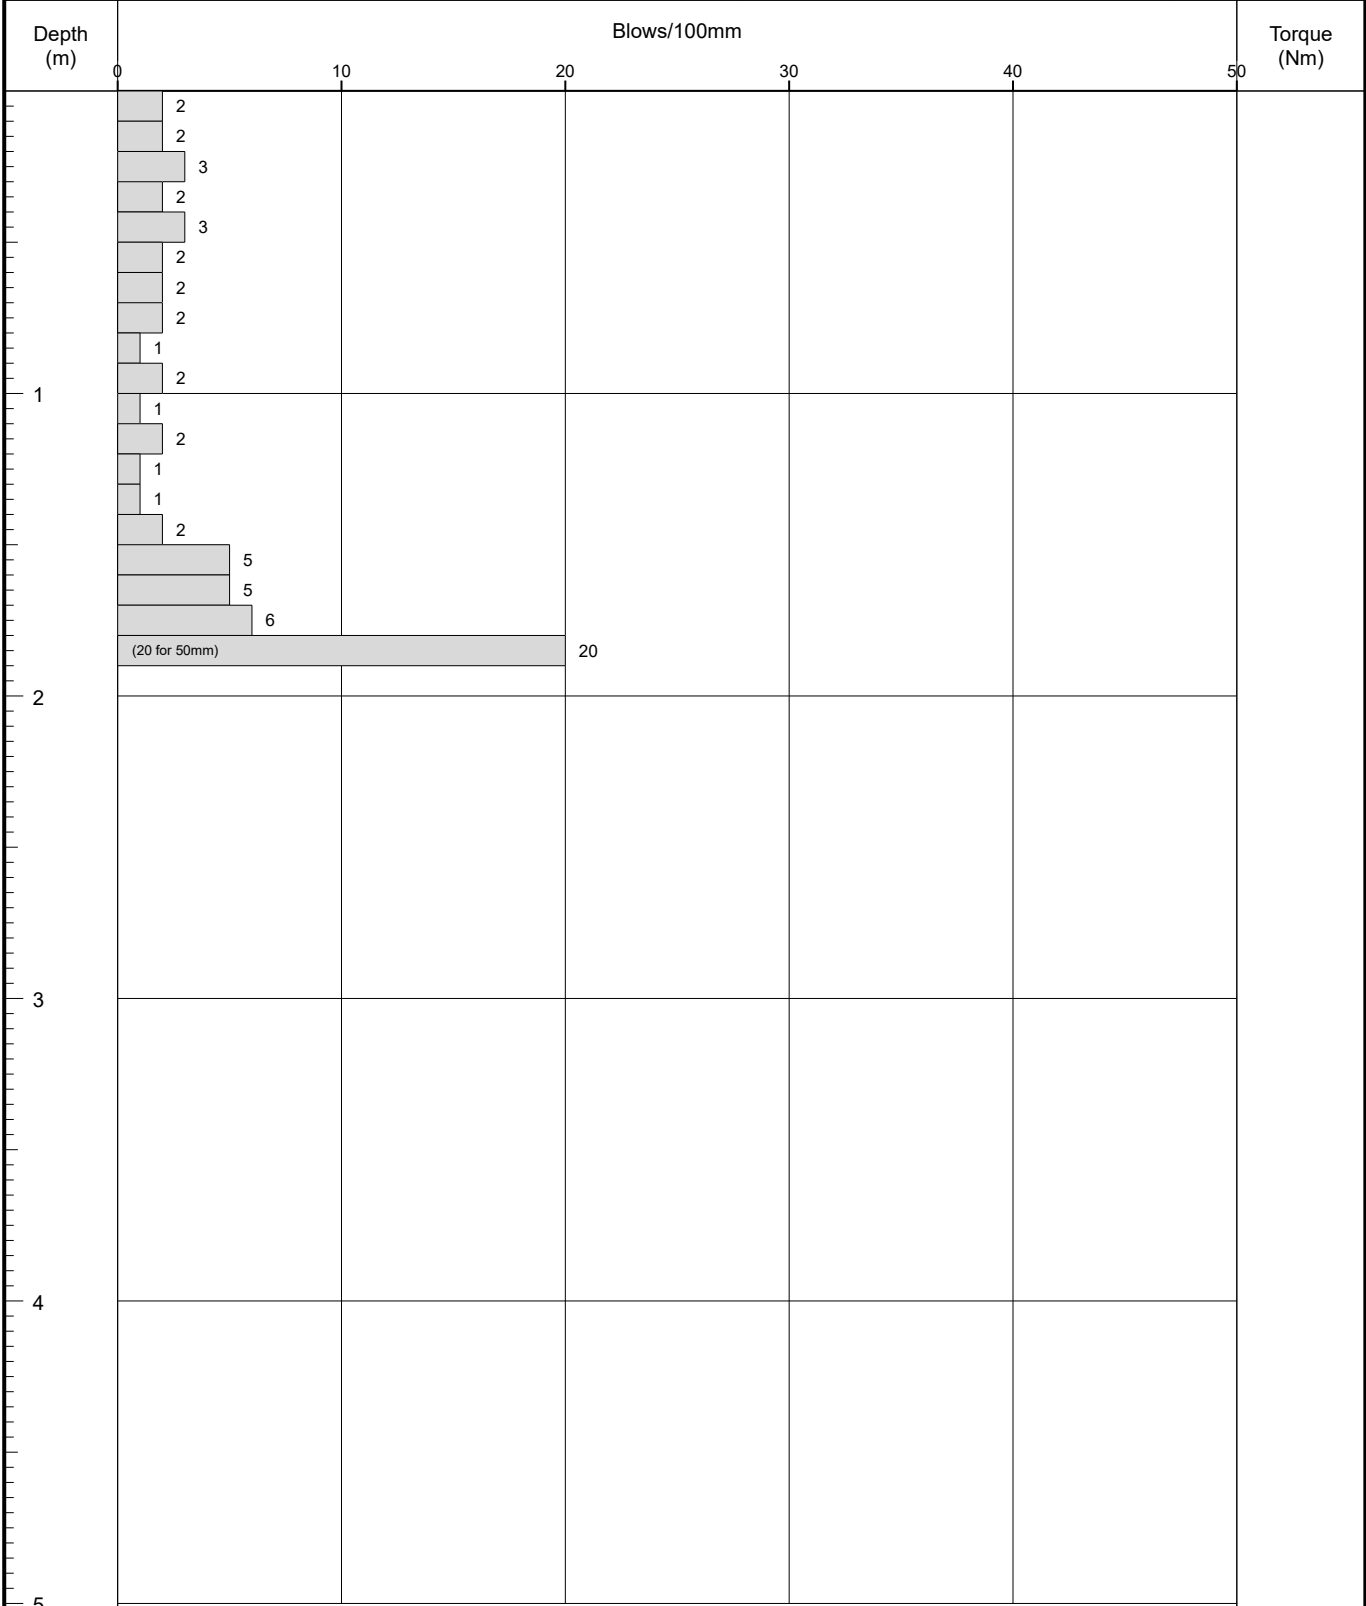
Project Name: Land adjacent to 21 Westcliffe Rise	Project No. C5245/25/E/8048	Co-ords:	Hole Type DCP
Location: Cleckheaton	Level:		Scale 1:25
Client: Mr Oldroyd	Dates: 19/06/2025		Logged By AB

Remarks:	Fall Height	750mm	Cone Base Diameter	50.5mm
	Hammer Wt	63.5kg	Final Depth	1.85m
	Probe Type	DPSH-B

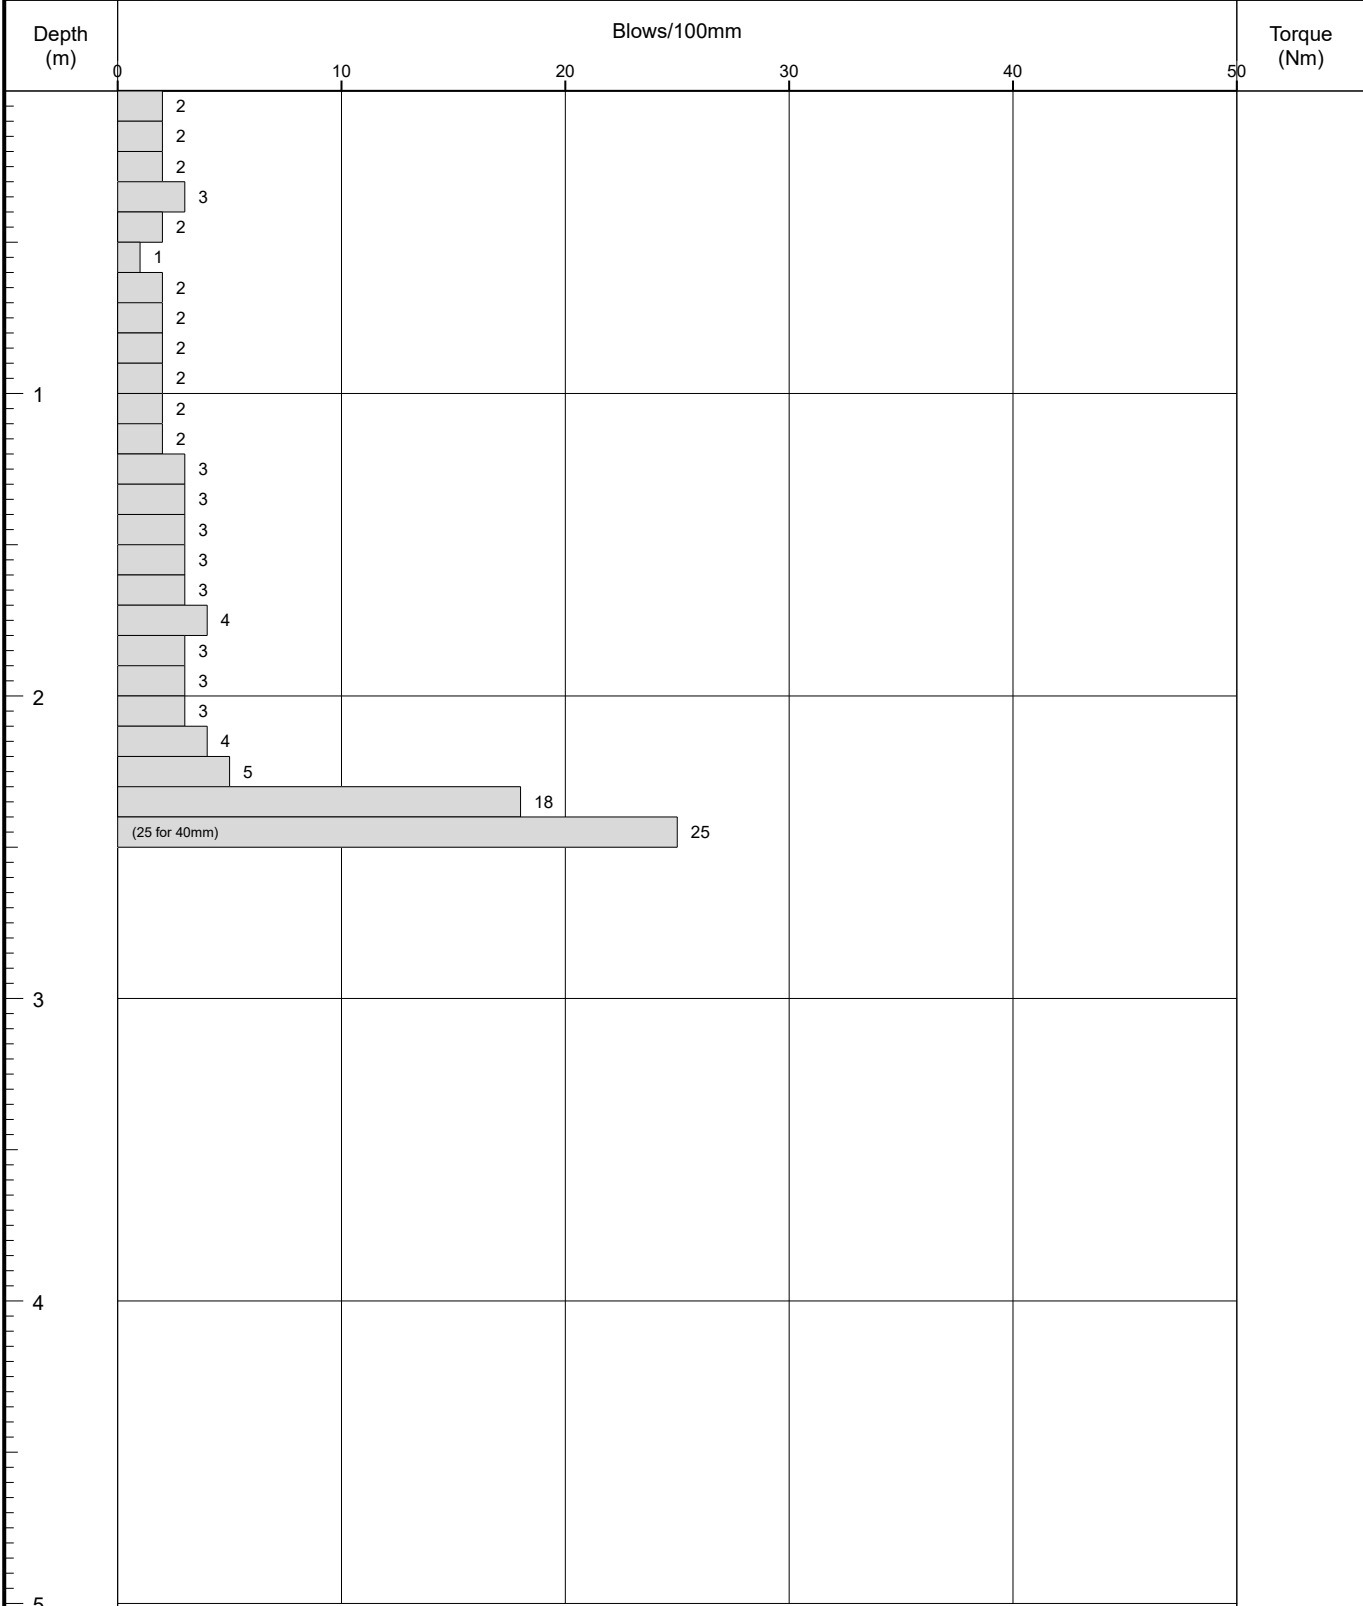
Project Name: Land adjacent to 21 Westcliffe Rise	Project No. C5245/25/E/8048	Co-ords:	Hole Type DCP
Location: Cleckheaton	Level:		Scale 1:25
Client: Mr Oldroyd	Dates: 19/06/2025		Logged By AB

Remarks:	Fall Height	750mm	Cone Base Diameter	50.5mm
	Hammer Wt	63.5kg	Final Depth	2.44m
	Probe Type	DPSH-B

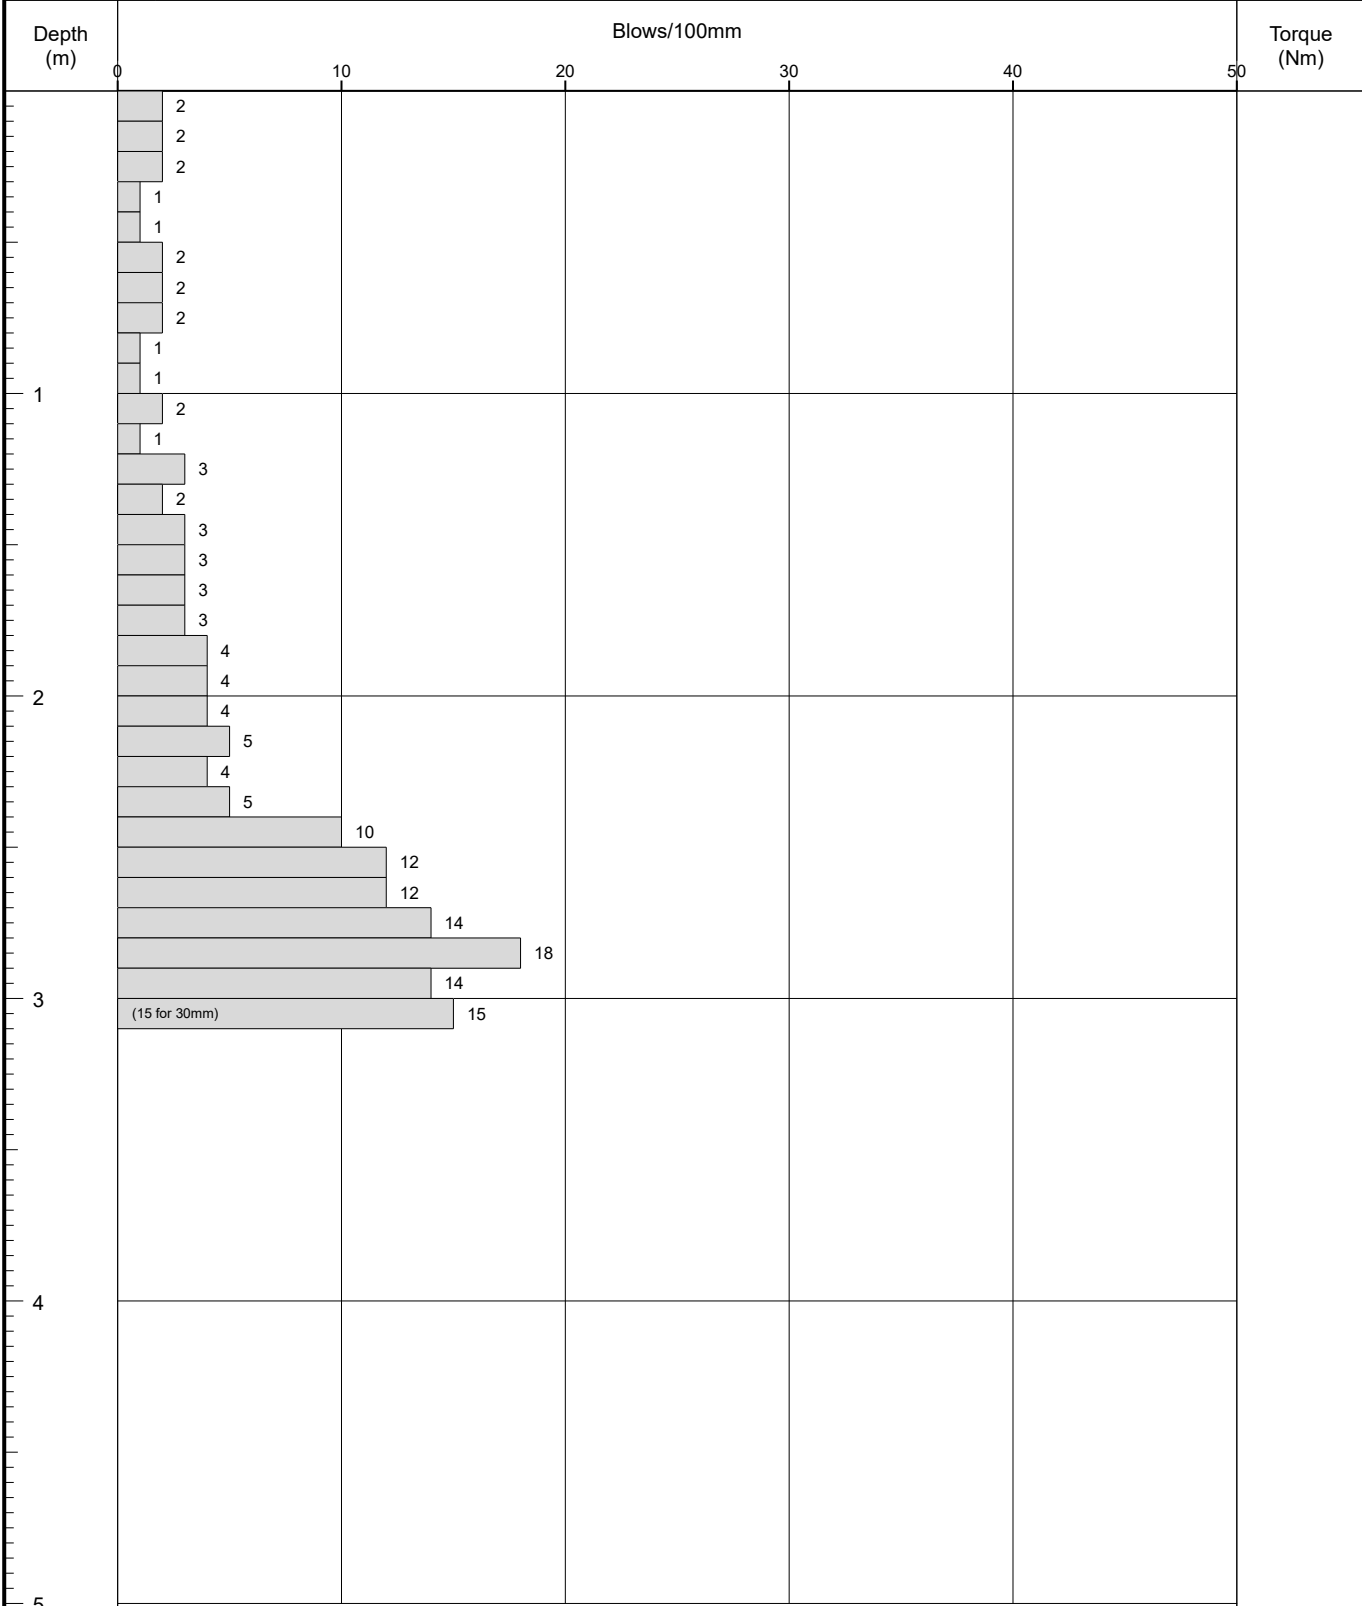
Project Name: Land adjacent to 21 Westcliffe Rise	Project No. C5245/25/E/8048	Co-ords:	Hole Type DCP
Location: Cleckheaton	Level:		Scale 1:25
Client: Mr Oldroyd	Dates: 19/06/2025		Logged By AB

Remarks:	Fall Height	750mm	Cone Base Diameter	50.5mm
	Hammer Wt	63.5kg	Final Depth	3.03m
	Probe Type	DPSH-B

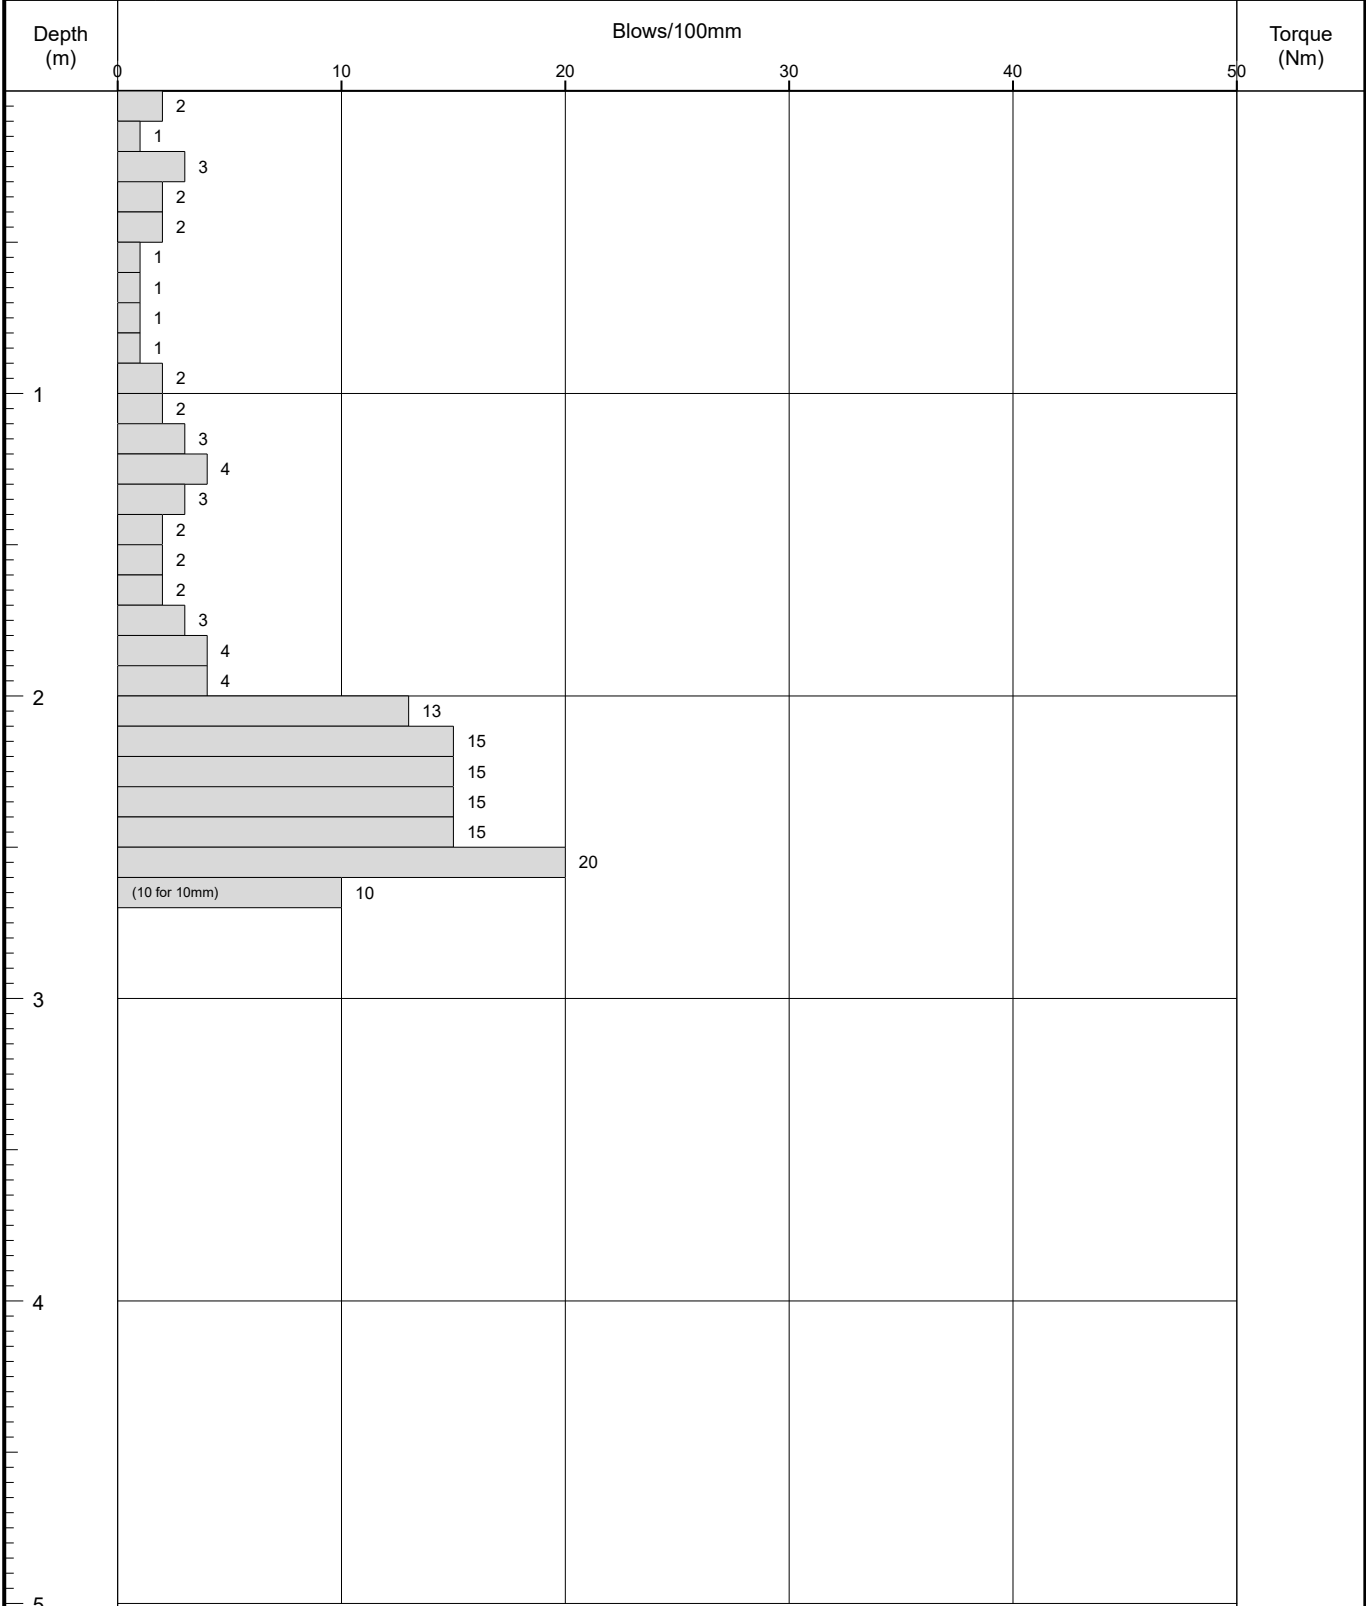
Project Name: Land adjacent to 21 Westcliffe Rise	Project No. C5245/25/E/8048	Co-ords:	Hole Type DCP
Location: Cleckheaton	Level:		Scale 1:25
Client: Mr Oldroyd	Dates: 19/06/2025		Logged By AB

Remarks:	Fall Height	750mm	Cone Base Diameter	50.5mm
	Hammer Wt	63.5kg	Final Depth	2.61m
	Probe Type	DPSH-B

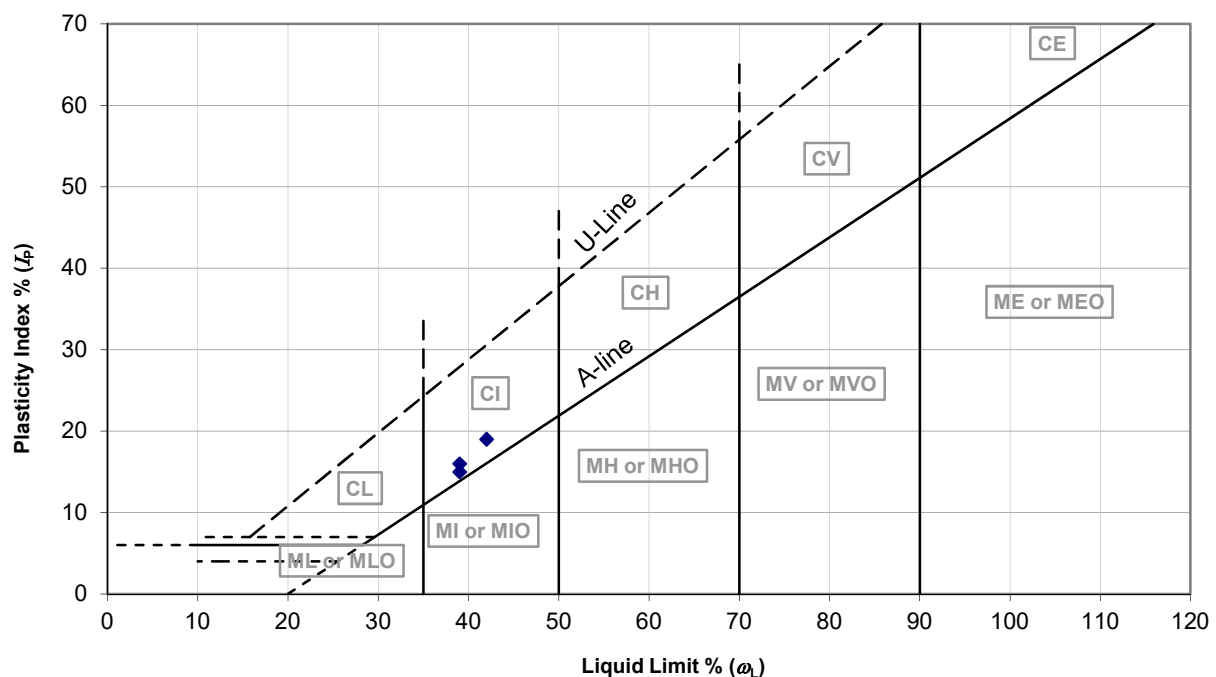
Location	Depth (m)	Water Content (ω) (%)	Liquid Limit (ω_L) (%)	Plastic Limit (ω_P) (%)	Plasticity Index (I_P) (%)	Retained by 0.425mm (%)	Modified (ω) (ω') (%)	Modified (I_P) (I_P') (%)	Liquidity/ Consistency		Casagrande Class	N.H.B.C Class (%)
									(I_L) (%)	(I_C) (%)		
WS01	1.30	20	39	23	16	23	26	12	-0.2	1.2	C I	LOW
WS02	0.90	20	39	24	15	31	29	10	-0.3	1.3	C I	LOW
WS04	0.80	18	42	23	19	19	22	15	-0.3	1.3	C I	LOW

Interpretation graph based on BS EN ISO 14688-2:2018 any interpretations are expressed outside of our UKAS Accreditation.
