Preliminary Roost Assessment

61 Leymoor Road, Huddersfield, West Yorkshire HD3 4SW

'Demolition of old outbuilding and toilet block'

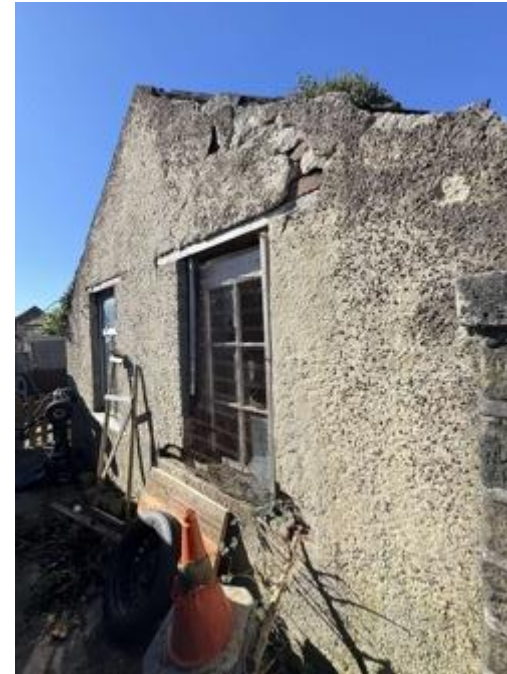
Eastern elevation of B1

B1 is a single-storey, detached, brick-built out-building with a gabled roof clad in tiles. No internal voids were recorded. No bat evidence was found during the survey.

In line with Good Practice Guidelines (Collins, J (Ed) 2023), B1 is assessed to have **low** habitat value for roosting bats due their being one or more feature present in room 1 that could be utilised by individual crevice dwelling bats. There is a high volume of light ingress into room 2 and 3 of the building which would deter void dwelling bats. Room 4 features dense ivy growth that would prevent bats from accessing the room.

- One bat emergence/re-entry survey will be required on B1 and B2, requiring 3 survey positions to provide full coverage of the building's elevations. If bat roosts are confirmed in the building two additional surveys may be required to characterise the roost and to inform an EPSL application to Natural England.
- These surveys must take place during the active bat season (May – September) to confirm presence/likely-absence of bats roosting in or on the building.
- These survey visits should be completed during the optimal survey period mid-May to August inclusive and the survey visits should be at least three weeks apart. Completing surveys in the sub-optimal season, early May and September, would require greater justification of timing e.g., weather conditions, known local bat activity.
- Lighting mitigation may be required based on the outcome of the night bat survey(s).

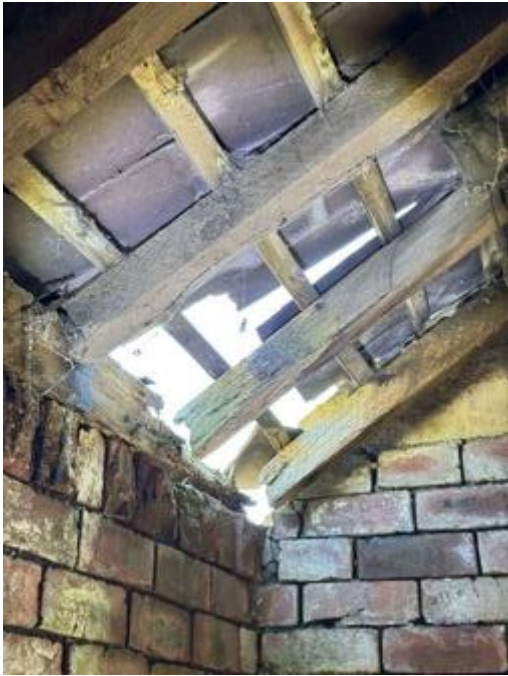
Roof	Tiles	<p>The roof is in a state of disrepair with open gaps and lifted tiles, particularly to the northeast. These features, along with dense ivy covering a section of the roof, provide potential roosting opportunities for individual crevice-dwelling bats and allow for internal access.</p>

<p><i>Condition of roofing tiles; Gaps and slipped tiles</i></p>	
--	------	-------	--	--	--

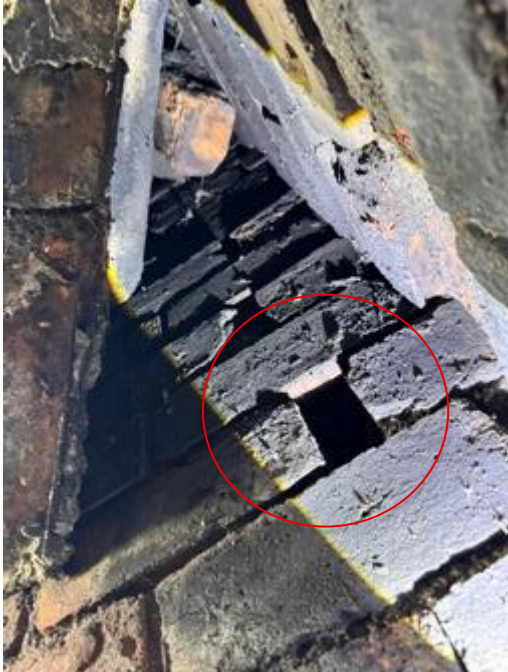
Walls	Brick-built (rendered on some elevations)	The walls are constructed of brick and exhibit loose masonry and cavities. Inside room one, crevices and gaps are present due to missing masonry within the walls and in the chimney flue. These features could be utilised by individual crevice dwelling bats.

<p><i>Missing and loose masonry in chimney</i></p>	
-------	--	--	--	--

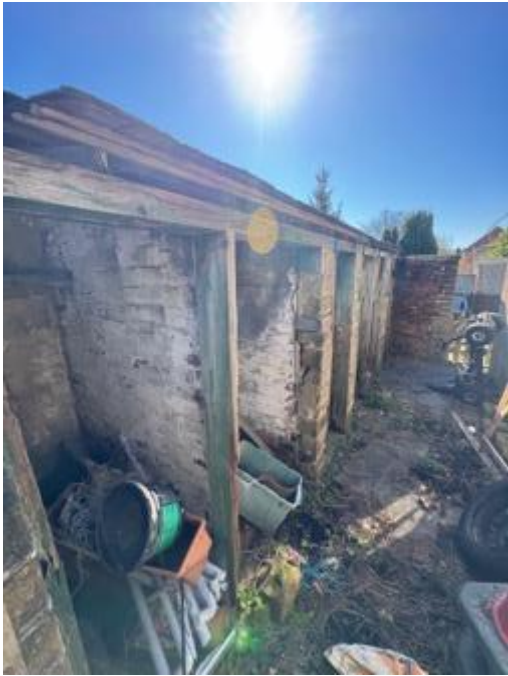
<p style="text-align: center;">B2</p>		
<p>Feature</p>	<p>Materials</p>	<p>Condition/Suitability</p>	<p>Photographs</p>

<p>B2 is a single-storey, detached, brick-built toilet block that features four cubicles with a lean-to roof structure clad in slate tiles. The building has no recorded internal voids. No bat evidence was found during the survey.</p> <p>In line with Good Practice Guidelines (Collins, J (Ed) 2023), B2 is assessed to have low habitat value for roosting bats due to their being one or more features that could be utilised by individual crevice dwelling bats.</p>

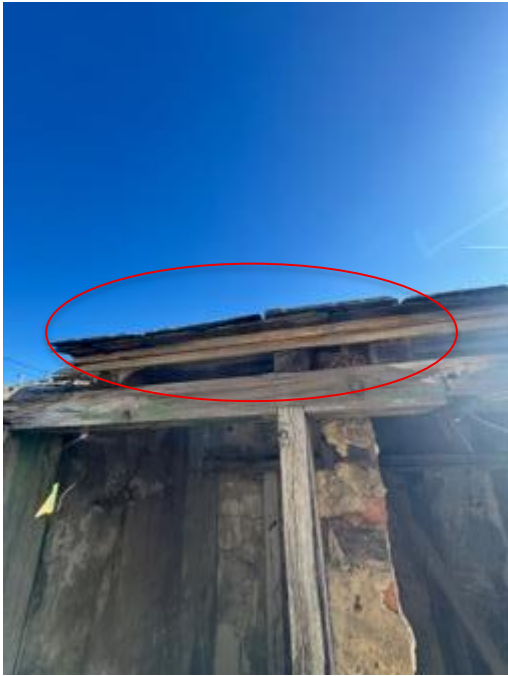
Roof	Tiles	The roof is clad in tiles and features slipped tiles and open gaps between the brickwork and tiles creating potential roosting opportunities.

<p data-bbox="1525 890 1630 916"><i>Lifted tiles</i></p>	
--	------	-------	---	--	--

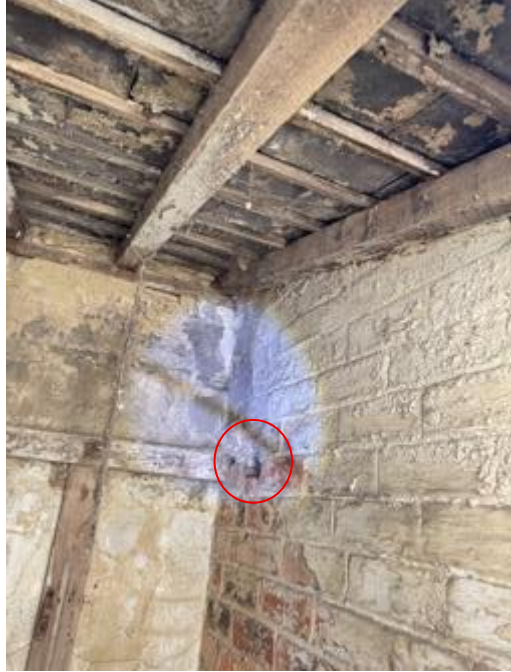
Walls	Brick-built	<p>The brick-built walls are in a condition of loose masonry and cavities. Within the individual toilet cubicles, missing masonry has formed small cavities, providing potential roosting opportunities for individual crevice-dwelling bats.</p>

<p><i>Small crevices from loose masonry</i></p>	
--	--	--	--	---	--

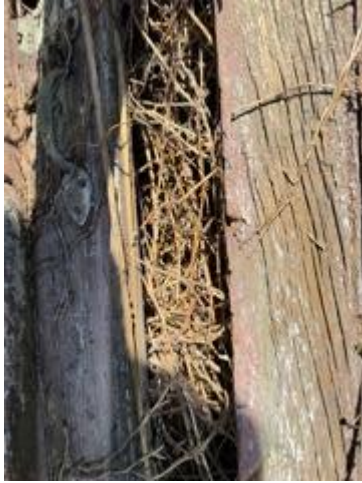
- One of the rooms was inaccessible due to dense ivy growth. The ivy prevented the door from being opened. However, as the room contained dense ivy with no viable access points it is not thought to be suitable for bats. Thus, this is not considered a significant limitation.

Photo 1: Dense ivy growth in room 4 preventing door from being opened

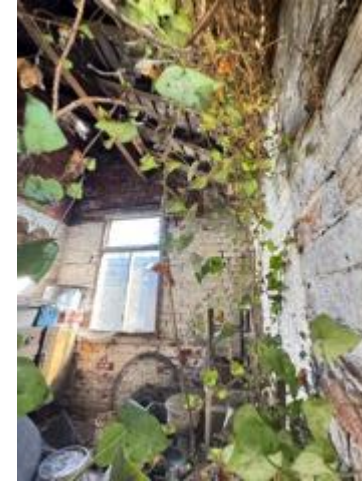
Photo 2: Light ingress and ivy preventing door to room 3 from being opened

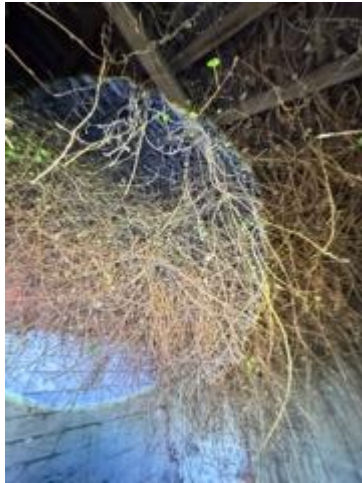
Photo 3: Ivy present growing into room one

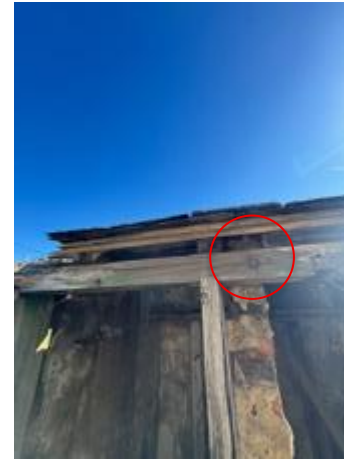
An old, uninhabited robin's *Erithacus rubecula* nest was found on a small ledge below the roof on B2. Both buildings offer nesting opportunities for bird particularly B1 were there is dense ivy growth.

Photo 4: Bird's nest in B2

Any building/vegetation removal should be undertaken outside the period 1st March to 31st August. If this timeframe cannot be avoided, a close inspection of the building/vegetation should be undertaken immediately, by a qualified ecologist, prior to the commencement of work. All active nests will need to be retained until the young have fledged.
