# Bat Emergence and Re-Entry Survey

**61 Leymoor Road, Huddersfield, West  
Yorkshire  
HD3 4SW**

**This report is prepared to inform a planning application for the proposal described as 'Demolition of old out-building and toilet block'.**

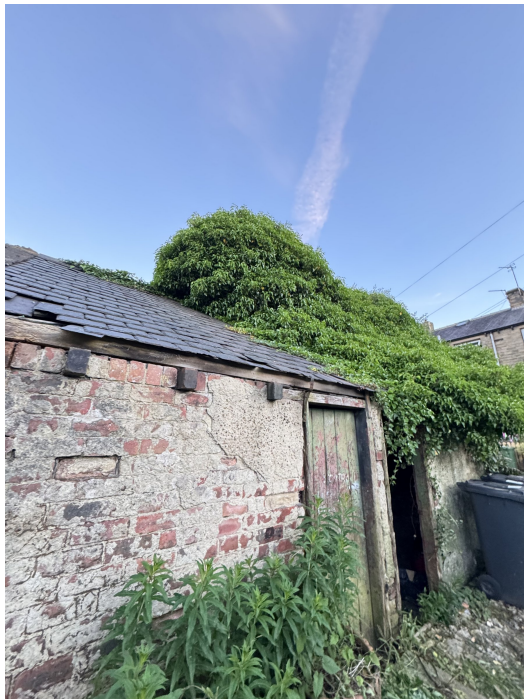
**Figure 1a:** Overview of B1

B1 and B2 are old brick-built structures with slate-tiled roofs. The main building (B1) features dense ivy growth, which has contributed to the structural decline of the building. Both buildings contain missing and slipped roof tiles, together with internal crevices that could be utilised by roosting bats.

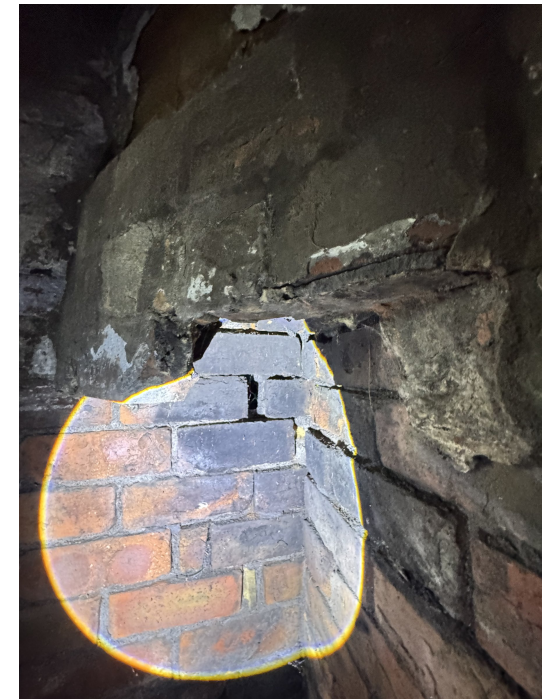
**Figure 1b:** Internal crevices still present in B1

No evidence of bats was identified during the updated inspection, consistent with the findings of the original PRA. In addition, all previously identified features remained unchanged, and therefore the conclusions of the original bat roost suitability assessment remain valid.
