Holmside Farm, Holmfirth

*Nocturnal Bat Survey Report*

June 2025

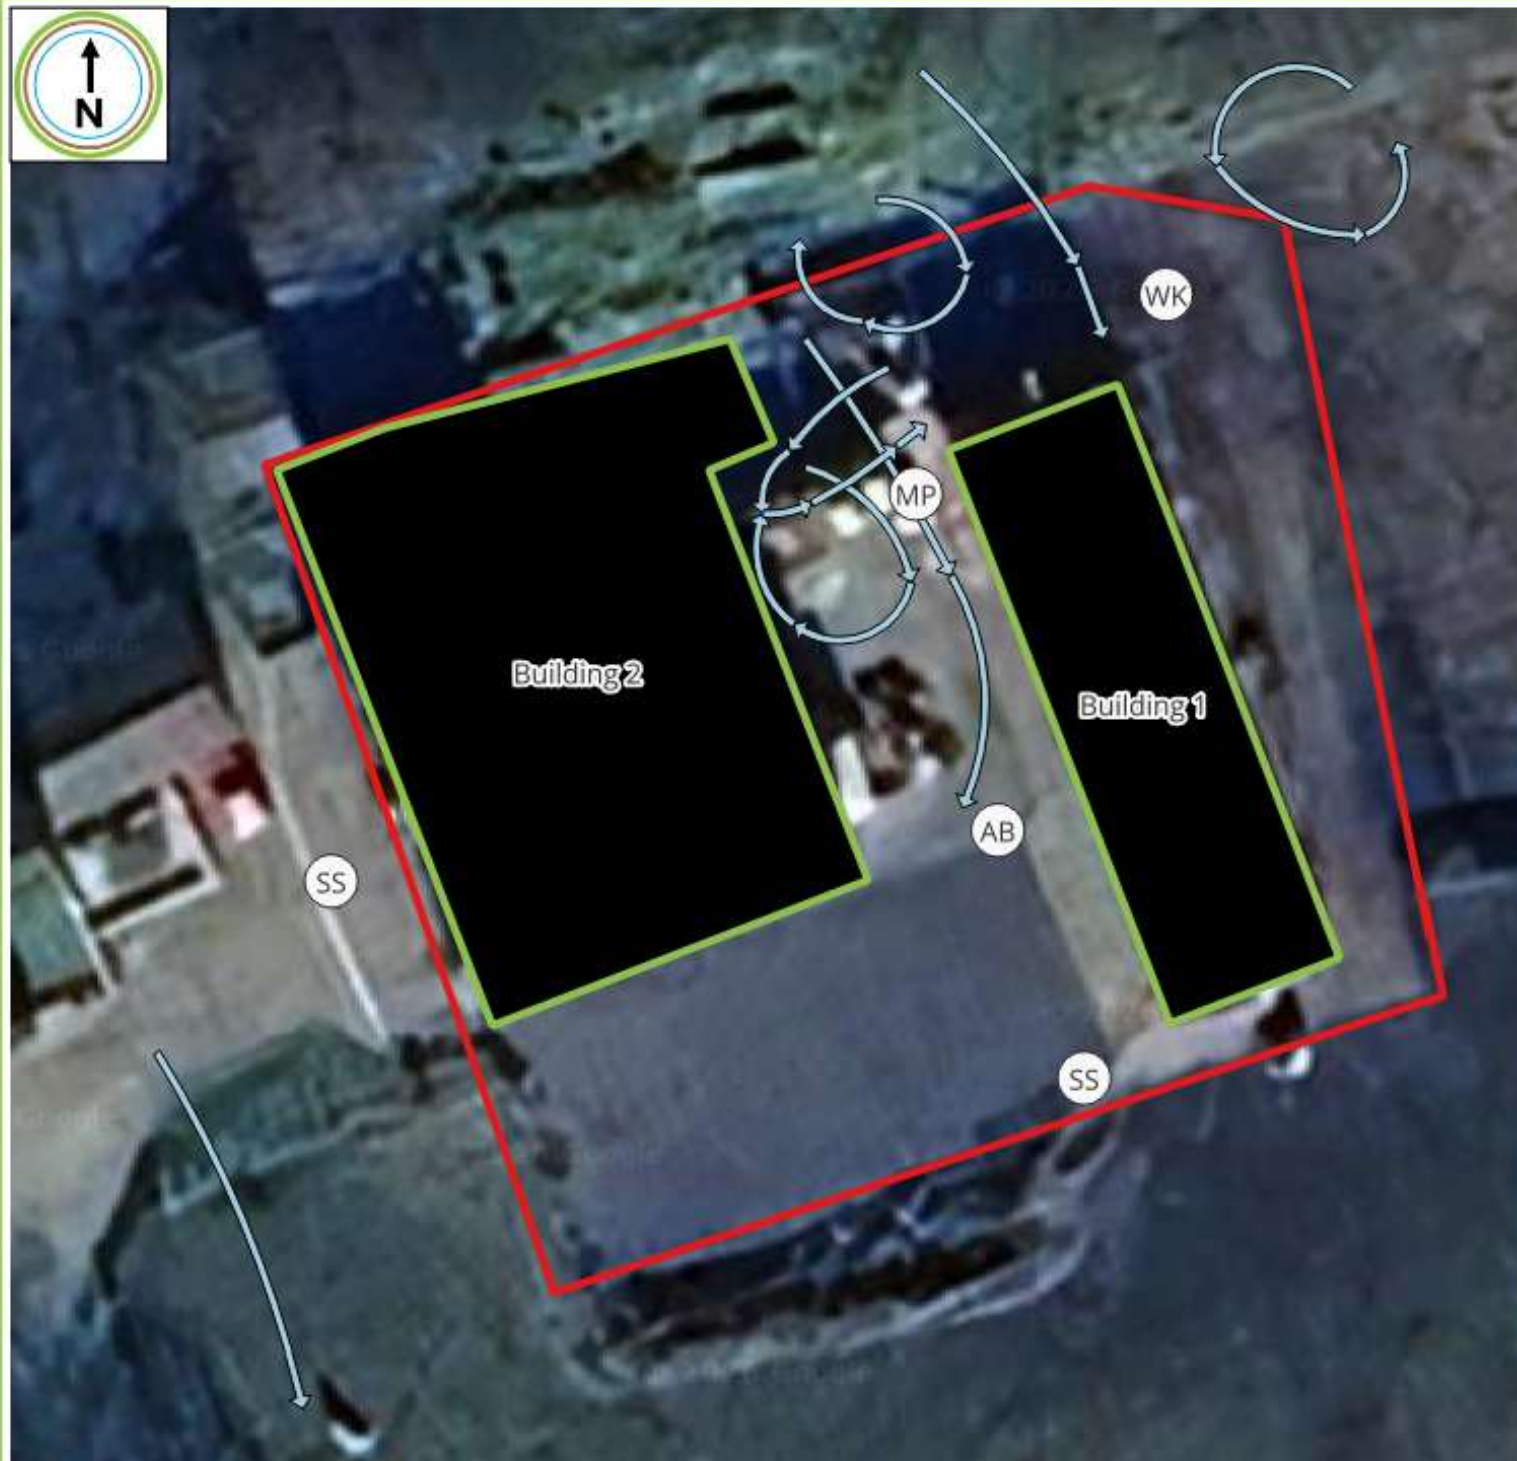
Figure 1  
Survey Results Map 2nd June 2026

- 3.2.1 No roosting bats were recorded within the Site during the survey (Figure 1.1).
- 3.2.2 The earliest bat recorded was a common pipistrelle *Pipistrellus pipistrellus* at 21:50, which was recorded by one surveyor in flight as a pass over. Common pipistrelle were the only species recorded throughout the survey.
- 3.2.3 The individuals in flight observed by the surveyors were most regularly seen associated with the eastern

extent of the Site, towards the agricultural fields and river corridor. In addition to this, individual bats were observed flying around the entrances of the buildings, but did not emerge from here. The final bat was recorded at 22:33, pertaining to a common pipistrelle observed foraging.
