**WOOD NOOK LANE, HONLEY.**

**BAT REPORT AND MITIGATION  
STRATEGY.**

**Ref No: 250641.**

**Date: 17<sup>th</sup> September 2025.**

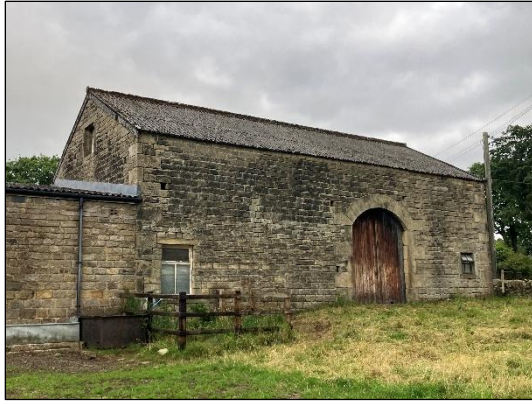
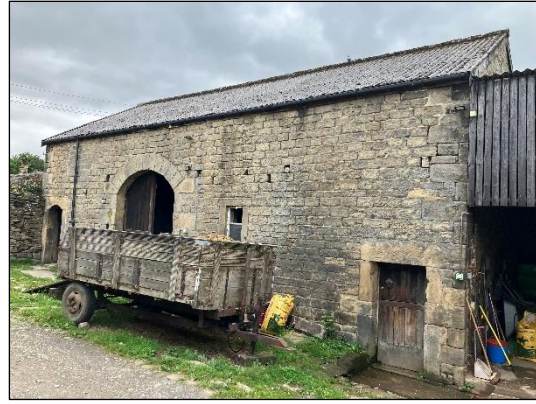
3.3.1.1. The main barn is a two-storey high building as shown in the photographs below.

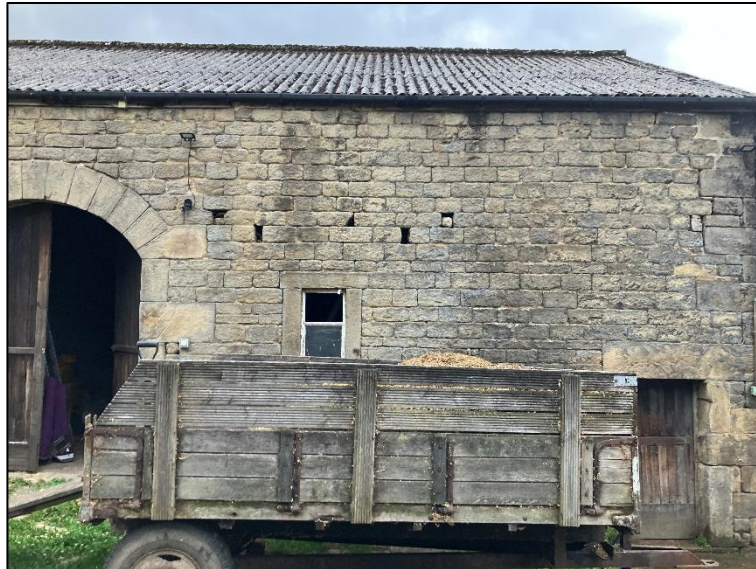
3.3.1.2. The walls are constructed from cut and dressed stone, with multiple missing stones and fractures / gaps in the stonework that provide potential for roosting bats.

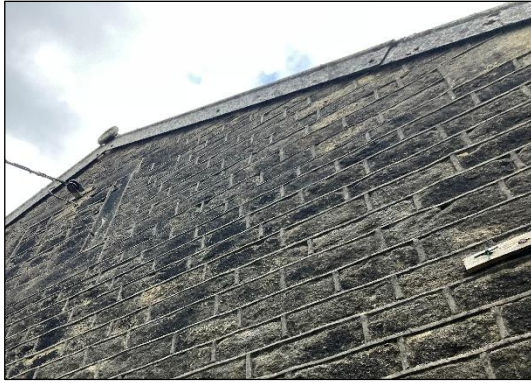
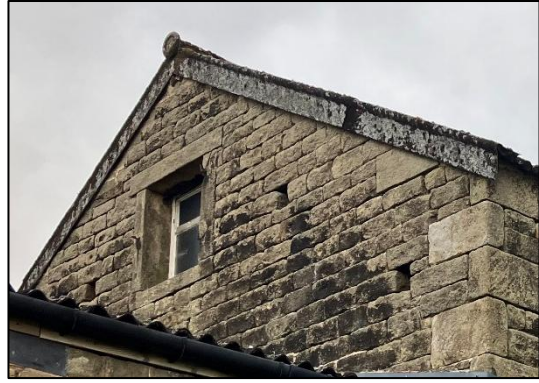
3.3.1.4. There are fascia boards on the gable ends of the barn that have gaps behind them providing opportunity for roosting bats.

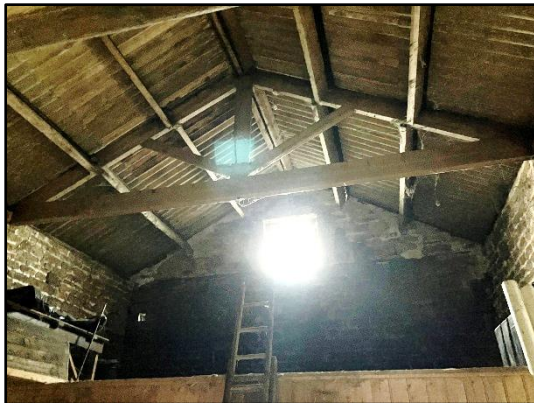
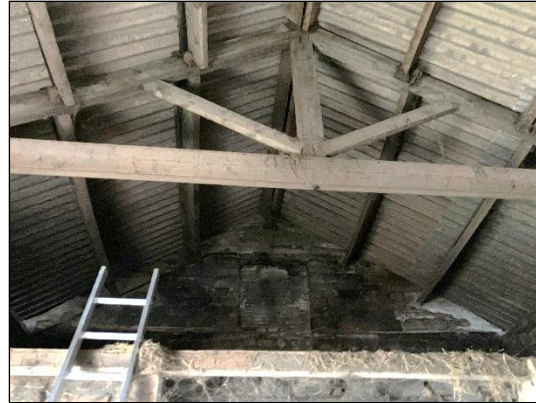
3.3.1.6. Internally, the barn has two small ground floor rooms, one at each end of the barn. The main and central part of the barn is completely open to the underside of the roof sheets, with two mezzanine floors on top of the ground floor rooms. There is a king post timber roof structure supporting the corrugated roof sheets, that appear to be in good condition.

3.3.1.7. There were some open / missing windows providing access for bats inside the main barn, and the internal of the stone walls also displayed numerous fractures and gaps suitable for bats to roost in.

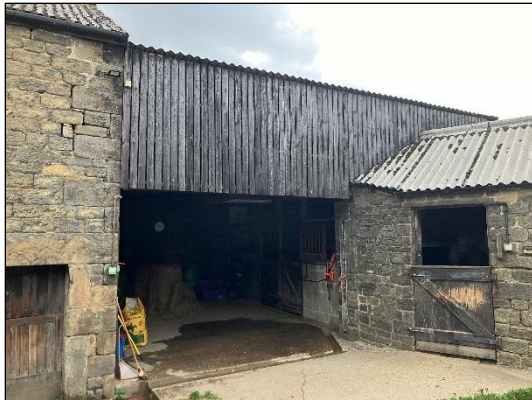
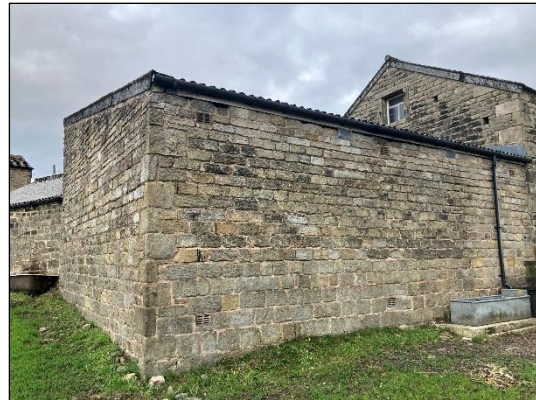
3.3.2.1. The building attached to the northeast gable end wall of Building 1 is a single storey open barn and stable block. The front is open, with some vertical wooden slats above.

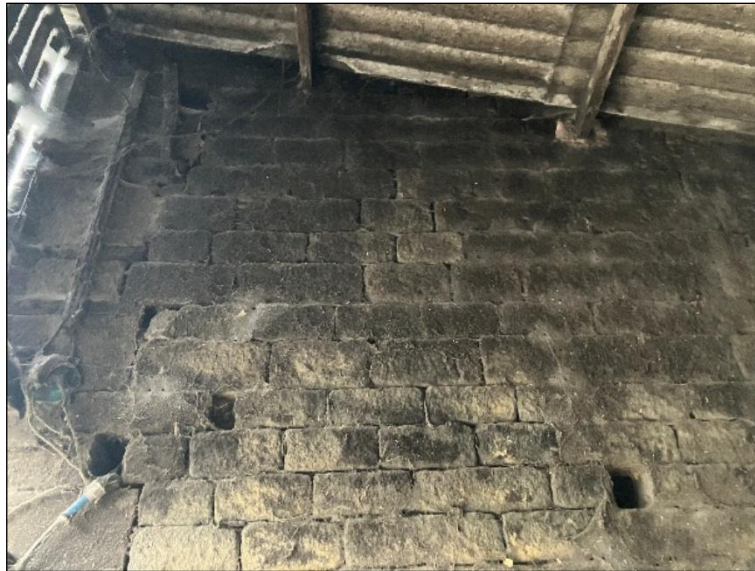
3.3.2.2. No holes or fractures were identified in the external walls that could provide roosting features for bats. There are however a few holes and gaps between the bricks in the external wall of Building 1, which forms the interior wall of Building 2.

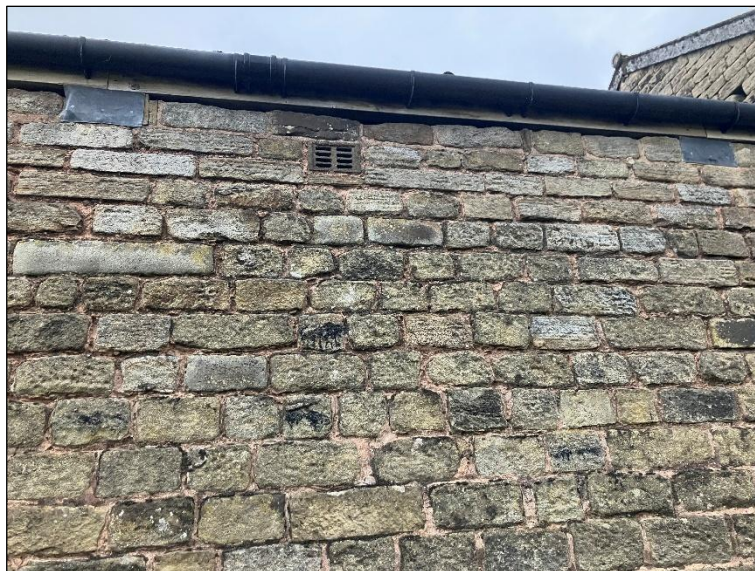
3.3.2.4. The fascia on the gable end sits flush against the wall and there is no gap behind it. However, there are gaps behind the fascia along the rear wall. These gaps allow access for bats directly into the building.

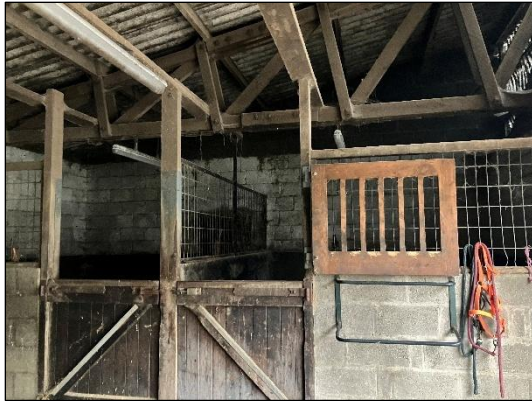
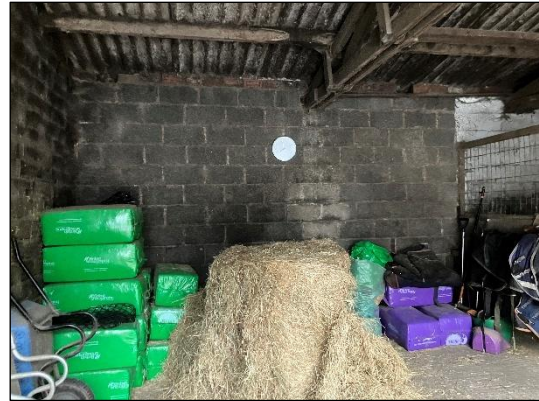
3.3.2.6. Internally the building is used for storage and stabling of horses. It is one open space open to the underside of the roof sheets. The internal walls are constructed from concrete blocks, which are generally in good condition.

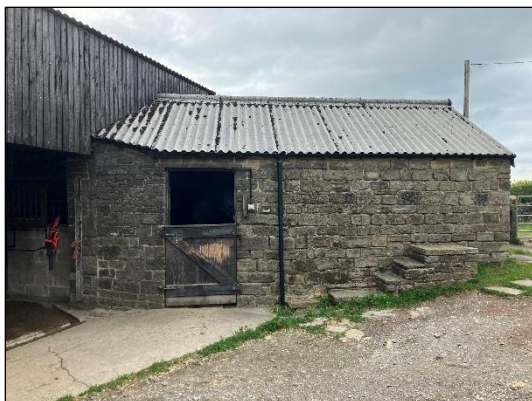
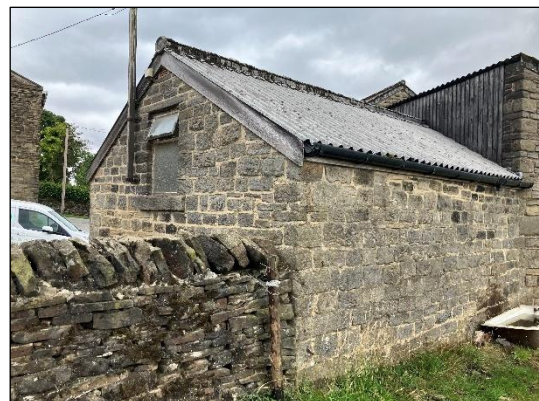
3.3.3.1. Building 3 is single story stable, attached to the southeast side of Building 2.

3.3.3.2. The building is made of the same material as described previously, stone walls and a pitched corrugated metal roof. There is a wooden fascia on the gable end /

northeast side of the building with gaps behind, although these are mostly cobwebbed over.

3.3.3.3. These walls and roof of Building 3 are all in good condition and provide no roosting features for bats. Any potential is limited to behind the fascia on the gable end. Therefore, Building 3 is assessed as low potential for roosting bats.

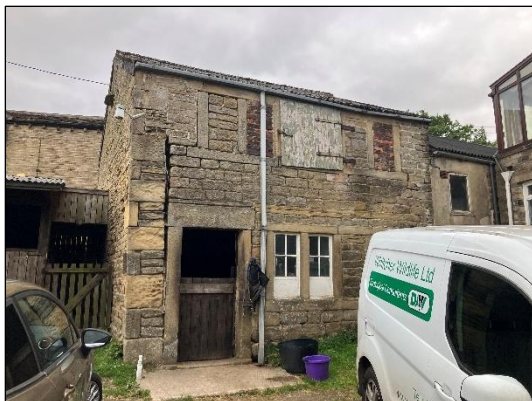
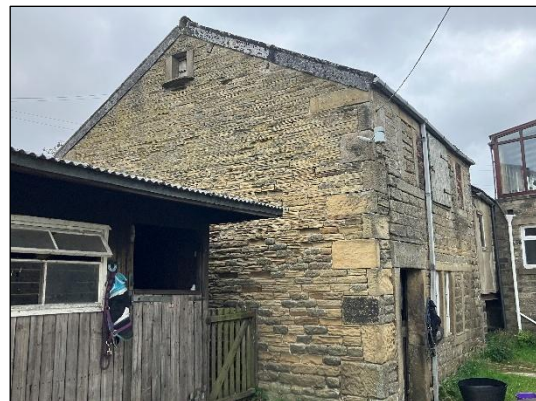
3.3.4.1. Building 4 is a standalone, two-storey building, the ground floor of which is being used as a stable and the first floor is a disused hay loft.

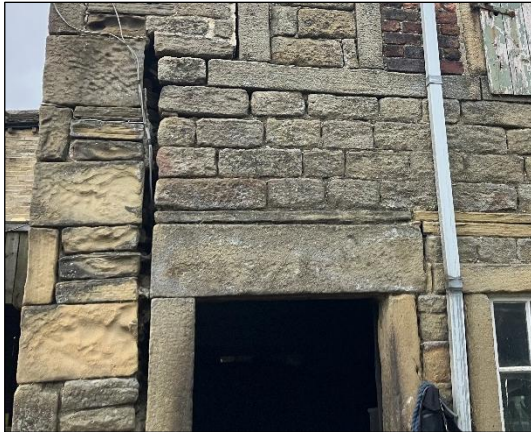
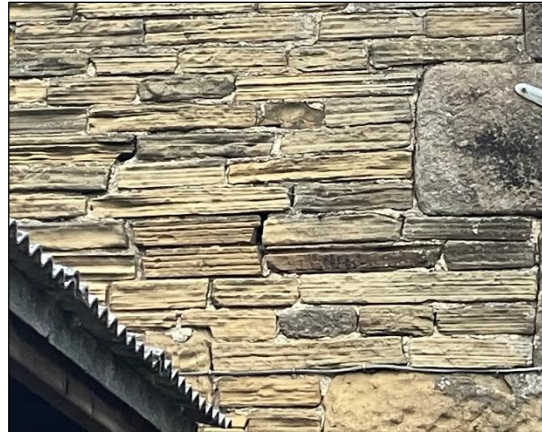
3.3.4.2. The walls comprise a patchwork of different types of stone, which is in poor condition with numerous gaps between the stonework. Some of these are quite wide and are not ideal for roosting bats as they will be exposed to predators and the external elements. However, there are still numerous other features that are ideal for crevice dwelling bats, such as those in the first picture below.

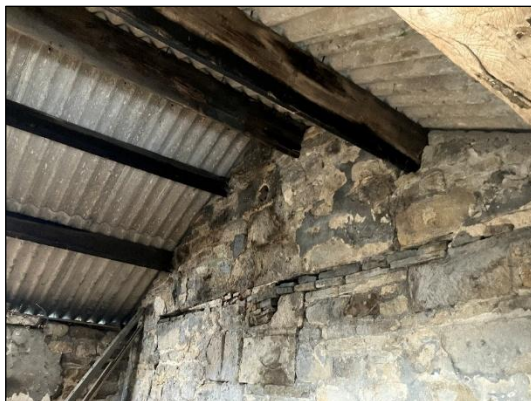
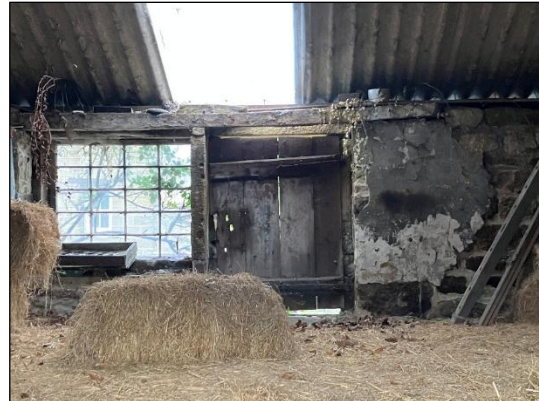
3.3.4.5. The first floor was unsafe to access due to the condition of the floor. However, this area was viewed from ladders through the first floor window. From what could be observed, there are opportunities for bats to access inside the first floor through gaps at the top of the walls and around windows. There were also fractures and gaps in some of the internal walls that could provide potential features for roosting bats.

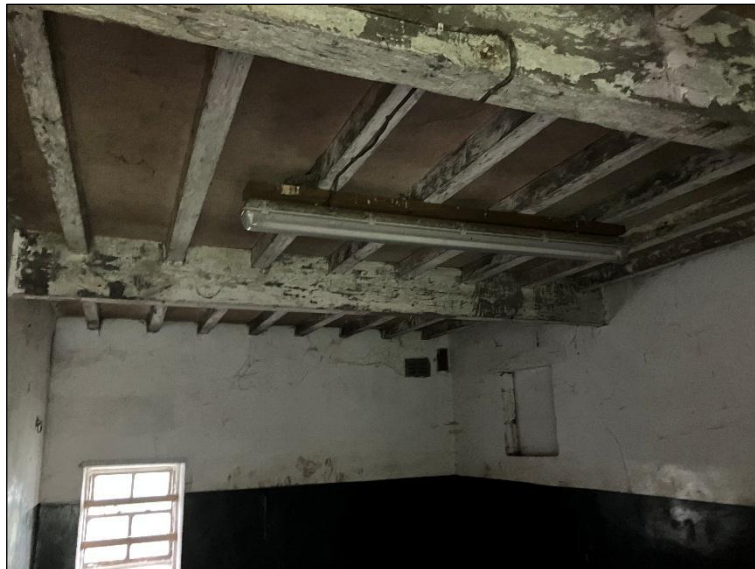
3.3.5.1. During the inspection, and subsequent surveys, swallows were identified inside Building 1 in both the main part of the barn in the roof timbers, and also in one of the ground floor rooms.

5.6. In addition, swallows were identified nesting inside Building 1, therefore it is recommended that provisions for swallows to nest are incorporated into the development. Swallows need an open building or canopy to nest under and artificial swallow cups can be provided in these locations.

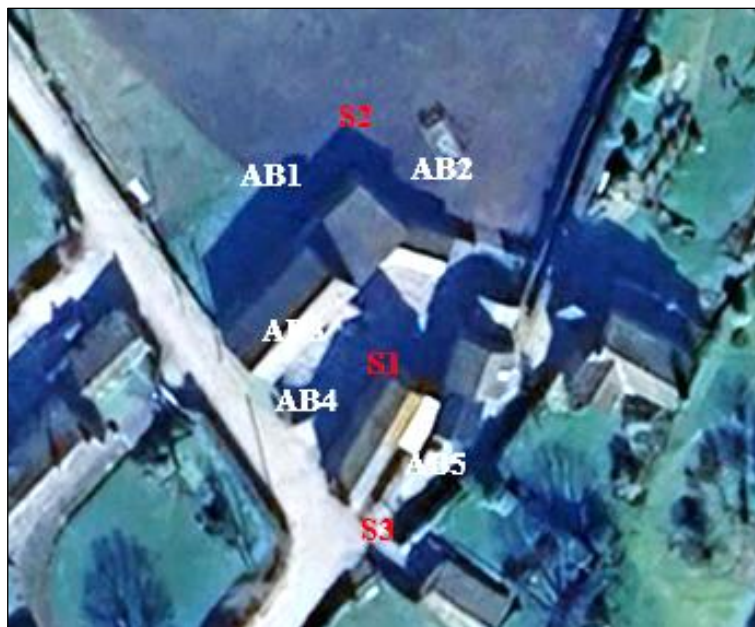
3.4.3.4. The aerial photograph below shows where the Surveyors (S) and Anabats (AB) were located throughout the survey.

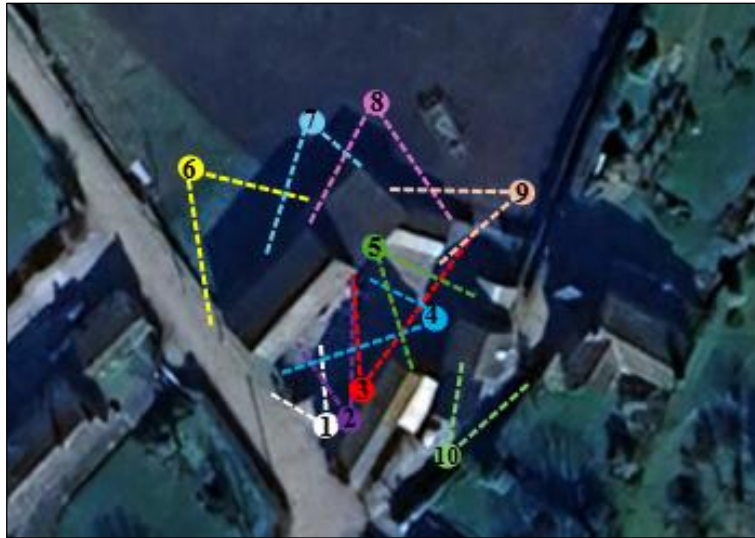
3.4.3.6. The aerial photograph below shows where the cameras were positioned along with their approximate field of view.

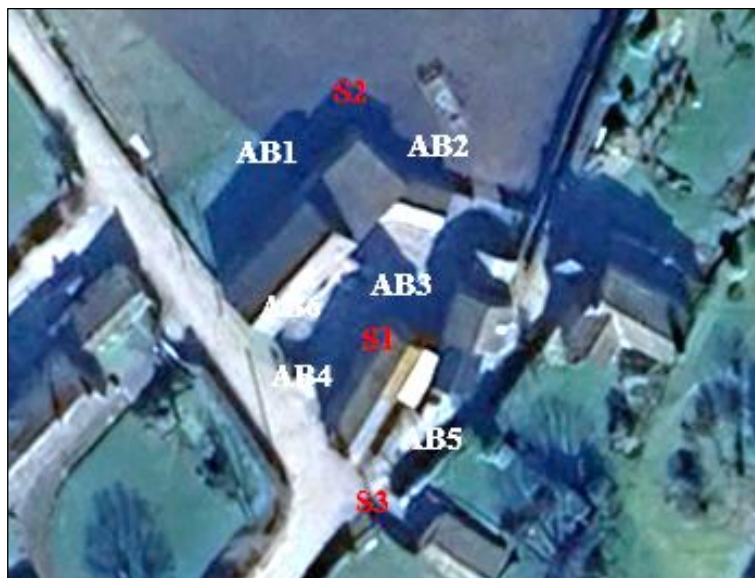
3.4.4.4. The aerial photograph below shows where the Surveyors (S) and Anabats (AB) were located throughout the survey.

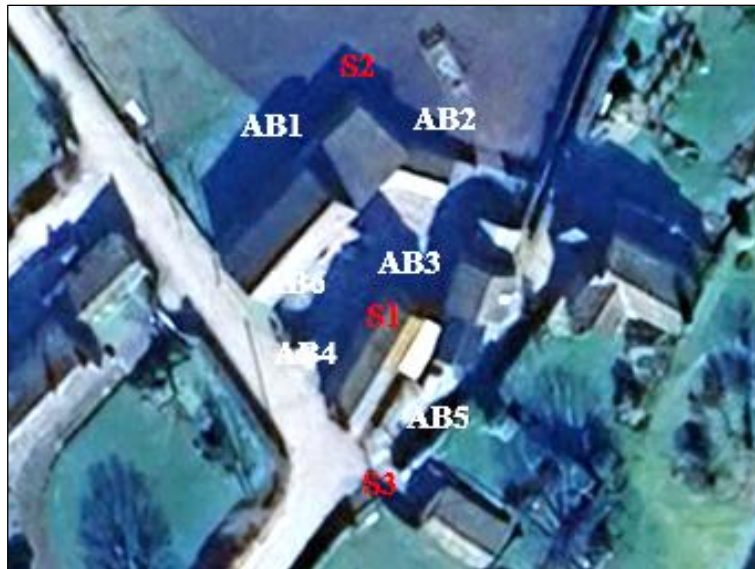
3.4.5.4. The aerial photograph below shows where the Surveyors (S) and Anabats (AB) were located throughout the survey.

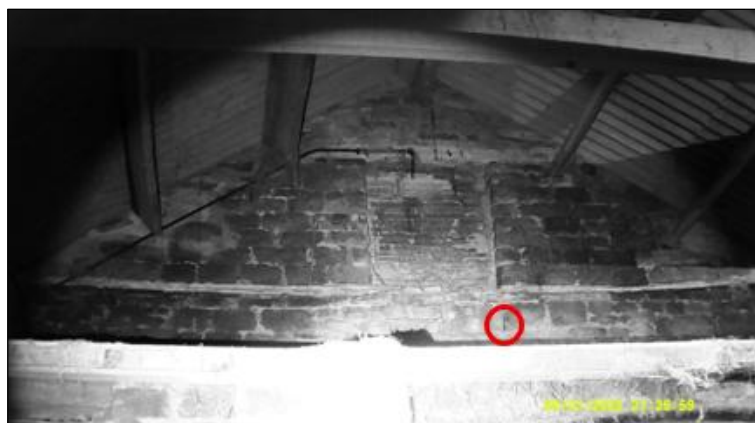
3.4.5.9. Additional cameras were utilised during this survey to attempt to locate the access points and roosting location of the brown long eared bat inside Building 1. Again, the surveyors did not observe the bat inside Building 1 at any time during the survey, however, subsequent analysis of the video footage of the internal cameras clearly identified the bat emerging from a gap in the southwest internal wall at 20:40, located fairly low down near the mezzanine floor, shown in the photograph below. This is consistent with the direction the bat was seen to emerge from during the previous survey.

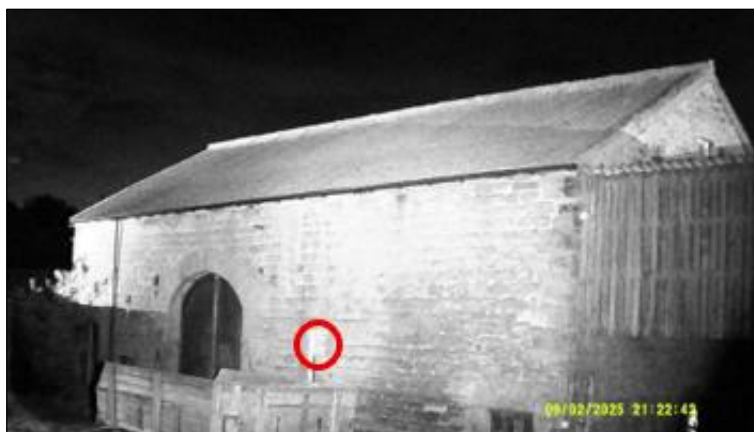
3.4.5.10. Subsequent analysis of the video footage from the external cameras shows the brown long eared bat then emerge out of Building 1 at 20:42 from a ground floor window. The image below shows the window and the location of the emergence.

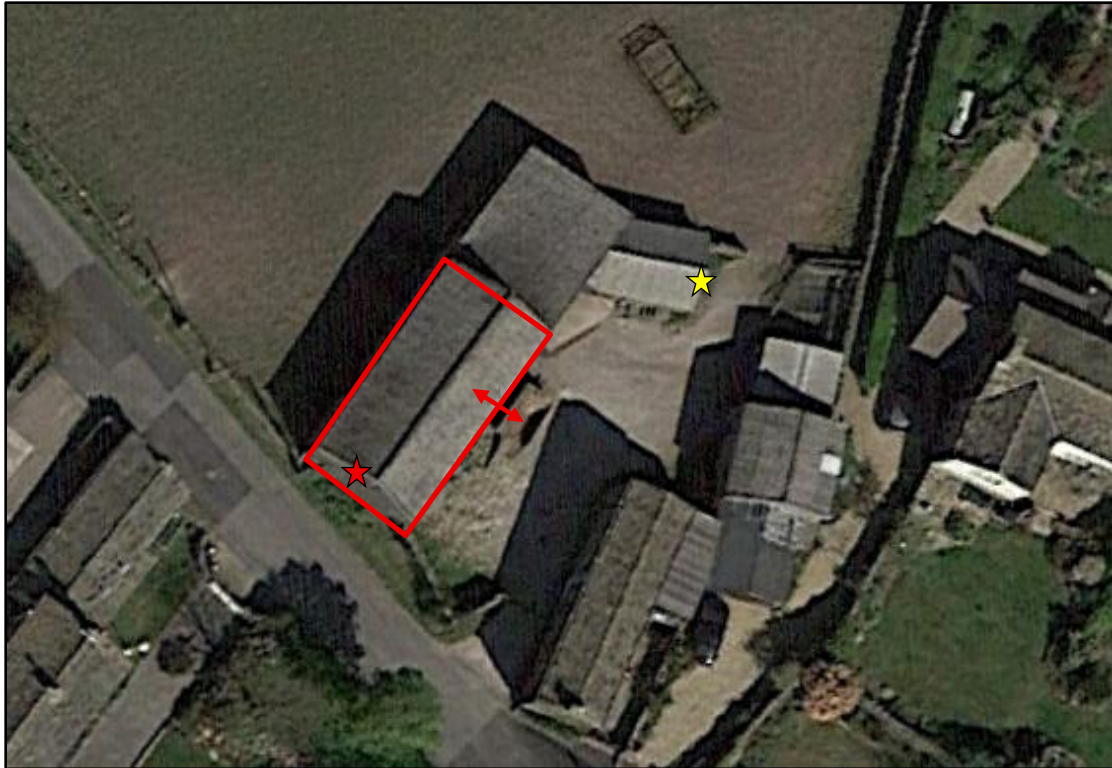
3.4.6.1. The survey results have identified one brown long eared day roost present in Building 1, with the bat roosting in a feature between the internal stonework in the southwest gable end wall and utilising a missing window on the ground floor as access and egress from the building. This roost is utilised by one brown long eared bat.

3.4.6.2. In addition, there is one occasional common pipistrelle day roost behind the east gable end fascia of Building 3. This roost is utilised by one common pipistrelle bat.

3.4.6.3. The aerial map below shows an overview of the status of bats on the site.
