## **PRELIMINARY ECOLOGICAL APPRAISAL**

**UNITED CHURCH, MARSDEN, HUDDERSFIELD, HD7 6AB**

**FEBRUARY 2026**

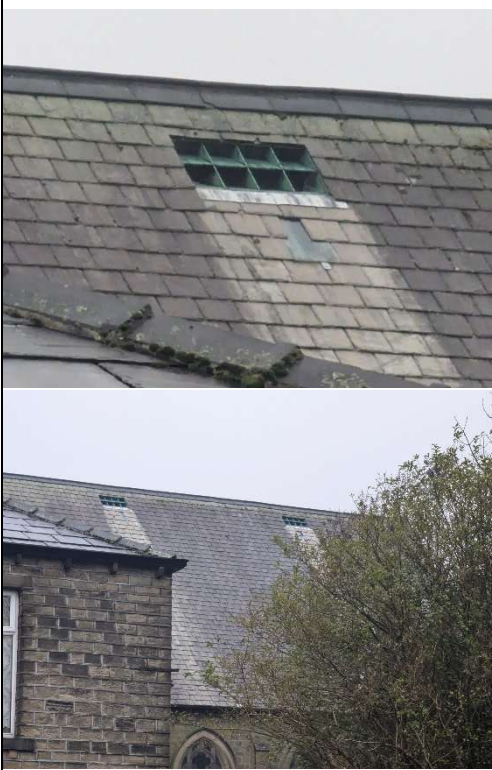
The roof is in moderate overall condition with only minor signs of damage and decay. A slate tile is missing beneath each of the vents on the eastern aspect of the roof. Gaps are present between the wall plate and the eaves of the central roof on the eastern and western aspects.

Bats may find access to the roof via the vents and missing slates (high potential roost features). In addition, gaps beneath the eaves may provide access for roosting bats (moderate potential roost feature).

| PRF | PRF description | PRF suitability | Photograph |
|---|---|---|---|
| 1 | Four louvred roof ventilators at the apex of the central pitched roof on both eastern and western aspects. These features may allow access to the roof void if still functional. Additionally, missing slates beneath two of the vents could allow access for bats if the vents have been internally sealed. As these features lead to an undisturbed roof void they have suitability for large numbers of roosting bats. | High | |

Three nocturnal emergence surveys are required between April – September with at least two between May-August to determine presence or likely absence of bats roosting within the building.

Two surveyors will be required to cover the roof vents and missing slates and two surveyors will be required to cover the gaps under the eaves (see surveyor location plan).

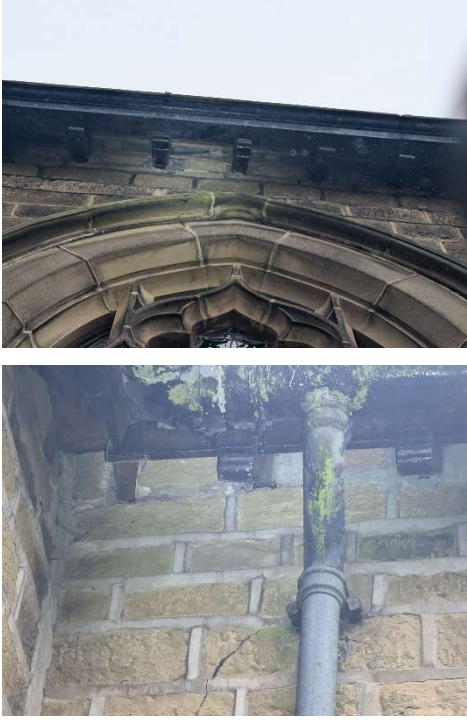
| 3 | Gaps at wall plate level and around rafters under eaves on eastern and western walls could lead to the roof structure. As the ceiling is vaulted these features would likely be suitable for crevice-dwelling bats in moderate numbers only. | Moderate | |

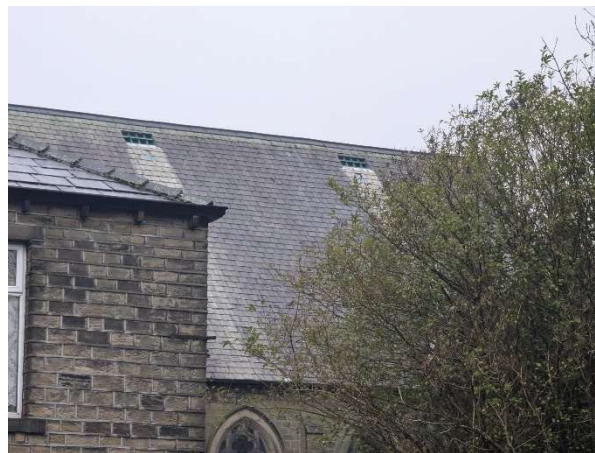
**Photograph 4: Eastern aspect of the central pitched roof.**

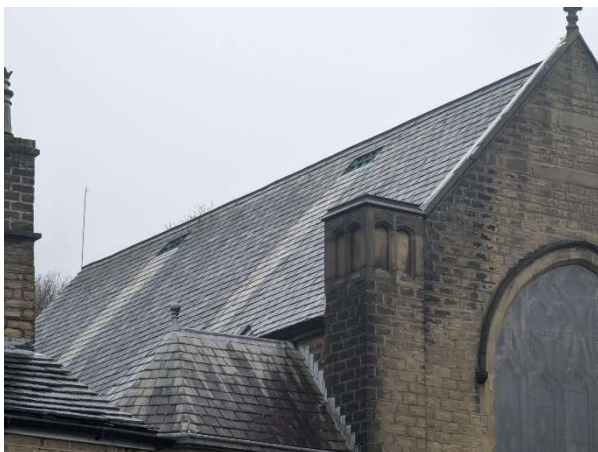
**Photograph 2: Western aspect of the central pitched roof.**

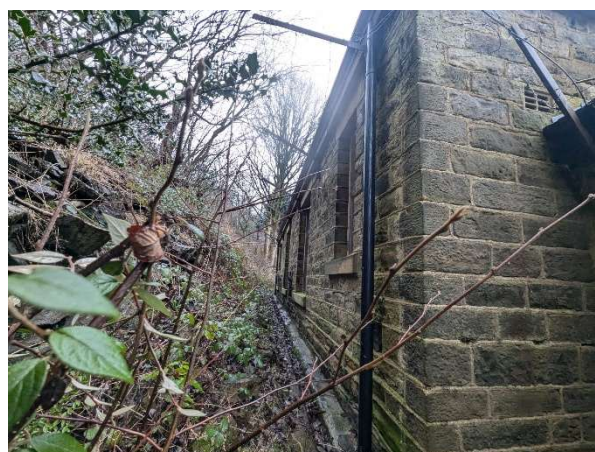
On the northern aspect of the building is a boarded window with a large gap above which could be used by bats to access the ground floor. However, the internal inspection found no internal features which could be used by roosting bats on the ground floor. The rooms accessible by the gap above the window had negligible potential for roosting bats.

**Photograph 6: Northern aspect of the building.**

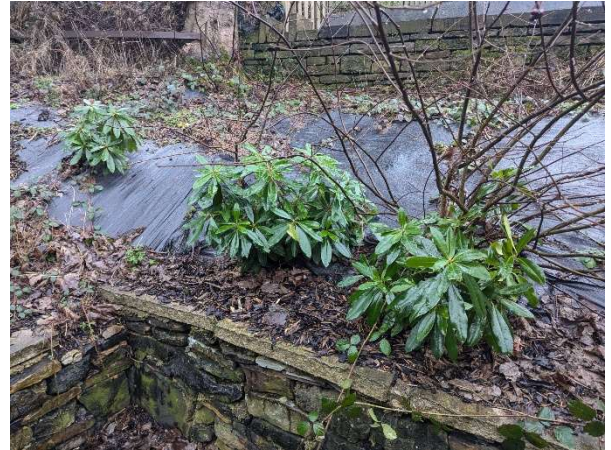
In the east of the site is a raised garden that has been covered with hessian to prevent an overgrowth of weeds. Penetrating the hessian in places is planted rhododendron and self-sown sycamore. Bramble is encroaching on the peripheries of the hessian cover.

**Photograph 10: Rhododendron in unvegetated garden.**

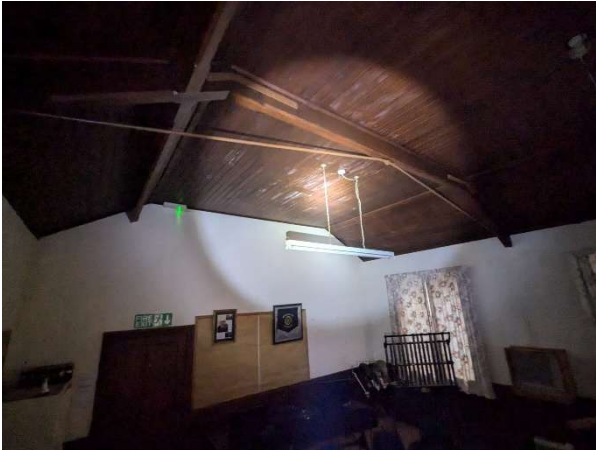
**Photograph 13: Internal view of wood paneled vaulted ceiling.**

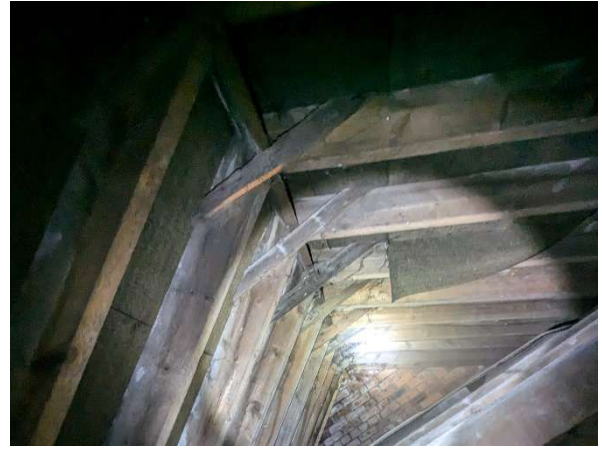
An internal inspection of the building found the roof to vaulted with inaccessible loft hatches indicating a small roof void. Small void spaces were accessed on the lower elevations. The internal structure of the roofs over lower elevations comprised timber with hessian lining.

**Photograph 16: Internal view of roof structure over a small loft space in the north of the building.**

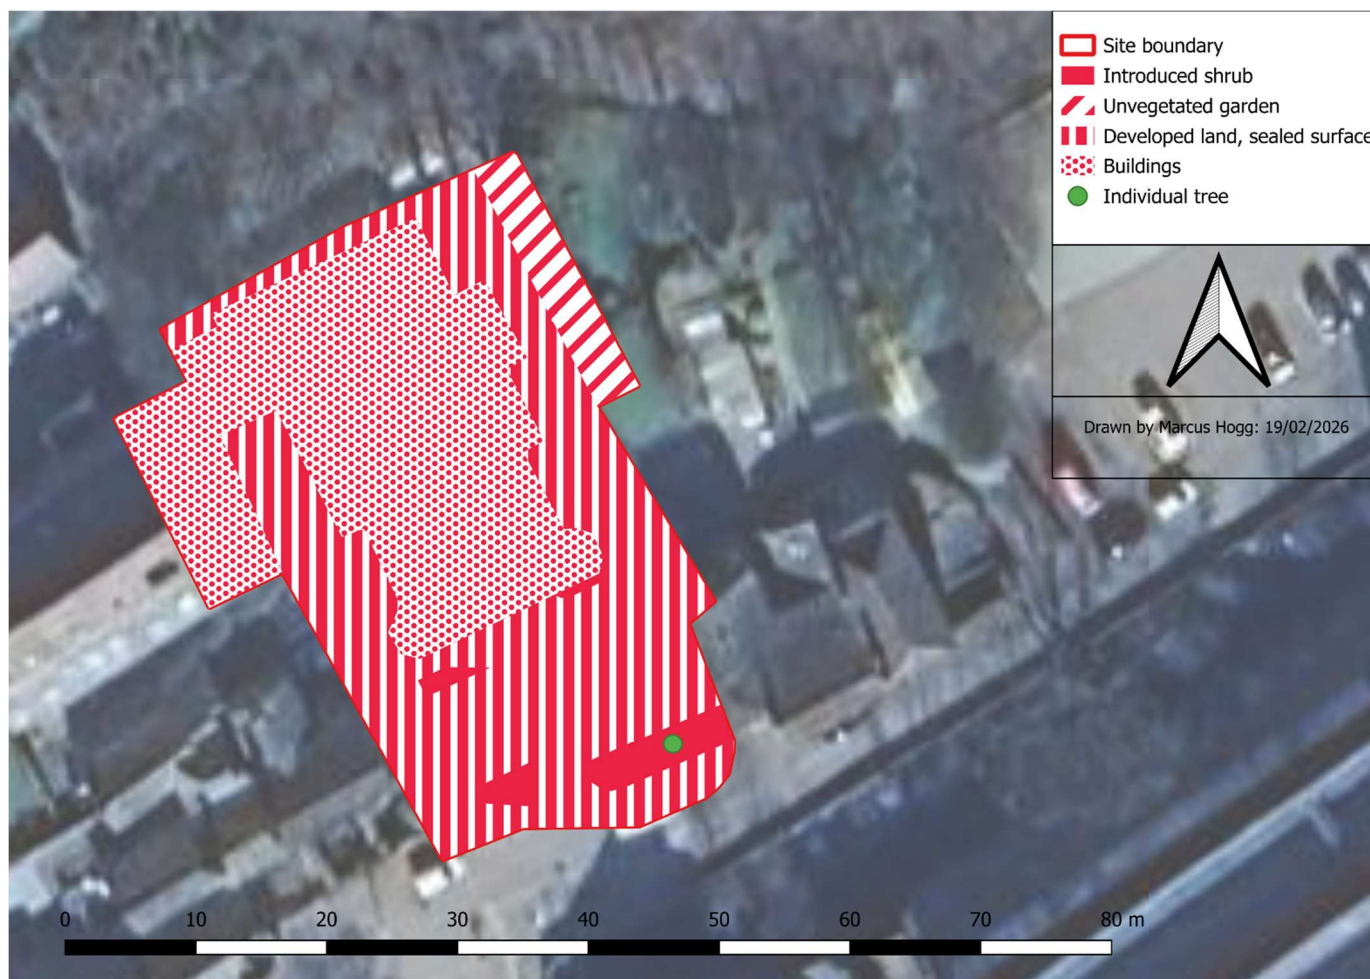
Figure 1 – UKHabs Baseline Map

- u1b5 Buildings
- u1b Developed land, sealed surface
- u1 (829, 847) Unvegetated garden (*introduced shrub*)
- u1 (32, 847) Introduced shrub (*scattered trees*)
