**Headfield Barn, Savile Town
Preliminary Roost Assessment**

27th November 2025

Document ref: MBE/BAT/2025/114/01				
Purpose and Description	Originated	Checked	Reviewed	Date
For Planning	R Bell MCIEEM	P Middleton MCIEEM(rtd)	R Bell MCIEEM	27/11/2025

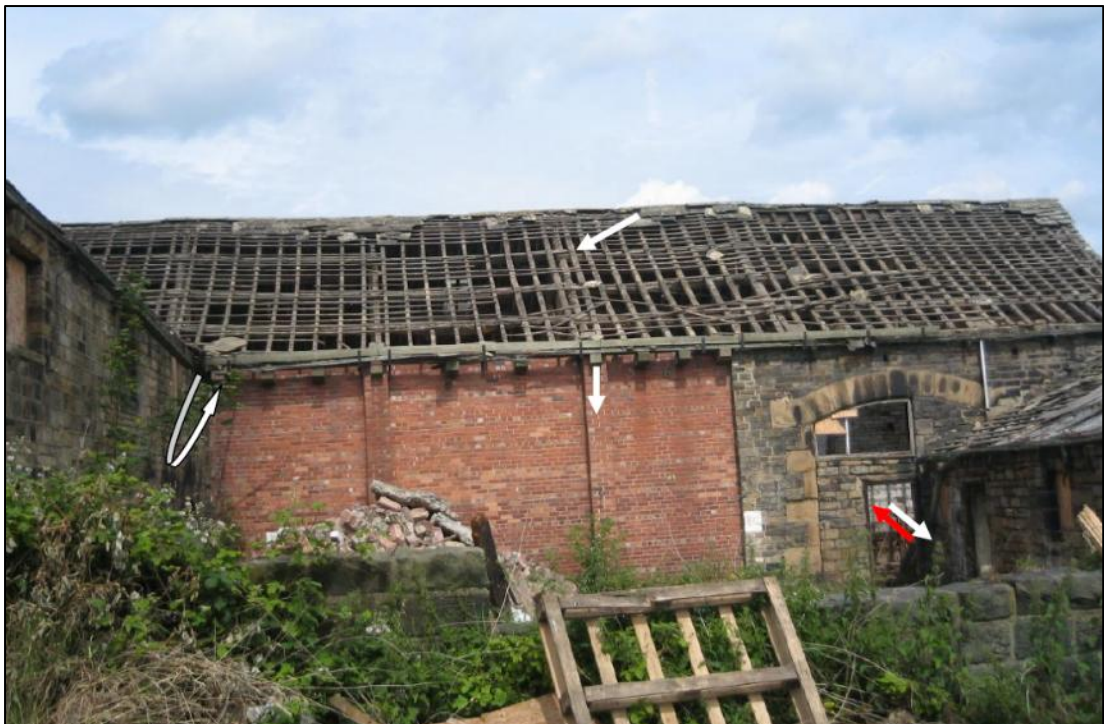
Plate 1. Image taken from 2010 Ecological Impact Assessment (Atkins, 2010) showing common pipistrelle emergence and return locations. The original image was taken in July 2008

- 5.1.1 The 2010 Ecological Impact Assessment (Atkins, 2010) recorded that during in June 2008 a single brown long-eared bat was recorded emerging from the main barn, although the exact roost location was not confirmed. In 2010 common pipistrelle bats were seen emerging from and returning to various locations along the southern wall/roof of the main section of the barn (Plate 1; B2, Figure 2) during all of the activity surveys (maximum count 2 on any one survey). Two soprano pipistrelles also emerged from the barn during one of the dusk surveys, although exact roost locations were not confirmed. In summary it would appear that one brown long-eared bat *Plecotus auritus* day roost, three common pipistrelle day roost and one soprano pipistrelle day roost appear to have been recorded from the main barn building during 2008 & 2010 nocturnal surveys.

- 6.1.1 Headfield Barn supported bat roosts in 2008 & 2010, with roosts recorded at that time located in Building Section 2 (Atkins, 2010). Although the building has deteriorated since then, a comparison of the southeast elevation in 2008 (Plate 1) and November 2025 (Plate 9) shows that the roof covering above some of the recorded roost locations was already missing in 2008. Given the time elapsed since 2010, the roosts recorded in 2008 and 2010 cannot be relied upon as still present. However, it remains entirely possible that the same species continue to roost on site, and their presence cannot be ruled out without up-to-date survey evidence.

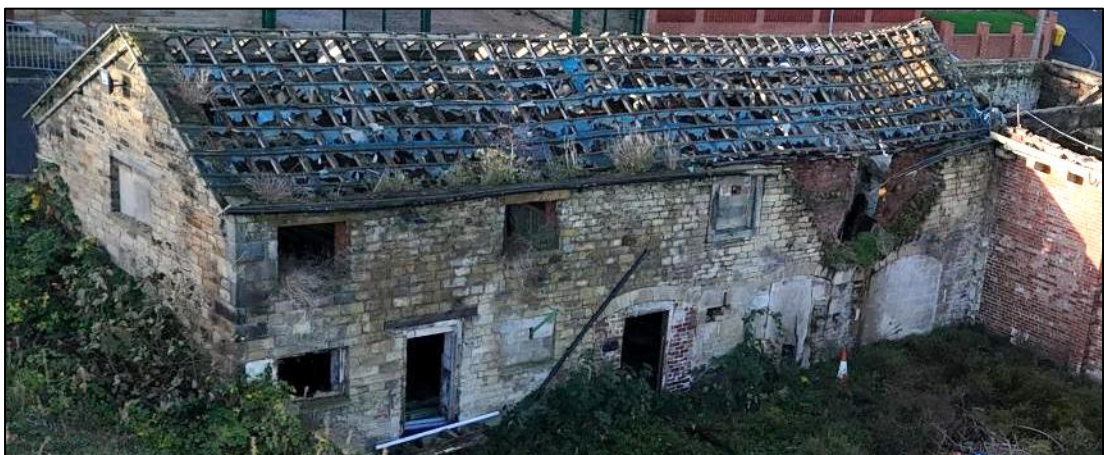
- 5.2.4 Building Section 1 comprised a C18th two-storey stone and brick built addition to the main barn (Figure 2; Plates 2-4). No roof covering remained on this section of the building with the roof framework exposed. The northeast wall (the façade) was part collapsed, exposing inner brickwork. Three former arched openings in the northeast elevation were largely filled in with concrete-block of brick, however, the majority of window and door openings were uncovered. Some wooden lintels were present.

Plate 4. Building Section 1, viewed from east corner

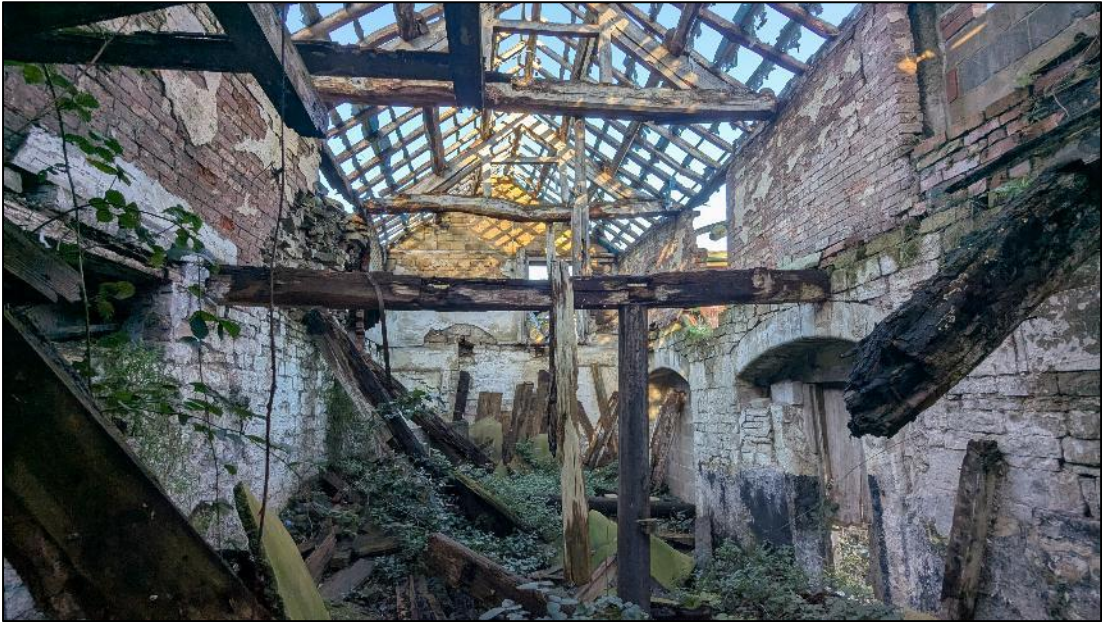
- 5.2.5 Internally, the framework of the uncovered roof comprised hand-made queen post trusses, with a ridge beam, purlins, rafters and some battens (Plate 5). No roof void was present and the first floor had largely collapsed. No signs of bats were noted from any location on either the inside or outside of the building.

Plate 5. Interior of Building Section 1

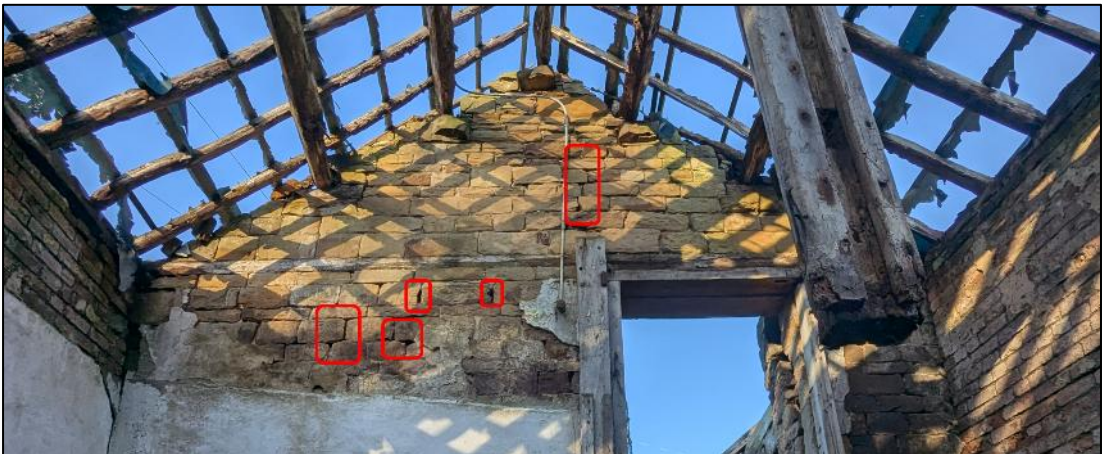
- 5.2.6 Potential roost features associated with Building Section 1 comprised the following:
- Open masonry joints on both the internal and external sides of walls (Plate 6).

Plate 6. Example of open masonry joints on internal face of northwest gable of Building Section 1

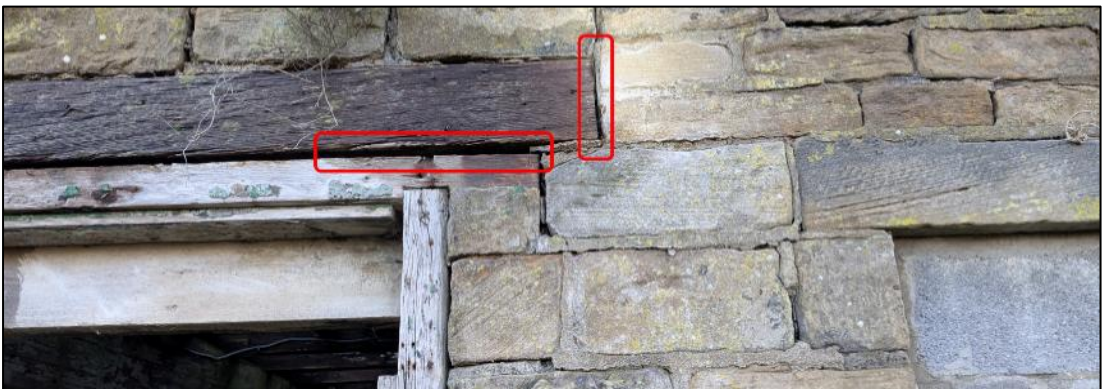
- Crevices present between timbers and masonry (for example associated with the lintel on the northeast elevation (Plate 7).
 - A network of crevices between the masonry and inner brickwork on the northeast elevation.

Plate 7. Crevices between wood lintel and masonry on Building Section 1

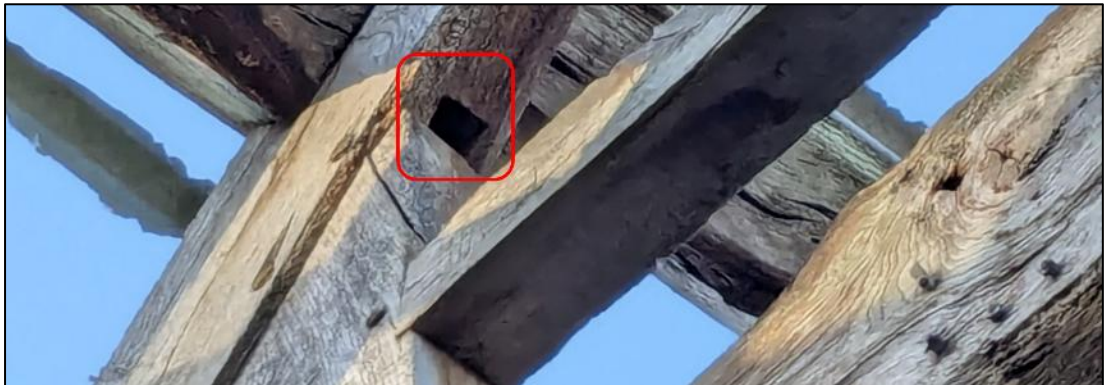
- Open mortice joints in hand-made wooden queen post roof trusses (Plate 8).

Plate 8. Open mortice joint on queen post-truss in Building Section 1

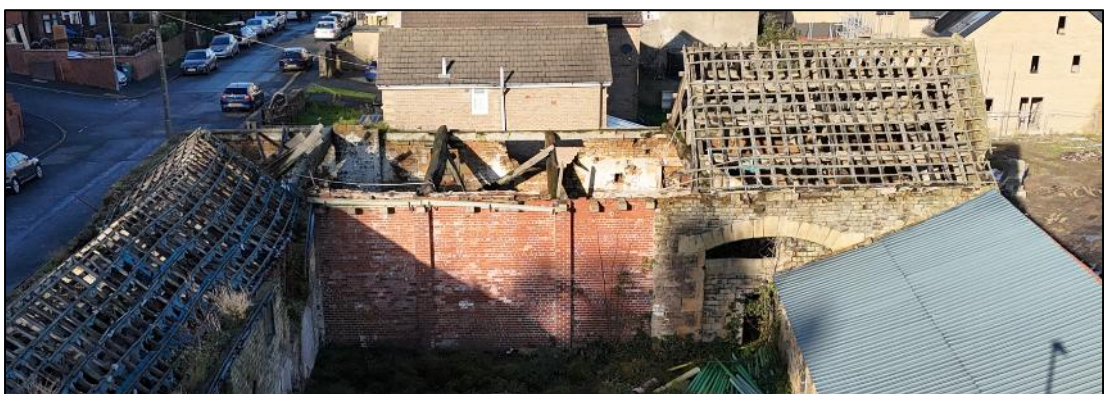
- 5.2.7 Building Section 2 comprised a C18th stone built barn with a part of the southeast elevation re-built in brick (Figure 2; Plates 2, 3 & 9). This section of building completely lacked a roof covering and approximately 2-3 of the roof timbers had collapsed. The deterioration of the building between 2008 and 2025 can be seen by comparing Plates 1 and 9. A double door opening in the northwest elevation had been bricked up, with a double door opening in the southeast elevation partly blocked by a subsequent extension but still largely open.

Plate 9. Southeast elevation of Building Section 2

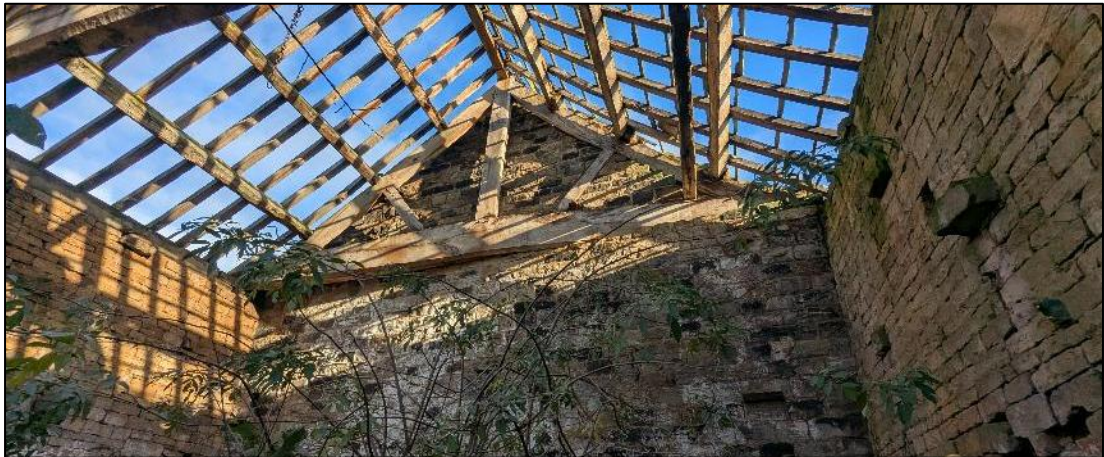
- 5.2.8 Internally, the remaining framework of the uncovered roof comprised hand-made king-post trusses, with a ridge beam, purlins, rafters and some battens (Plate 10). No roof void was present. No signs of bats were noted from any location on either the inside or outside of the building.

Plate 10. Interior of Building Section 2

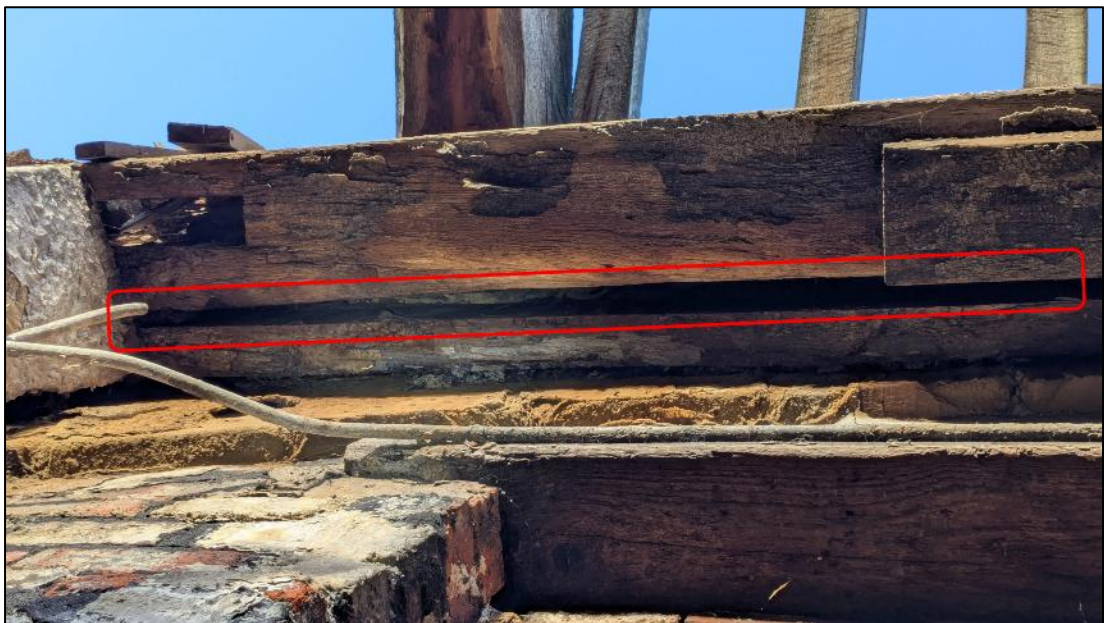
- Crevices present between timbers and masonry – notably two long crevices (up to 5 cm wide) formed between wooden lintels and masonry above the two double door openings in southeast and northwest elevations (Plate 11).

Plate 11. Crevice between lintels over double door opening in southeast elevation of Building Section 2

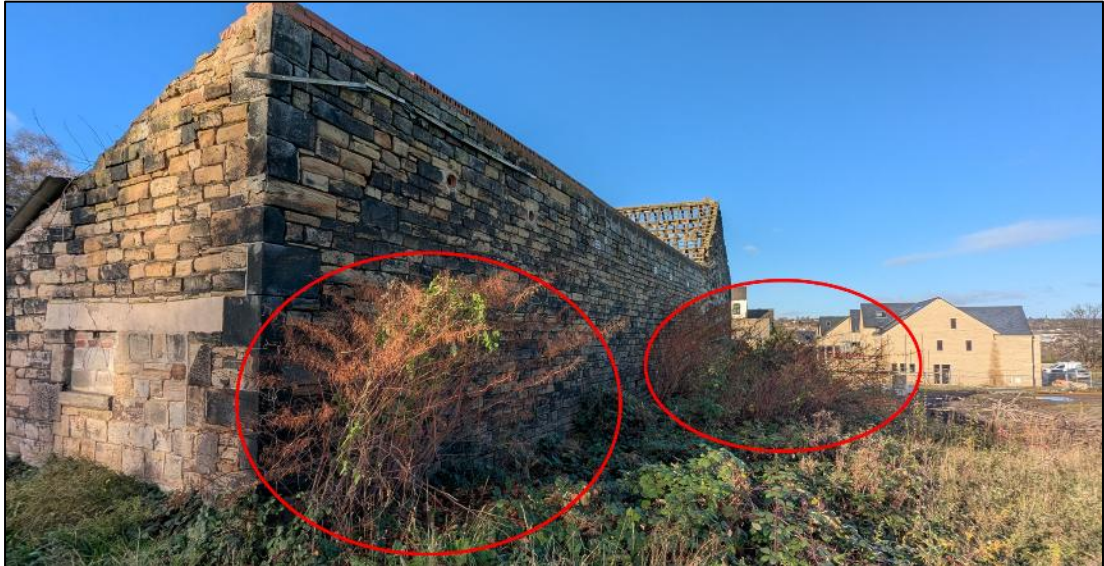
- 5.2.10 Building Section 3 comprised a single storey late C18th or early C19th stone-built extension to the original barn (Figure 2; Plates 2, 3 & 12). This building had a single-pitch corrugated-metal sheet covered roof. Ventilation bricks and pipes were built into the rear/northeast elevation. A metal roller-shutter door was present in the southwest elevation/façade. A mix of blocked up and wooden -shutter-covered window and door openings were spread across the northwest, southwest and southeast elevations.
- 5.2.11 The roof was lined with a torn breathable roofing membrane and suspended on mono-pitch trusses, purlins and rafters (Plate 13). No roof void was present and the interior of the building was cobwebby. No signs of bats were noted from any location on either the inside or outside of the building.

Plate 12. East corner of Building Section 3, with Japanese knotweed circled in red

5.2.13 The invasive non-native plant species Japanese knotweed, included on Schedule 9 of the Wildlife and Countryside Act 1981 (as amended) was recorded growing adjacent to the northeast elevation of Building Section 3 (Plate 12).

- 6.3.5 Japanese knotweed is an invasive, fast-growing perennial plant with bamboo-like stems and deep rhizomes that can spread aggressively and cause significant structural problems if not properly controlled. An invasive species specialist should be contracted to develop and deliver an eradication plan for stands of this plant.

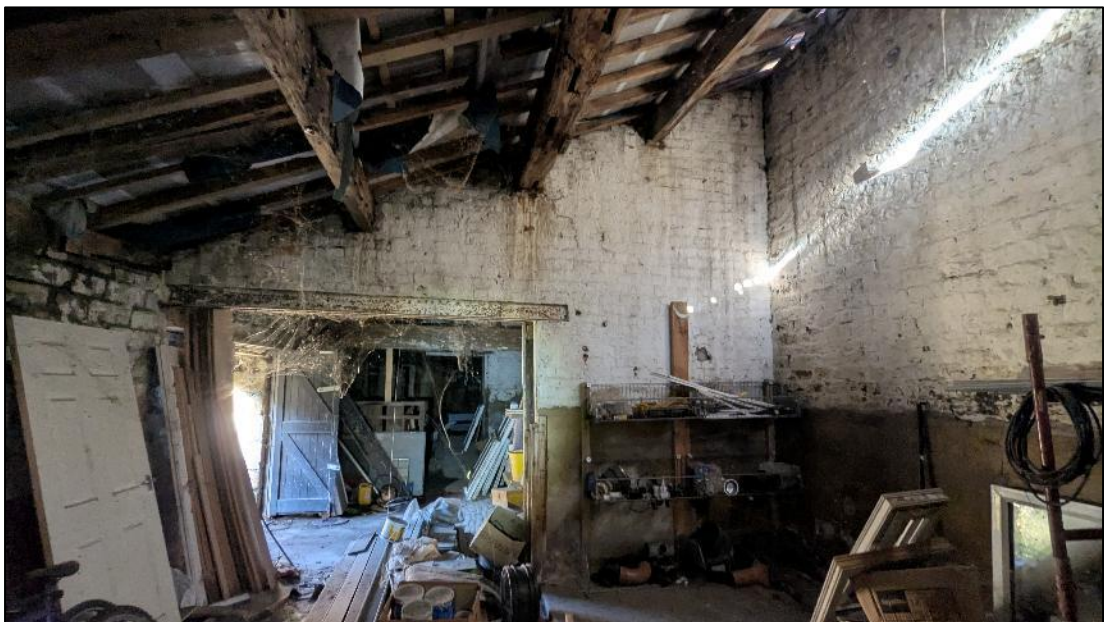
Plate 13. Interior of Building Section 3

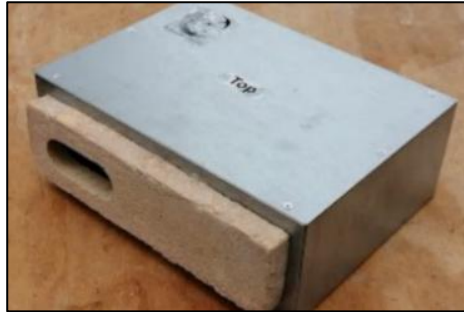
Plate 17. S Brick

- 6.3.3 Removal of vegetation, demolition and the commencement of re-development works should either taken place outside the main bird nesting period (March to August), or be preceded by a nesting bird check, to be undertaken by an ecologist.
- 6.3.4 In accordance with the aims of the National Planning Policy Framework, and to provide an enhancement for nesting birds, it is recommended that one integrated swift *Apus apus* box (i.e. S Brick (Plate 17) be installed within the renovated building. This box should be fitted at wall top height and may be installed across any elevation. Studies have shown that swift boxes are used by other bird species that utilise buildings and consequently this measure will provide potential nesting space for house sparrows *Passer domesticus* and starlings *Sturnus vulgaris*, in addition to swift.

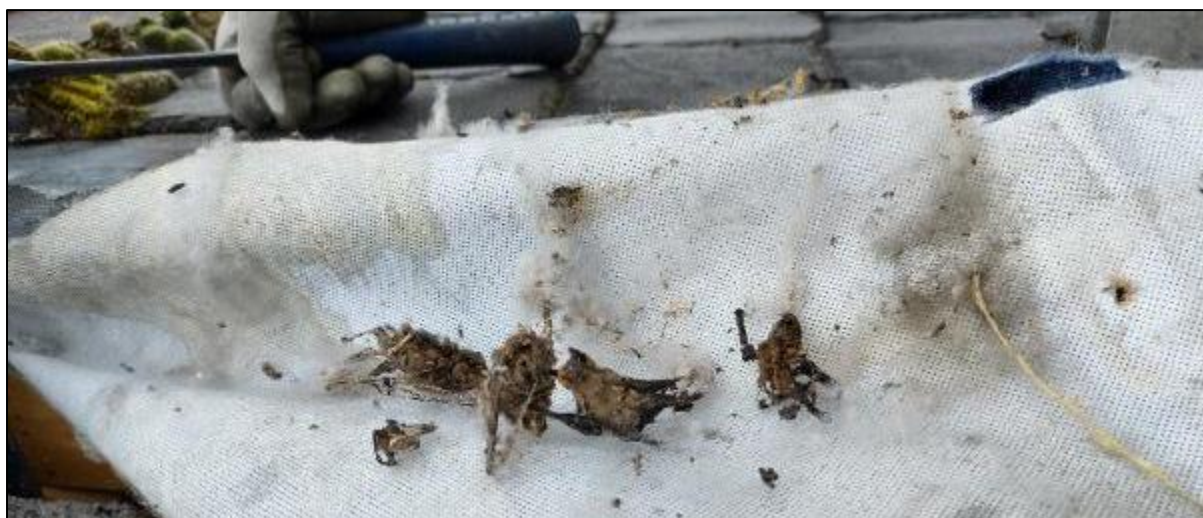
One example we have encountered comprised a pipistrelle roost which formed in a building extension constructed in 2009. Over the course of just 13 years the roofing felt degraded to the extent that it trapped and killed more than 10 bats. Fortunately, the problem in this roost was identified and remedial work was undertaken to replace the roofing membrane in 2022.

Plate A1.1. Four dead pipistrelles tangled in breathable roofing felt

The best roofing membrane option for areas where bat roosts are expected is traditional Type 1F bitumen coated hessian backed roofing felt. Bitumen coated roofing felts have been widely and safely used as a secondary weather barrier since approximately the 1950s/1960s. Wooden sarking has also been used for many decades and if appropriately treated, is safe for use in bat roosts, or where bats could be, present. Most commercially available products come

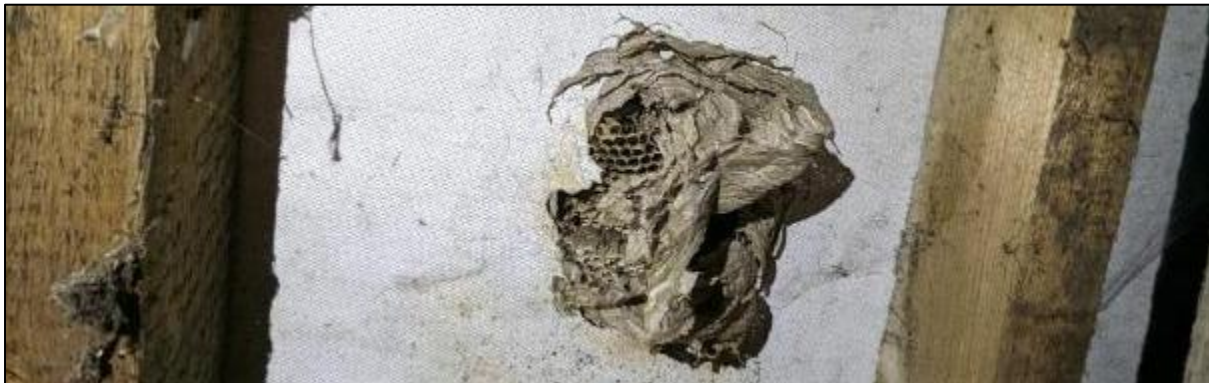
In recent years a fairly substantial proportion of the lofts we have surveyed which had existing breathable felt, were found to have been damaged by wasps (Plate A2.2). In these situations, the wasps appear to have chewed holes in the felt and formed nests in the holes. This doesn't appear to be a problem associated with the traditional bitumen coated roofing felt. Obviously, any holes within roofing felt would be likely to significantly reduce its functionality as a secondary weather barrier. Where bats or birds do come into contact with breathable roofing membranes, they can damage the membrane causing it to leak and they can also significantly reduce the breathability of the felt in that location.

Plate A1.2. Damage to a breathable roofing membrane adjacent to a wasp nest
