Our ref: 25-901.01L

11th February 2026

Re: Coal Mining Risk Assessment (CMRA) – Proposed New Detached Dwelling with Barn Conversion Leisure Annexe, Headfield Farm, Manor Avenue, Savile Town, Dewsbury, West Yorkshire

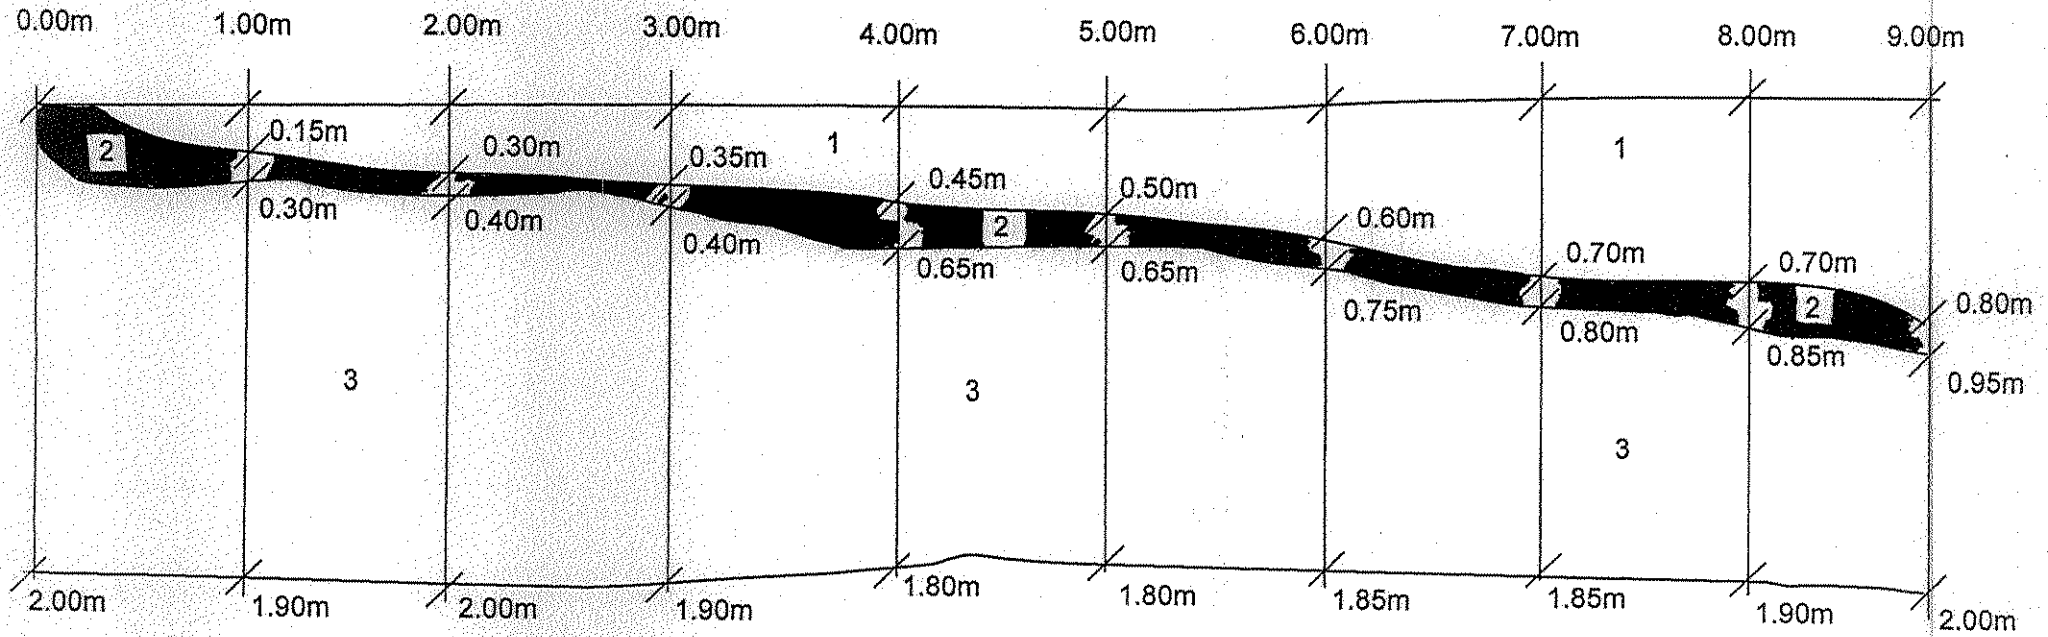
TRENCH NO. 2 SAVILLE ROAD

- 1 Made Ground / stiff mudstony clay
- 2 Apparent Coal Seam (including seat earth etc)
- 3 Mudstone

From the trench record sheets for trenches 2 and 3, where the subcrop of the 2BM seam has been located, it has been recorded as thin up to c.0.20m thick and comprising poor to reasonable quality (generally inferior) coal with a seat earth below and no evidence of extraction. The reports concluded that whilst the site was not considered to be at risk from any shallow unrecorded workings in either the deeper 3BM seam noted in RBH's 2 & 3, or within the 2BM seam at subcrop, for those plots affected future foundations would need to be taken down through the subcrop of the 2BM seam and be based in the underlying bedrock materials.

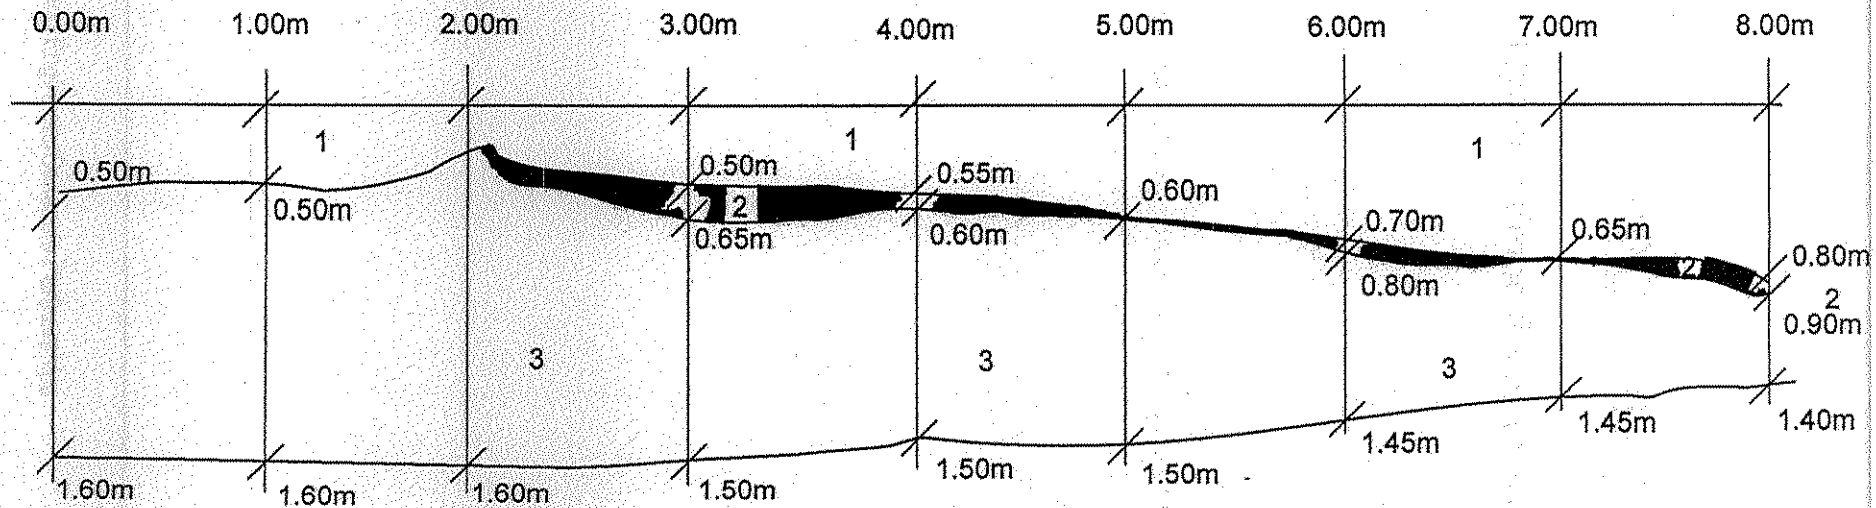
TRENCH NO. 3 SAVILLE ROAD

- 1 Made Ground / stiff mudstony clay
- 2 Apparent Coal Seam (very poor)
- 3 Mudstone (occasionally very mudstony clays)

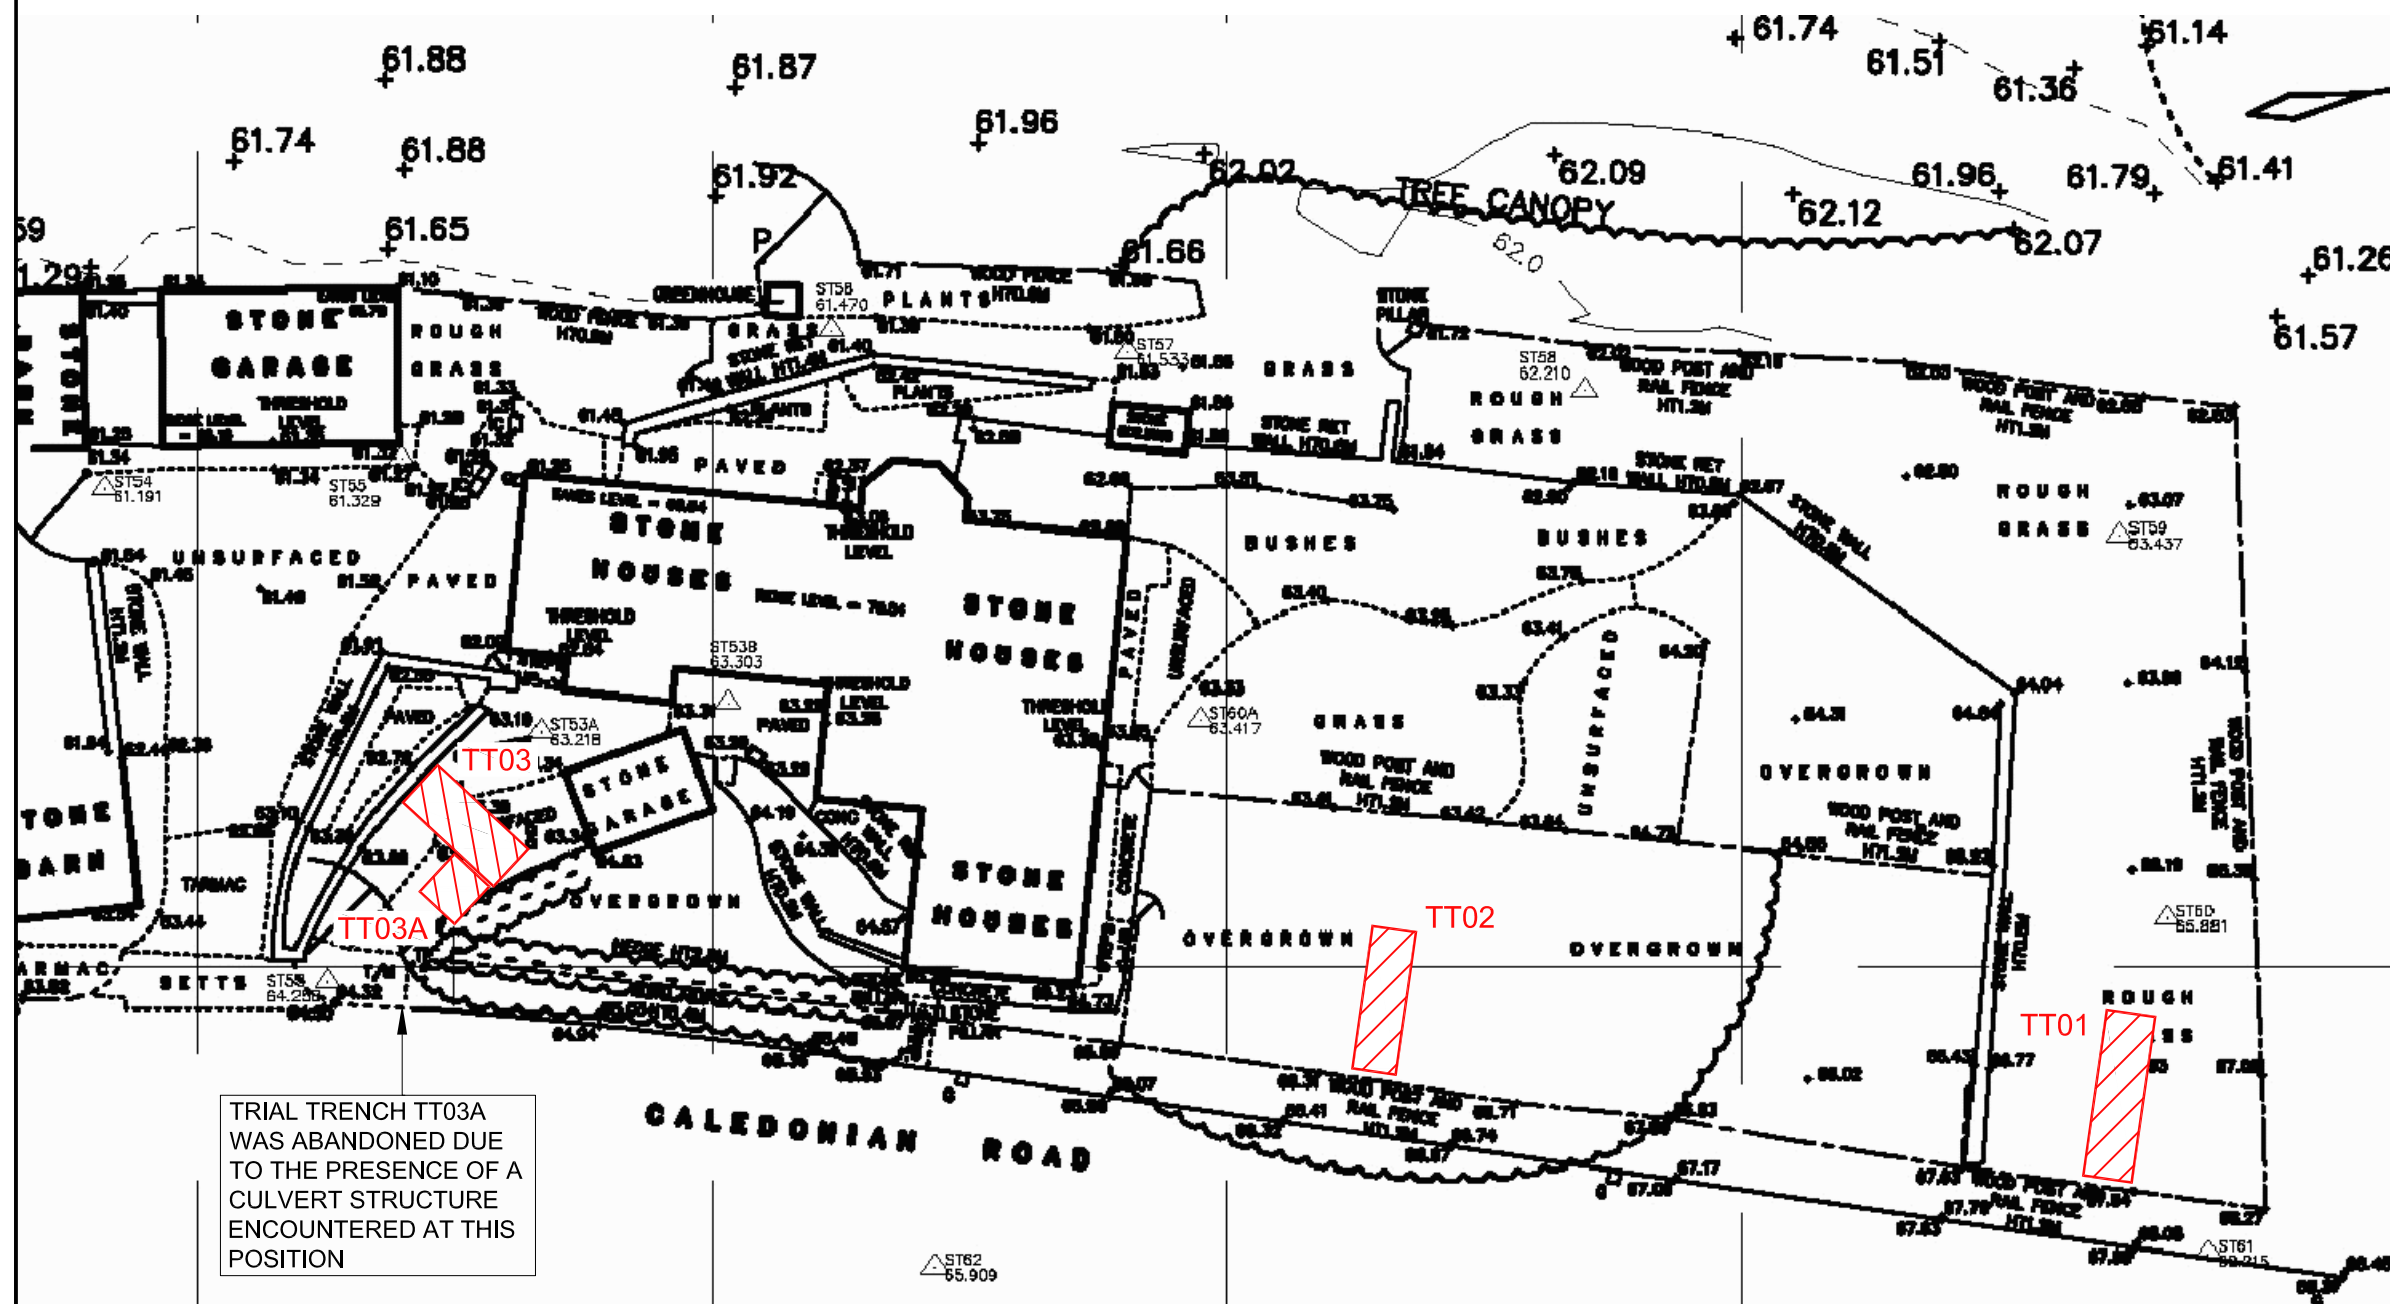
TRIAL TRENCH TT03A WAS ABANDONED DUE TO THE PRESENCE OF A CULVERT STRUCTURE ENCOUNTERED AT THIS POSITION

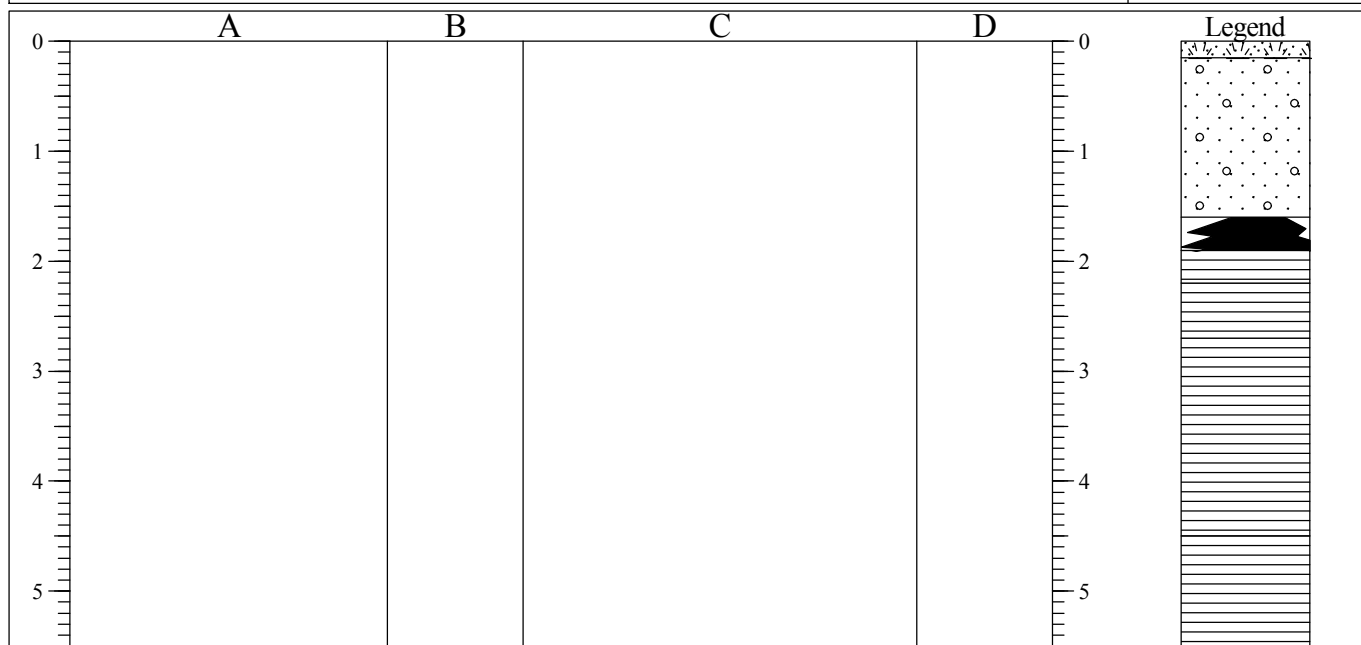
Project Land adjacent to Caledonian Road, Savile Town, Dewsbury				TRIAL PIT No TT01
Job No 11-183	Date 05-05-11	Ground Level (m) 67.94	Co-Ordinates ()	
Contractor Arc Environmental Limited				Sheet 1 of 2

STRATA			SAMPLES & TESTS		
Depth	No	DESCRIPTION	Depth	No	Remarks/Tests
0.00-0.15		Unmanaged vegetation over TOPSOIL, with many roots (TOPSOIL).			
0.15-1.60		Brown slightly clayey gravelly fine to medium SAND, with many sandstone cobbles and boulders. Gravel consists of sandstone (RESIDUAL SOIL).	0.40-0.80	B1

At the locations of TT01 and TT02 bands of anthracitic black coal, with bands of inter-bedded coal and carbonaceous mudstone, were noted within the initial mudstone deposits, at depths of between 2.50m to 3.50m (TT02) and 5.60m to 6.40m bcgl (TT01).

In addition, at the location of TT01 an initial shallow band of very weak black weathered coal was also noted at rock head, from 1.60m to 1.90m bgl, with this band noted to be tapering in thickness and was no longer evident 2.00m from the site boundary. Similarly, a thin layer of inter-bedded carbonaceous mudstone and extremely weak weathered coal was noted in TT03 at depths of between 1.90m to 2.00m bgl, within the initial mudstone bedrock materials.

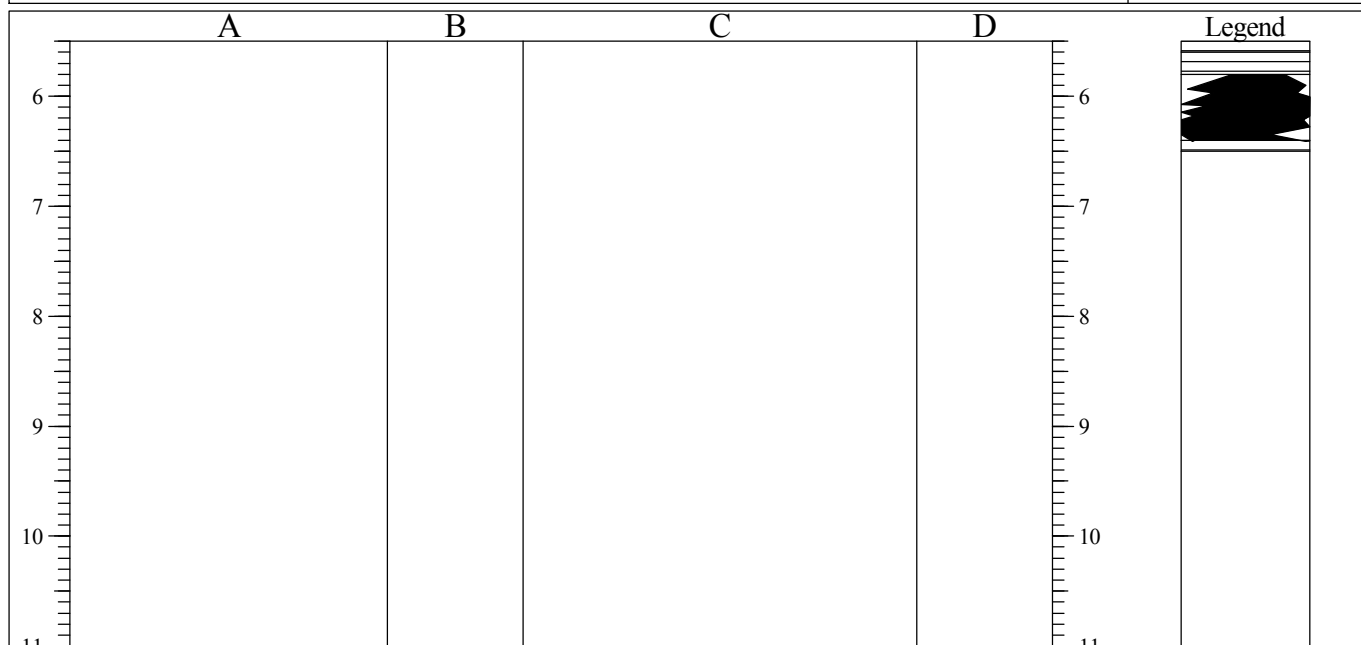
Project Land adjacent to Caledonian Road, Savile Town, Dewsbury				TRIAL PIT No TT01
Job No 11-183	Date 05-05-11	Ground Level (m) 67.94	Co-Ordinates ()	
Contractor Arc Environmental Limited				Sheet 2 of 2

STRATA			SAMPLES & TESTS		
Depth	No	DESCRIPTION	Depth	No	Remarks/Tests
5.60-5.80		Extremely weak weathered black COAL, thinly interbedded with extremely weak dark grey carbonaceous MUDSTONE, slightly disintegrated (UPPER COAL MEASURES). Very weak anthracitic black COAL (UPPER COAL MEASURES).	5.60-5.80	B9	
5.80-6.40			6.00-6.20	B10	
6.40-6.50		Very weak dark grey and light grey carbonaceous MUDSTONE, with occasional very thin COAL bands and inclusions (UPPER COAL MEASURES). Trial trench complete at 6.50m.	6.40-6.50	B11	
6.50

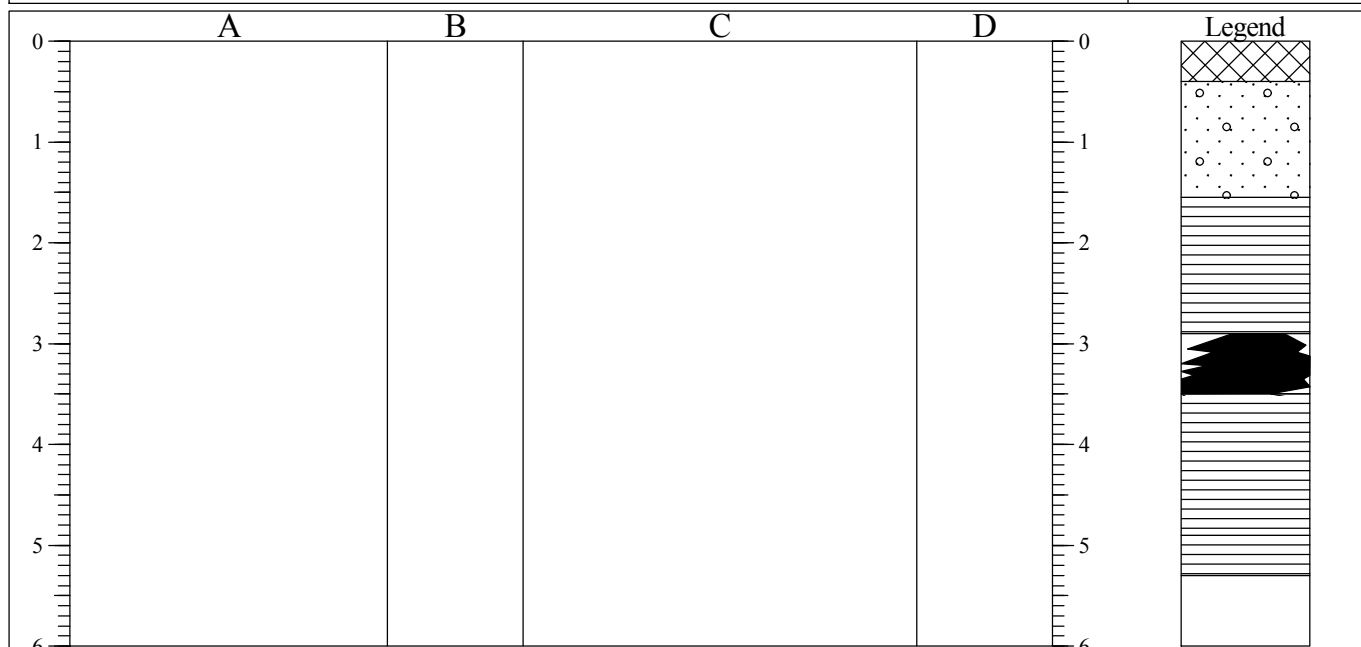
Project Land adjacent to Caledonian Road, Savile Town, Dewsbury				TRIAL PIT No TT02
Job No 11-183	Date 05-05-11	Ground Level (m) 66.31	Co-Ordinates ()	
Contractor Arc Environmental Limited				Sheet 1 of 1

STRATA			SAMPLES & TESTS		
Depth	No	DESCRIPTION	Depth	No	Remarks/Tests
0.00-0.40		Unmanaged vegetation over topsoil, with conglomerated mudstone pockets, many roots and occasional plastic fragments (MADE GROUND).	0.10-0.30	B1

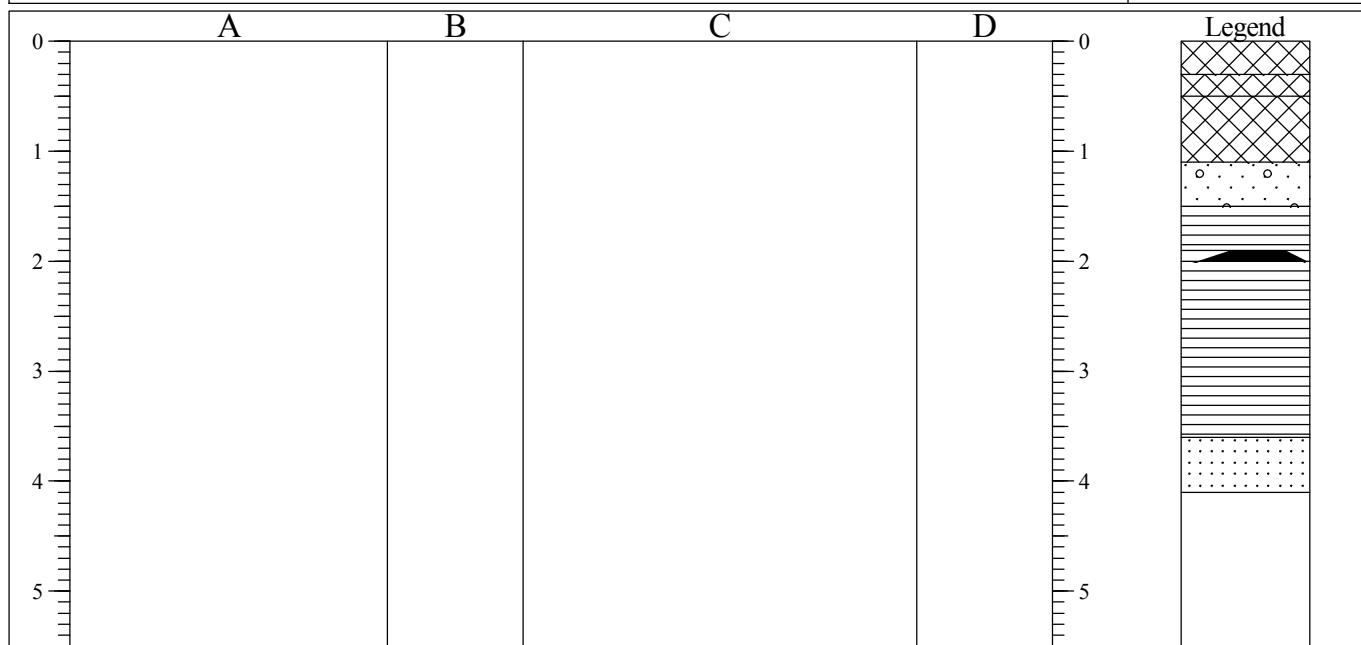
Project Land adjacent to Caledonian Road, Savile Town, Dewsbury				TRIAL PIT No TT03
Job No 11-183	Date 05-05-11	Ground Level (m) 63.59	Co-Ordinates ()	
Contractor Arc Environmental Limited				Sheet 1 of 1

STRATA			SAMPLES & TESTS		
Depth	No	DESCRIPTION	Depth	No	Remarks/Tests
0.00-0.30		Concrete with underlying gravel sub-base (former access road) and crushed concrete, dolomite and brick surfacing (MADE GROUND).	0.30-0.50	B1

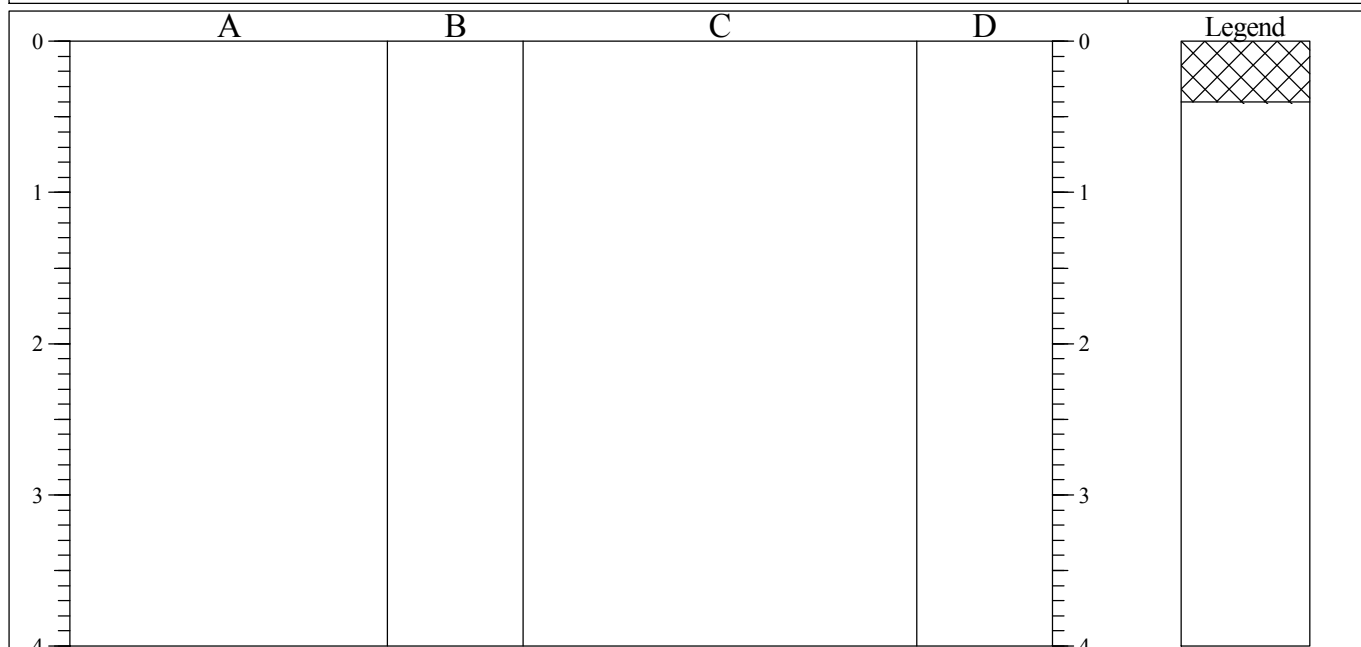
Project Land adjacent to Caledonian Road, Savile Town, Dewsbury				TRIAL PIT No TT03A
Job No 11-183	Date 05-05-11	Ground Level (m) 63.59	Co-Ordinates ()	
Contractor Arc Environmental Limited				Sheet 1 of 1

STRATA			SAMPLES & TESTS		
Depth	No	DESCRIPTION	Depth	No	Remarks/Tests
0.00-0.40		Concrete with underlying gravel sub-base (former access road) and crushed concrete, dolomite and brick surfacing (MADE GROUND).	0.10-0.30	B1	
0.40		Trial trench terminated at 0.40m as uncovered service culvert within western face of trench (cast iron pipe visible at base of culvert) - noted to trend E-W below the existing yard area and also extend below adjacent Caledonian Road. To avoid potential damage trial trench location moved c.1m south - see TT03A for further detail.

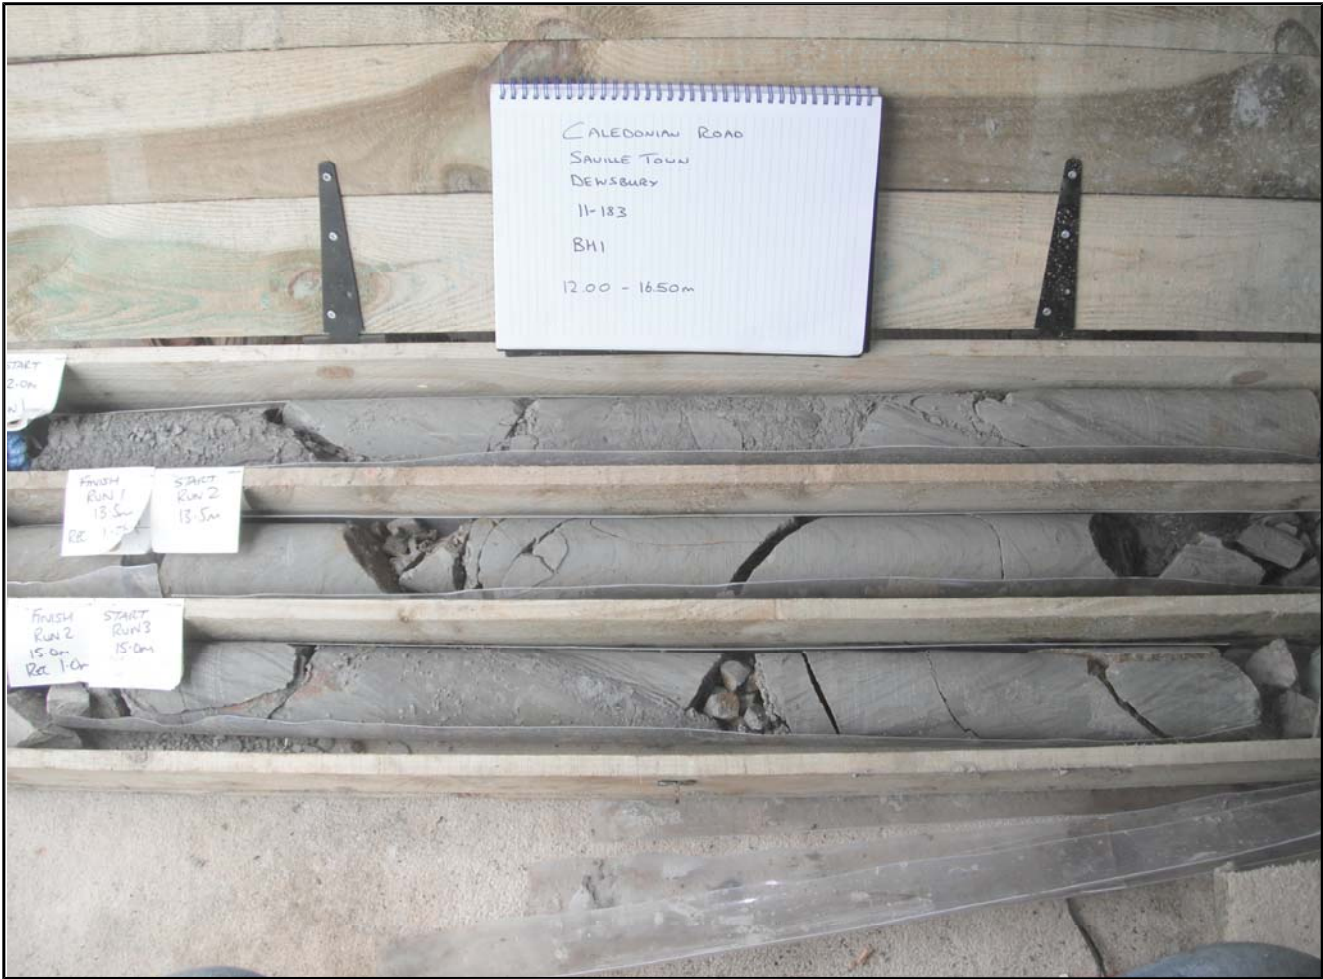
ROTARY CORE PHOTOGRAPHIC RECORD

CORE DETAILS	
BOREHOLE REF	BH1
CORE SECTION (DEPTHS)	12.0M to 16.5M
CORE RECOVERY	LESS THAN 100% CORE RECOVERY THROUGH CORE RUN

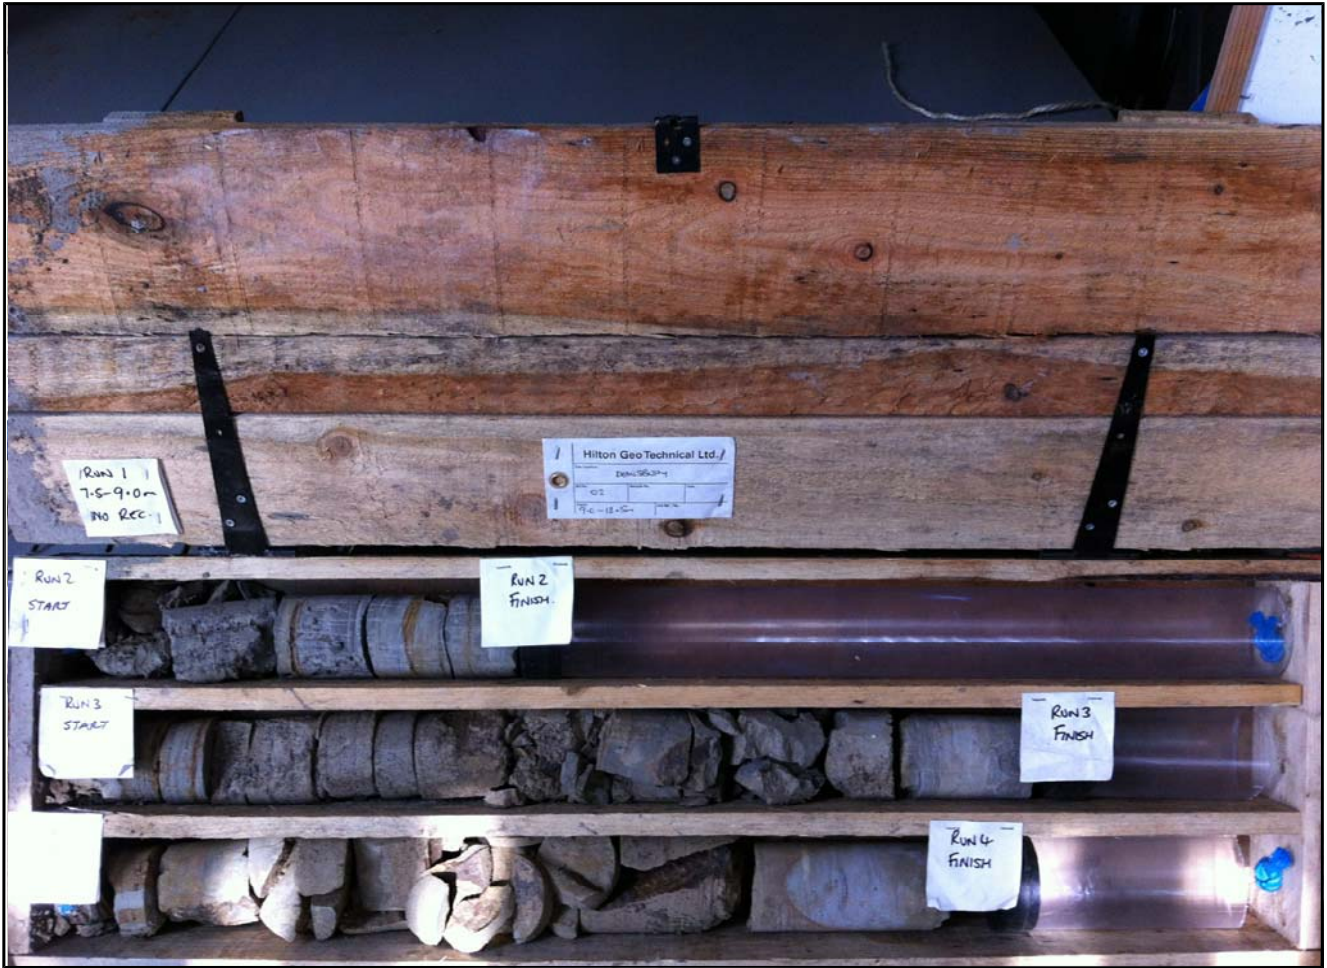
ROTARY CORE PHOTOGRAPHIC RECORD

CORE DETAILS	
BOREHOLE REF	CP6
CORE SECTION (DEPTHS)	7.50M to 12.00M
CORE RECOVERY	LESS THAN 100% CORE RECOVERY THROUGH CORE RUN
