PHASE I DESK STUDY

STONE PIT HALL, HORN LANE
NEW MILL, HOLMFIRTH, HD9 7DH

FOR
MR S SYKES

REPORT REF: MSS 3522

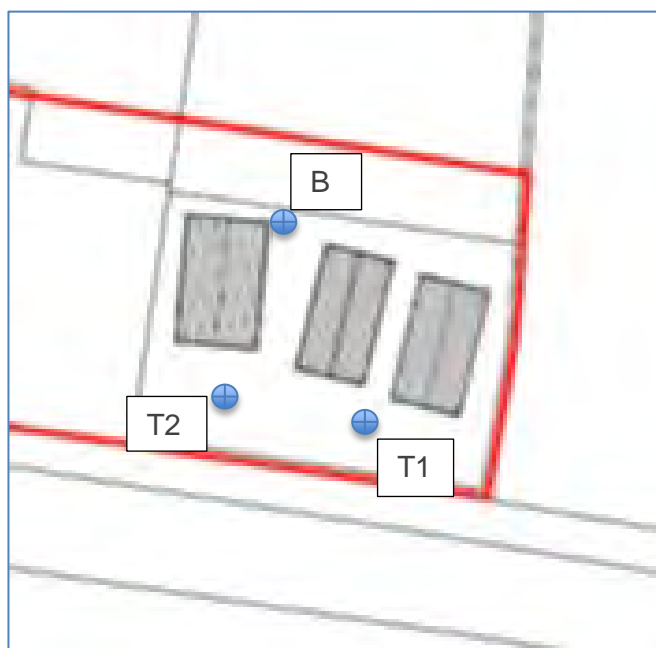
Figure 12 Trial Pit Location Plan

On August 9th 2023, 3 samples (T1, T2 & B) of material were collected from front of, around and behind the existing sheds. The laboratory tested the samples for heavy metals, speciated PAH USEPA16, TPH CWG UK, pH and sulphate and one sample was tested for asbestos. The Trial Pit Locations are shown in Figure 12.

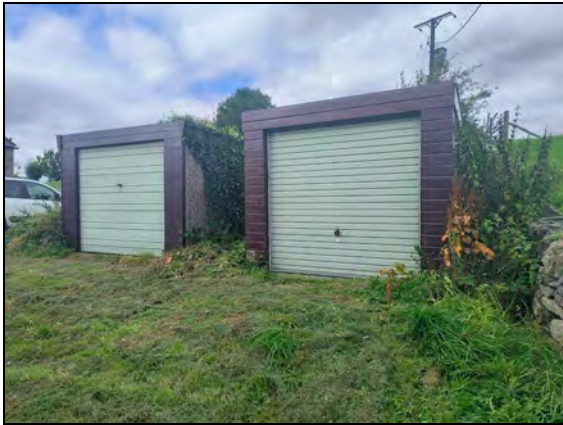
View from Horn Lane showing two garages.

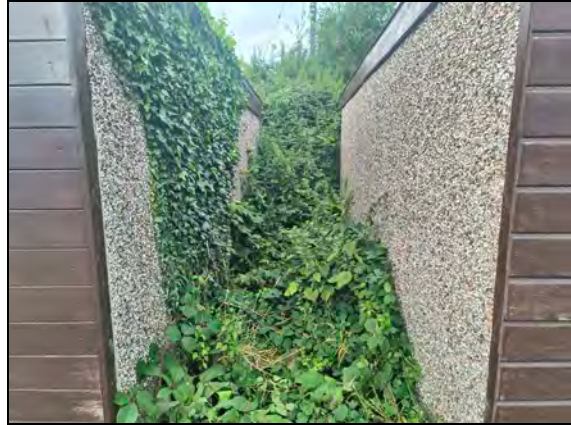
View from front of garages showing land between

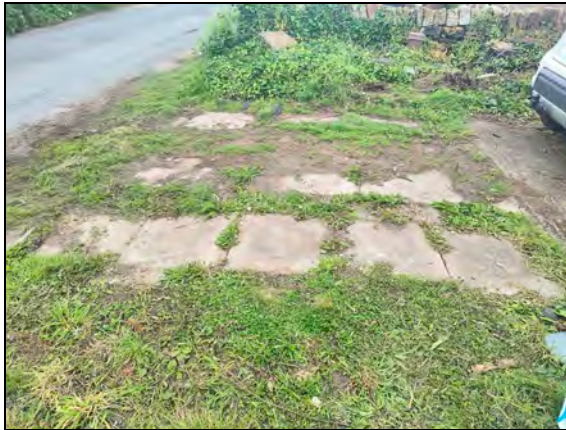
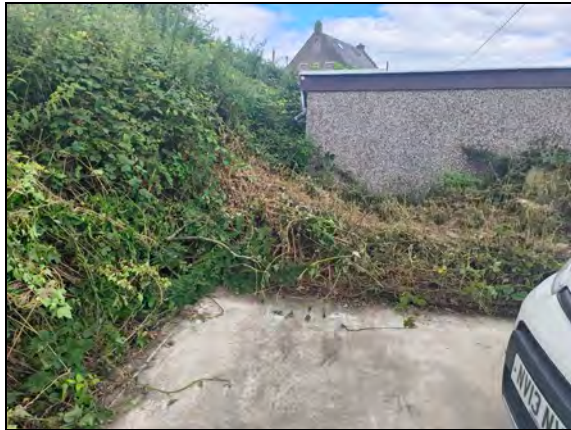
Slabbed drive to hard covered parking area to immediate wet of garages

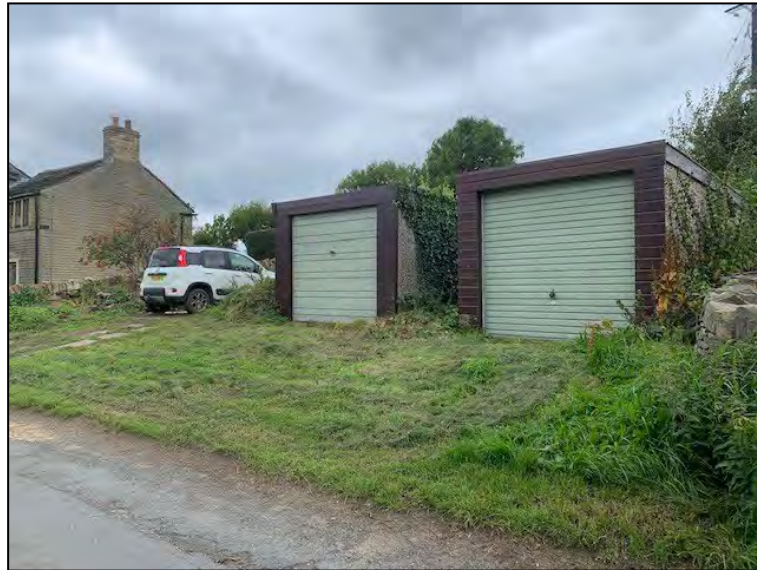
View of site area from Horn Lane and locations of T1 and T2

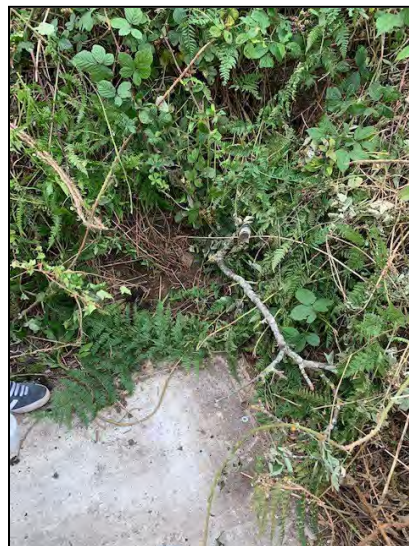
Sample B from rear of external hard covered parking area

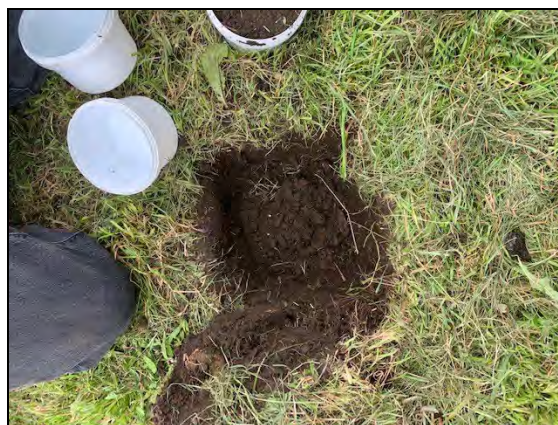
Sample T1 from in front of garage in grassed area
