Pennine Autos, Grange Moor  
Bat Roost Inspection Survey  
and Mitigation Statement

Client [Atlas Retailers Ltd](#)  
Project Title [Pennine Autos, Grange Moor](#)  
Project Reference [RHE.4720](#)  
Project Manager [Amy Donaldson](#)  
Project Director [Tim Palmer](#)  
Contact Details [Amy@rachelhackingecology.co.uk](mailto:Amy@rachelhackingecology.co.uk)

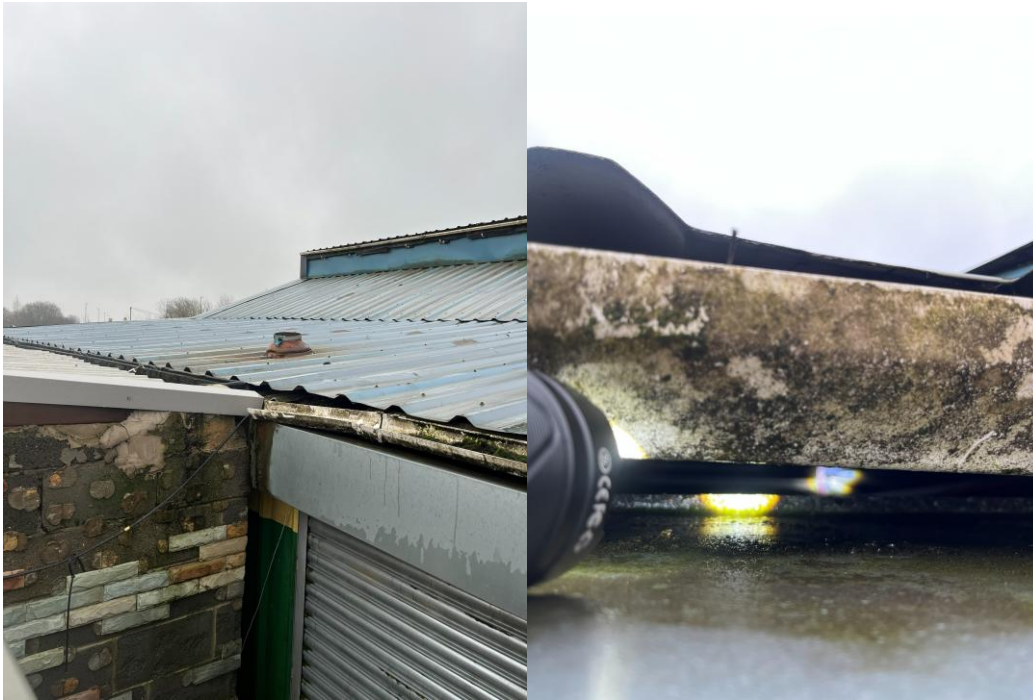
- 3.2.1 The main building on site is a former car showroom of modern construction. The building is two-storey and brick-built, clad with corrugated steel sheeting on the 2<sup>nd</sup> storey with a stepped, single-pitched roof sloping north. The brickwork is in good order, and the windows/doors are well sealed.
- 3.2.2 The building is co-joined with Buildings B, C and D. The union with Building B is fully sealed and does not provide any PRFs; the junction of Buildings C and D is open above narrow timber beams and access is possible to the north (Plate 2). The resulting cavity is extensive but too wide and thermally unregulated to support bats (Plate 2).

Plate 2: Showing the join between Buildings A and D (left) and resulting cavity (right).

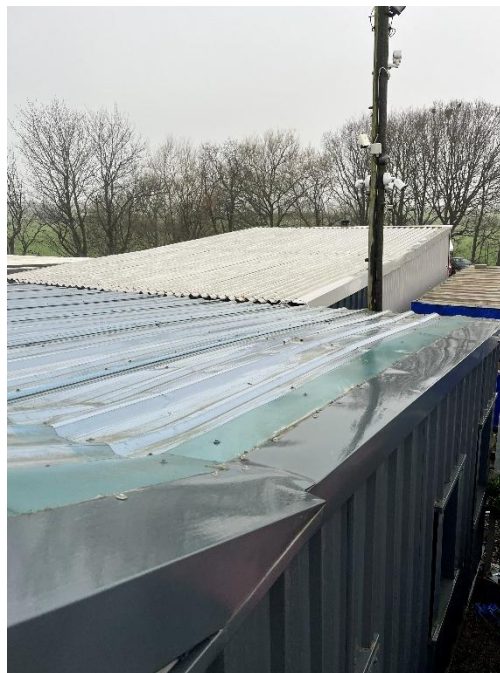
- 3.2.3 Gaps are present along the fascia where the cladding joins (Plate 3), which may be of a suitable size to support bats, but the fascia is metal and therefore thermally unstable. No signs of bat presence were noted during the endoscope survey.

Plate 3: Gaps under the fascia where the cladding joins to the east of the Building A.

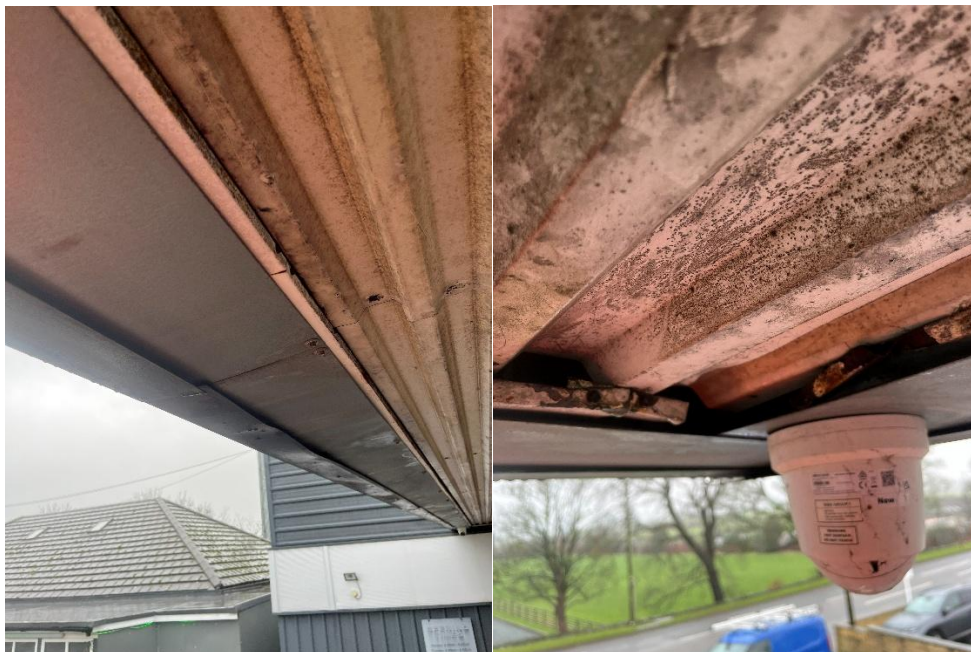
- 3.2.5 This building is the canopy over the forecourt to the south of Building A. The canopy is supported by steel columns and is clad in corrugated metal to all sides. The union with Building A is fully sealed and provides no access nor PRFS.
- 3.2.6 Where columns and light fixings under the structure meet the cladding, small gaps are present, however these are very shallow (<10cm deep) and are considered unsuitable as PRFS.
- 3.2.7 There are small gaps along the fascia boards to all sides; these are particularly prevalent on the most southern aspect as the panels align adjacent to the fascia resulting in access to a good cavity that is of a suitable size for bats (Plate 4). During the endoscope survey the whole feature was searched and no signs of bat presence were found.

**Plate 4:** Gaps on the western aspect of Building B (left) and on the southeastern corner (right).

- Should works occur during the bat active period, a Licensed Bat Ecologist will supervise works to the roof structure of Buildings B and D which could influence the features identified, to include removal of roofing material using hand tools only.

- The Licenced Bat Ecologist will perform a final check of such features within the roof structures of Buildings B and D, using an endoscope and torch, as required.

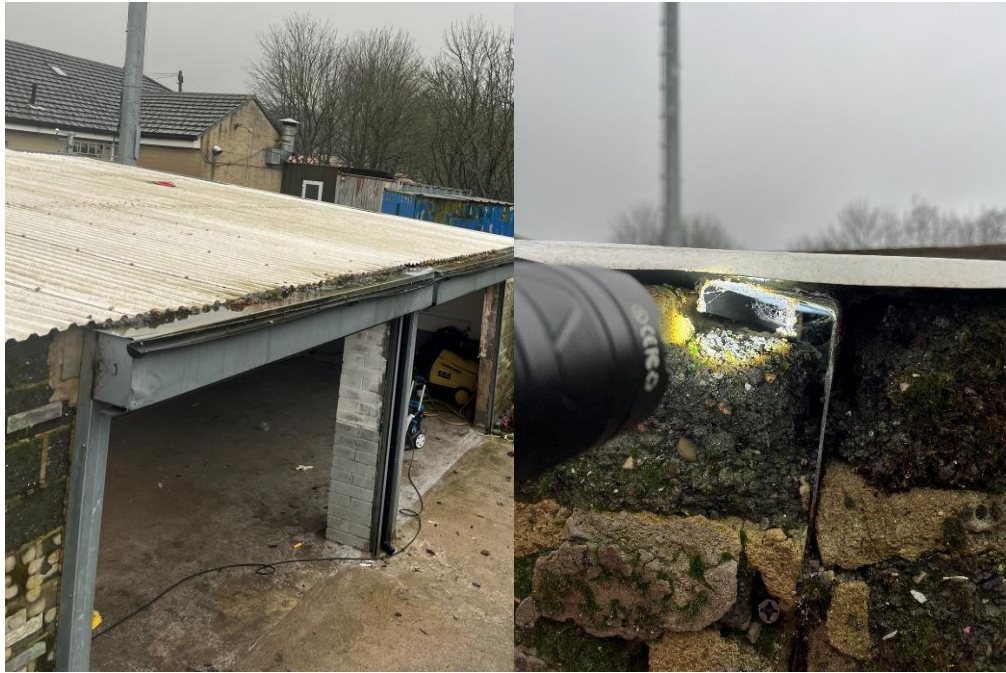
- 3.2.8 An extension to the rear of the building which joins to Building A at single storey roof level. The building has coursed breezeblock walls with corrugated steel roofing. A shale slip façade has been installed which is now in a state of disrepair. All gaps between the corrugation have been sealed with expanding foam (Plate 5).
- 3.2.9 There is a large cavity to the south of the building, which continues horizontally through the entire structure (Plate 5). Cobwebs were noted at the entrance to the cavity, and the cavity is likely too exposed to support roosting bats. No signs or evidence of roosting bats were noted during the survey.

Plate 5: Infilled gaps under corrugated roofing sheets on Building C (left). Cavity to the south (right).

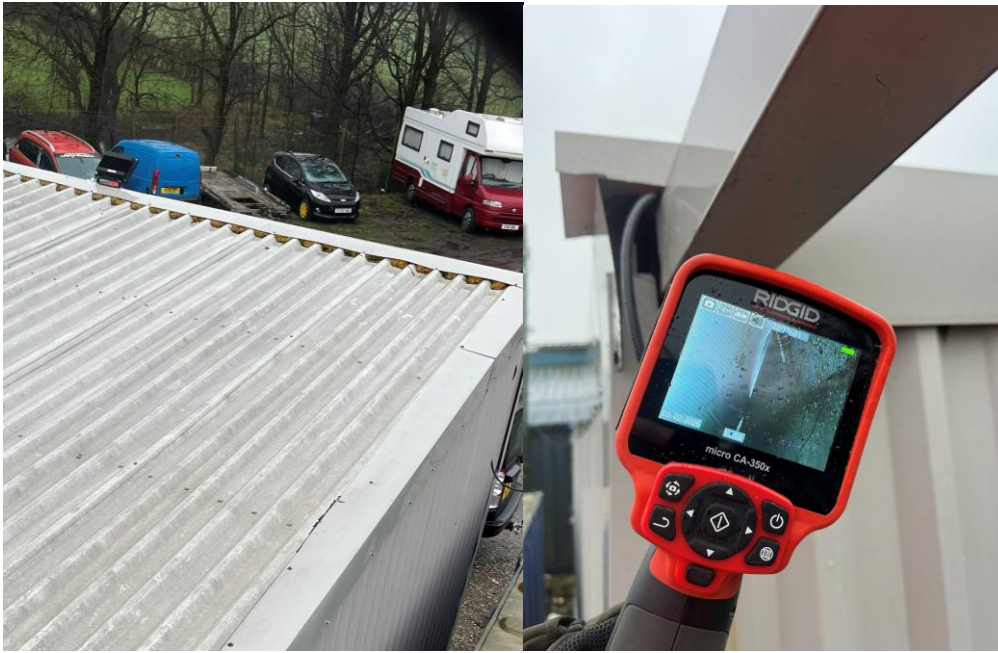
- 3.2.10 Another extension to the rear of Building A, similar in construction to that of Building C although the entirety of the structure is clad in corrugated steel sheeting. All gaps formed at the ends of the sheets are filled with expanding foam (Plate 5). Some gaps under the fascia were present however these were relatively shallow (<7cm) and no bat evidence was recorded.
- 3.2.11 Two large structural beams protrude from the northern corners of the building. Gaps around the beams (Plate 6) provide potential bat access to a lengthy cavity which may be a suitable size to support roosting bats. Thorough inspection using the endoscope and torch showed no signs of usage by bats.

Plate 6: Infilled gaps under metal roofing on Building D (left) and the cavity between structural support and cladding (right).
