# Factual Report on a Ground Investigation

Location: **Barncliffe Mills Car Park**  
Shelley, Huddersfield, HD8 8LU

Report No. **C1893/21/E/2914**

Report date: **July 2021**

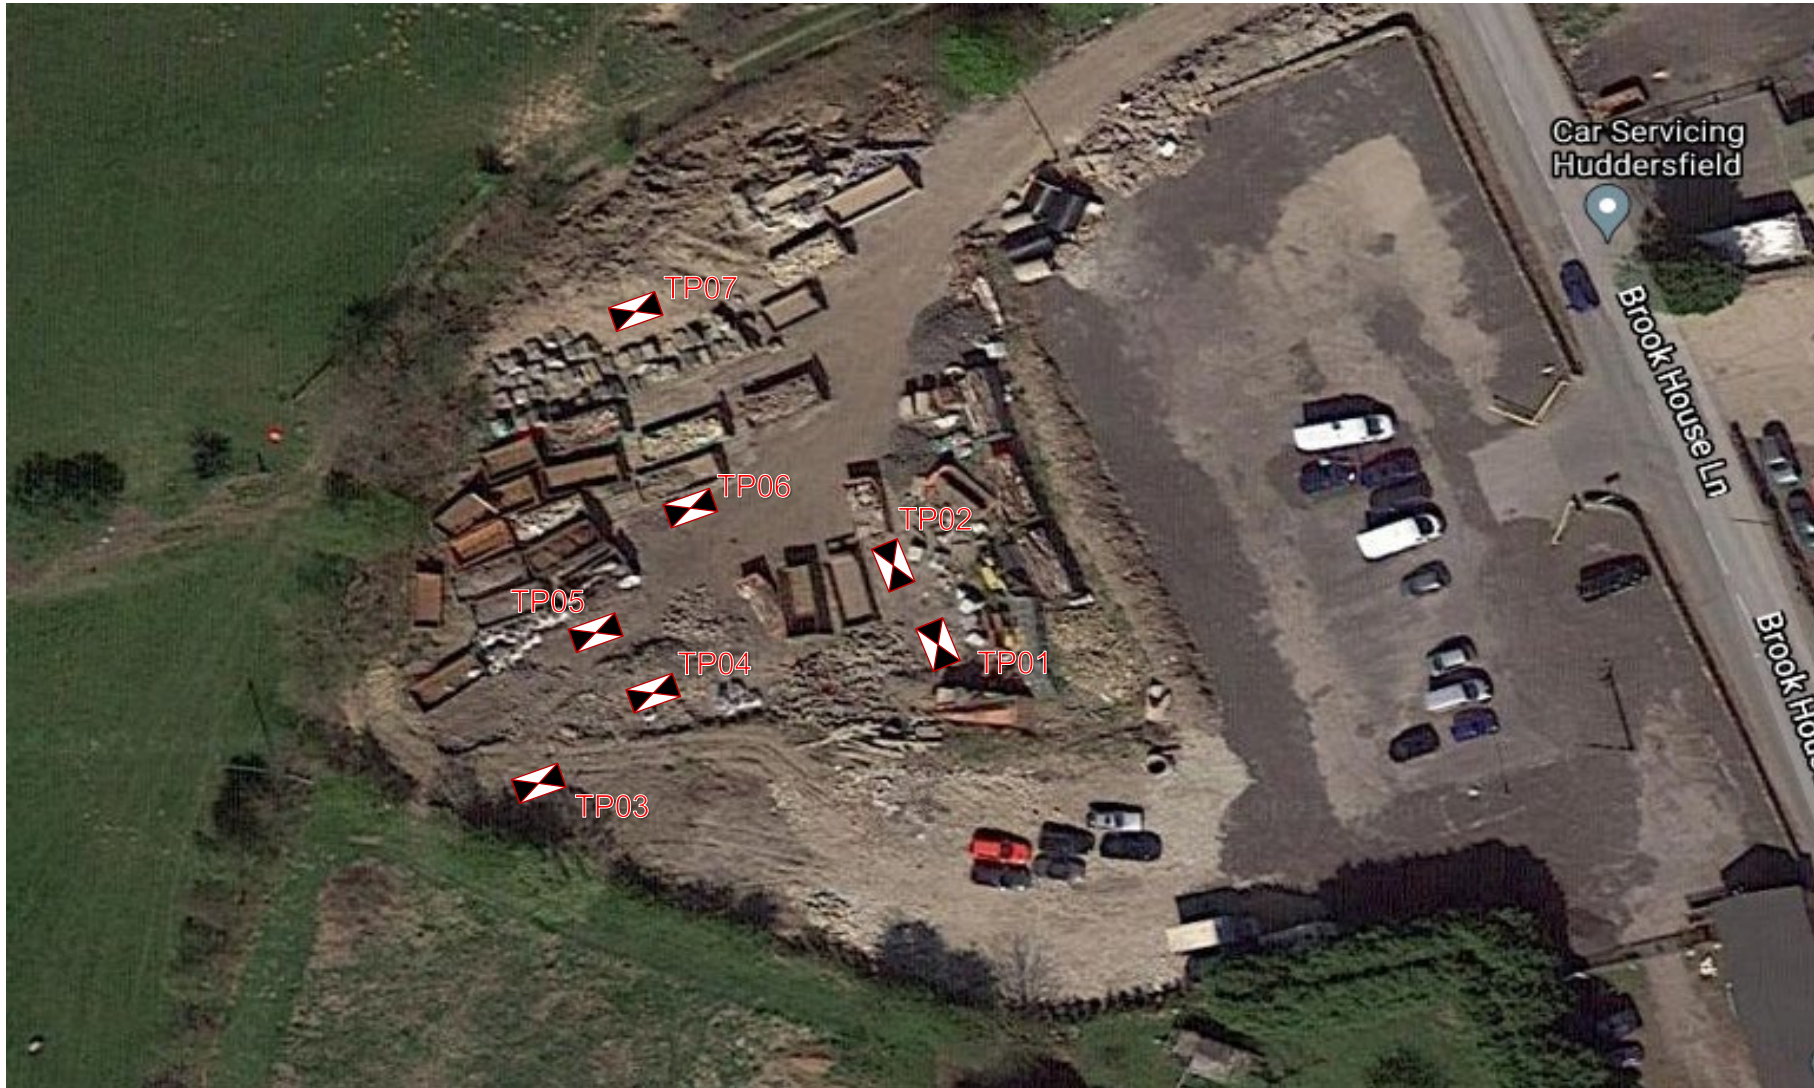
### Site Plan

The investigatory locations are shown on the site plan which is presented in Appendix 1 to this report.

Investigation positions approximated from site operative's notes.
