# APPENDIX 3.1 – Built Heritage Impact Assessment and Setting Assessment

## Phase 2 – Kirklees Cultural Heart – Combined Museum & Art Gallery

On behalf of Kirklees Council

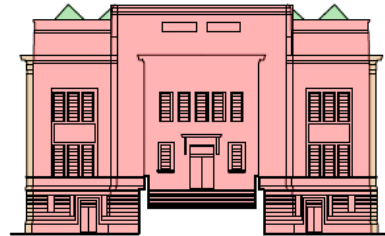
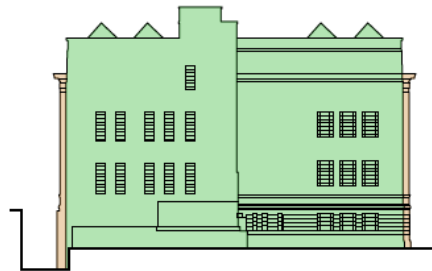
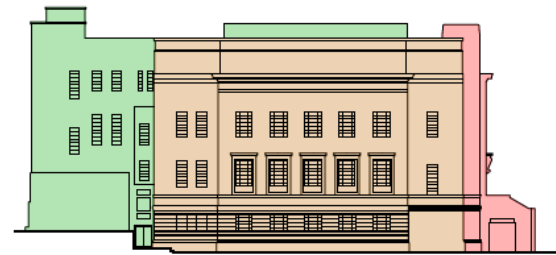
### 4.9 - SUMMARY OF SIGNIFICANCE - Elevations

SOUTH - PRIMARY ELEVATION

EAST - SECONDARY ELEVATION

- 4.14. The following pages are extracts from the Statement of Significance that summarise the building's significance in floor plans and elevations.

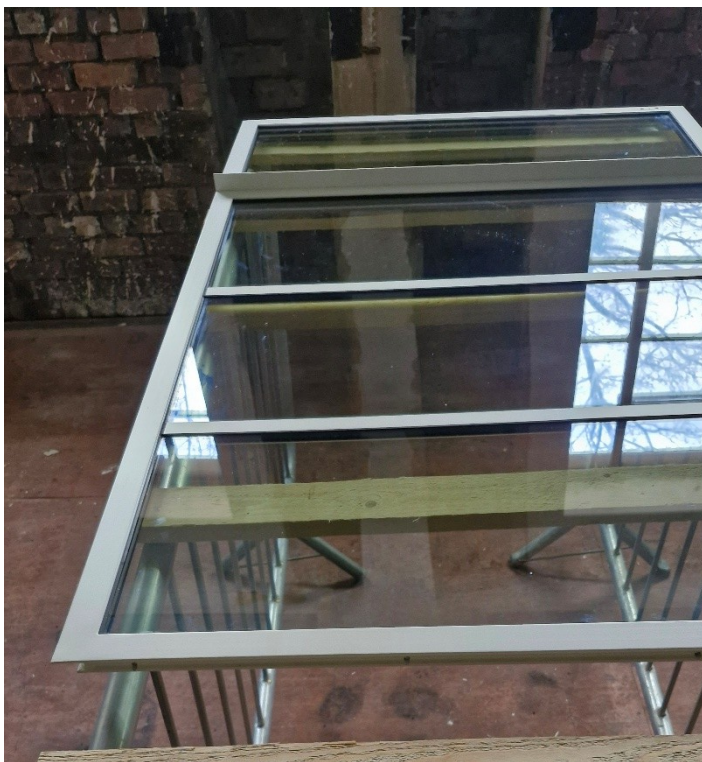
Plate 8: New (sample) Crittall window, showing the external appearance.

- 5.27. A sample of the proposed replacement window has been prepared and demonstrates that the general appearance of the existing windows can be replicated with the emphasis placed on the horizontal glazing bars. Whilst the flatness of the appearance of the glazing bars will be replicated externally, as shown by the original window drawings, the internal profile of the bars is unlikely to be fully be replicated due to the lack of glazing beading and operating openers (Plate 6 to Plate 8).

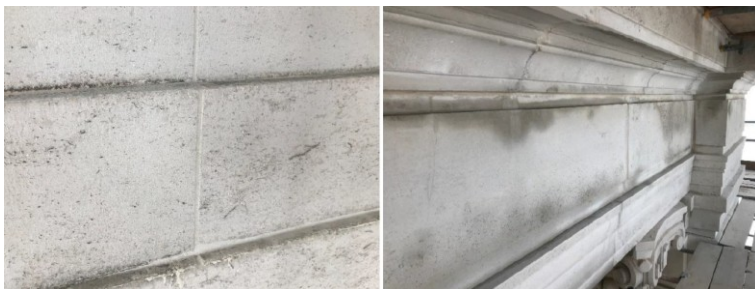
Plate 9: Examples of a completed system with the CP anodes chased and over mortared, albeit in a Portland stone façade.<sup>37</sup>

- 5.38. The system would be installed predominantly from the external face as this is more effective, with anodes chased into the masonry joints of the facades. The joints will need to be widened from the current 5mm – 12mm up to 12mm. The CP system would then be grouted into the joints and over-pointed with an appropriate lime mortar.

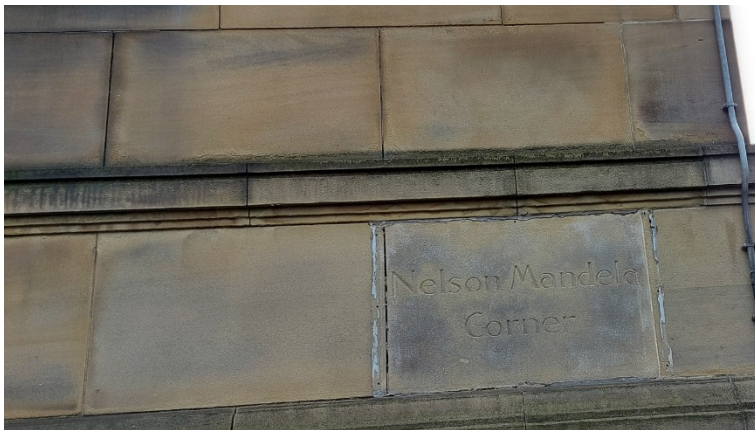
*Plate 11: Example of the open mortar joints to the facades.*

- 5.40. Overall, any notable change to the building would be from the widening of any joints on the masonry to accommodate the anodes. However, the existing mortar joints are varied and reasonably wide; the building was not constructed as finely cut ashlar where the appearance is mortar less. Further, extensive repointing of the facades is required, and currently the lack of mortar from joints is notable. Any widening is unlikely to be noticeable, and the subsequent repointing of the joints will be a visual improvement to the façade, and any minor harm that might arise is considered to be

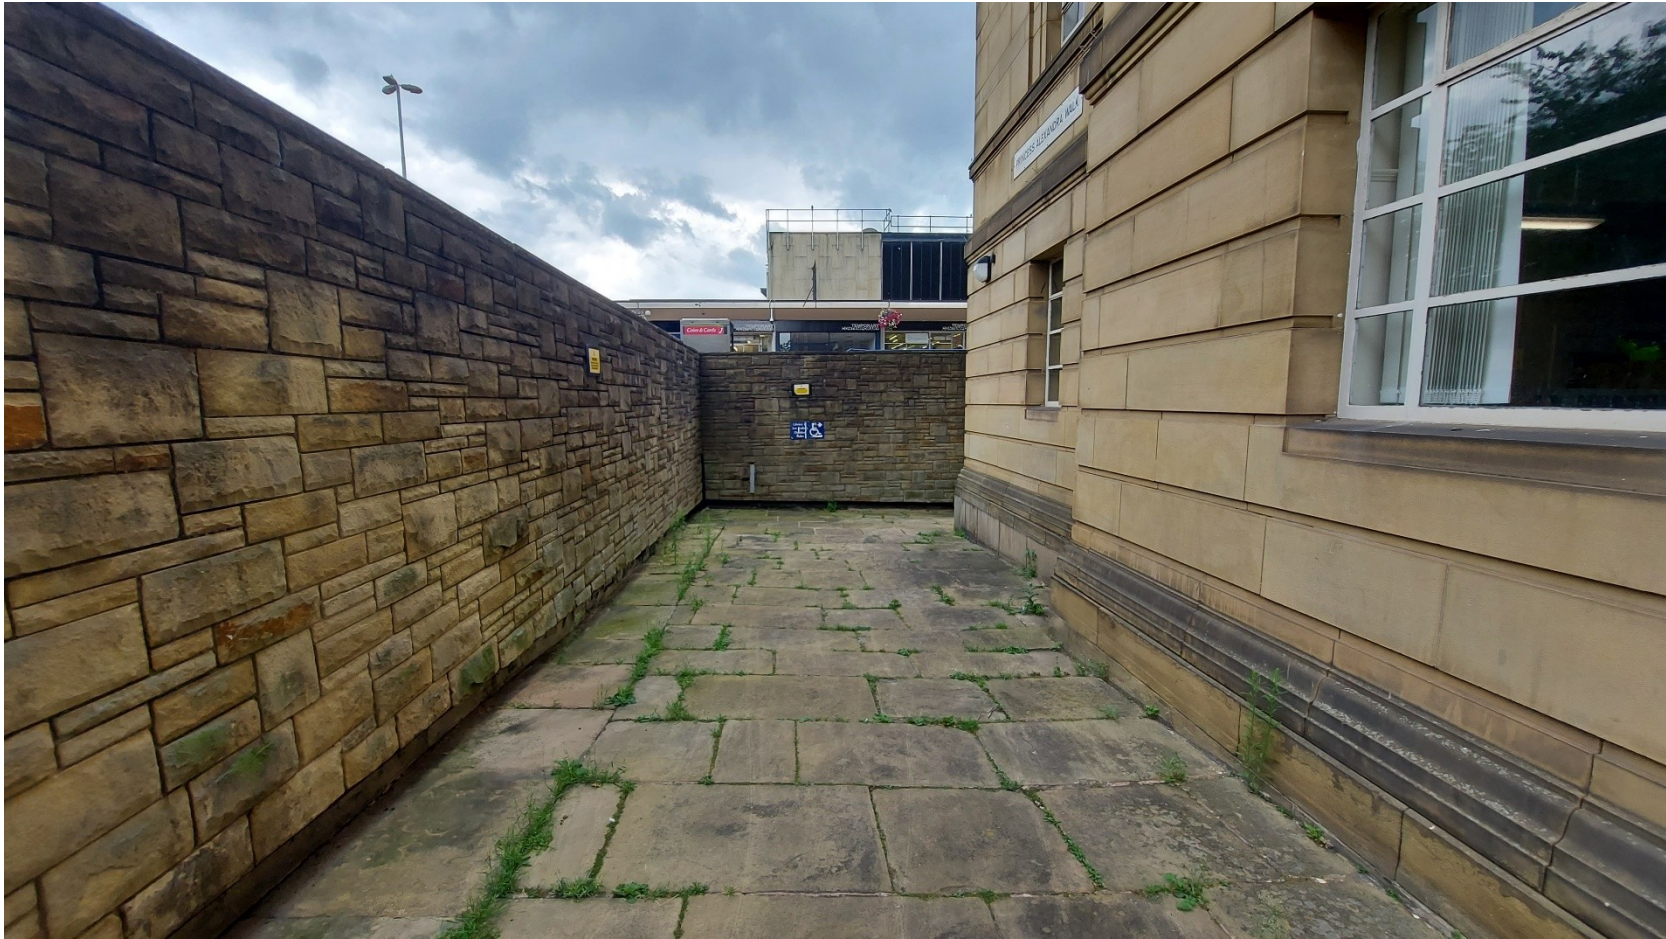
*Plate 12: The area of the proposed amenity space and new structures, showing the modern retaining wall as existing.*

| <p>5.46. The revised proposals now allow for the retention of the existing retaining structures, albeit modern (1960s) additions, and enable the creation of a private amenity space for staff and the Education Rooms. The omission of the ramp also allows this space to accommodate a new workshop, dry-prep area, and cycle storage.</p> | <p>5.50. Overall, the proposed changes within the setting will not result in the loss of any historic fabric and will have a neutral effect when considered against the previously consented scheme.</p> |

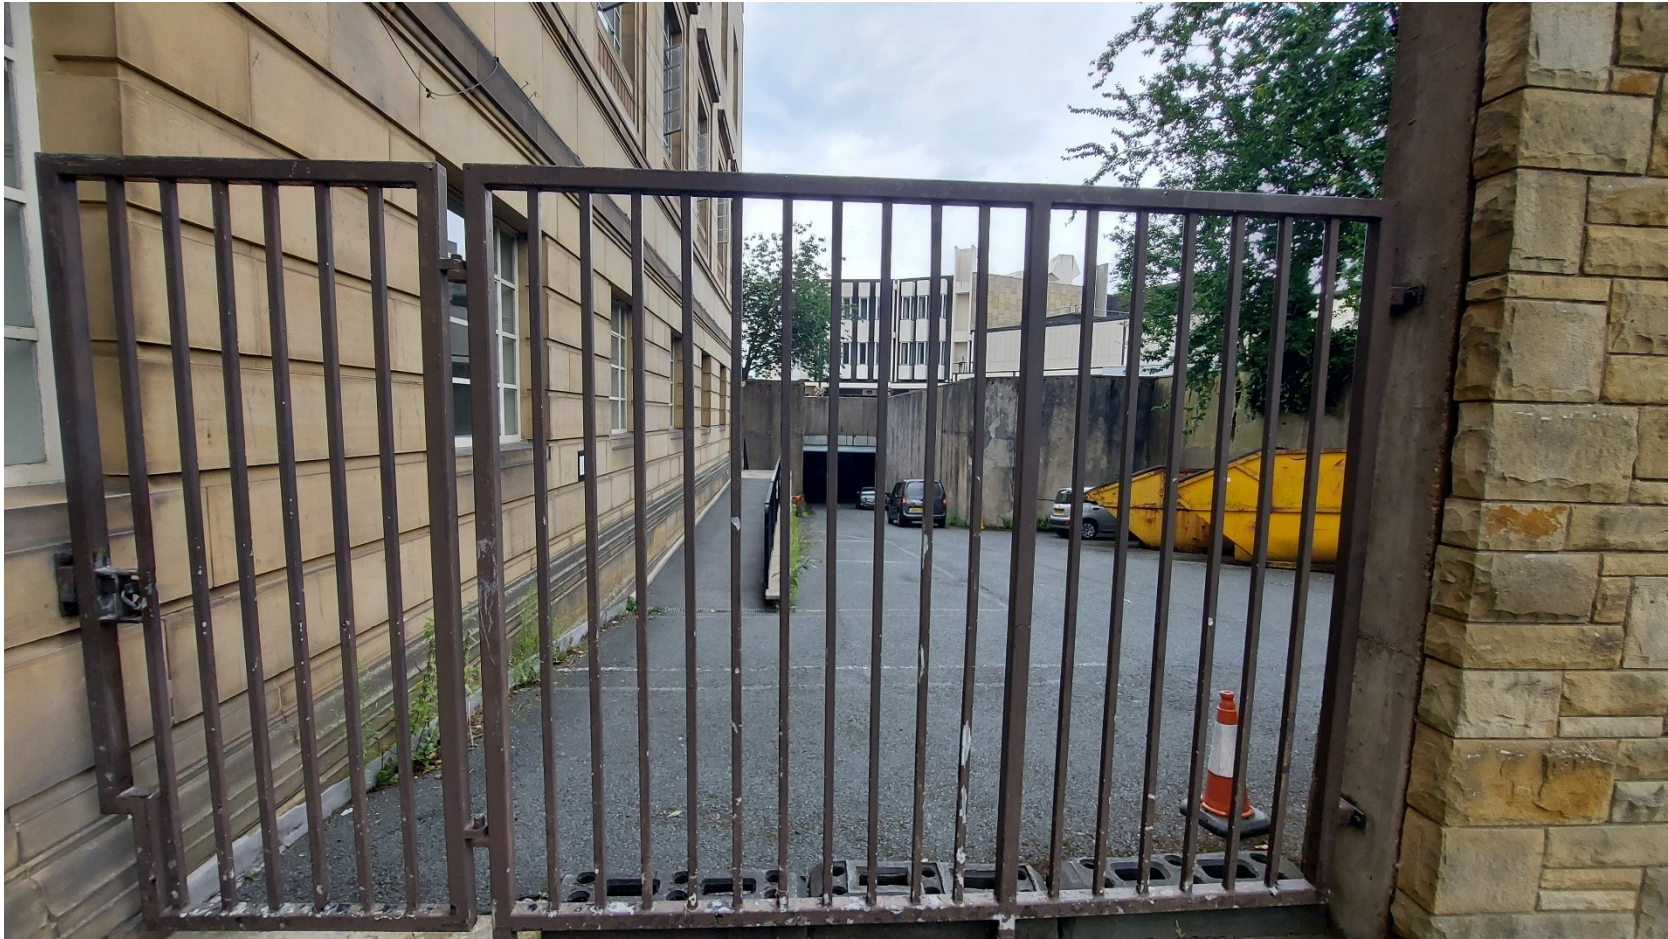
*Plate 13: The area of the proposed amenity space and new structures, showing the modern retaining wall as existing*

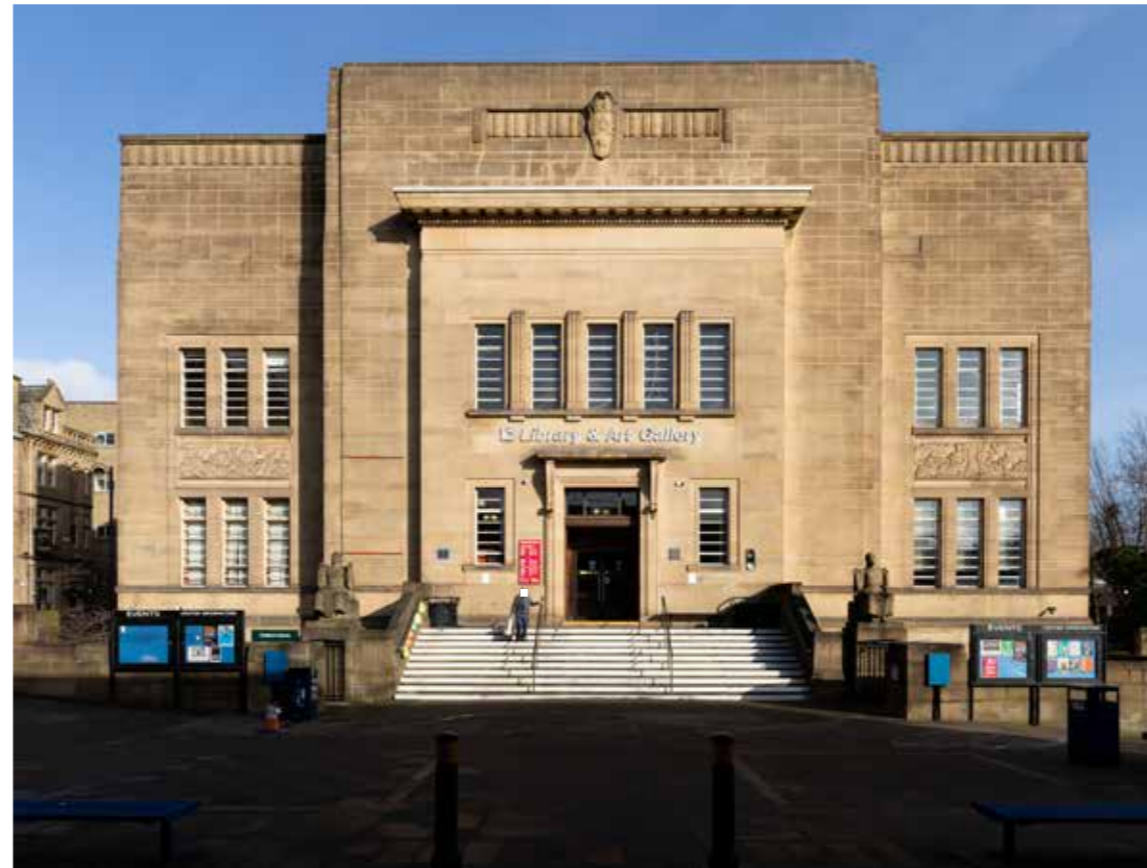
4.4.1 - South elevation onto Princess Alexandra Walk

This south-facing elevation is in a reductive Art Deco style with clear Egyptian and Greek stylistic influences. The entrance is somewhat pinched, set at the centre of the elevation below a series of five tall windows that describe the first-floor landing above the entrance hall. The public entrance seems too understated a gesture for the boldness of the elevation but is likely the consequence of achieving a practical threshold between inside and out. The two enthroned sculptures of 'Spirit of Literature' and 'Spirit of Art', by James Woodford RA and situated to the west and east of the entrance respectively, are of very high aesthetic and artistic value. These are carved from local stone and are highly significant assets in their own right, but also as components in the composition and stylistic execution of the primary elevation. Their inclusion emphasises the main entrance approach. Woodford also created the decoratively carved relief panels set in the spandrel between the ground and first floor windows, which comprise grouped figures symbolising arts and cultural activities. Bronze grilles that originally marked the entrance door head and windows flanking the entrance have since been lost. The central handrails on the approach stair are later 1980s additions.

As an aesthetic and architectural composition, the south elevation is carefully controlled and has an austere elegance. The detailing shows a strong transition between the Art Deco influences of the 1930s and the Modern Movement that was set to dominate.

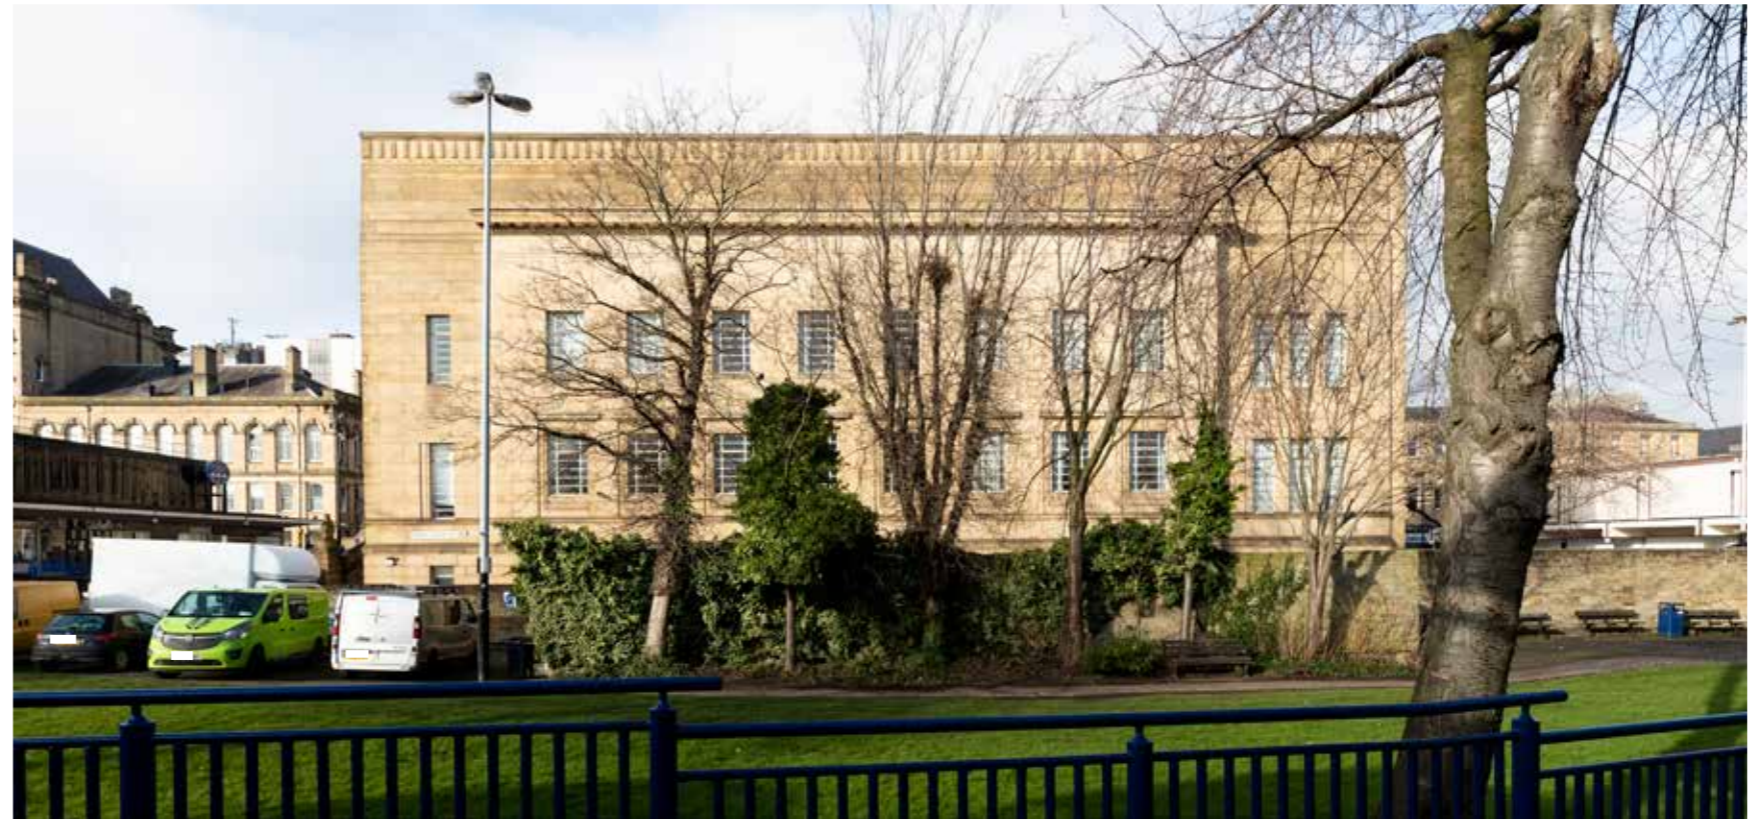
4.4.5 - East elevation facing the Piazza Shopping Centre

The façade of the Library was to be seen in the context of the primary elevation and as a continuation is of the same architectural aesthetic, but on a simplified canvas with reduced artistic adornment. The changes made to the surrounding townscape as a result of the 1969-1974 Murrayfield development left this elevation far more visible than Ashburner would have envisaged. Furthermore, the removal of Bull and Mouth Street and the subsequent formation of a steeply sloping route into subterranean tunnels has served to isolate this elevation from the public realm. This space was initially excavated to form a car park and adjacent delivery zone. The continuation of this as an access route from the tunnels to the upper street level was made some time after 1990.

The east elevation holds value for its architectural detailing, however the erosion of it imposes a negative impact on this aspect of the building.

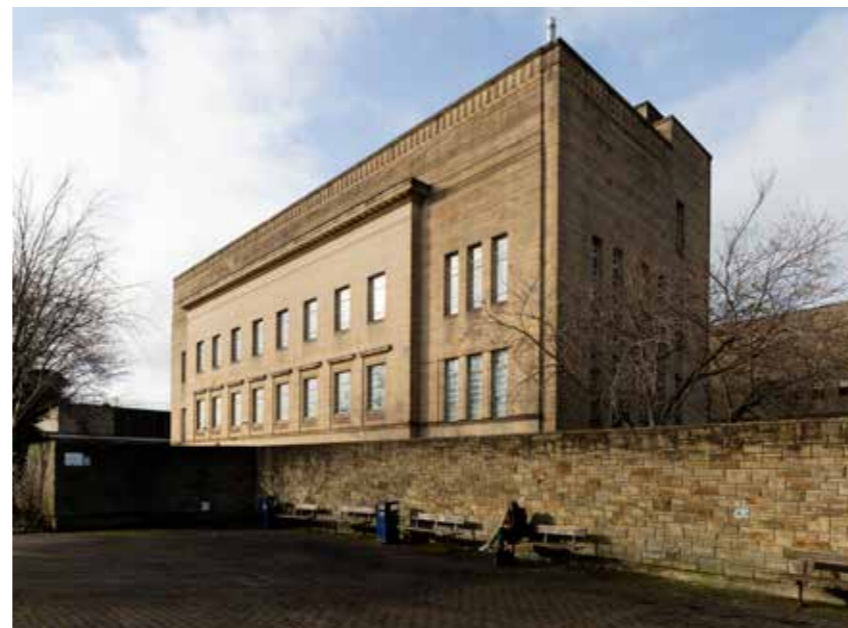
4.4.6 - East elevation facing the Piazza Shopping Centre

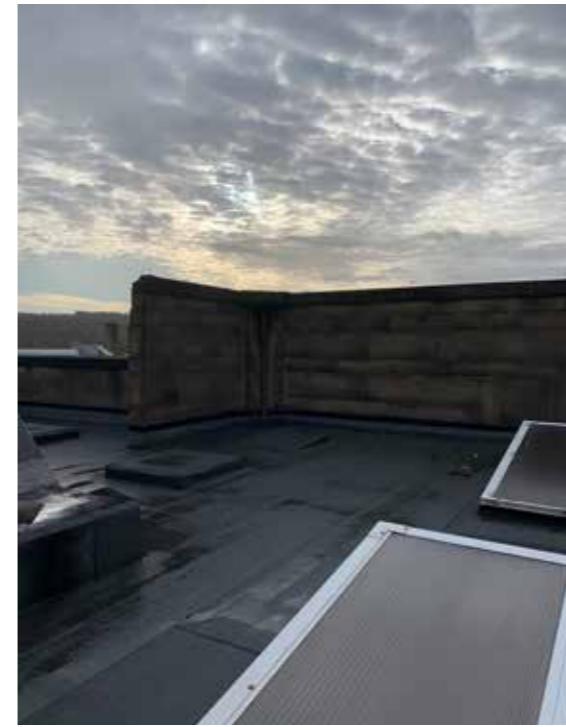
4.4.14 - Modern lanterns to roof

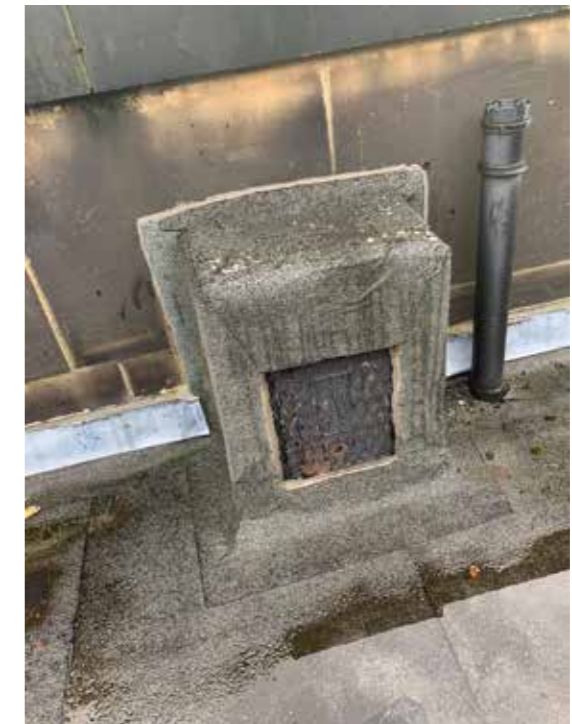
4.4.18 - Service access at roof

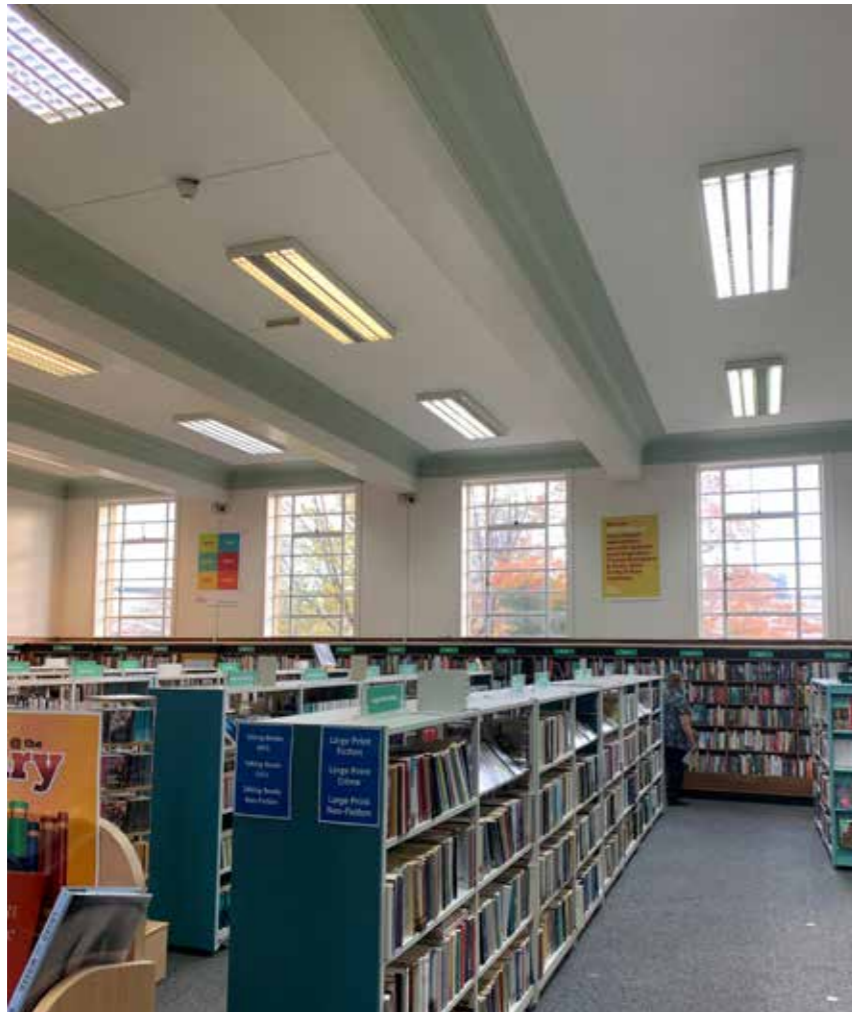
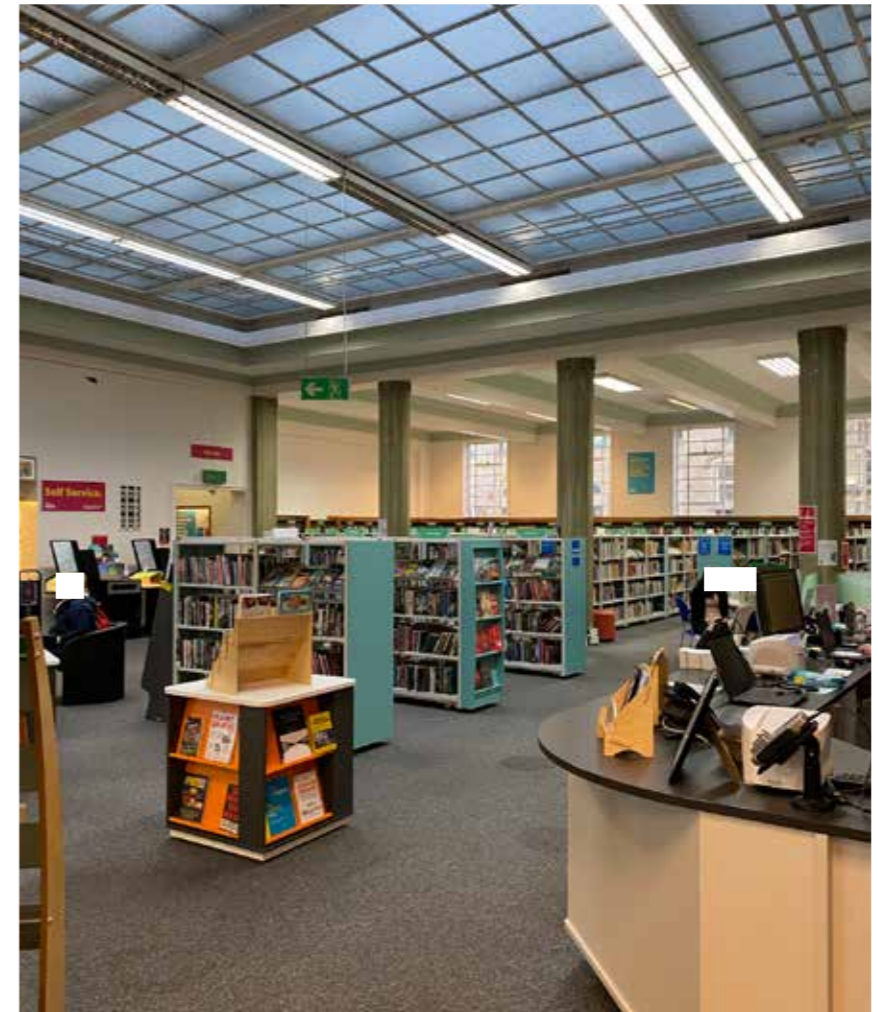
The fittings are a combination of original shelving to the perimeter with modern movable shelving within the floor plate and a modern serving counter. A number of original fittings and fixtures have been lost, including the original serving counter, turnstiles, shelving from the body of the floor area and electric lighting. It is also noted that the current room layout has been flipped from that of the original design, with the modern serving counter currently located at the north end of the plan.

4.5.6 - Main Lending Library (Rm.47)

4.5.8 - Main Lending Library (Rm.47)

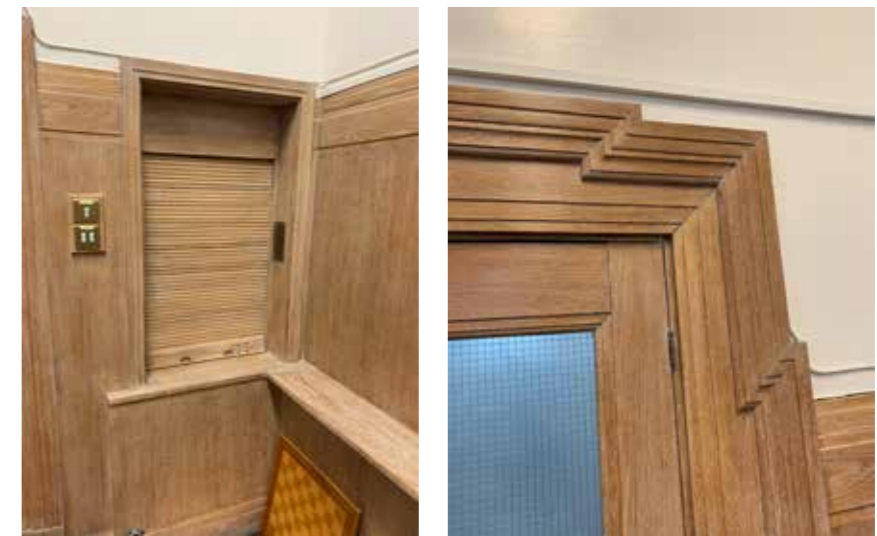
The room finishes are similar to those found in the main Lending Library. Original shelving is evident along the room perimeter only. Other joinery elements including the shelving, doors, architraves, wall panelling, and book lift have been stripped and treated to give the appearance of a limed oak finish. This is at odds with the aesthetic of the wider building and an inappropriate treatment for high quality joinery in this context.

4.5.14 / 4.5.15 - Timber detailing to Special Library / Graphic Novels (Rm.98)

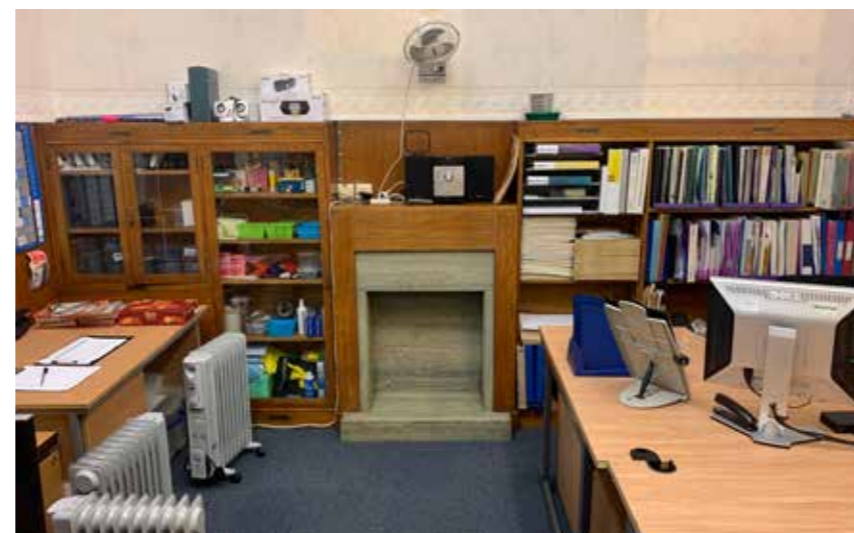
4.5.18 - Marble-lined fireplace in the Office (Rm.48)

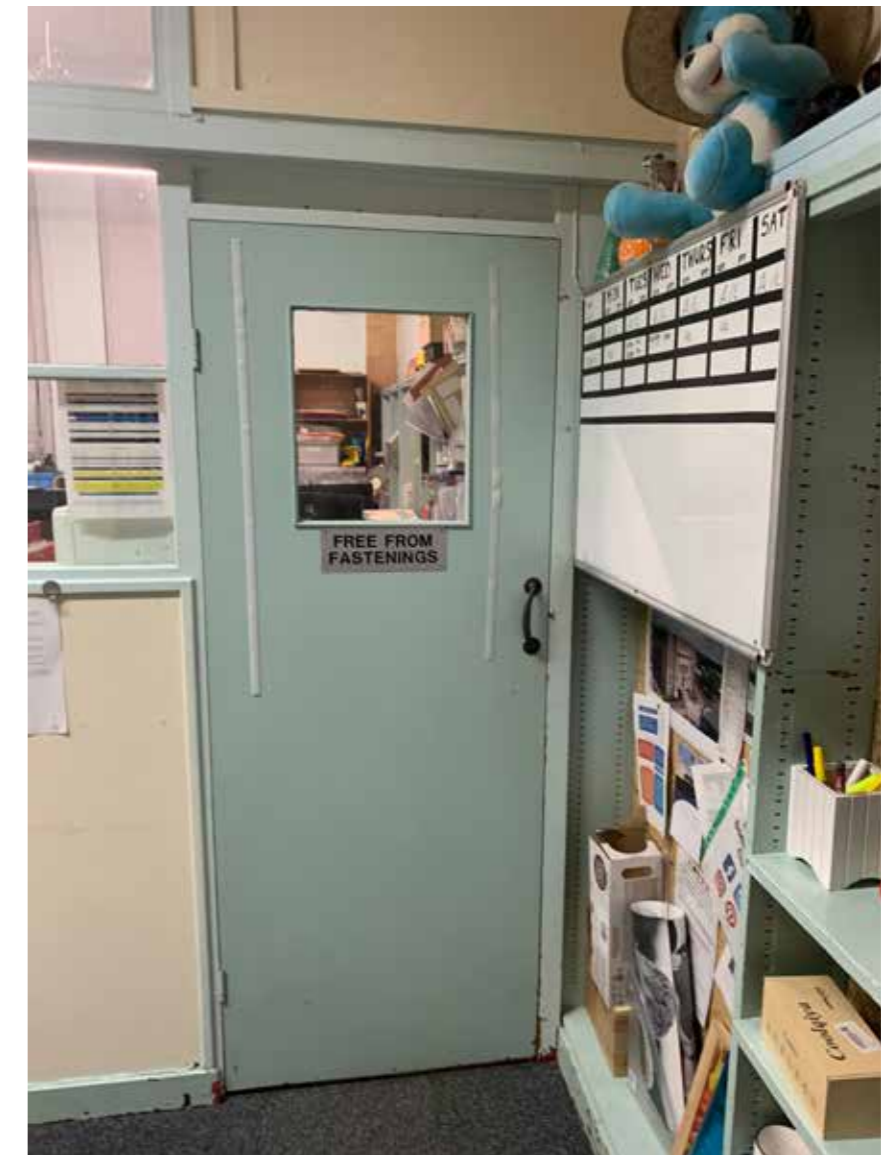
This room is largely introspective and appears to be windowless. The walls have been overlined with a thin boarding material that has been papered. The main ceiling is concealed above a suspended grid and the floor is lined with carpet tiles. There are no notable features of heritage value within this space.

4.5.29 - Administration Office (Rm.39a)

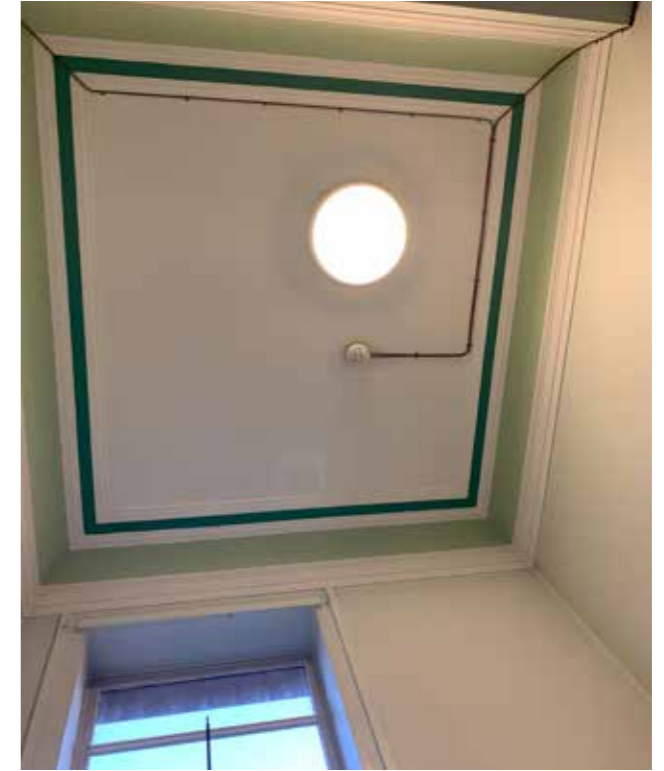
4.6.4 - Ceiling to First Floor Stair Lobby (Rm.71)

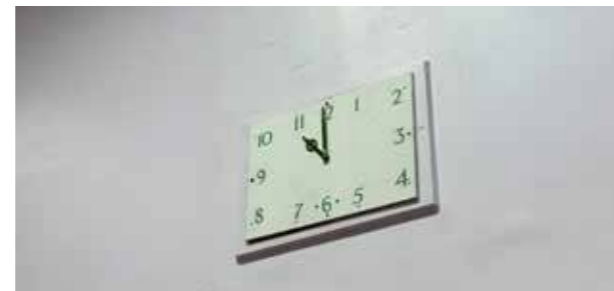
At the north end of the room, an original rectangular clock formally mains-wired with green painted numbers on an off-white face is set over a painted timber base and is similar in appearance to those found in other rooms. Original and modern picture hooks fixed to the walls, and modern plastic conduits are present in a number of areas on the walls and the ceiling.

4.6.10 - Wall clock in Local History Library (Rm.68)

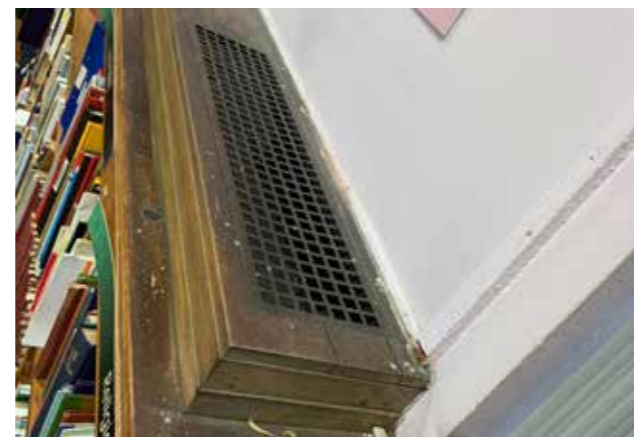
4.6.11 - Ventilation in Local History Library (Rm.68)

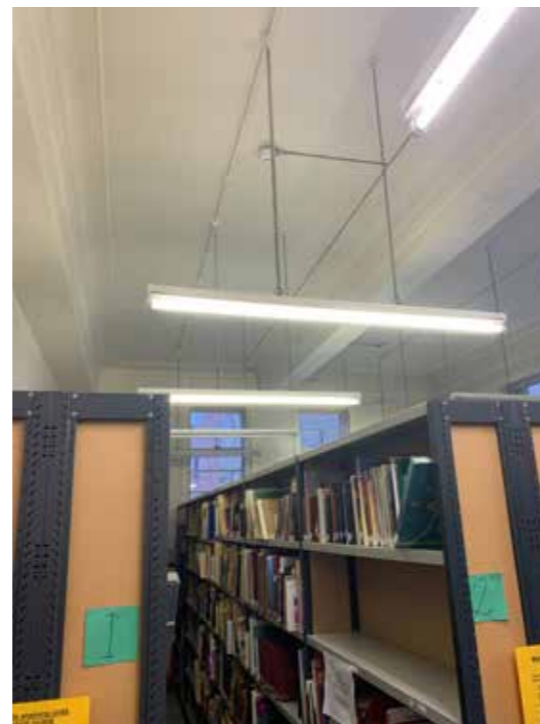
In its current form as a single space, the room has windows on three aspects, to the east, south and west. Vent grilles are evident at the window cills, indicating the presence of the ventilation system ducts behind the panelling. As with other rooms on this floor, the ceiling is divided into structural bays, each with decorative perimeter corncicing. The original lights have been replaced with modern florescent tubes set into surface-mounted reflectors.

Above the entrance doors from the Stair Lobby are the workings of an original clock, the majority of its movements of which have been removed. At the north end of the room, an original clock similar to that seen in the Local History Library survives, comprising light blue numbers at the quarter hours and strikes between on what appears to be a white acrylic or plexiglass face set over a painted timber base. A modern conduit rises to this, which may have been installed to replace the original power supply chased into the wall.

4.6.13 - Reference Archive (Rm.66)

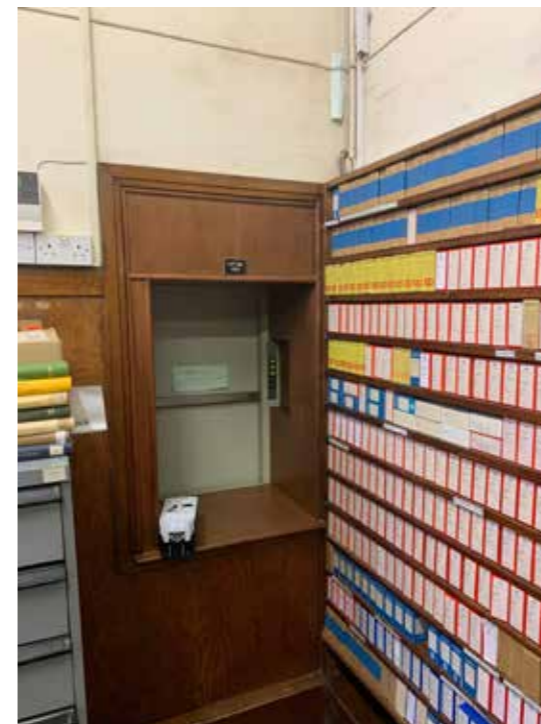
4.6.14 - Book lift in Reference Archive (Rm.66)

The floor is lined with the same modern patterned carpet found in the West Yorkshire Archive, Rm.68. At the north end, the former book lift opening has been boarded up.

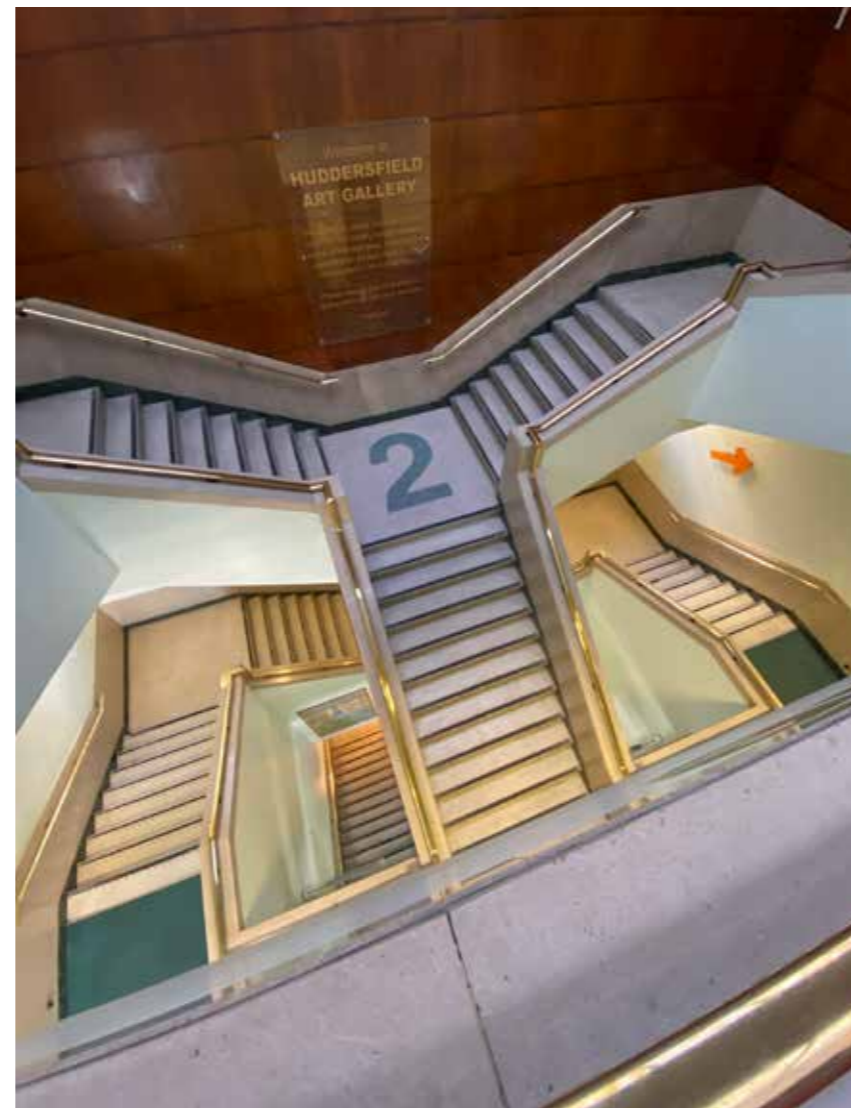
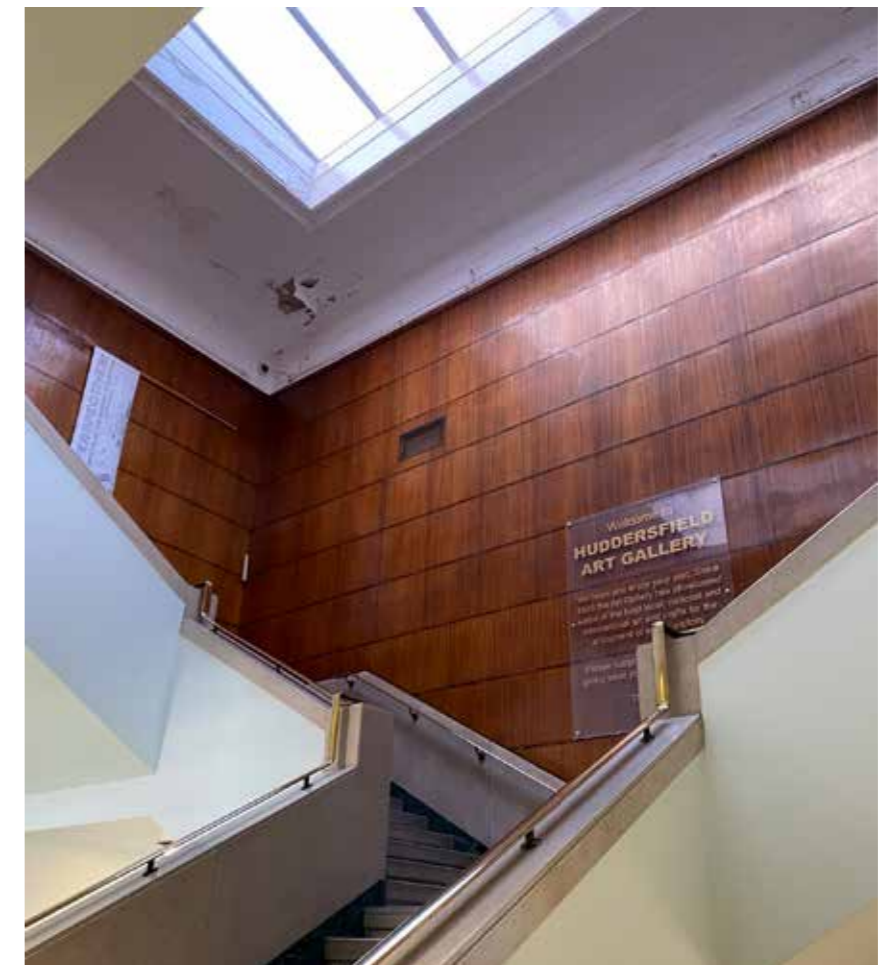
The second-floor Stair Lobby / Gallery Reception is substantially intact. The floors are lined with light and dark cork tiles in a basket weave pattern. Skirting to the Lobby corresponds with the finish of the wall generally. The walls of the Lobby comprise a combination of stained teak and walnut veneered panelling in a stepped profile and Swedish Green marble over buff light marble to dado level. Horizontal strips of walnut within the wall panelling disguises the presence of small vent openings. The wall panelling rises to picture rail level, above which there is a plain plaster frieze and a decorative plaster cornice. The ceiling has two large mono-pitched, north-facing roof lanterns, both of which comprise modern polycarbonate replacements of the original elements. The passenger lift in the south-west corner is also a relatively modern replacement.

4.7.1 - Gallery Reception / Stair Lobby (Rm.91)

4.7.2 - Gallery Reception / Stair Lobby (Rm.91)

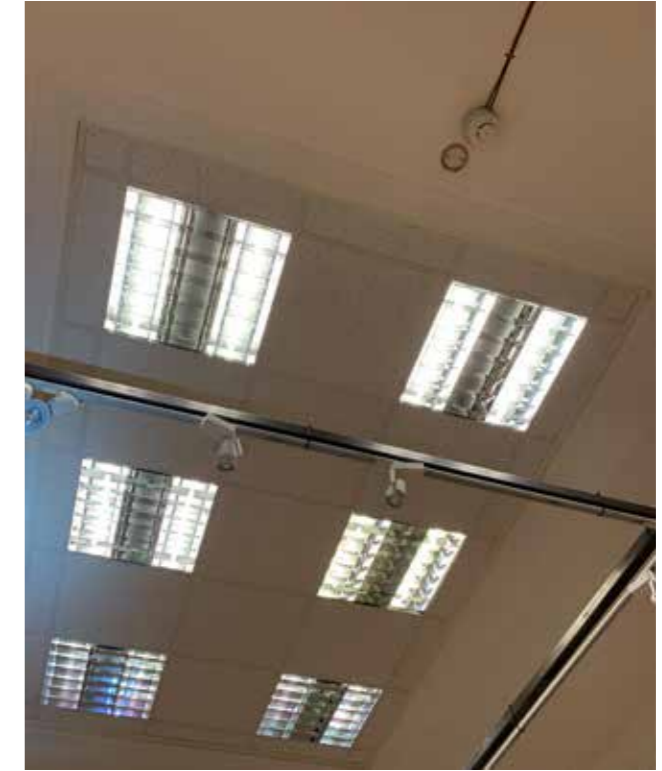
4.7.11 - Infilled rooflight opening to Gallery 1 (Rm. 87)

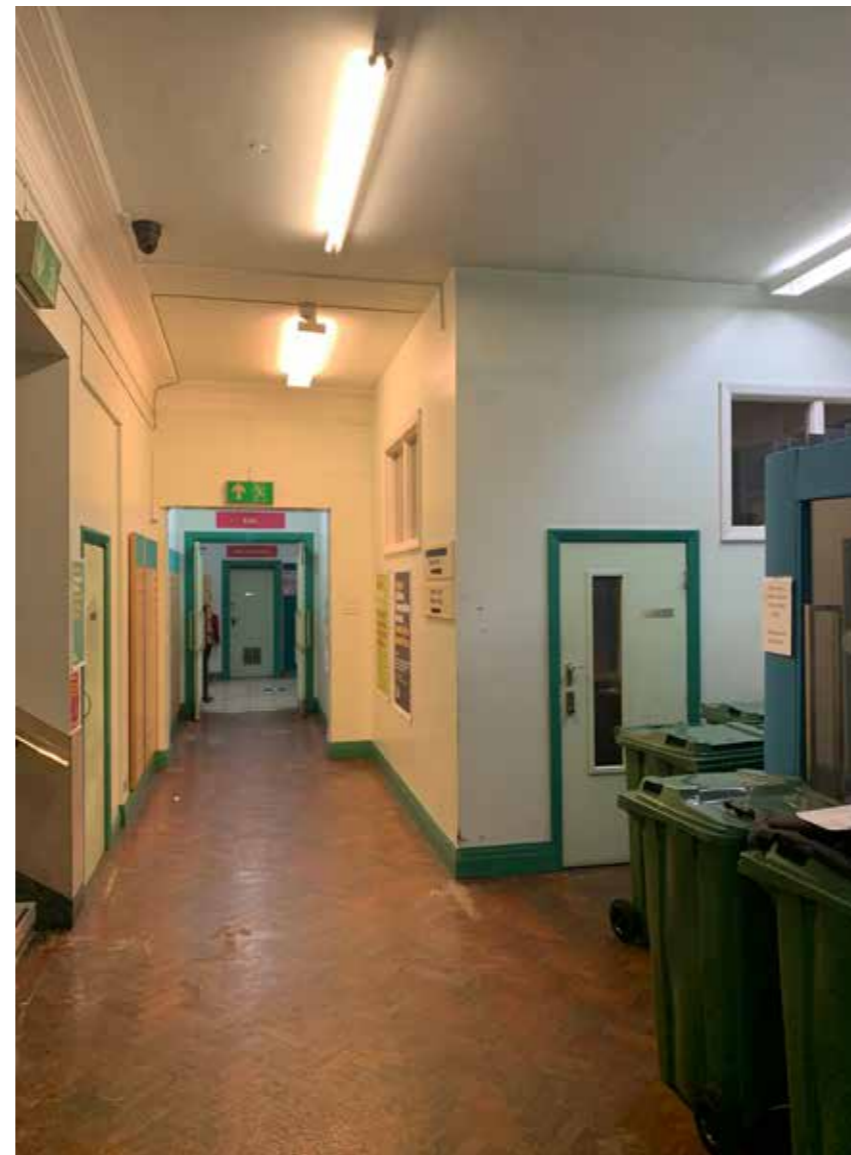
There have been a number of changes since the building was constructed, all of which appear to date from the 1960s or 70s. Double doors have been added across the top of the lower flight of stairs that separate the Lower Ground Stair Lobby from the main Entrance Lobby above. In addition, doors have been inserted through the return walls on each side of the stair to create small storage cupboards using space

appropriated from the Store behind (Rm.19). Within the Lobby, a modern partition has been inserted to form an additional new Store (Rm.26). This adaption has disrupted the character of the Lobby, changing it from an open and symmetrical area designed with the potential for collections display into a more serviceable circulation space. This has had a large impact on the potential quality of the room.

4.8.1 - Lower Ground Stair Lobby (Rm.24) with new room on right (Rm.26)

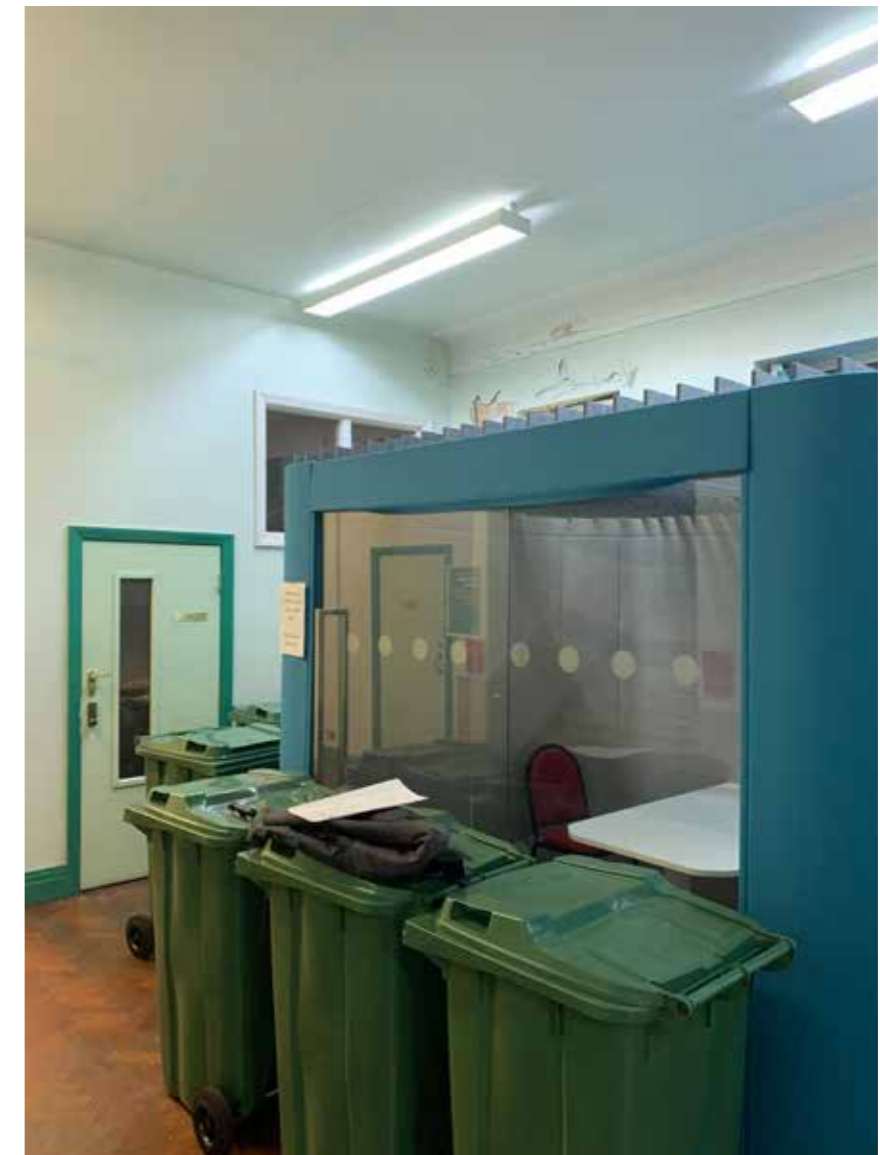
4.8.2 - Lower Ground Stair Lobby (Rm.24) with new room on left (Rm.26) and new enclosure

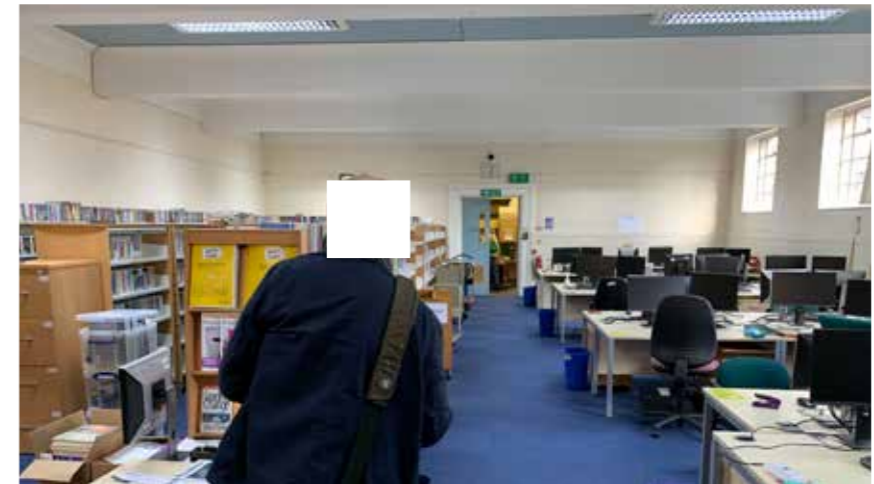
4.8.10 - Interlibrary Loans (Rm.31)

The internal door from the Lobby into the Interlibrary Loans Room is original, although it has been adapted with Georgian wired glass panels. The doors to the adjacent WC are flush and painted, although these may have original material beneath. Modern services are present throughout in the form of new fire, security and access systems. Light fittings are all modern replacements.

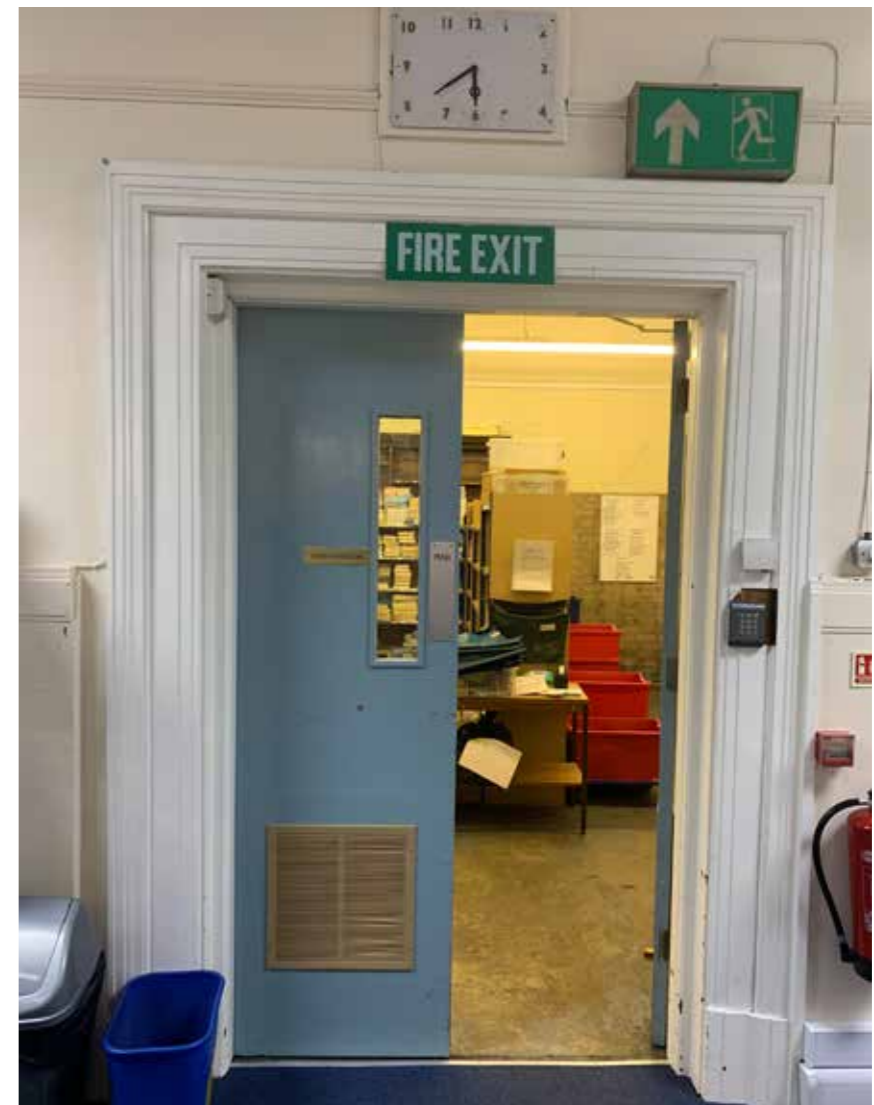
4.8.11 - Original clock and early fire signage in Interlibrary Loans (Rm.31)
