# APPENDIX 3.1 – Built Heritage Impact Assessment and Setting Assessment

## Phase 2 – Kirklees Cultural Heart – Combined Museum & Art Gallery

On behalf of Kirklees Council

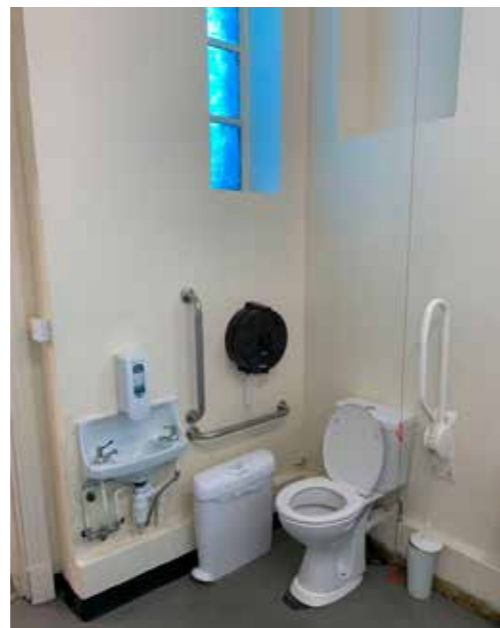
4.8.17 - Accessible WC (Rm.27)

The Accessible WC is noted as a 'Men's Public Lav' on Ashburner's original plans, whilst the adjacent room is noted as an 'Attendants Room'. Both of these functions illustrate the use of and oversight for the adjacent Newspaper Room, which was intended as an area designed for regular access by men. This 'Men's Lav' is now the Accessible WC, although nothing remains of its original finishes. The 'Attendant's Room' has become the Server Room, and has evidently functioned as a storage area for many years. It has therefore retained its earlier decorative scheme with original joinery skirtings and architraves. The floor is the original oak woodblock laid in a herringbone pattern.

The Accessible WC has no aesthetic and limited historic value. The Server Room holds some aesthetic value for its original finishes.

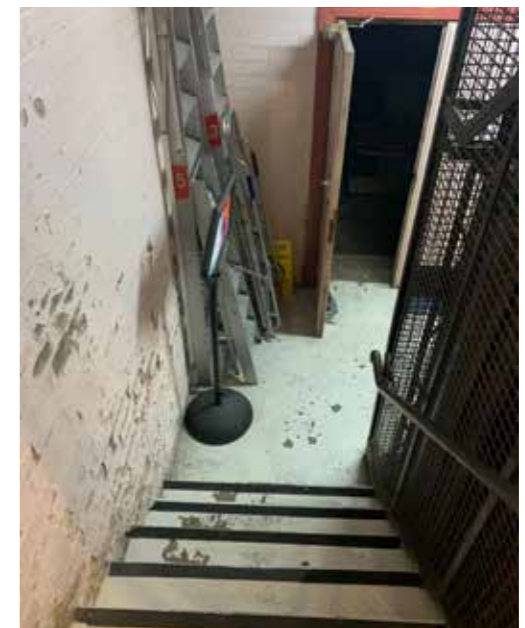
4.8.20 - Service Stair and Lift (Rm.05)

Refer to assessment description for ground floor Service Stair and Lift (Rm. 40 & 41).
