Our Ref C5402/25/E/8536
4th December 2025

Ref: Ground Gas Assessment

Whistlestop Valley,
Clayton West

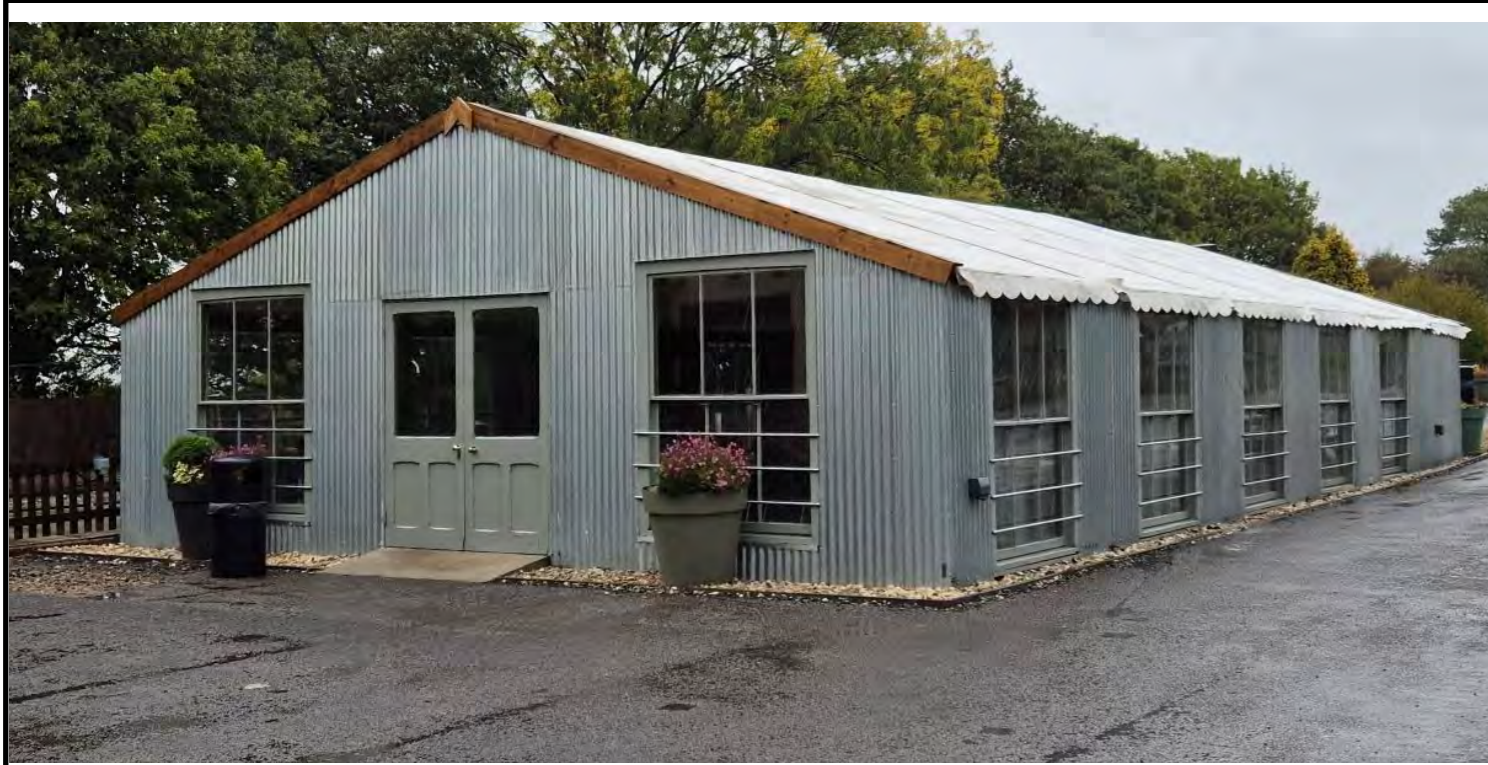
Photo 1: Structure constructed at Whistlestop Valley. Stone layer can be seen externally.

- A bed of crushed stone was installed at surface.
- A layer of Visqueen (damp proof membrane) was placed above the stone.
- No anchorage and no footings were installed.
- A marquee framework was constructed, with scaffold board flooring. Metal wall cladding and windows were subsequently installed.
- A stone layer forms a ~300mm wide decorative perimeter around the building, beyond which permanent hard-standing (asphalt) is insitu.

In view of the above, it would appear that the client has inadvertently installed a good performance dispersal layer.

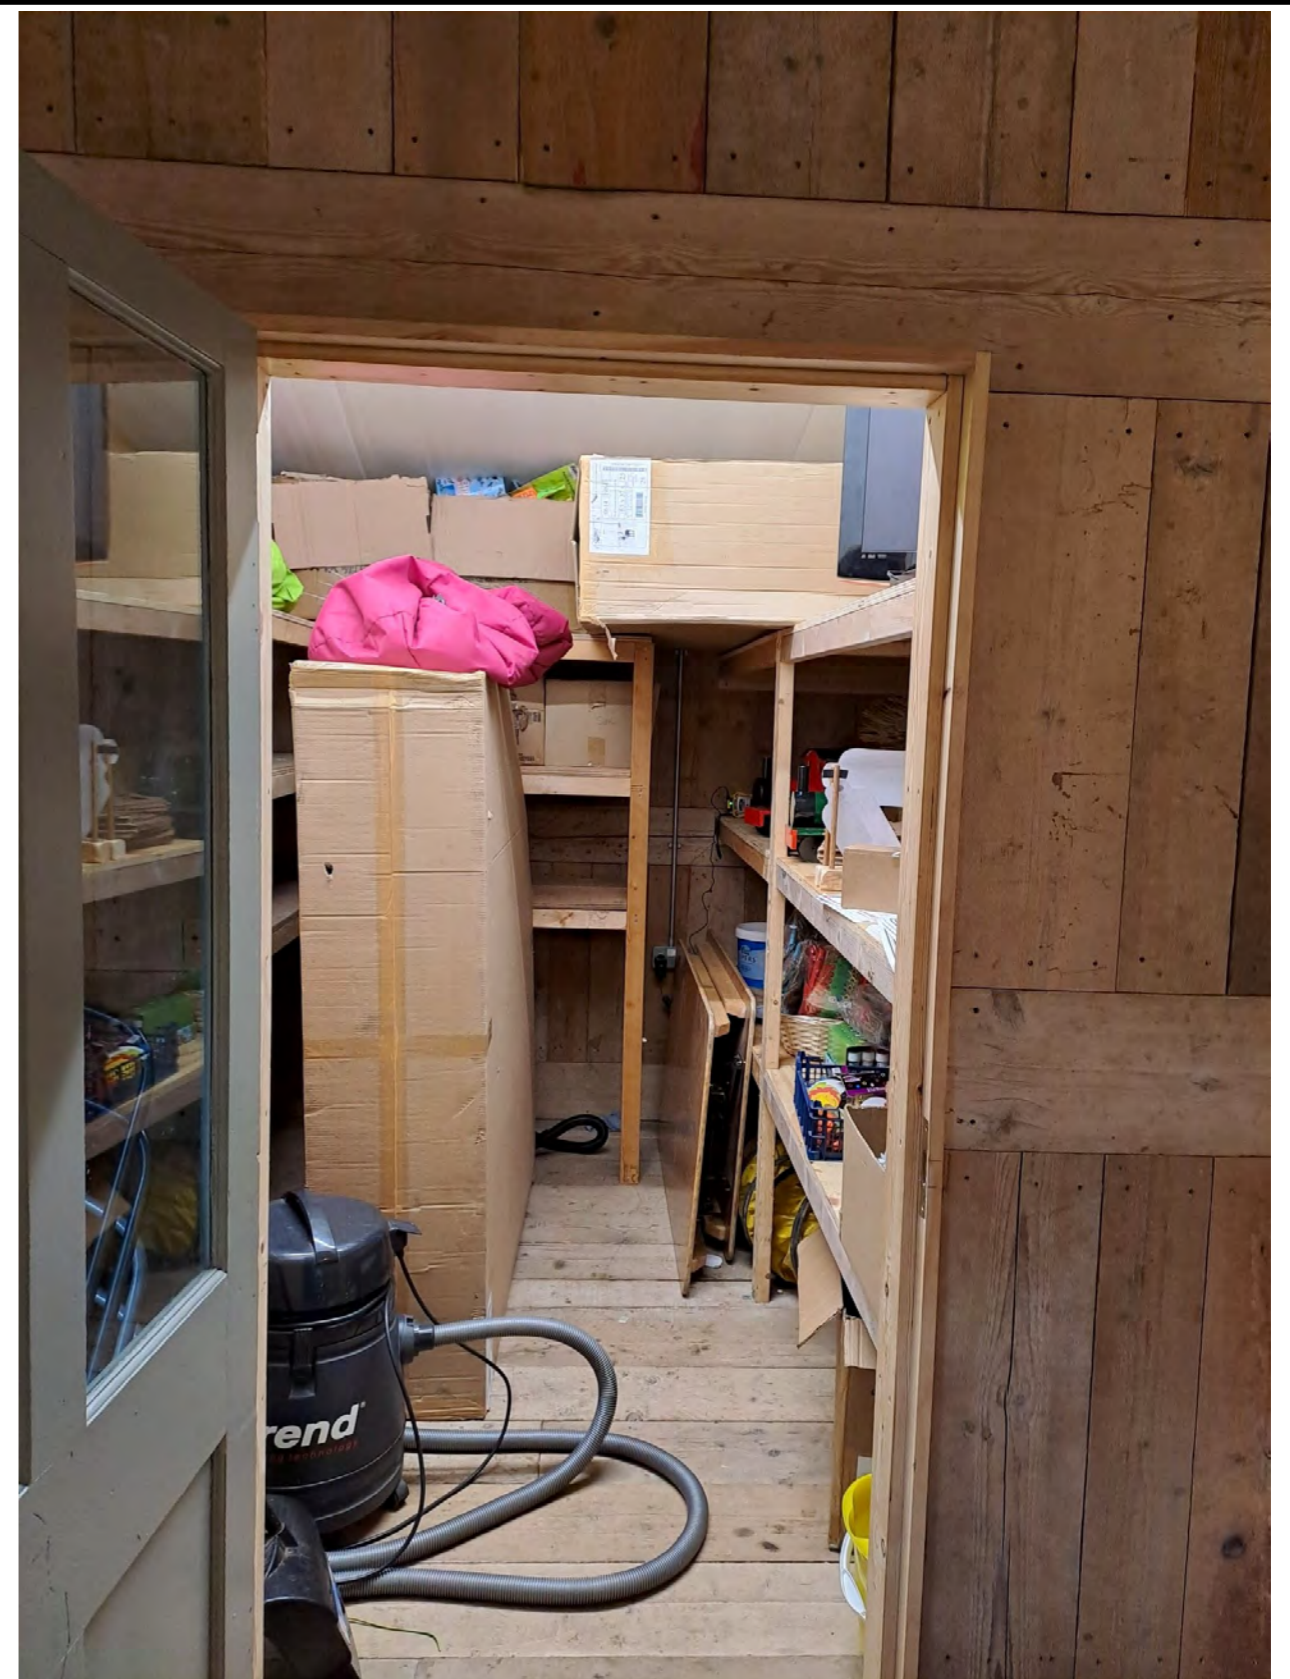
Photo 3: Storeroom.

The structure comprises a large open area, with a smaller storeroom in the south-eastern corner. As this storeroom represented the most likely area for gas accumulation, the monitoring unit was placed within this room for three weeks. It is understood that the structure was not utilised throughout the monitoring period for business. Notwithstanding this, it should be appreciated that the client was informed that all windows had to be closed throughout the monitoring period and where possible the door be left closed. During the visits conducted by RGS, on each occasion all windows were closed and doors were locked.

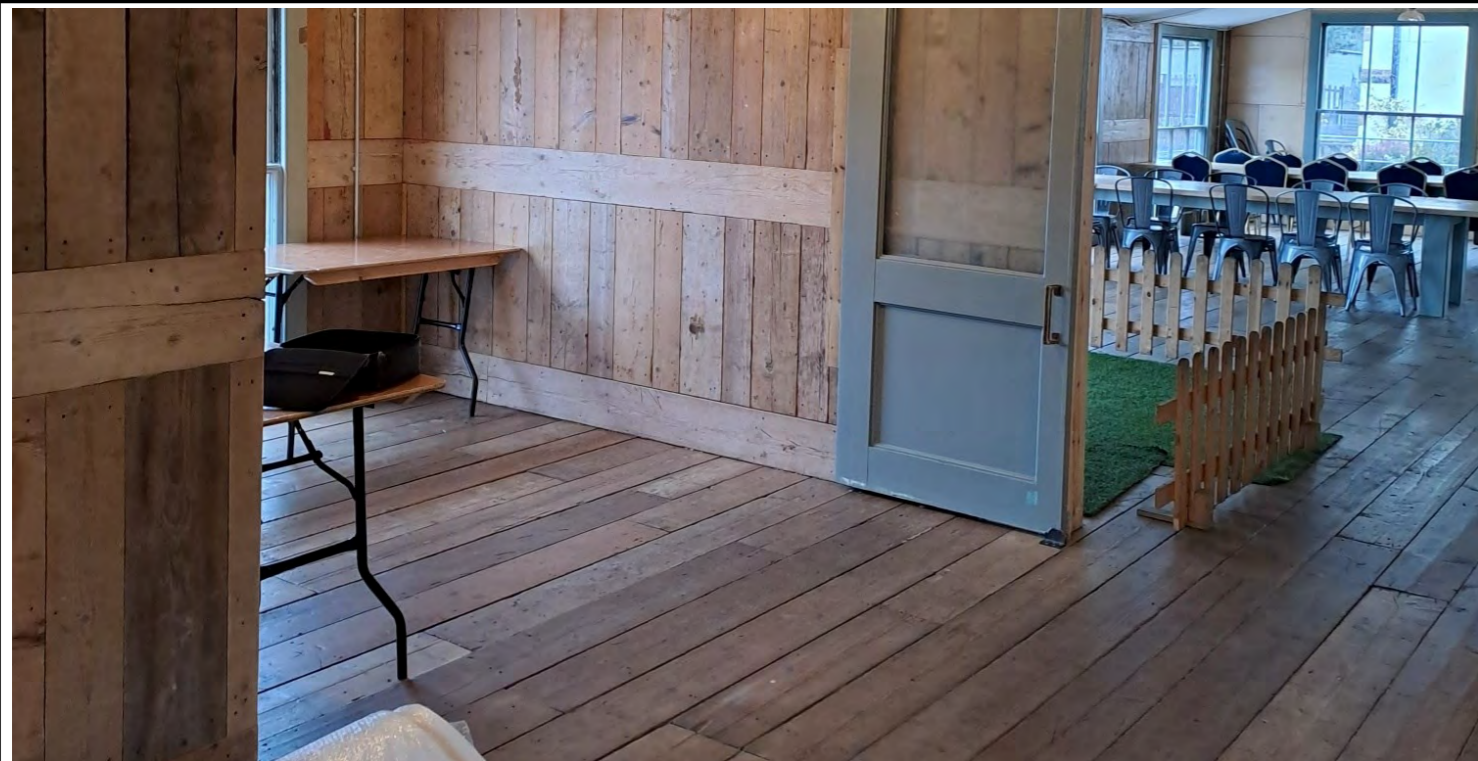
Photo 2: Walking in from east, it is evident that the majority of the structure is open plan.

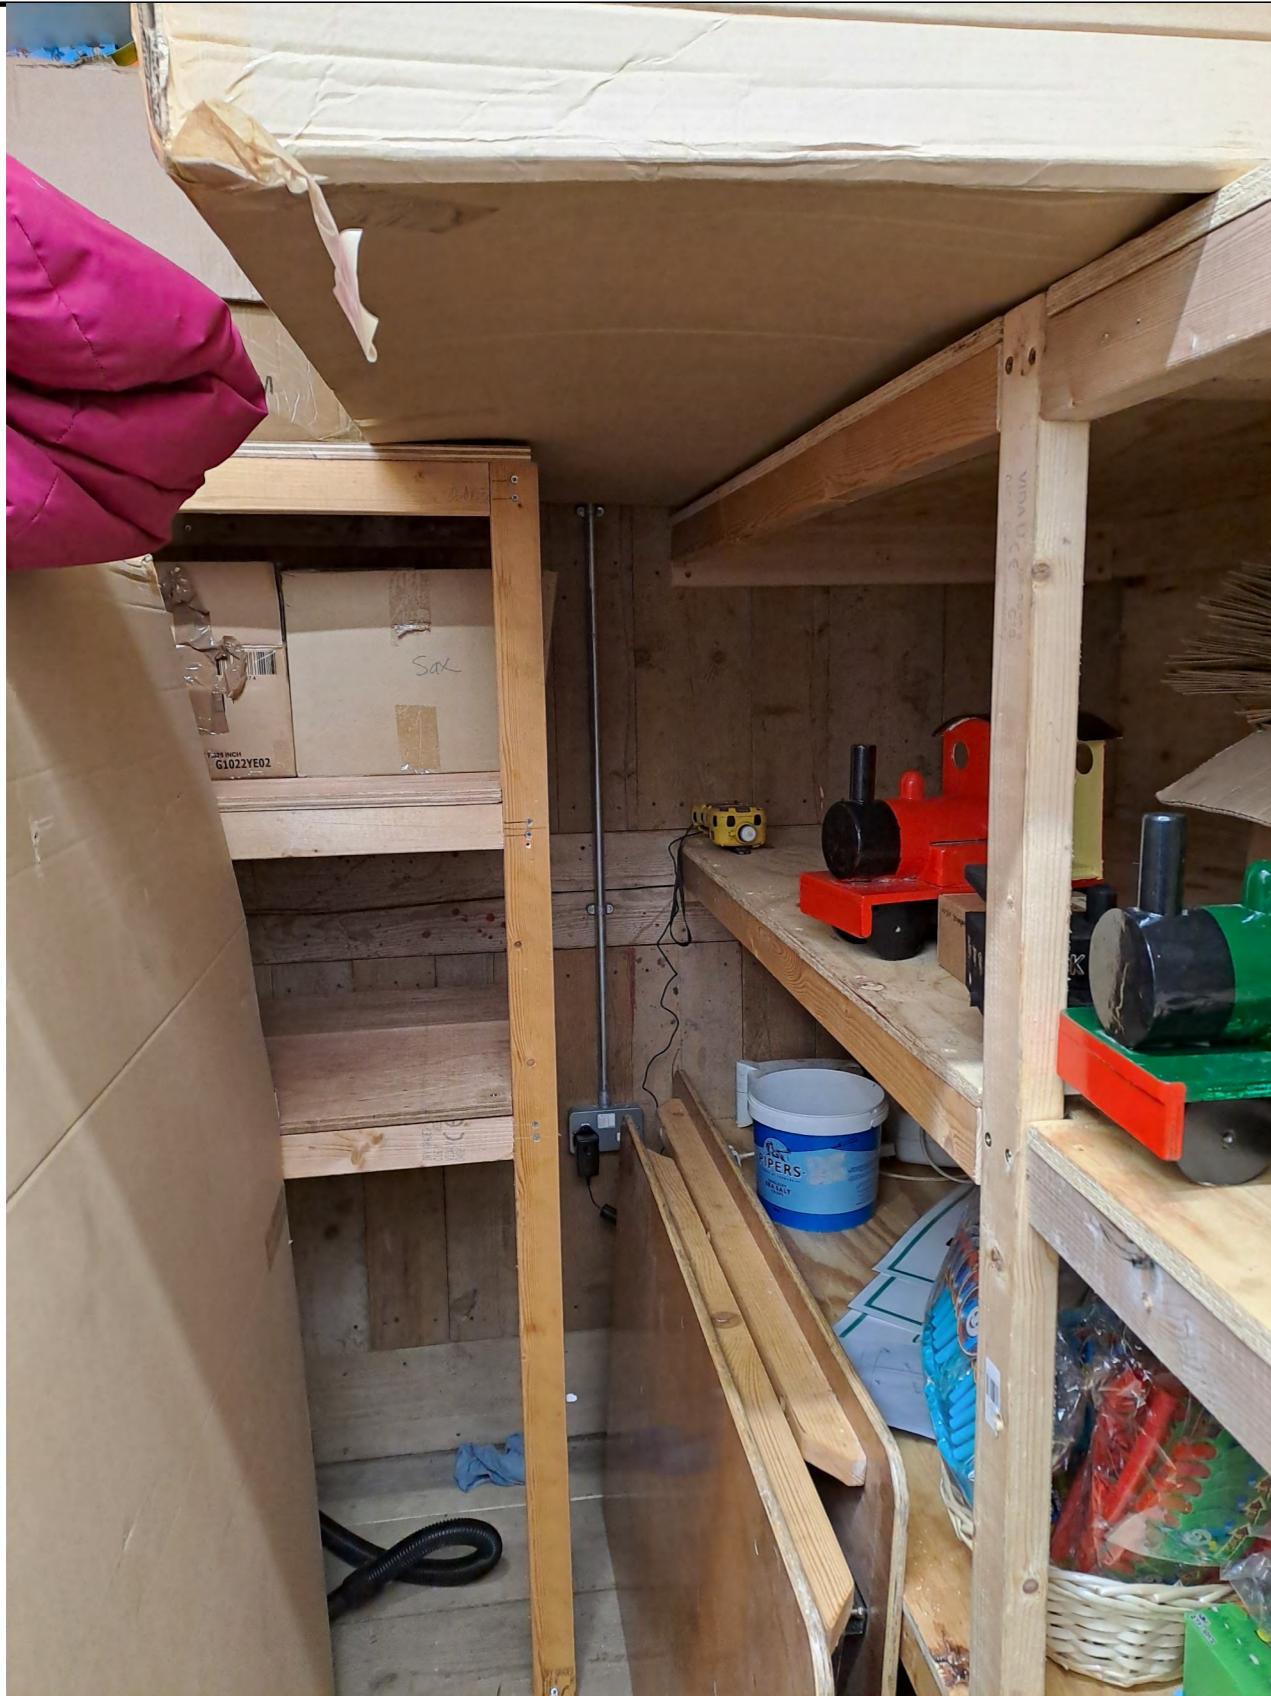
Photo 4: Monitor placed on shelf at the back of the storeroom.

A MultiRAE Lite (serial number M01C020115) was utilised for the monitoring period; see appended photographs for the placement of the machine. The monitor was set up to detect concentrations of oxygen, methane and carbon dioxide at minute intervals. Full records can be issued upon request, but a summary of the results is issued below:

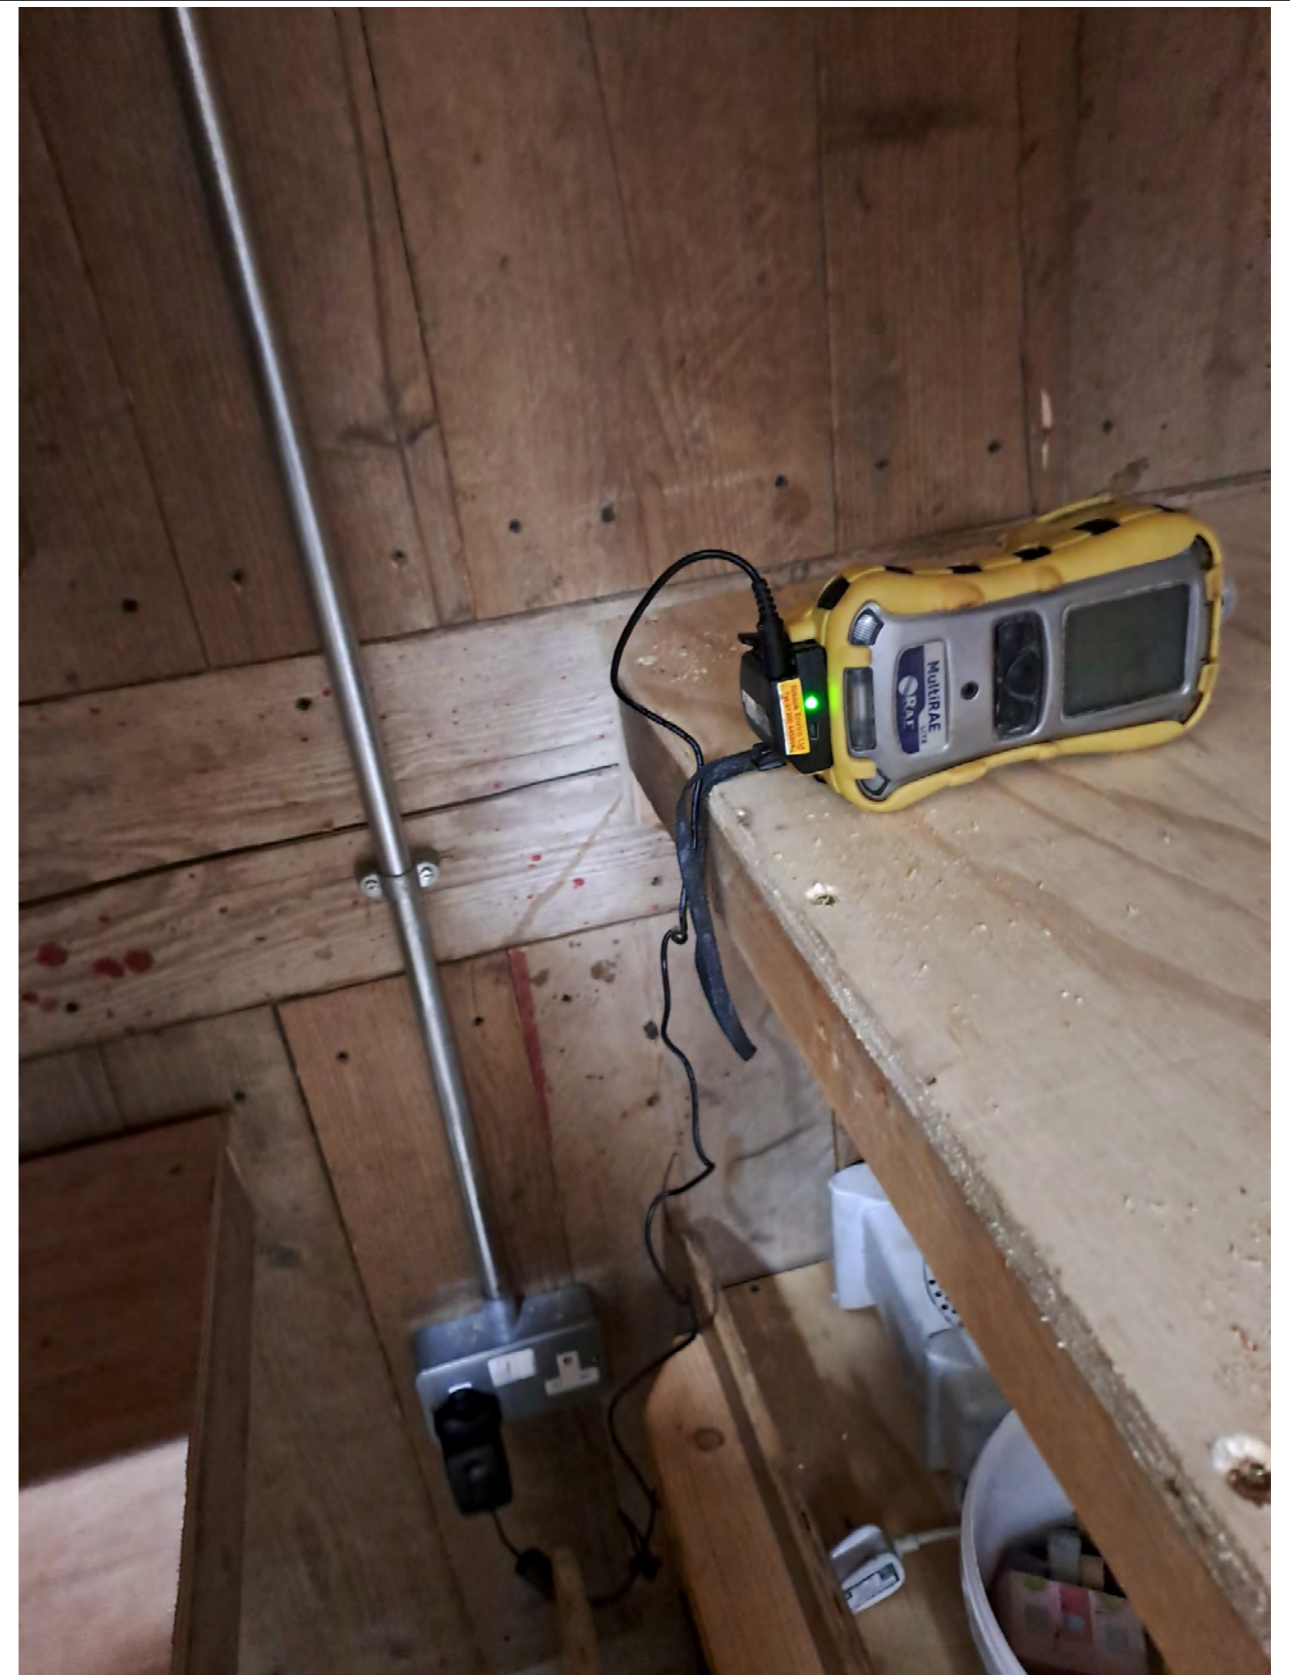
Photo 5: Monitor remained at this location and was collected 3 weeks after installation.

Table 1: Continuous Gas Monitoring – Max and Min Values				
Location	Value	CH ₄ (ppm)	CO ₂ (ppm)	Comments
Storeroom	Max	0.0	300	Equivalent of 0.03% CO ₂
	Min	0.0	200	Equivalent of 0.02% CO ₂
